**From:** [Kramer Donald](#)  
**To:** [Malinowski Edward](#)  
**Subject:** Materials Laboratory Factual Report - CEN16FA276 - Plainfield, IL - Piper PA-30, N7409Y - July 21, 2016  
**Date:** Wednesday, August 31, 2016 11:13:29  
**Attachments:** [IMG 0161.JPG](#)  
[Forward crankshaft piece.JPG](#)

Vehicle: Piper PA-30, N7409Y

NTSB No.: CEN16FA276

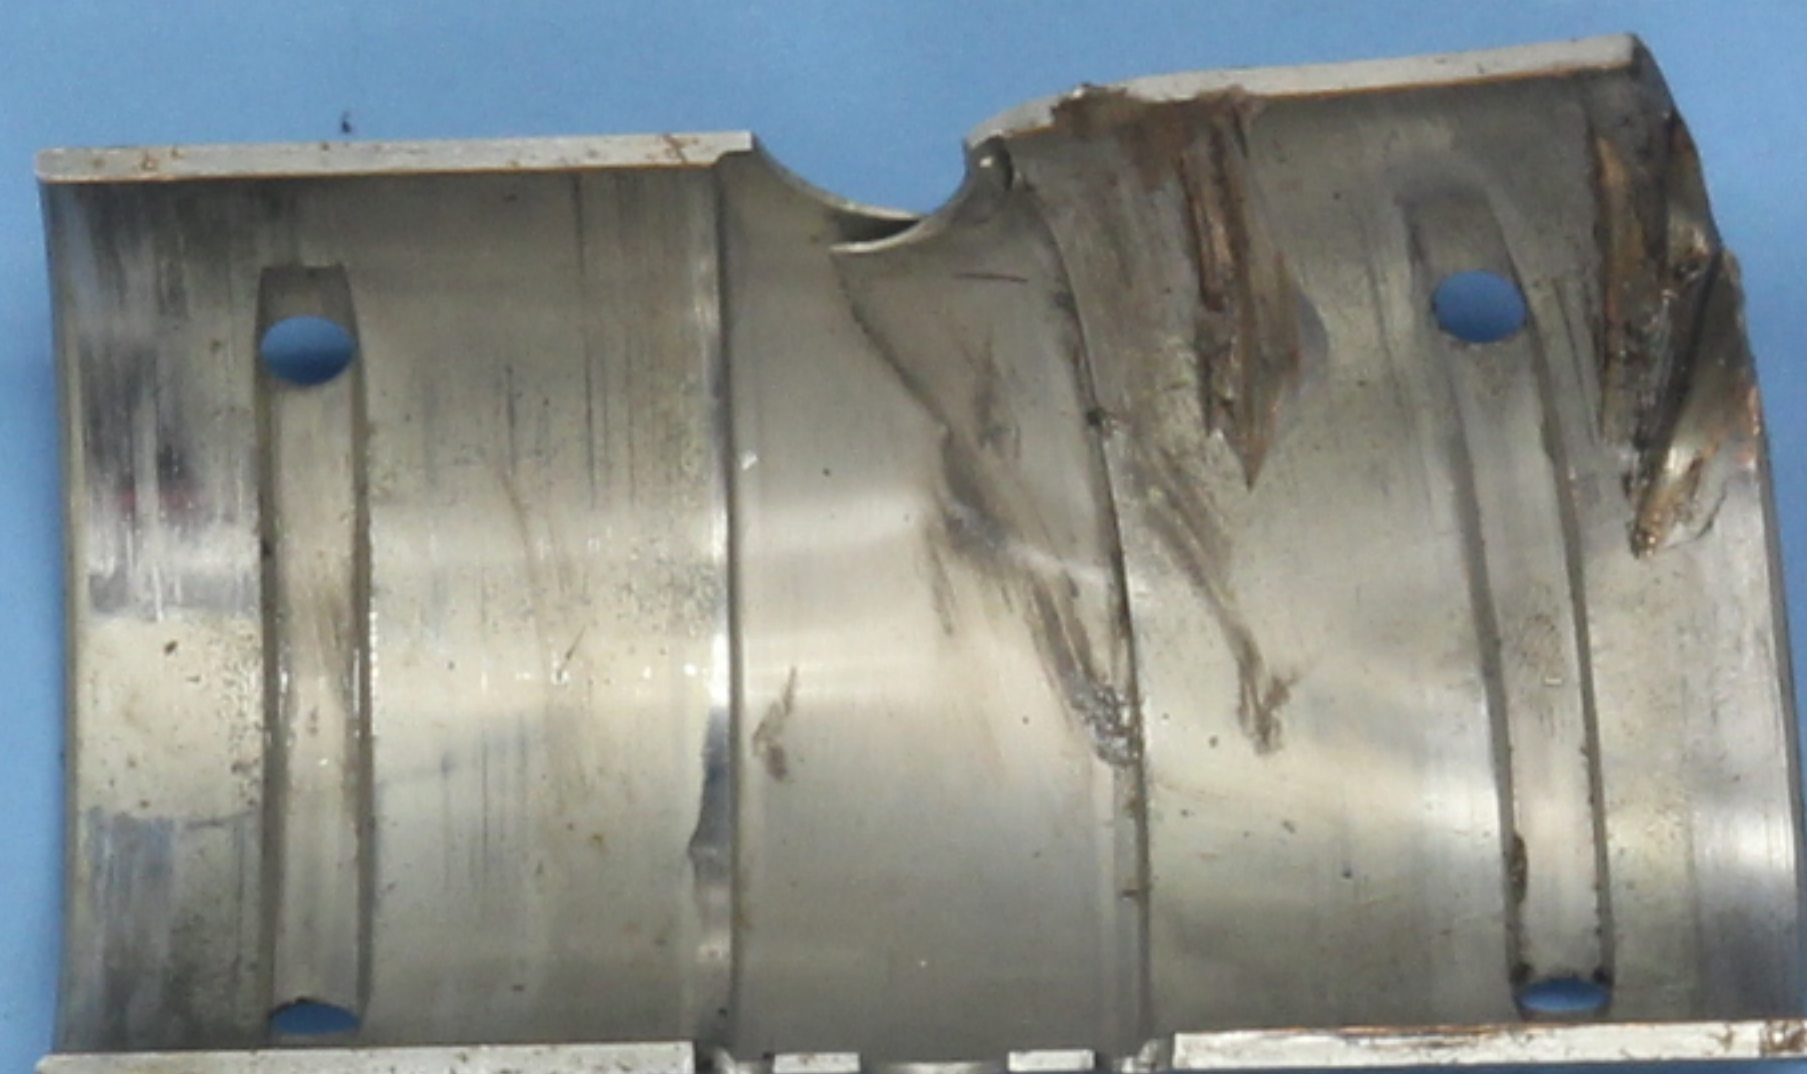
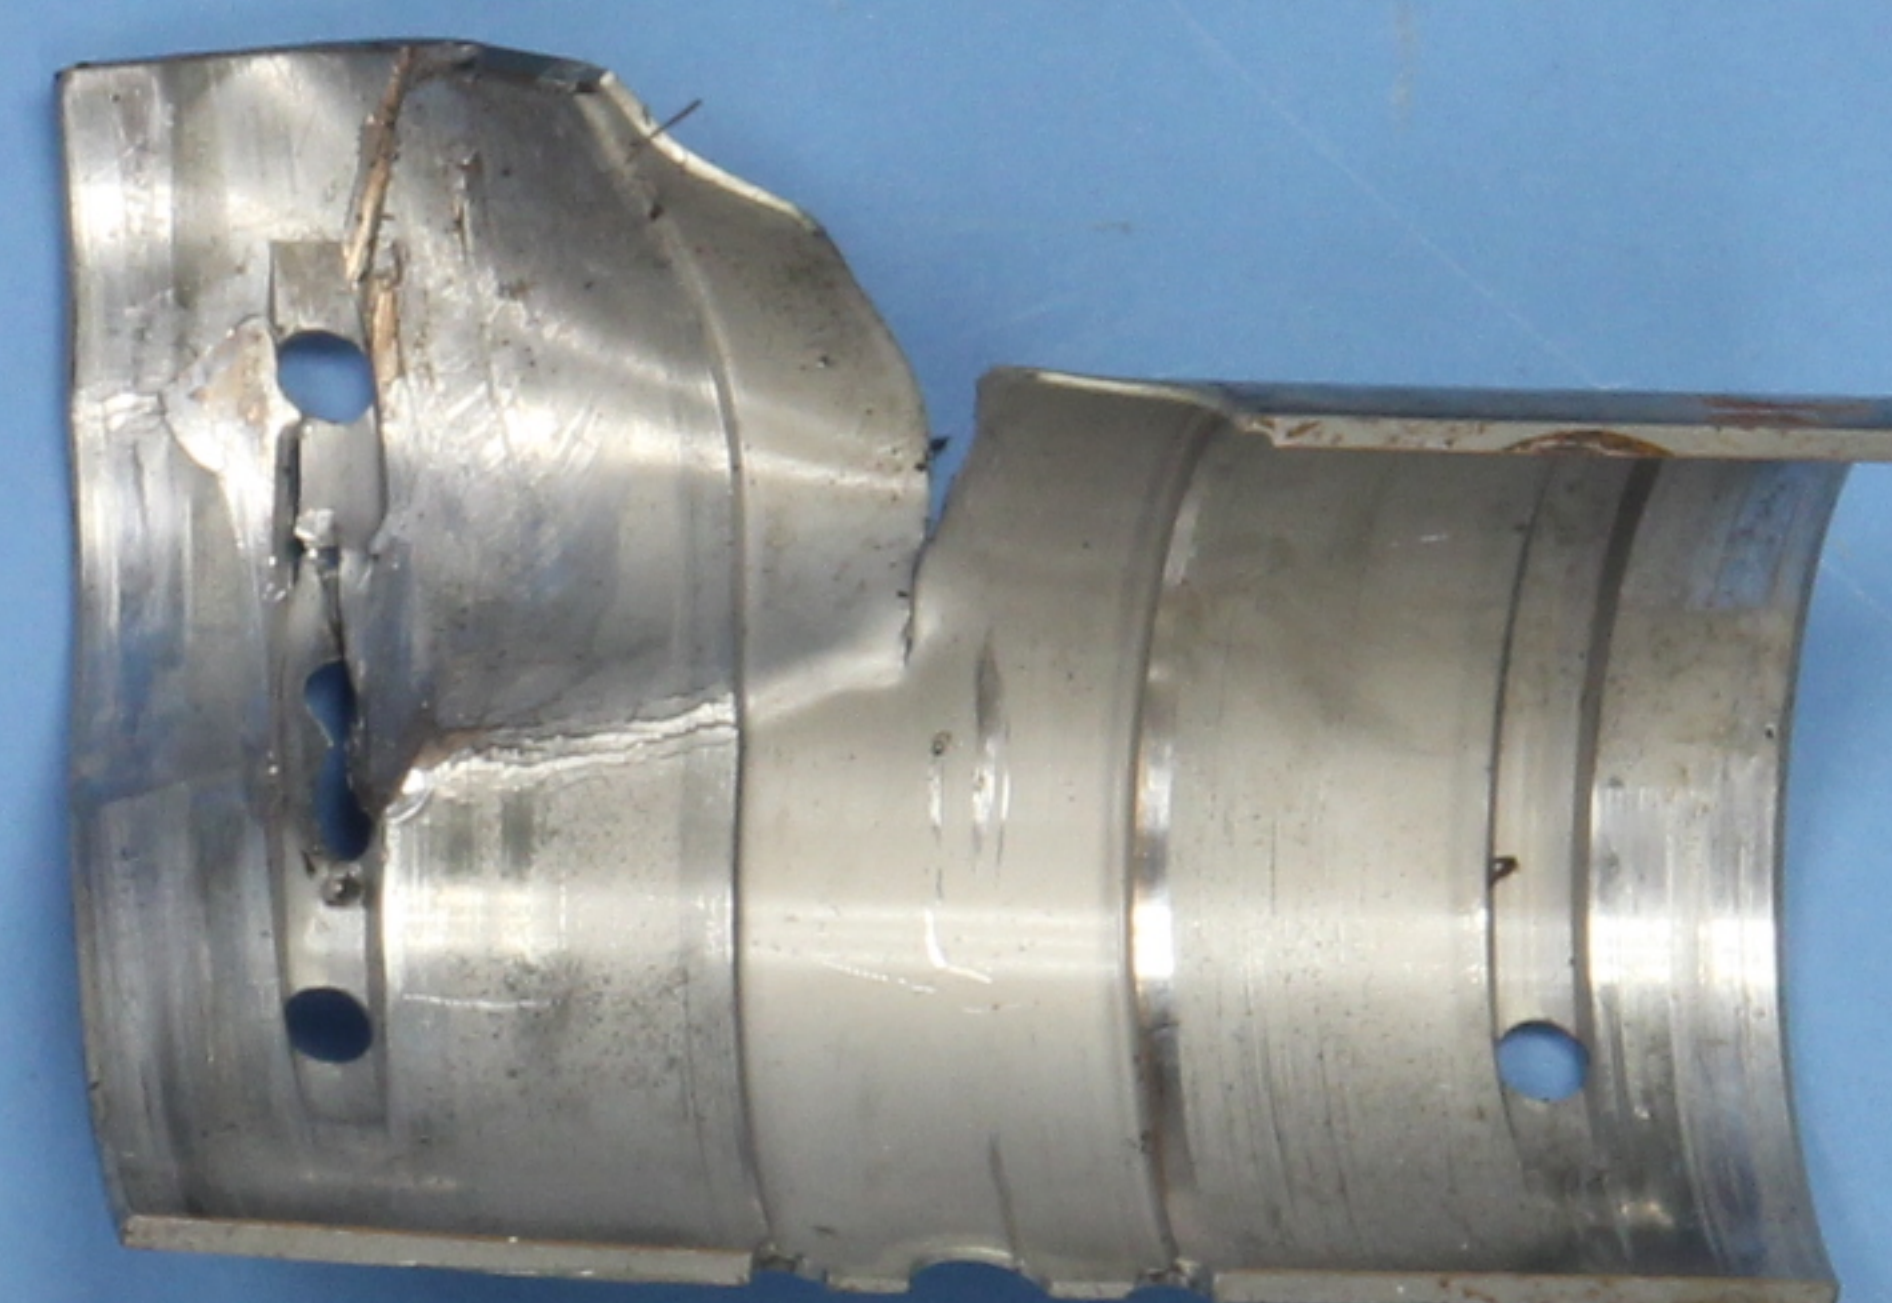
The two pieces of the crankshaft and the bearing shells were sent to the NTSB Materials Laboratory for examination. The propeller flange on the crankshaft exhibited bending deformation, with one region bent forward and the opposite region 180 degrees around the shaft bent aft. A portion of the oil flinger flange was fractured leaving an approximately 120 degree region intact. The crankshaft was fractured in the circumferential direction at the oil tube hole in the first (forward) main bearing journal. The fracture surfaces had a comparatively rough appearance and were inclined approximately 45 degrees to the bearing surface. Taken together, the features were consistent with a bending overstress fracture.
