**NATIONAL TRANSPORTATION SAFETY BOARD**

**System's Group Chairman's Factual Report**

**NTSB ID No.: CEN16FA372**

Location: Alexandria, Minnesota  
Date: September 17, 2017  
Time: 0207 Central Daylight Time  
Aircraft: Agusta S.p.A A109S helicopter, N91NM

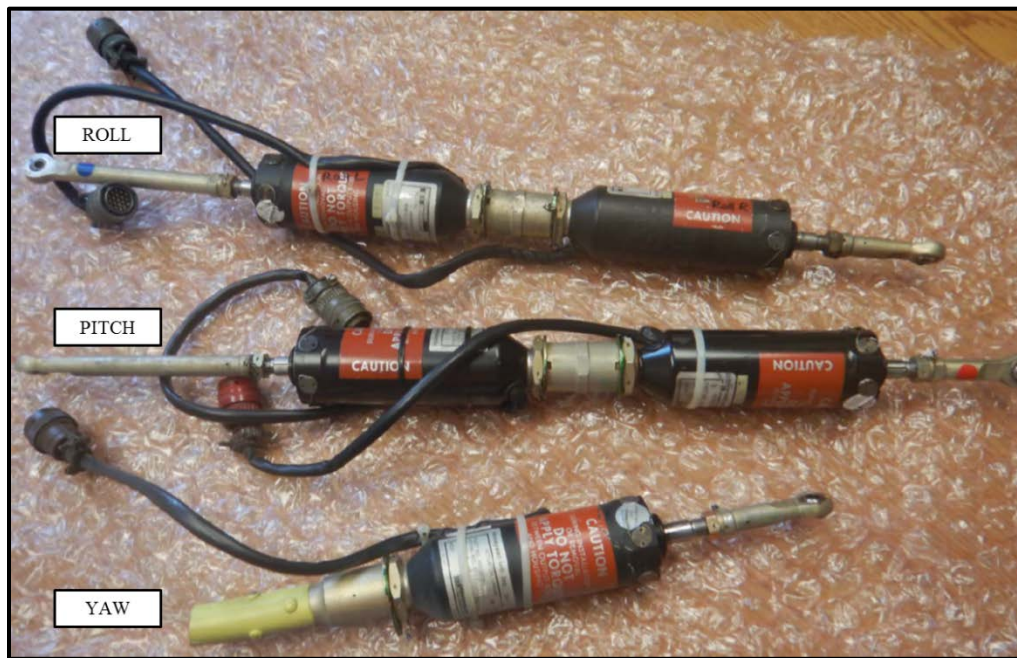
**Figure 12 - Linear Actuators at Honeywell**

As previously stated, the pitch, roll and yaw linear actuators were removed from the helicopter on April 24, 2017, at the Wentworth Aircraft hangar at Airlake Airport (LVN), Lakeville, MN. The actuators were shipped to the Honeywell facility located in Boyne City, MI and examined on August 16 and 17th 2017. Reference Figure 12.

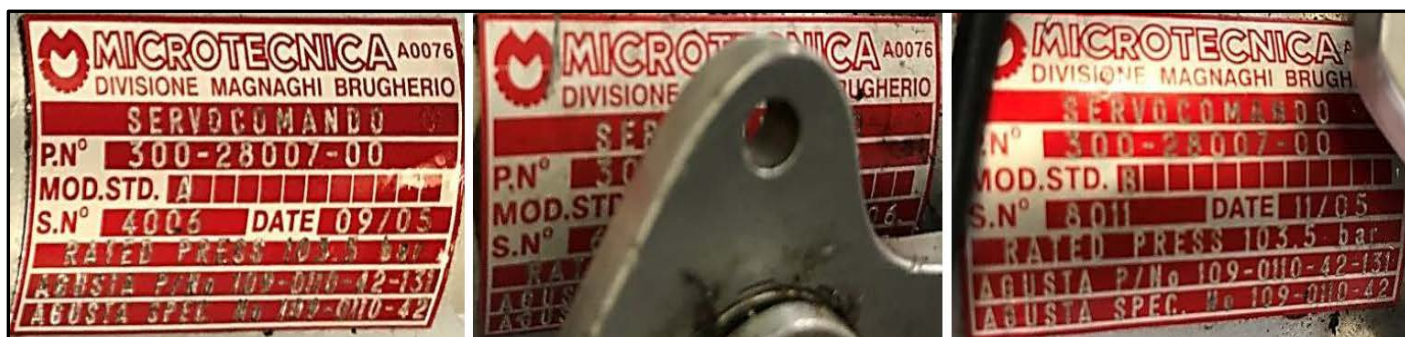
**Figure 20 Identification labels for the three actuators**

The three (red, blue, and yellow) main rotor actuators were removed from the helicopter on April 24, 2017 at the Wentworth Aircraft hangar. All three actuators were shipped to their manufacturer, UTC Aerospace Systems, located in Brugherio, Italy for examination and functional testing. Reference Figures 20 and 21.

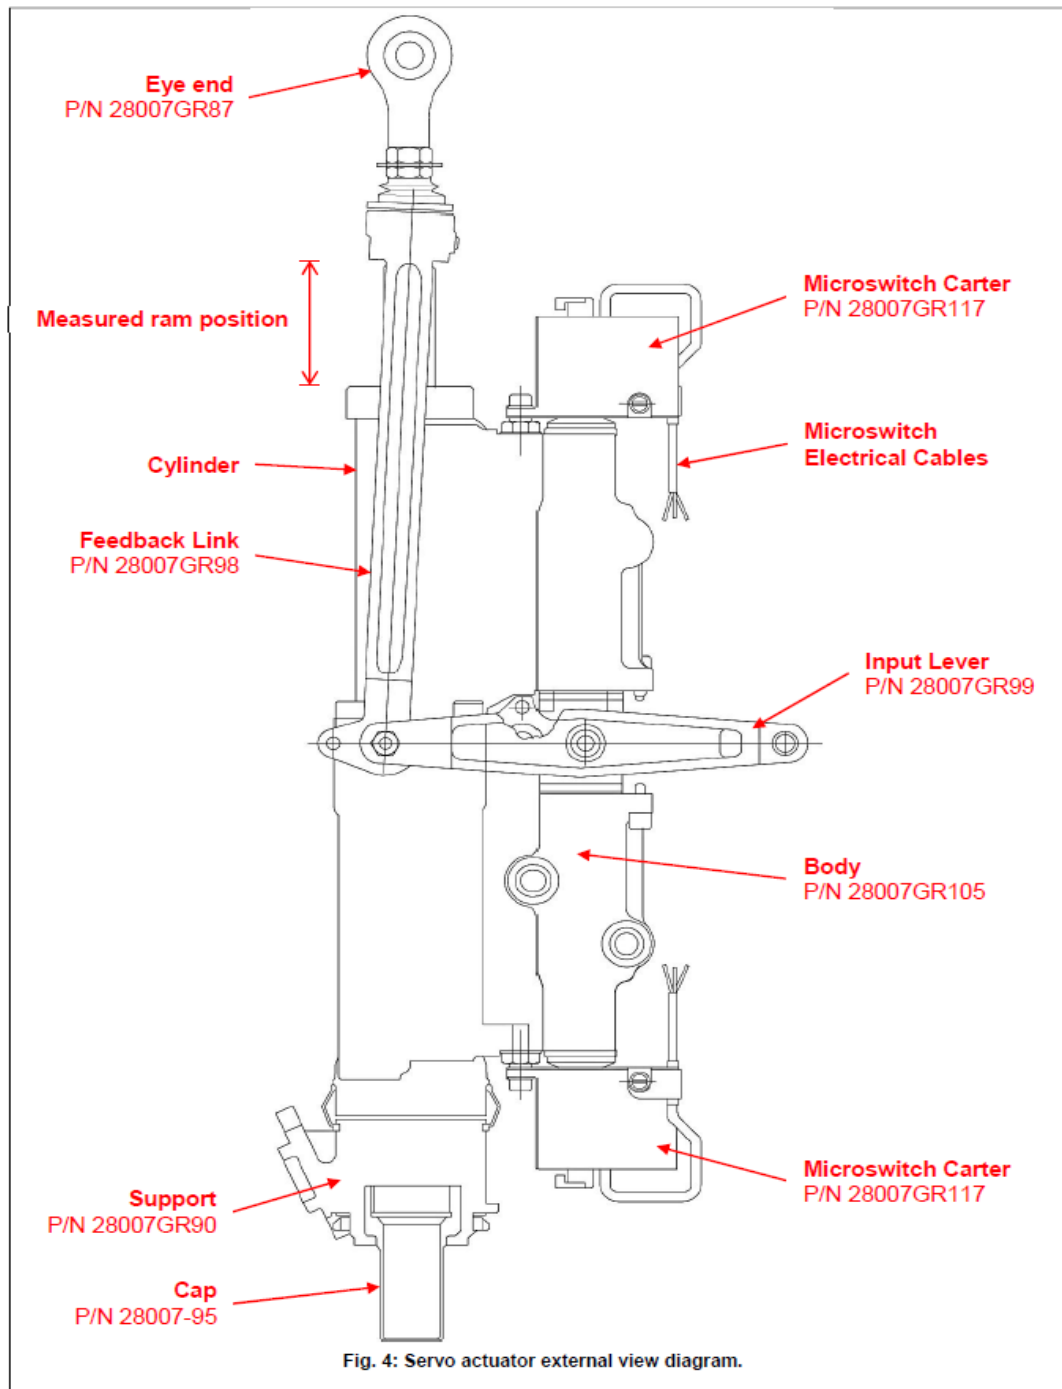
Figure 22 Schematic of a main rotor actuator

After removing the actuators from their shipping container, a thorough visual inspection was performed on each of the actuators in their “as received” condition. Reference Figure 22 and 23. A varying level of dirtiness (both soil and hydraulic fluid<sup>9</sup>) was observed on their external surfaces. As received, the three servo actuators remained connected with their electrical cables<sup>10</sup>. The results of this visual inspection are provided in Table 7.
