## 2. Purpose

This Airworthiness Bulletin (AWB) is a compilation of information contained in Airworthiness Advisory Circulars (AAC), Service Bulletins (SB), Service Difficulty Reports (SDR) and Advisory Circulars (AC) and will be revised from time to time to incorporate new magneto defects.

## Magneto Defects

**AWB** 74-005 **Issue :** 3  
**Date :** 20 October 2014

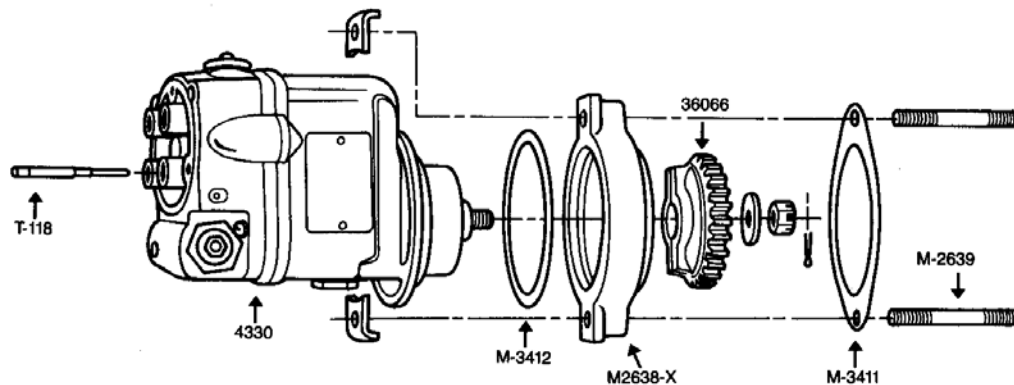
Figure 14 - Extract from SL1-93

"Transport Canada (TC) has recently been informed of certain Piper and Mooney aircraft, powered by Lycoming engines, which had magnetos installed with incorrect gaskets. The magnetos were Bendix S-20 and S-200 series from Teledyne Continental Motors (TCM). The first report was a Piper PA23-250, powered by a Lycoming IO-540 engine, which had a magneto fall off in flight in the USA.

According to the A&P mechanic who repaired the aircraft, the failure was caused by the installation of an incorrect gasket which did not provide proper support for the mounting flange, causing the flange to fail. It is thought that the thickness of the gasket had a bearing on the failure. The aircraft's remaining magnetos were inspected and were also found to have incorrect gaskets installed and, although two of the magnetos were cracked, none had progressed to failure. This particular magneto application calls for the installation of two Lycoming gaskets (P/N 62224), one on each side of the adapter plate see Figure 14. The failed magneto on this aircraft had one P/N 62224 gasket between the adapter and the engine case, but had an LW 12681 gasket, and possibly a TCM P/N 534750 gasket, between the magneto and the adapter plate, which is incorrect.

The repair shop operator, who reported this problem to Transport Canada, has since found two aircraft with the same problem: a Mooney powered by a Lycoming O-360 engine, and a Piper PA24-250 powered by Lycoming O-540 engine. Although incorrect gasket installation was found, none of the magnetos had progressed to failure. None of these magnetos were installed by the engine manufacturer, but had been removed and reinstalled.
