# Continental Motors

## ENGINE EXAMINATION REPORT

| ENGINE MODEL | TSIO-520-P |
| FILE NUMBER | 15-415 |

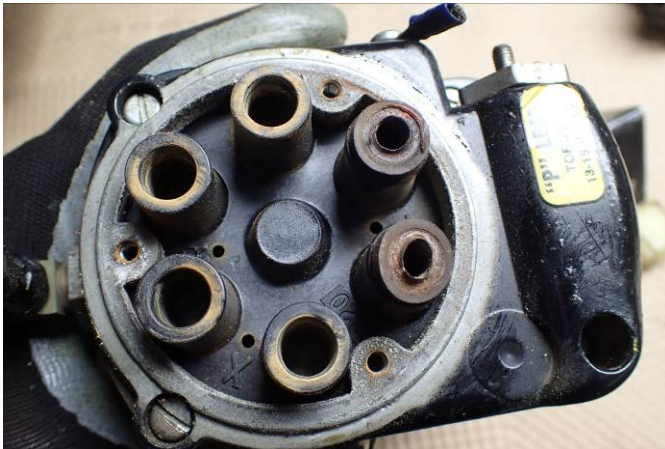
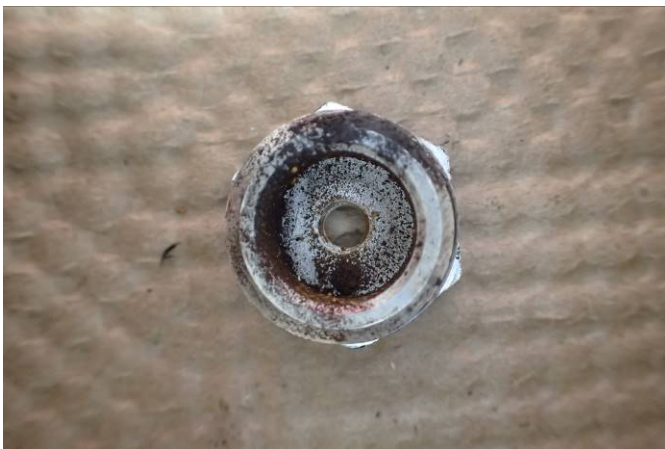
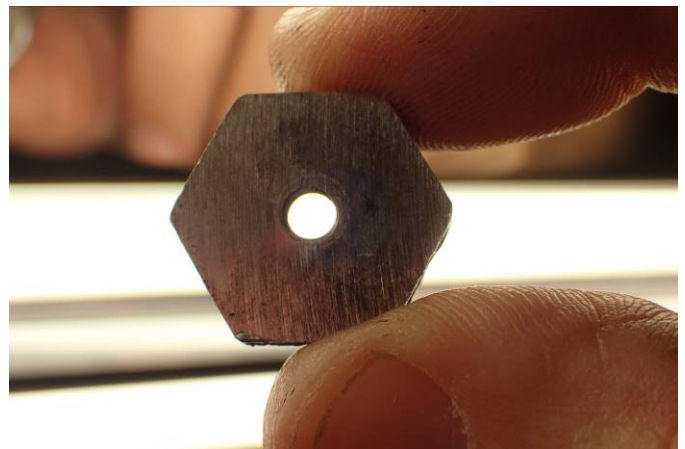
S/N: 05081968

**Condition:** The magneto remained attached to its installation point and was undamaged. The magneto was removed from the engine and installed on a magneto test bench. It was noted that the magneto was not capable of producing a spark on any of the posts. The magneto was disassembled and it was noted that the internal components displayed a significant amount of corrosion. The magneto was further inspected and it was found that the magneto pressurization vent was completely blocked.

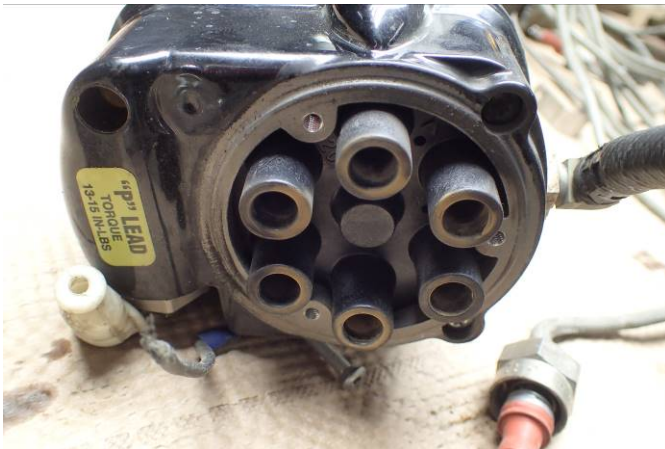
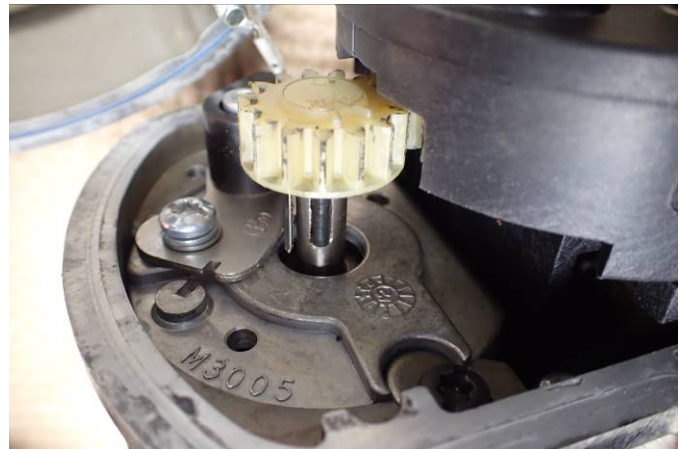
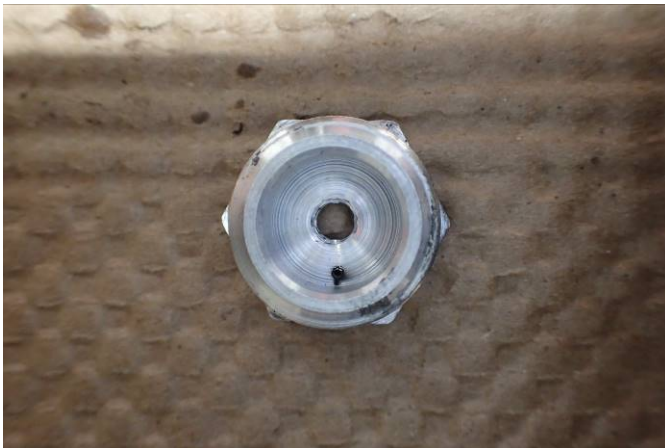
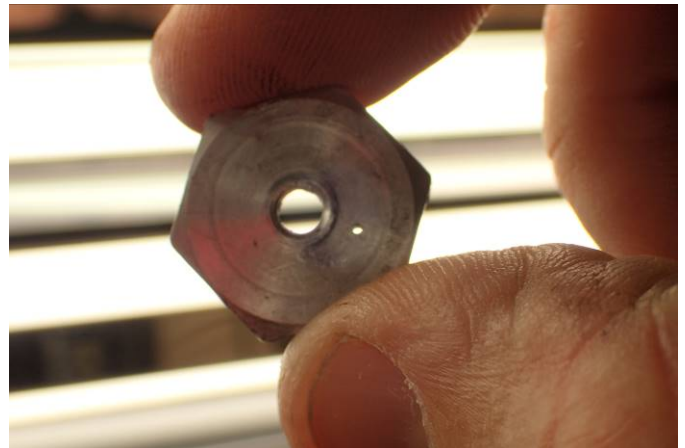
S/N: 12091498

**Condition:** The magneto remained attached to its installation point and was undamaged. The magneto was removed from the engine and installed on a magneto test bench. It was noted that the magneto was able to produce a spark on all six posts. The magneto was disassembled and the internal components displayed normal operating signatures; it was noted that the magneto pressurization vent was clear.

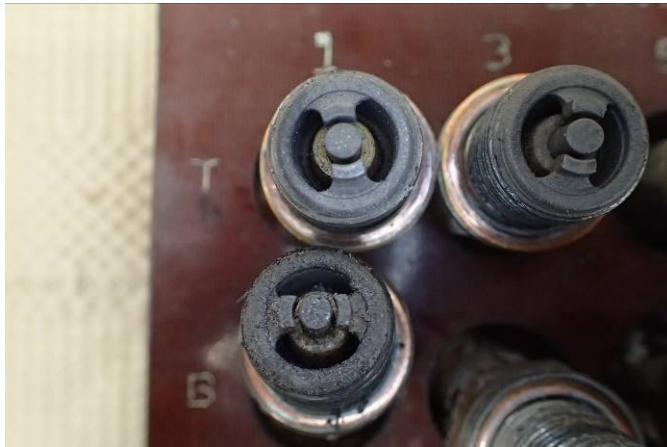
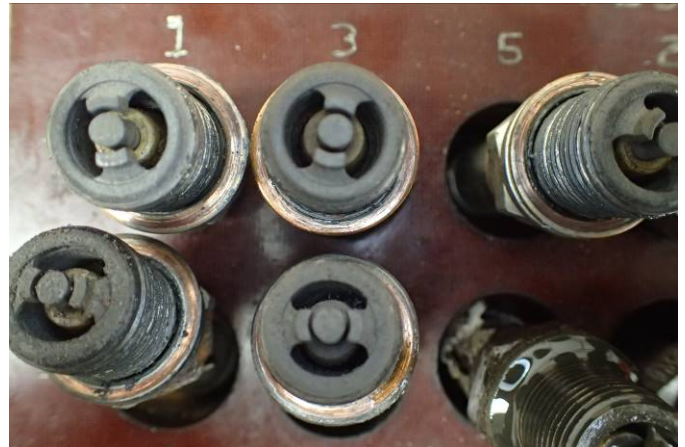
**Condition:** All of the spark plugs remained installed in their cylinders and were undamaged. The spark plugs were removed and visually inspected. The bottom #5 and #6 spark plugs were oil soaked which was consistent with post-accident accumulation. The remaining spark plugs displayed normal operating and wear signatures.

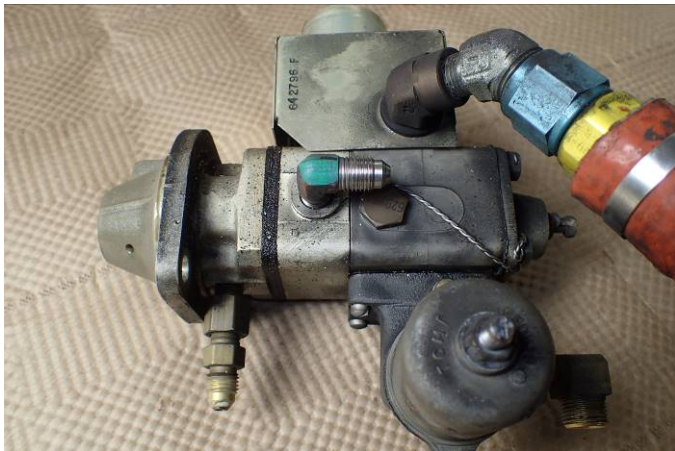
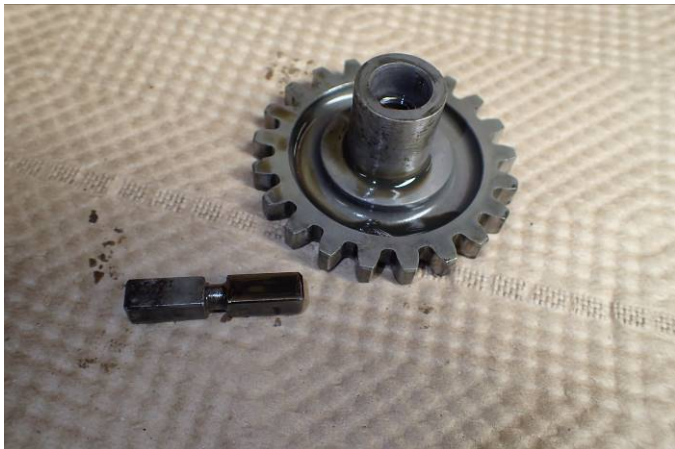
S/N: B05HA334R

Condition: The fuel pump remained attached to its installation point and was undamaged. The fuel pump was removed and it was noted that the fuel pump drive coupling remained intact; it was also noted there several flakes of metal were found between several of the fuel pump drive gear teeth. The fuel pump drive shaft was capable of rotation and there were no anomalies noted with the fuel pump.

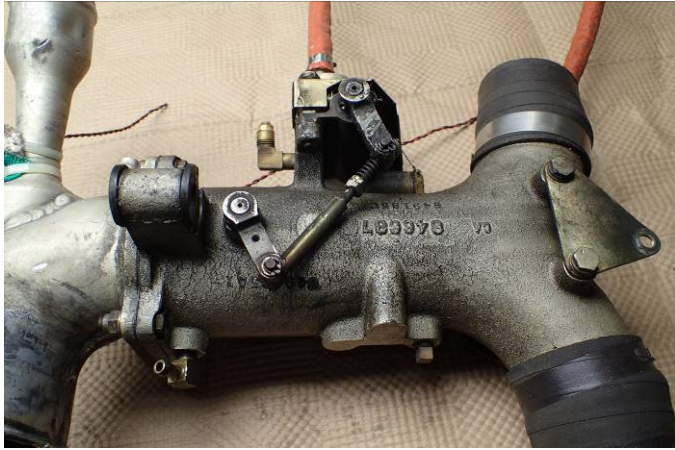
S/N: A05HA291R

**Condition:** The throttle and fuel metering unit displayed some impact damage signatures. The throttle and mixture arms were capable of normal movement. There were no anomalies noted with the throttle and fuel metering assembly.

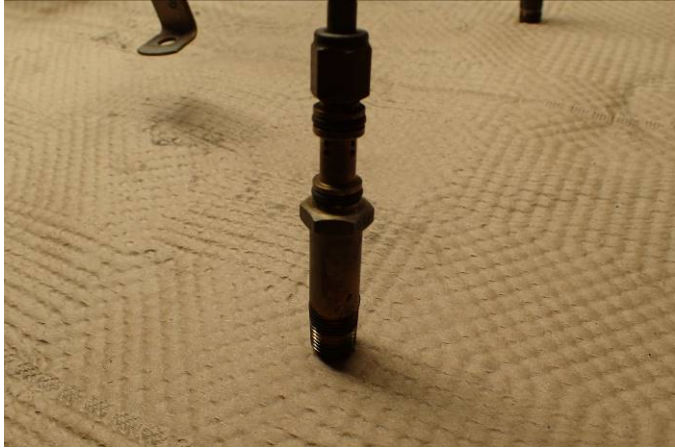
#1 Injector

**Condition:** All of the fuel nozzles remained installed in their cylinders and remained attached to their fuel lines. There were no anomalies noted with the fuel nozzles.

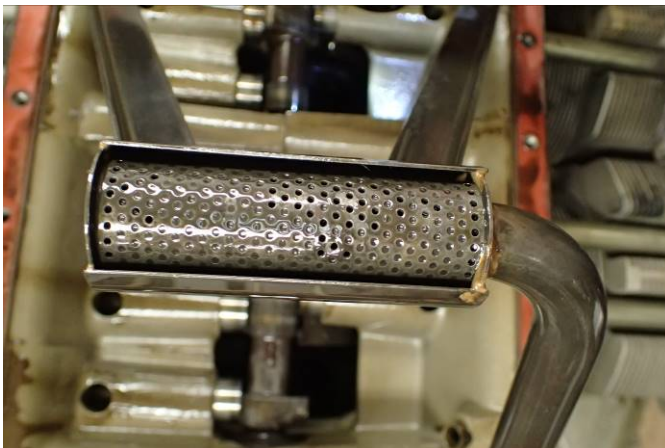
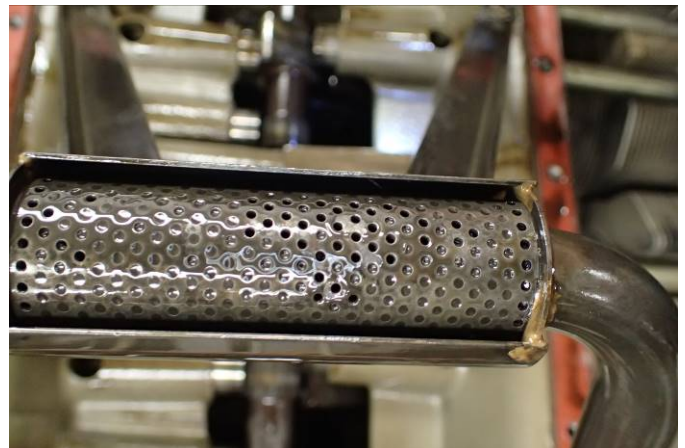
Condition: The oil sump remained intact and displayed impact damage signatures. The oil sump was removed and it was noted that there were several pieces of material consistent with bearing and piston material found in the oil sump.

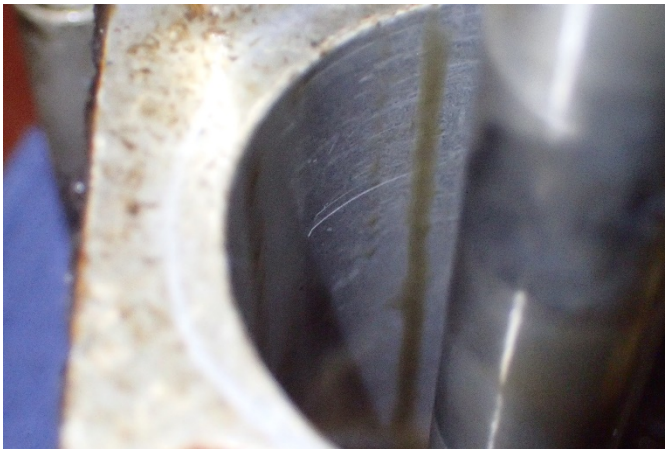
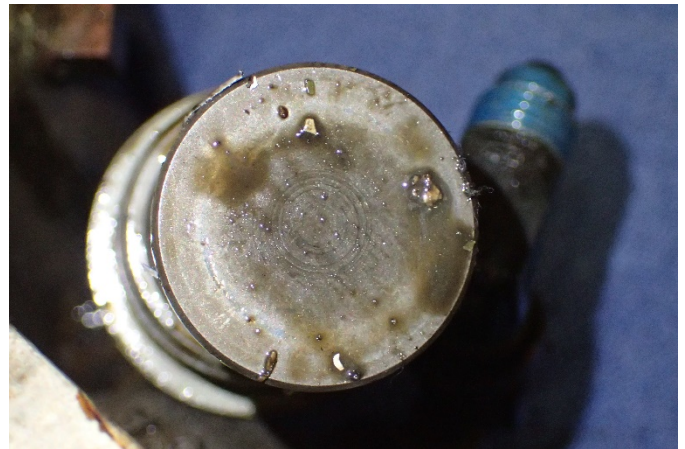
### OIL PUMP

Condition: The oil pump remained intact and undamaged. The oil pump and the scavenge pump were disassembled and the internal components were visually inspected. The oil pump housing displayed scoring consistent with hard particle passage. The oil pump and scavenge pump gears displayed normal operating and lubrication signatures. The oil pressure relief valve had several flakes of metal on the surface.

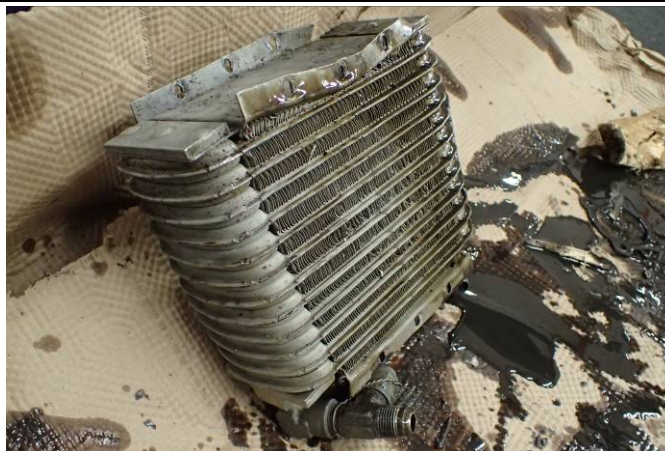
The remote oil cooler displayed normal operating signatures. There were no anomalies noted with the oil cooler.

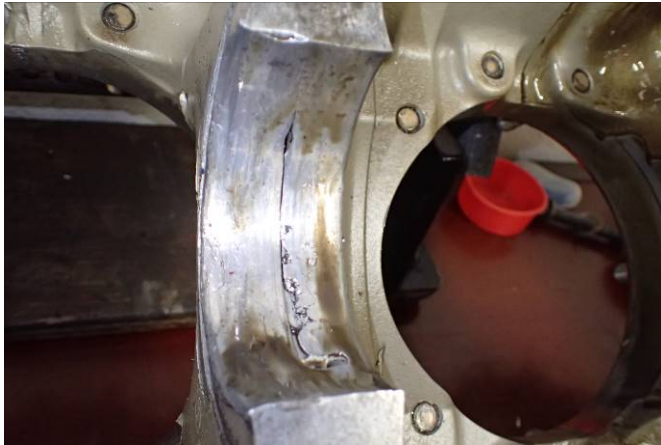
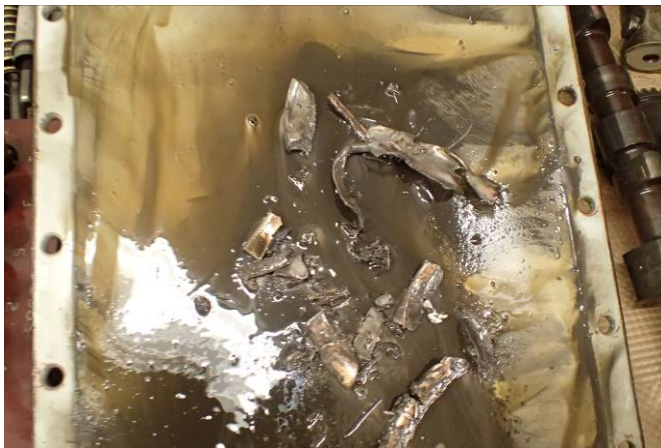
The bearings displayed damage consistent with a bearing movement event. Several portions of the bearing were located in the oil sump. One portion of the right side bearing remained within the bearing saddle; the bearing had extruded out of the bearing support.

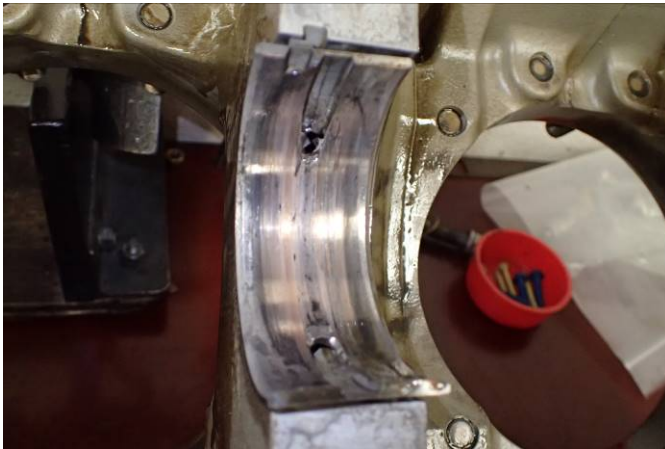
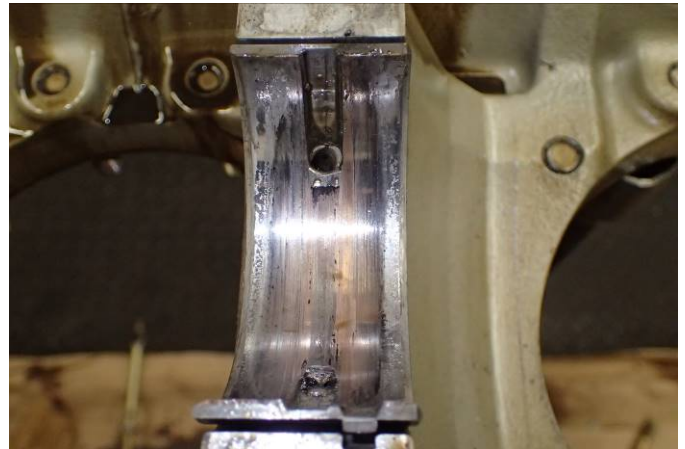
**Condition:** The bearings remained in their bearing supports and there were no signatures of bearing shift. It was noted that the #3 bearings displayed signs of lubrication distress and the copper layer was exposed.

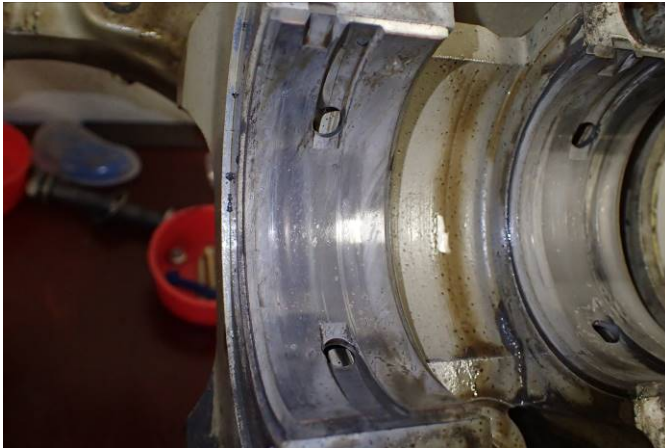
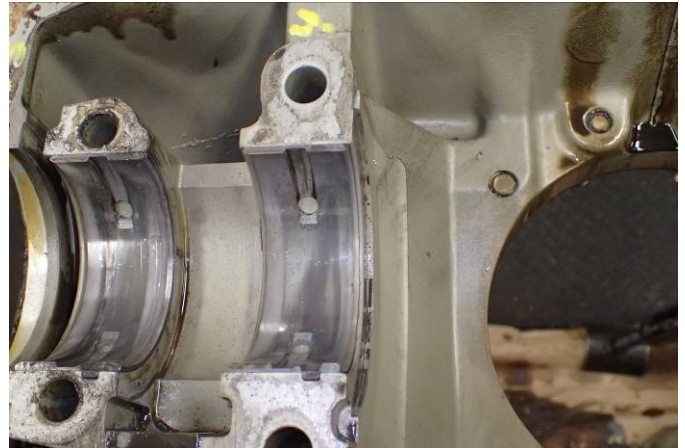
## #4 MAIN BEARINGS

**Condition:** The bearings remained in their bearing supports and there were no signatures of bearing shift. The bearing displayed normal wear, operating, and lubrication signatures.

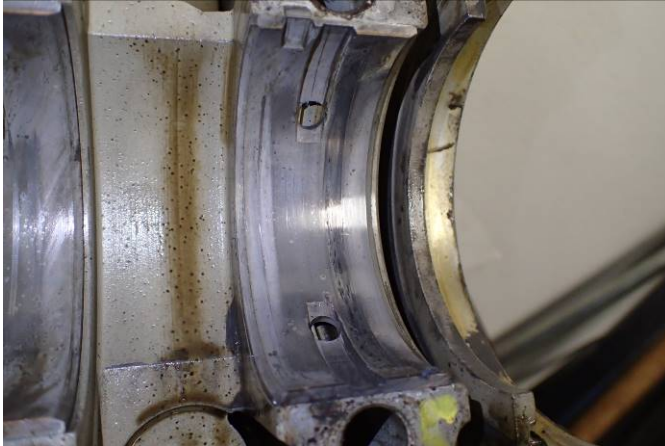
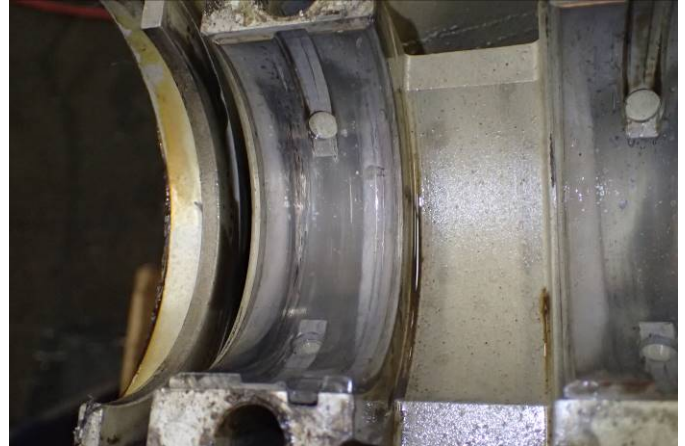
The bearings remained in their bearing supports and there were no signatures of bearing shift. The bearing displayed normal wear, operating, and lubrication signatures.

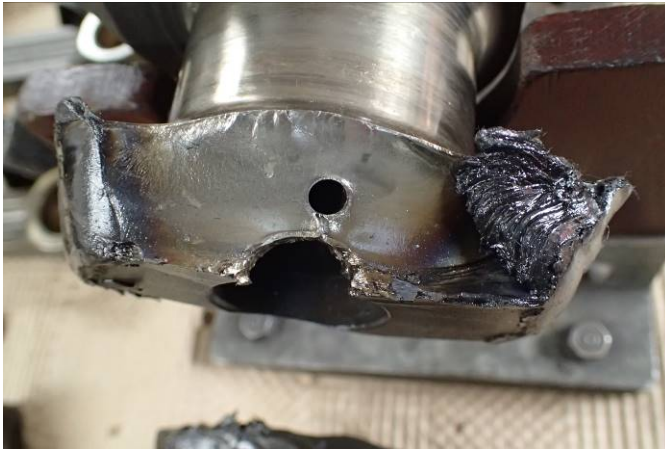
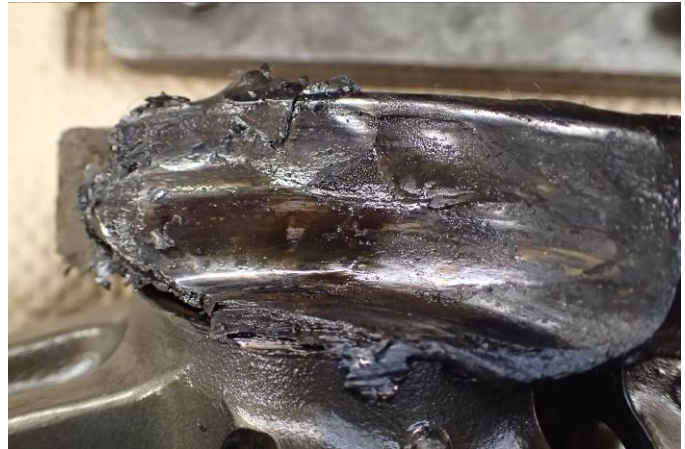
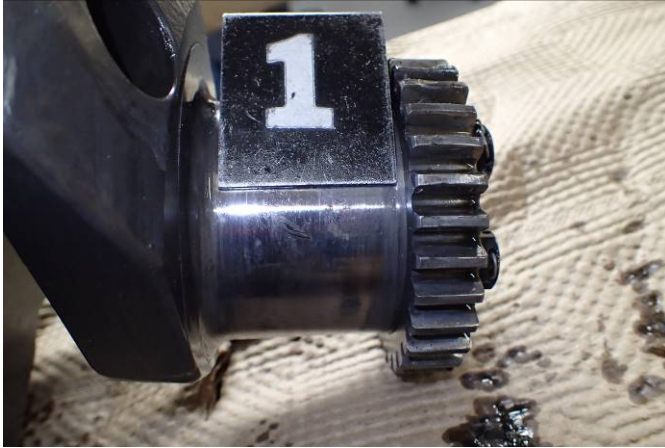
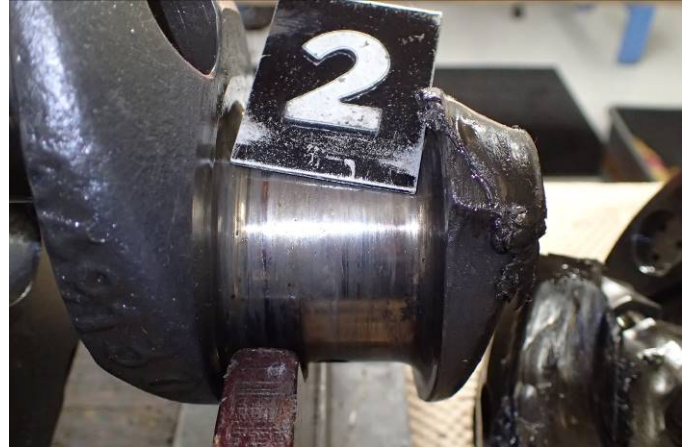
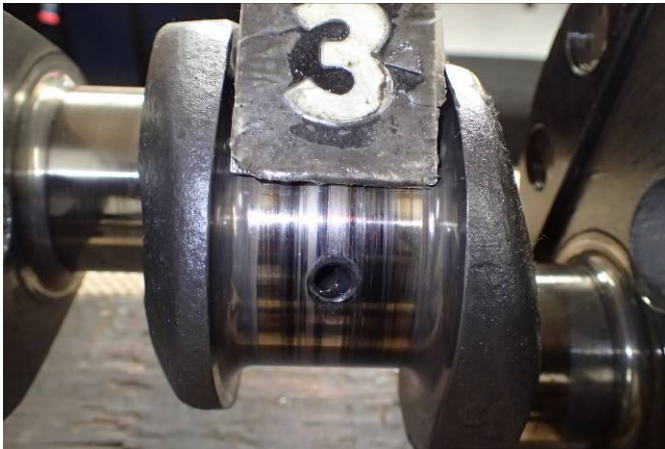
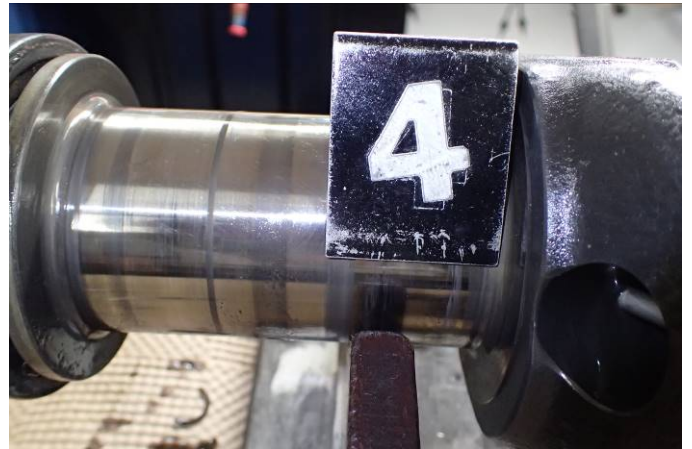
**Condition:** The crankshaft was fractured into two pieces; the fracture was located at the crankshaft cheek between the #2 main bearing journal and the #2 connecting rod journal. The #3 main journal displayed heat discoloration consistent with heat and scratches consistent with hard particle passage. The remaining main journals displayed normal operating and lubrication signatures. The #2 connecting rod journal was unable to be observed due to the #2 connecting rod being impinged in place on the journal. The connecting rod journals capable of inspection displayed normal operating and lubrication signatures.

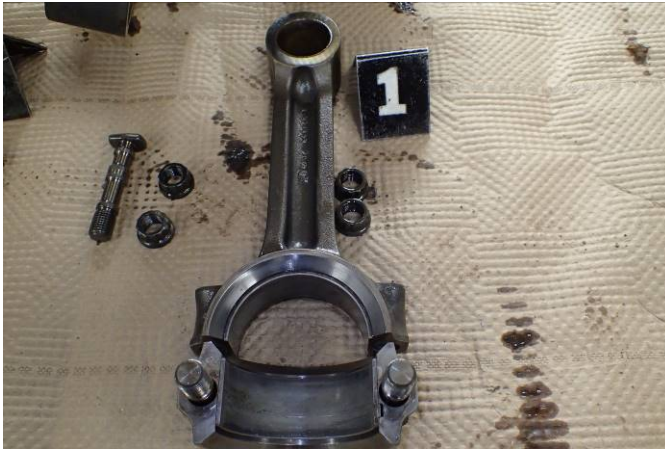
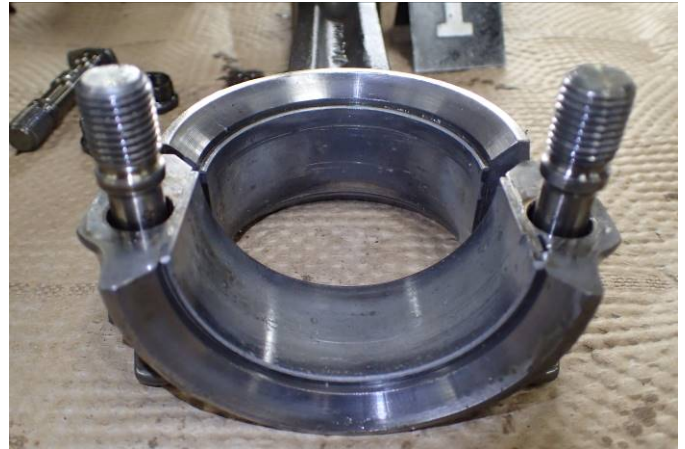
Condition: The connecting rod remained attached to its connecting rod journal and displayed normal operating signatures.

Condition: The connecting rod bearing displayed normal operating and lubrication signatures.

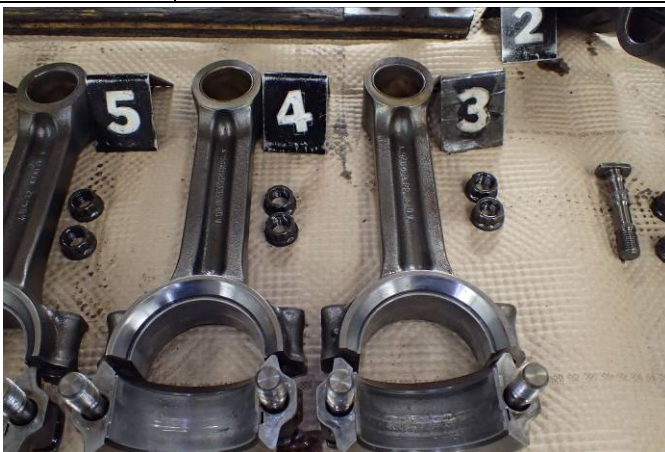
## #3 CONNECTING ROD

Condition: The connecting rod remained attached to its connecting rod journal and displayed normal operating signatures.

Condition: The connecting rod bearing displayed the incipient signs of lubrication distress. It was noted that the #3 connecting rod journal and bearing receive oil from the #2 main bearing journal.

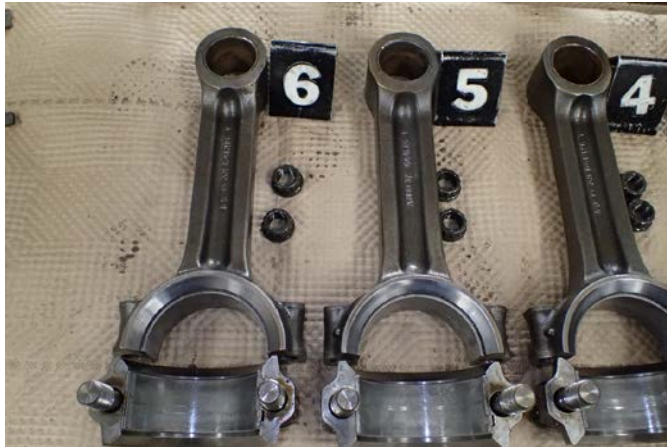
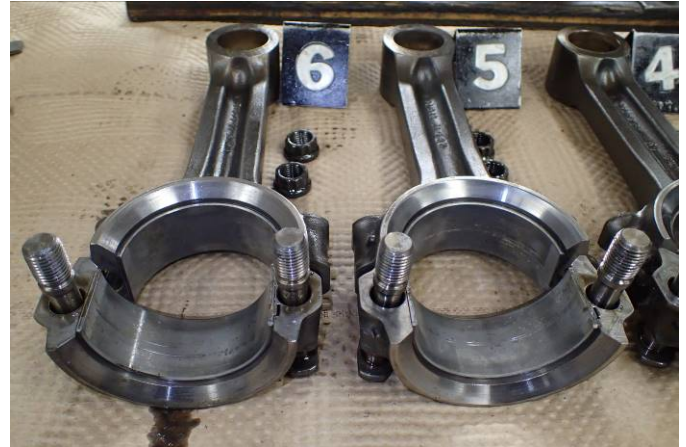
Condition: The connecting rod remained attached to its connecting rod journal and displayed normal operating signatures.

Condition: The connecting rod bearing displayed normal operating and lubrication signatures.

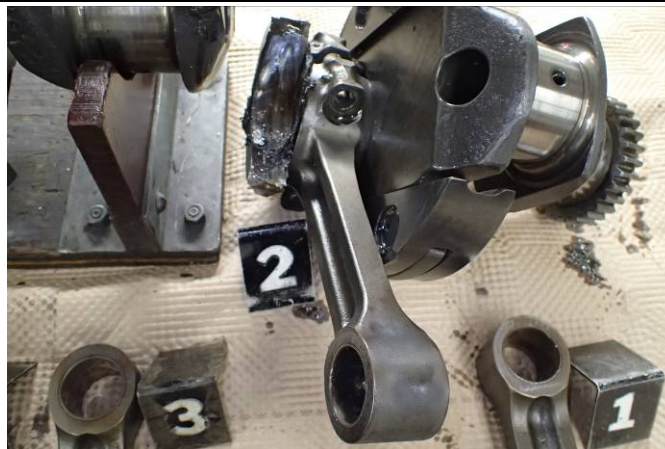
## #2 CONNECTING ROD

Condition: The connecting rod remained secured to its connecting rod journal and displayed some mechanical damage. The connecting rod was impinged onto its journal by displaced crankshaft material at fractured area of the crankshaft. There were no anomalies noted with the connecting rod.

Condition: Due to the connecting rod being impinged in place the bearing was not capable of being observed.

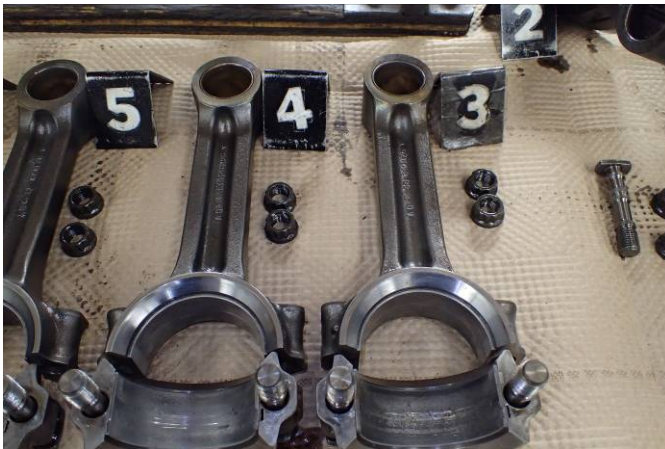
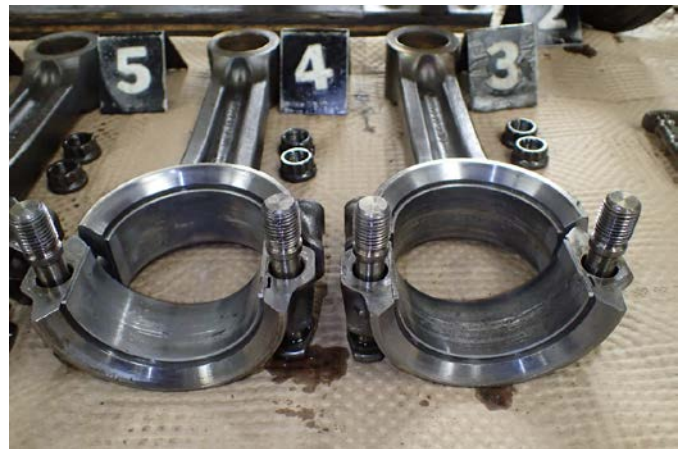
Condition: The connecting rod remained attached to its connecting rod journal and displayed normal operating signatures.

Condition: The connecting rod bearing displayed normal operating and lubrication signatures.

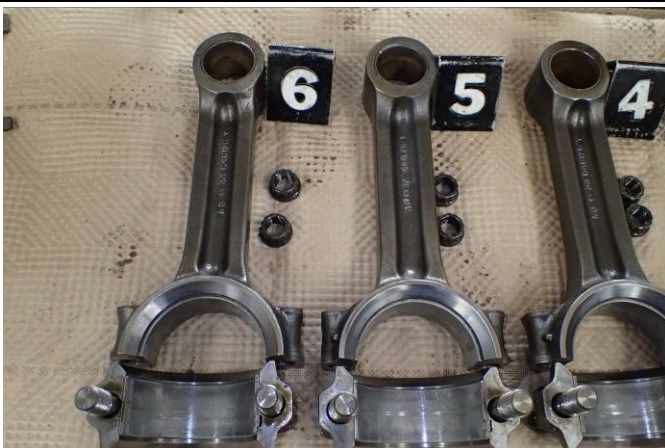
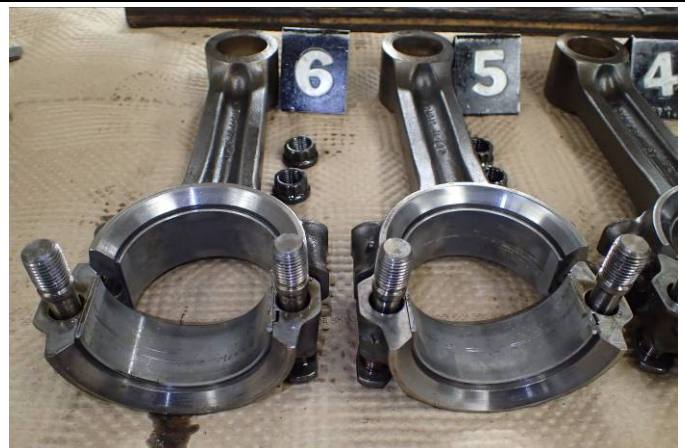
## #6 CONNECTING ROD

Condition: The connecting rod remained attached to its connecting rod journal and displayed normal operating signatures.

Condition: The connecting rod bearing displayed normal operating and lubrication signatures.

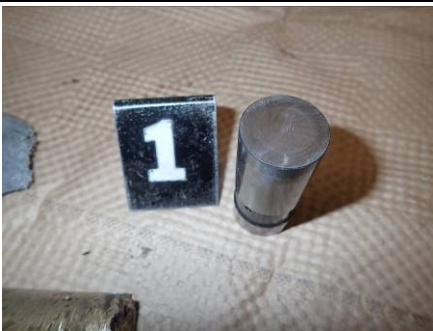
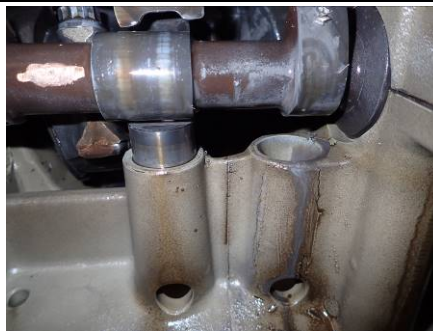
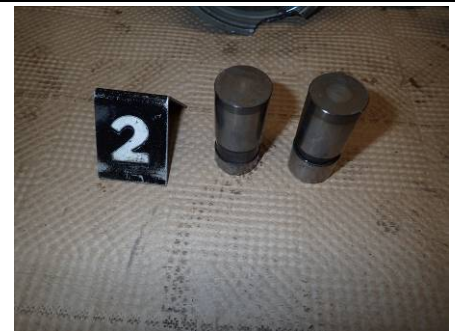
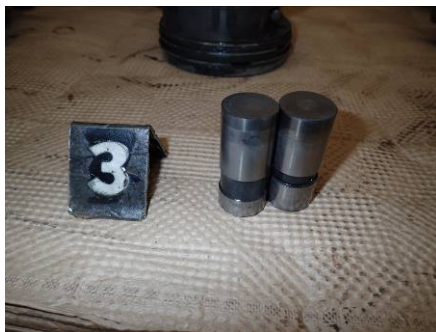
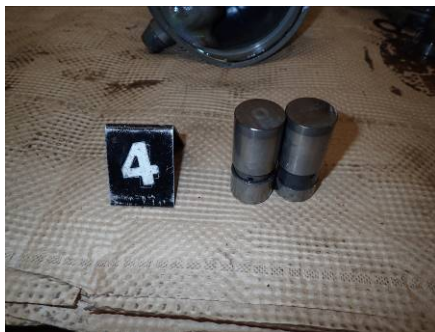
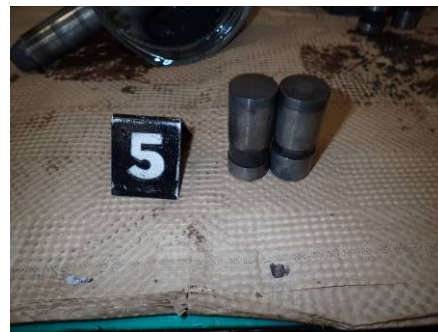
| CAMSHAFT | P/N: 655384 | S/N: Z05HA109 |
|---|---|---|
| Condition: | The camshaft was intact and displayed mechanical damage towards the rear of the camshaft. The camshaft gear remained intact and was secured. The camshaft lobes displayed normal operating signatures. | |

| LIFTERS | #1 | #3 | #5 | #2 | #4 | #6 |
|---|---|---|---|---|---|---|
| Condition: | The #1 intake lifter was impinged in its installation area and was unable to be removed. The visible portions of the #1 intake lifter displayed normal operating and lubrication signatures. The remaining lifters all displayed normal operating and lubrication signatures. | | | | | |

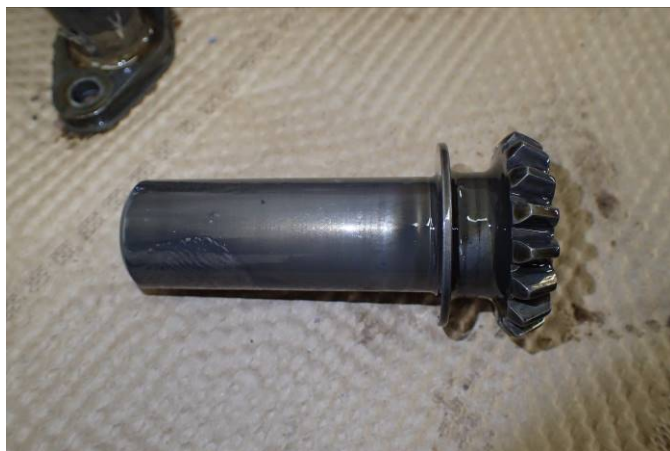
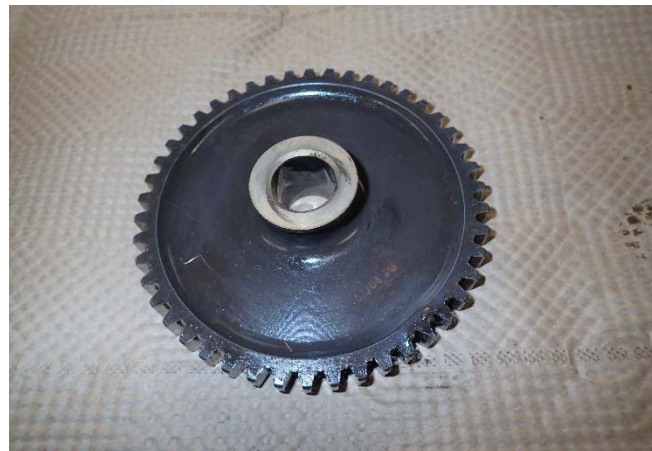
## ACCESSORY GEARS

The accessory gears displayed normal operating signatures. There were no anomalies noted.

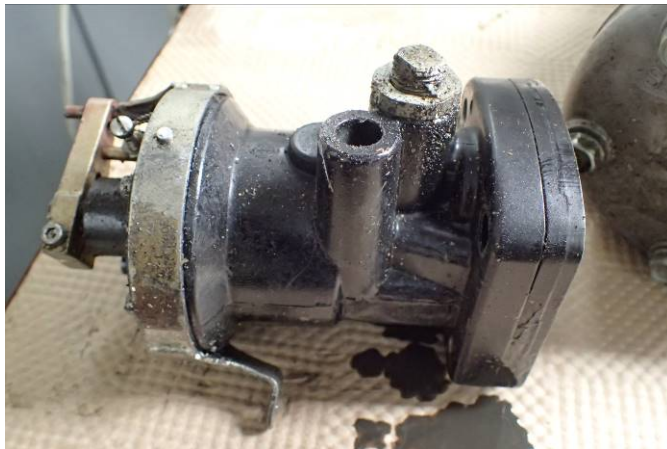
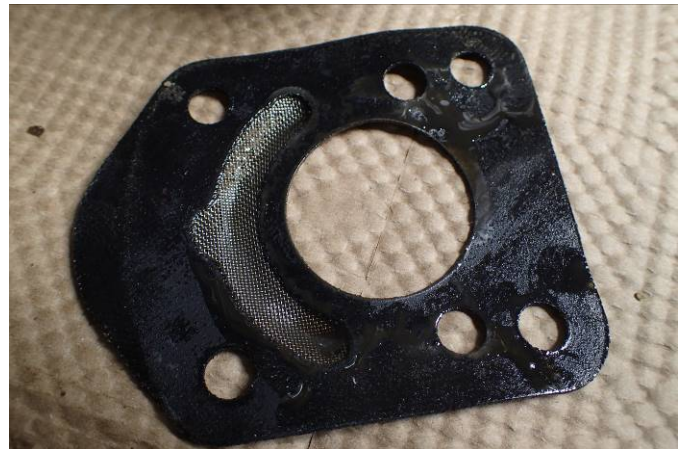
**Condition:** The propeller governor remained attached to its installation point and displayed only minor impact damage. The propeller governor was removed and it was noted that the gasket screen was clear of any contaminants.

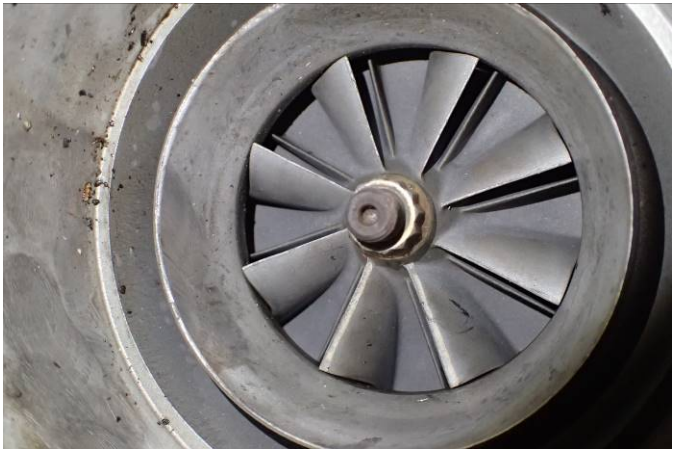
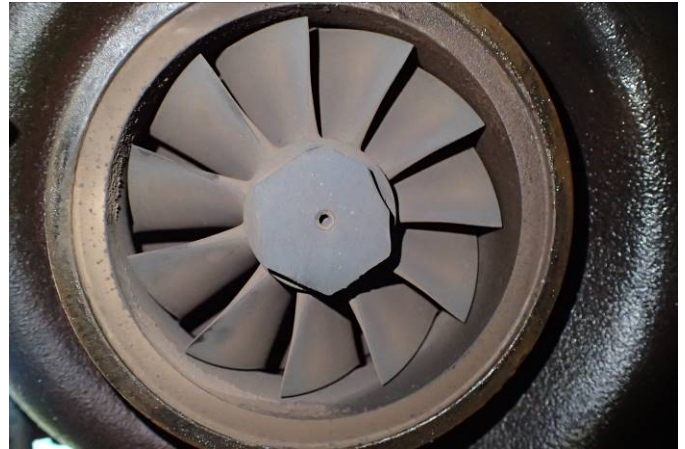
The turbocharger remained attached to the exhaust system and had been removed from the engine with the right side exhaust. The turbine and the compressor were capable of rotating freely and both sections displayed normal operating signatures.
