# National Transportation Safety Board

CEN16LA154

## **MATERIALS LABORATORY**

Factual Report 26-008

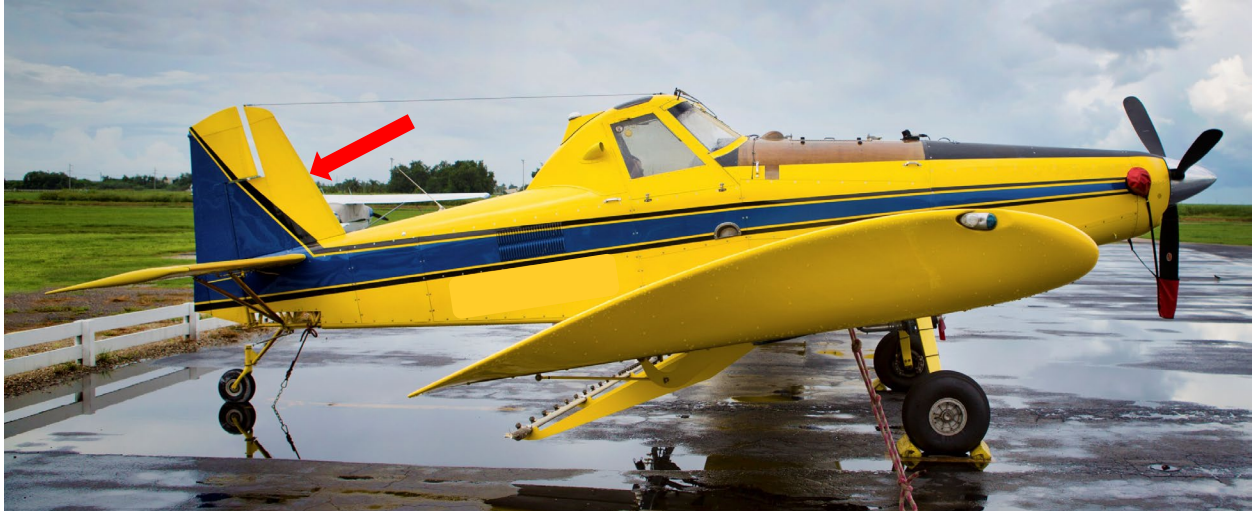
A group exam of the recovered vertical stabilizer with the above listed personnel occurred on February 3, 2026. An exemplar aircraft of the same make and model is shown in Figure 1 with the vertical stabilizer identified (red arrow).

**Figure 1.** Overall photo of an exemplar aircraft of the same make and model with a red arrow pointing to the vertical stabilizer.
