**November 15, 2016 : Supplemental Evidence/Report Information**

RE: Crosswind Aviation, LLC (7580-XL)  
July 19, 2016 Aircraft Incident of N299RS

**Review of Surveillance Video production from Atlantic Aviation (Crosswinds' Hangar-Landlord)**

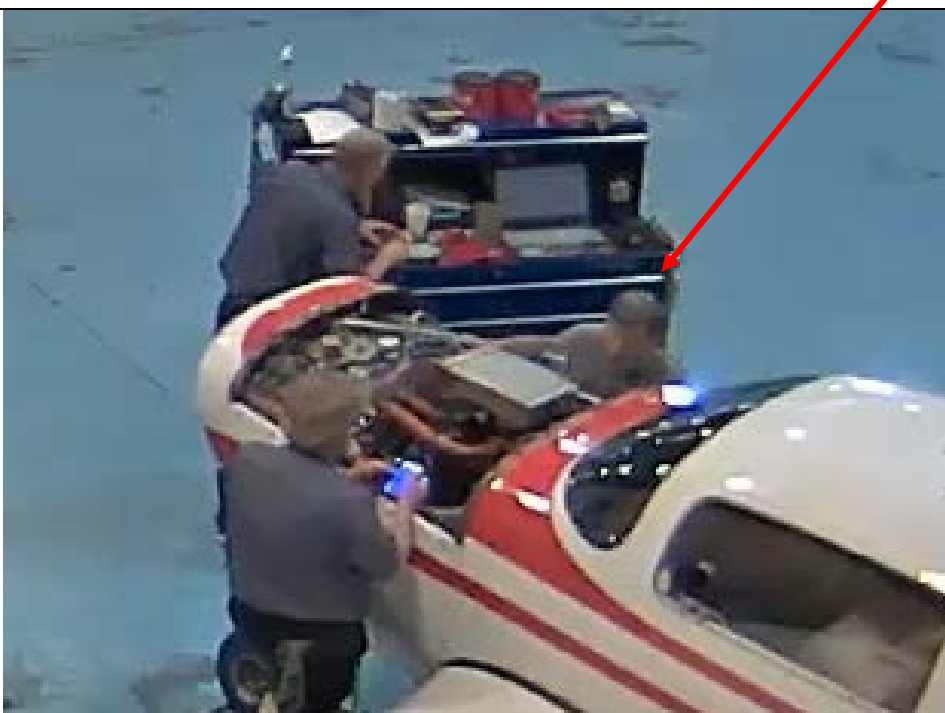
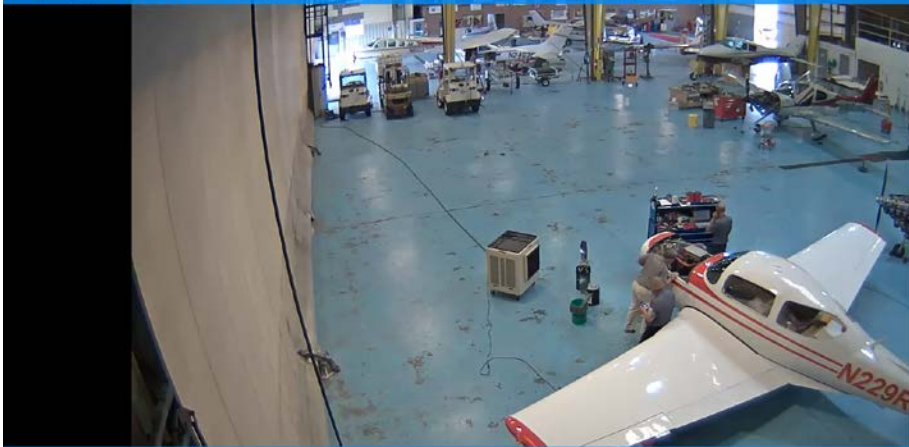
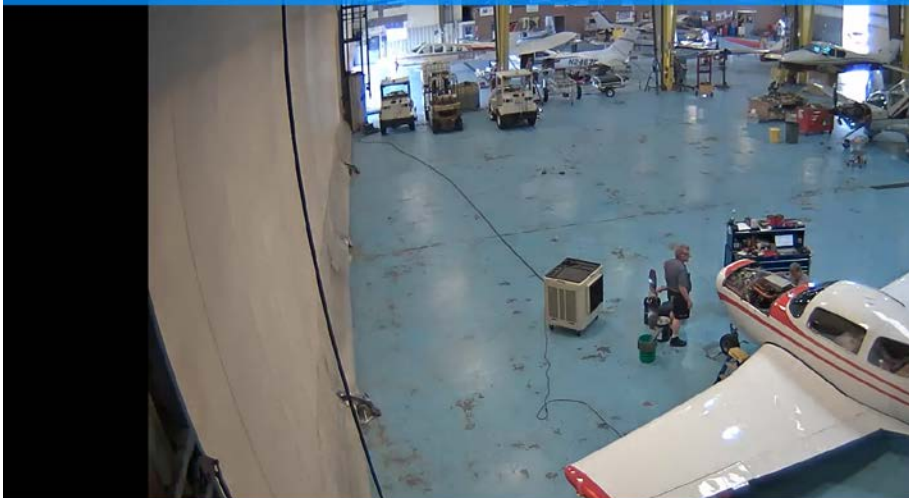
**Mayes looking at safety-wire area from right side.**

Mayes looks into the area of the safety wire and the drain line more than 5 times – this time he steps onto a step-ladder to get a better look.

And in the frames to the left – Mayes actually reaches inside to feel something in the area of the alleged “missing bolt” / “missing safety-wire”.

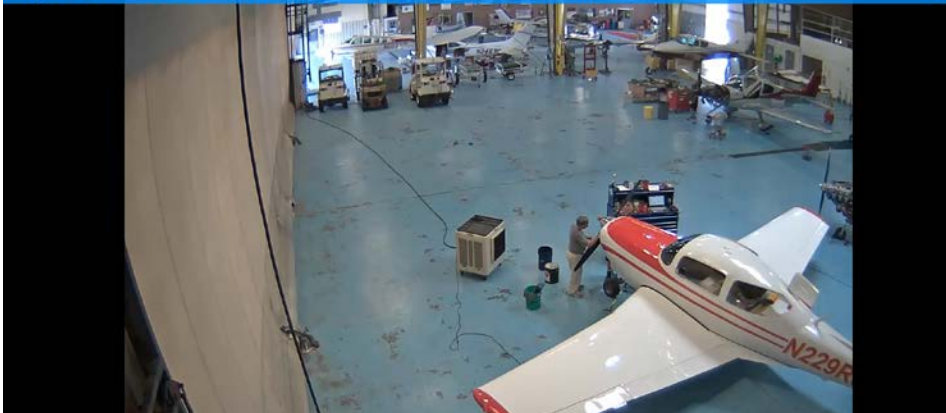
Additional/separate Mayes inspection looks into the **Repair 3** area – where the safety-wired bolt is said to have been readily visible – and easily removable by the claimant if he was so inclined after the accident.  
(Note: no cowling in place or visible in accident photos).
