**Air Tractor, Inc.**  
Accident Investigation

**AIRFRAME ACCIDENT REPORT**

**CEN16LA292**

AT-402 manufactured in 1989  
402-0720  
N1016G

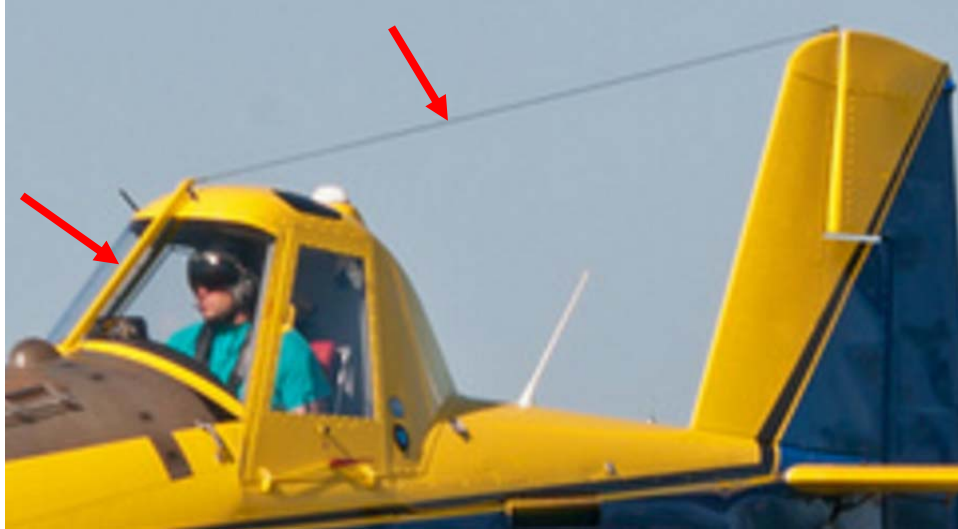
This aircraft was equipped with a single piece windshield which consists of a single curved piece of clear acrylic. There is an aluminum bar in front of the windshield and a deflector cable connecting the top of the canopy to the top of the vertical fin. These two items are provided to add some protection against wire strikes.

**Typical AT-402 showing aluminum bar and deflector cable**
