# Continental Motors

## ENGINE FIELD INSPECTION REPORT

| ENGINE MODEL | IO-360-ES |
| FILE NUMBER | 13-101 |

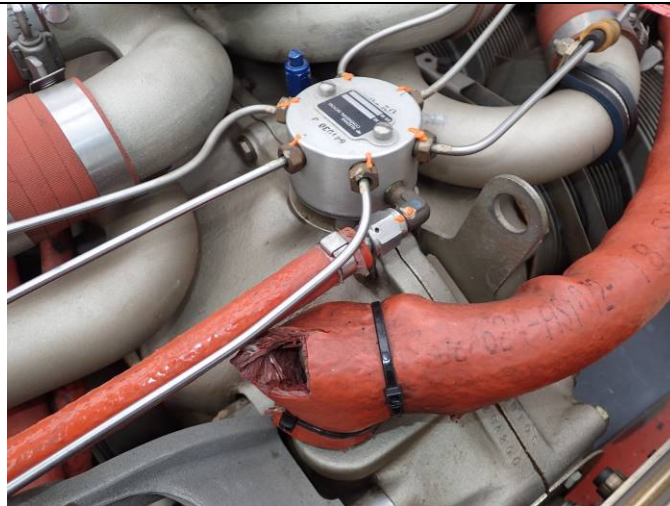
The fuel manifold valve remained attached to its installation point and was undamaged. There were no signs of fuel leaks or other anomalies noted with the fuel manifold valve.

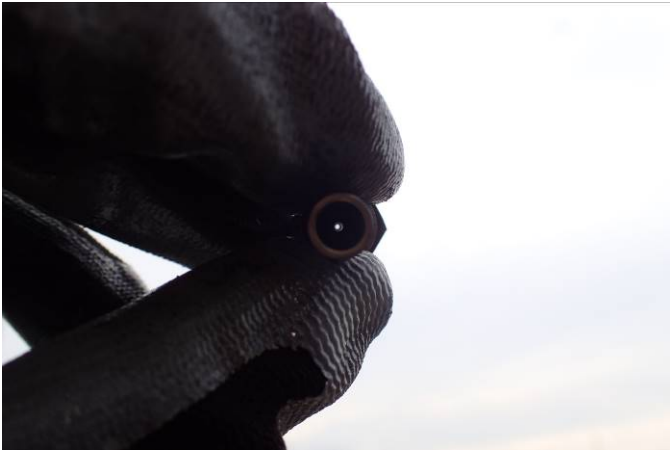
#4 Nozzle

| Position | #1 | #3 | #5 | #2 | #4 | #6 |
|---|---|---|---|---|---|---|
| Condition: | All of the fuel nozzles remained installed in their cylinders and there were no signs of fuel leaks around the nozzles. It was noted that the #4 fuel nozzle was cross threaded in the cylinder and was not installed in the cylinder as far as the other nozzles. All of the nozzles were removed and it was noted that all of the nozzles were clear of obstructions. | | | | | |

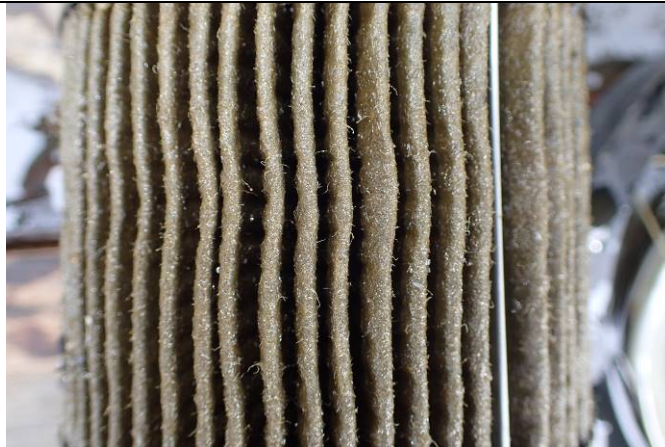
Condition: The oil filter remained secured to the oil filter adapter and was undamaged. The oil filter was removed and the oil housing was cut open. The oil filter pleats were visually inspected; there were no anomalies noted.

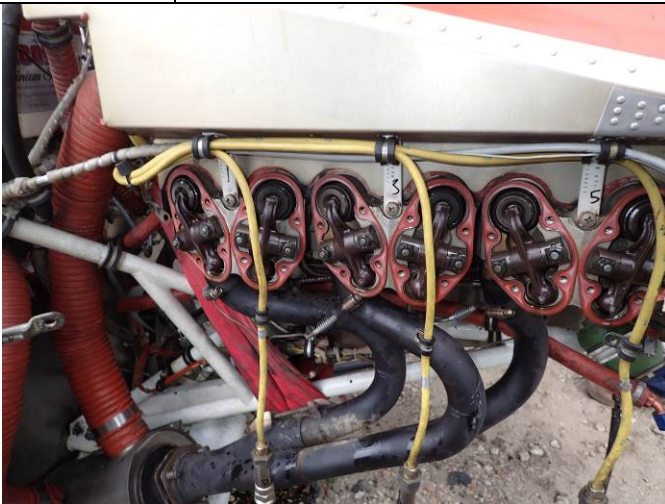
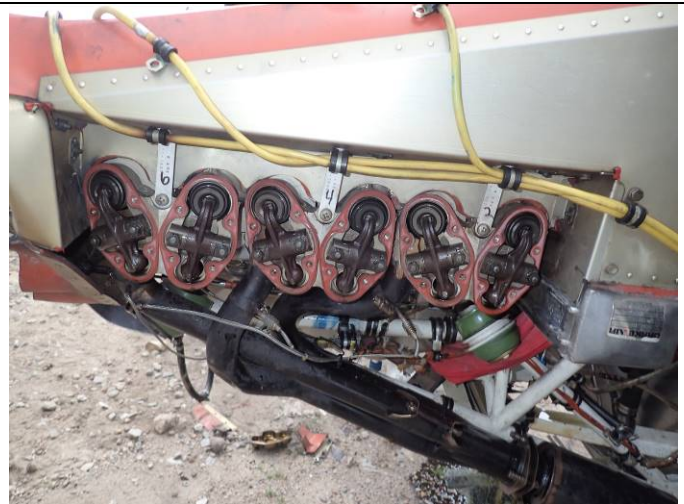
All of the rocker arms displayed normal operating and lubrication signatures. During crankshaft rotation the rocker arms operated normally.

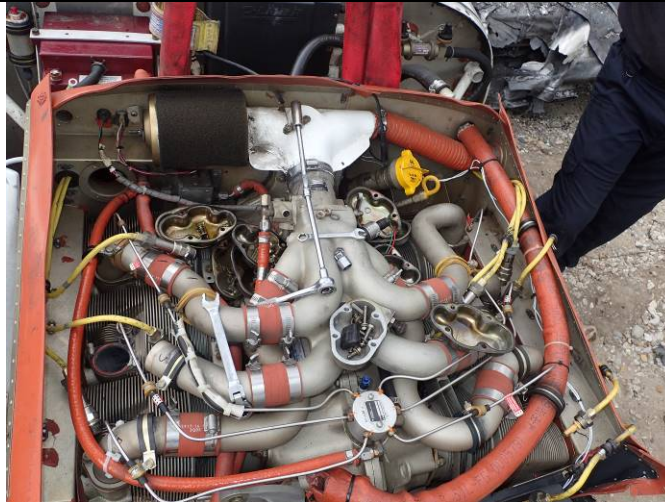
The crankcase was intact and undamaged. There were no anomalies noted with the crankcase.

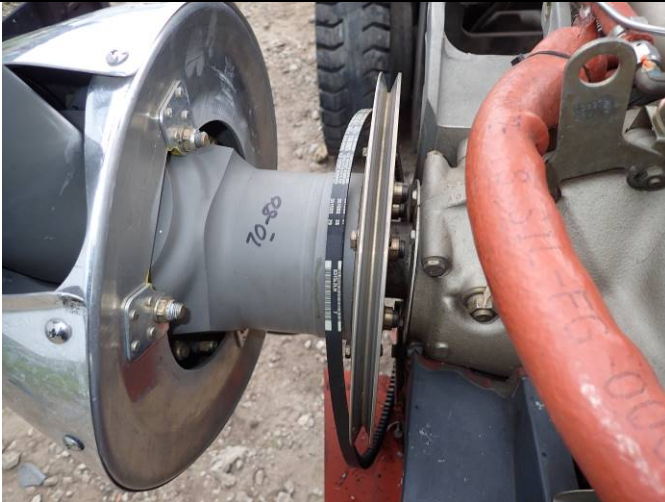
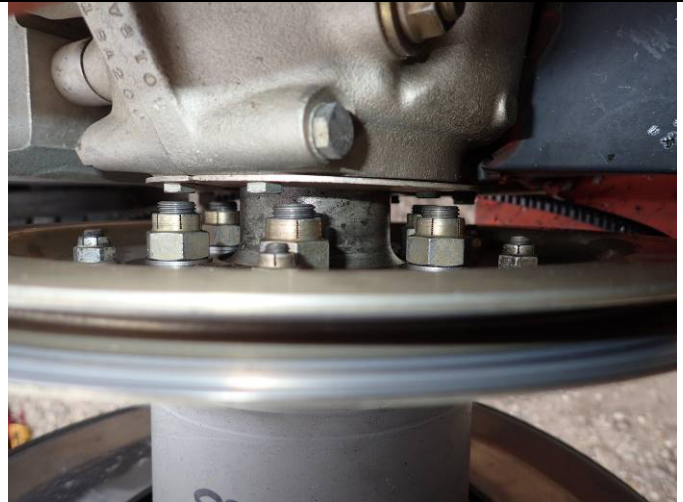
| Condition: | The crankshaft remained intact and there was no damage noted to the visible portion of the crankshaft. The crankshaft was rotated by hand and continuity was established between the crankshaft, camshaft, connecting rods, and associated components. There were no anomalies noted with the crankshaft. | | |

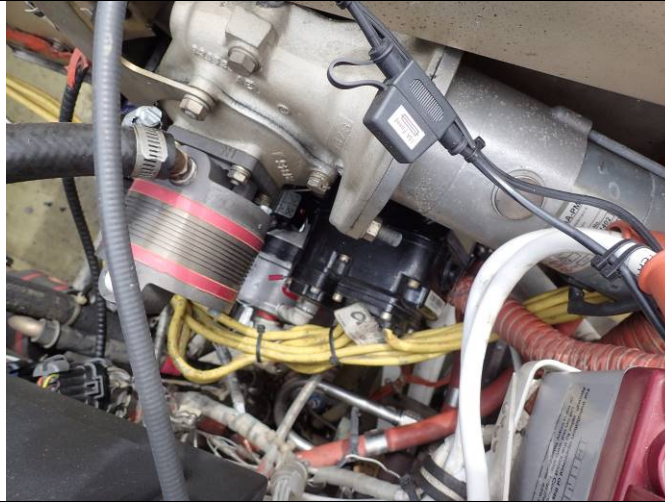
The starter remained intact and undamaged. There were no anomalies noted with the starter.

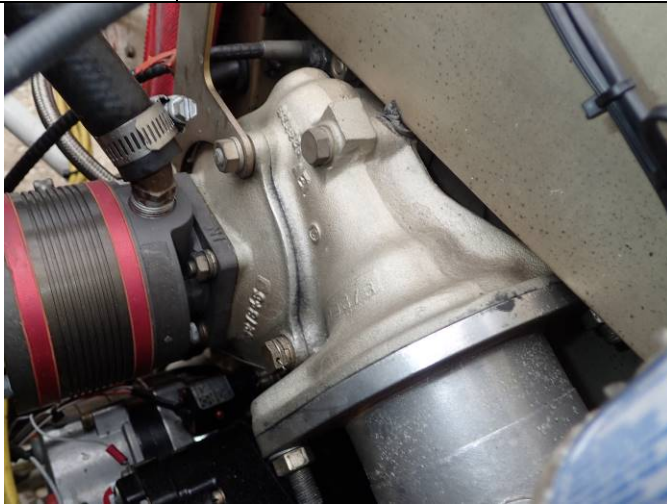
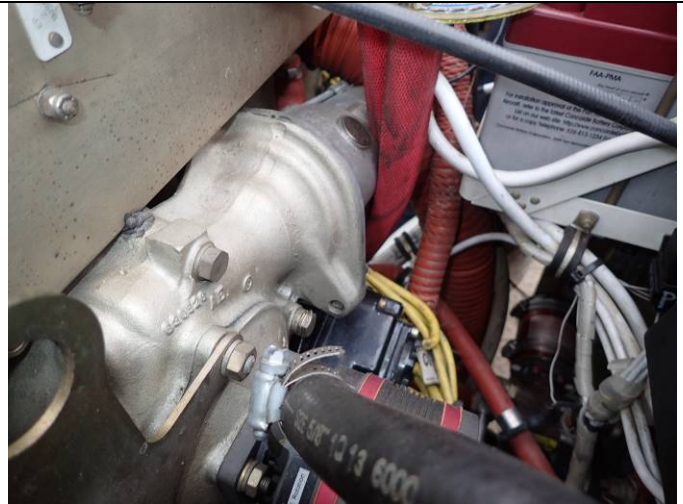
The starter adapter remained intact and was undamaged. There were no anomalies noted with the starter adapter.

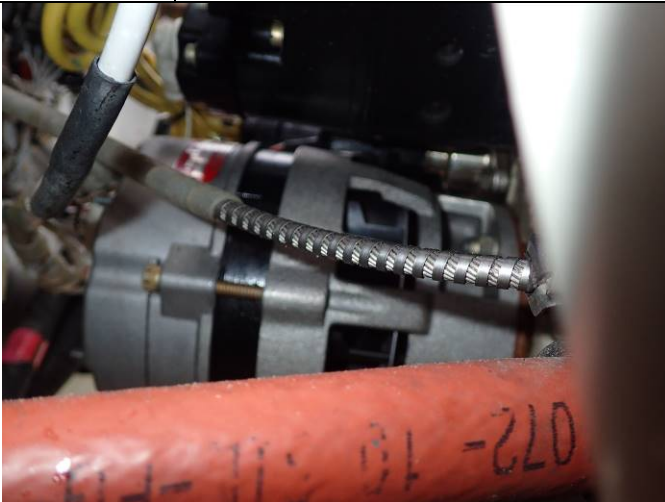
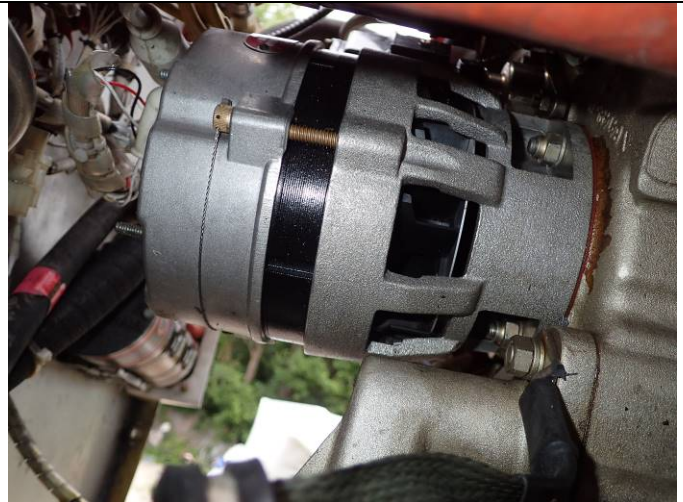
The alternator remained attached to its installation point and was undamaged. There were no anomalies noted with the alternator.

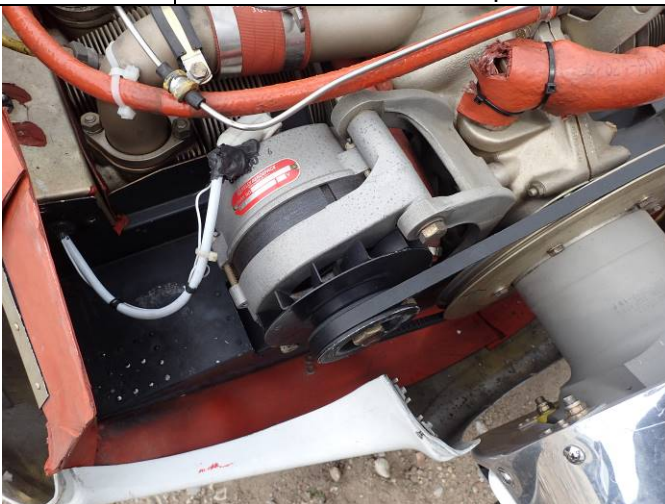
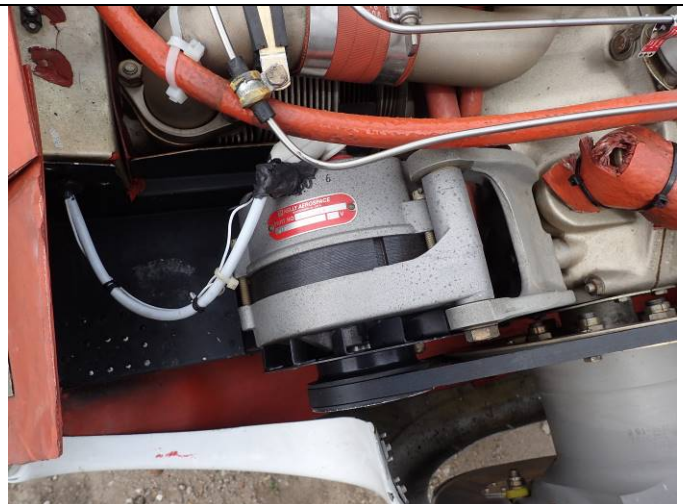
The alternator remained attached to its installation point and was undamaged. There were no anomalies noted. The alternator was removed and it was noted that the alternator drive was capable of normal rotation.
