# Continental Motors

## ENGINE RUN REPORT

| AIRCRAFT MAKE & MODEL | Cessna 180J |
| FILE NUMBER | 17-151 |

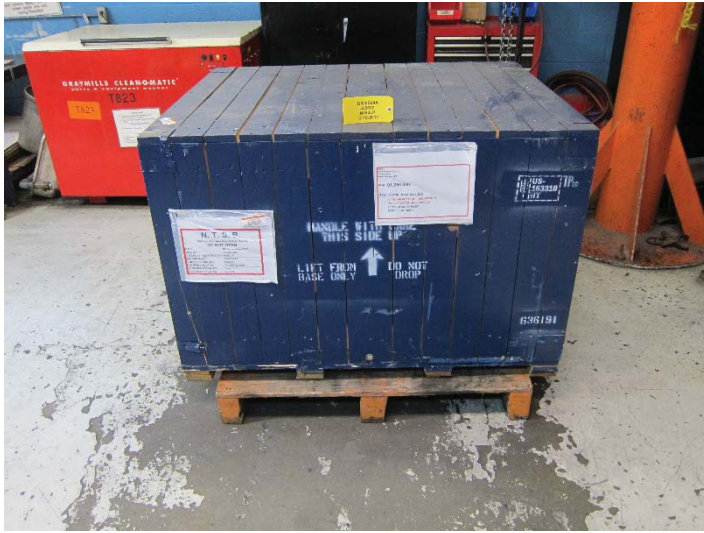
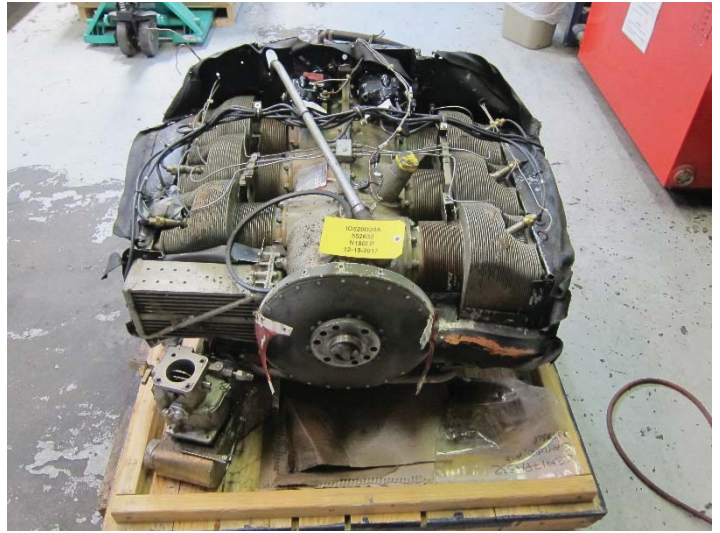
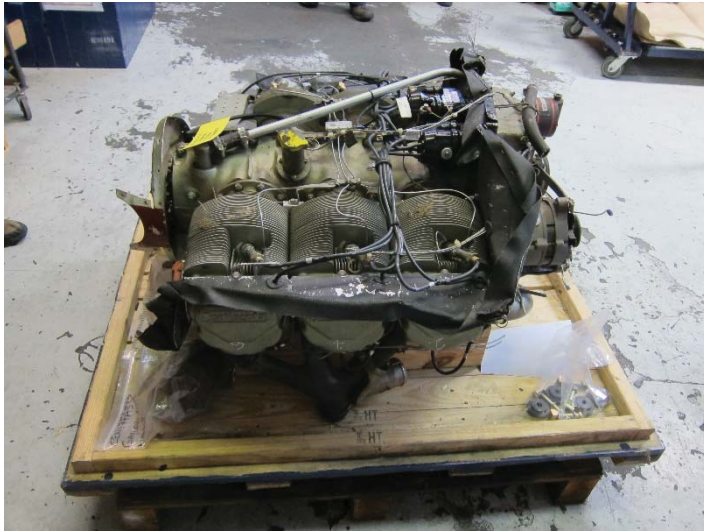
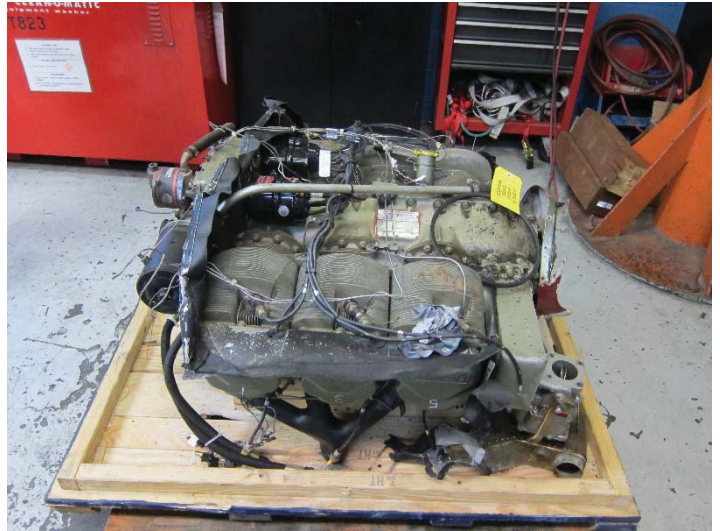
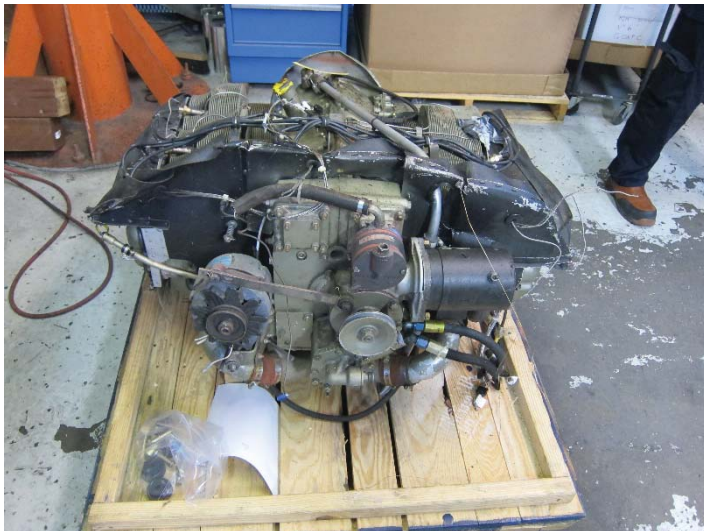
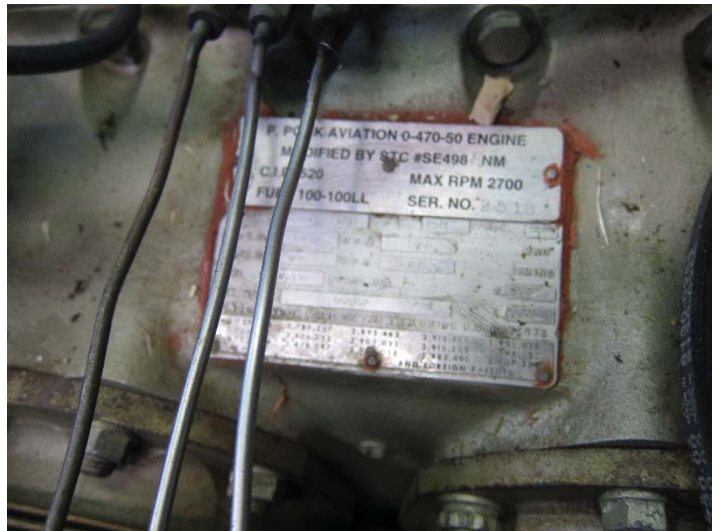
The engine was placed in the crate with the carburetor separated from the engine. No differences were noted from the last time it was inspected at the accident site.

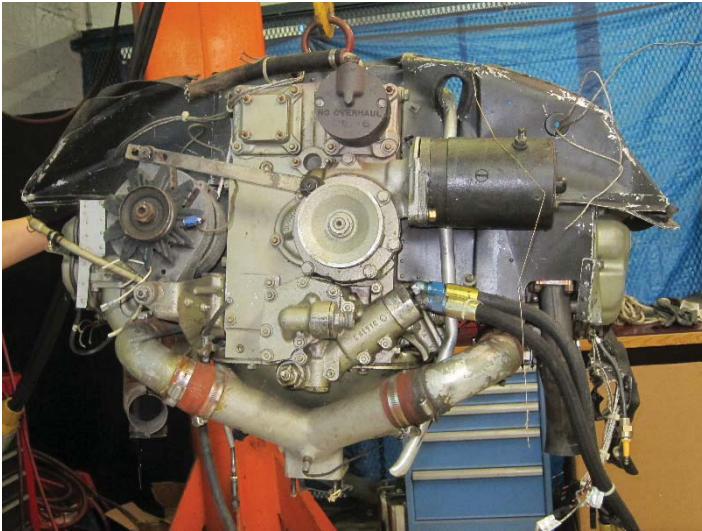
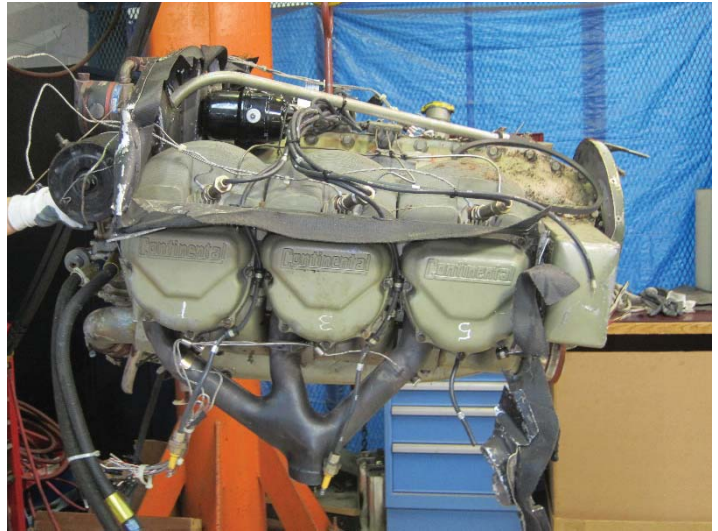
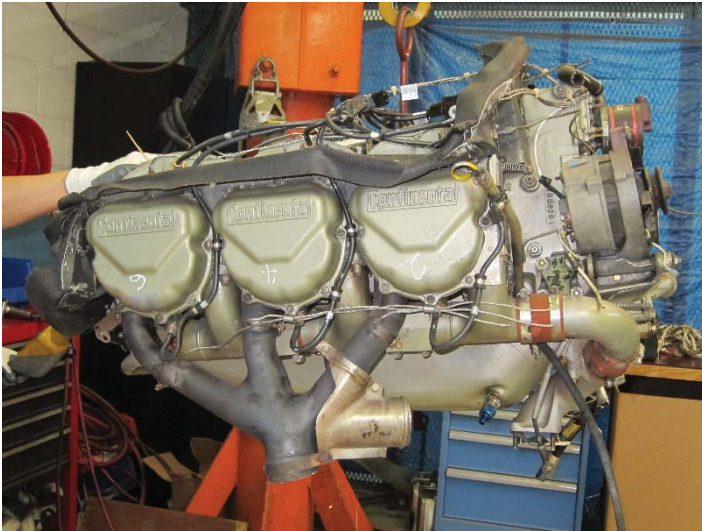
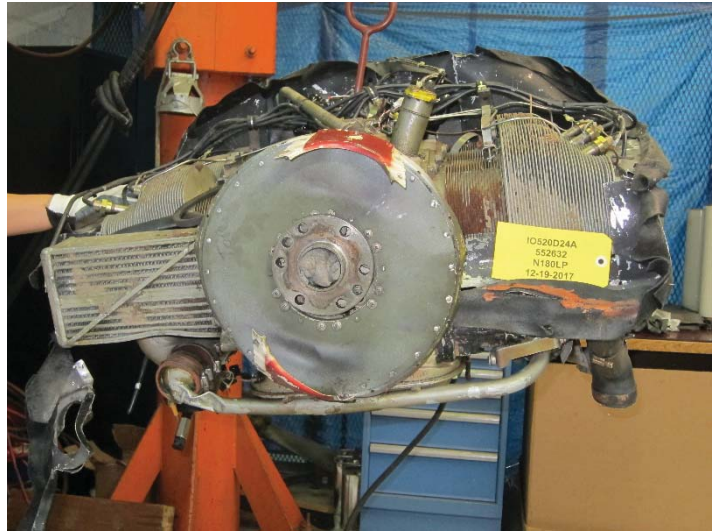
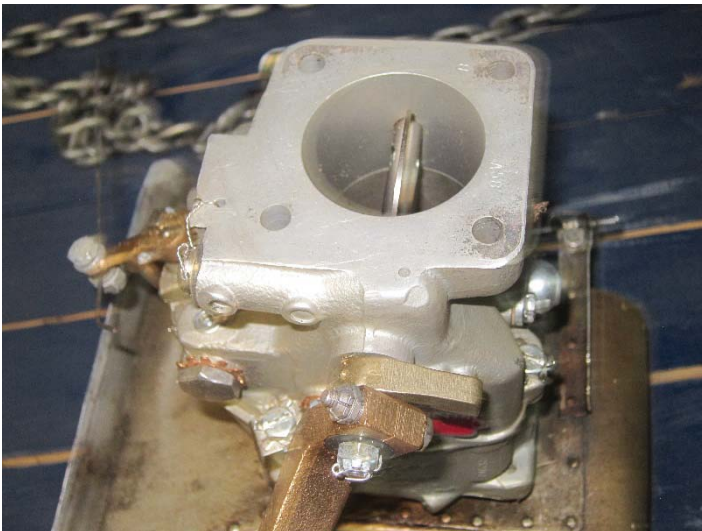
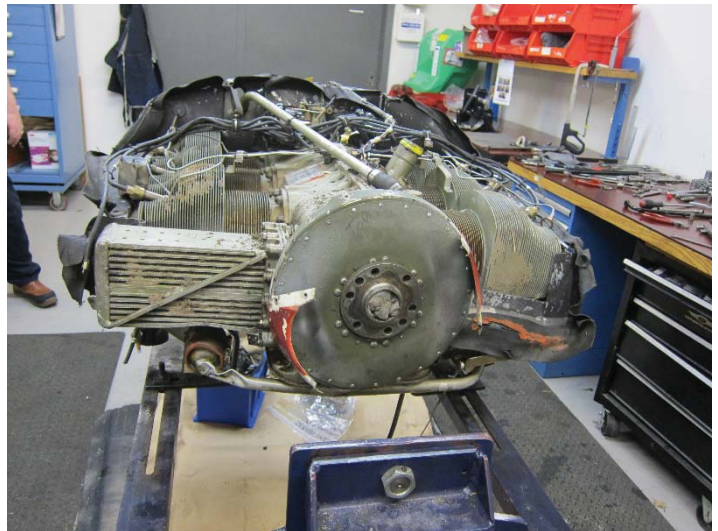
There were a number of airframe related items removed in preparation for operation on the CMI test bed. The removed items included the alternator, vacuum pump, and propeller governor.

The following substitute or repaired parts were required for engine operation: all four engine mounts, starter adapter, starter motor, balance tube, oil filter, oil sump, and intake manifold.

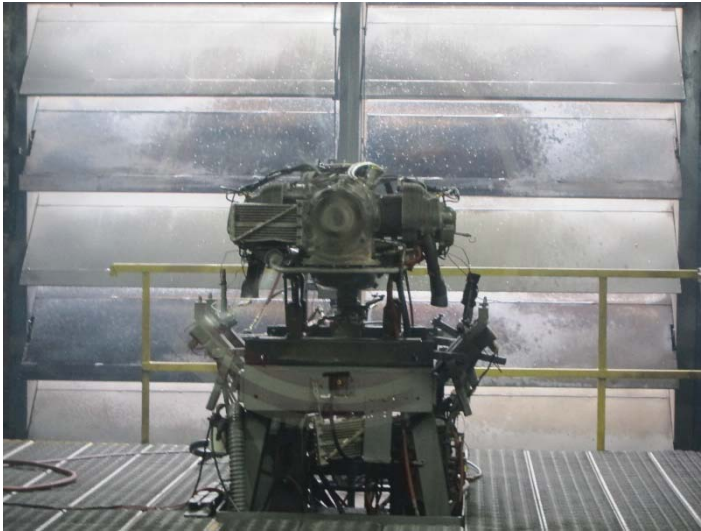
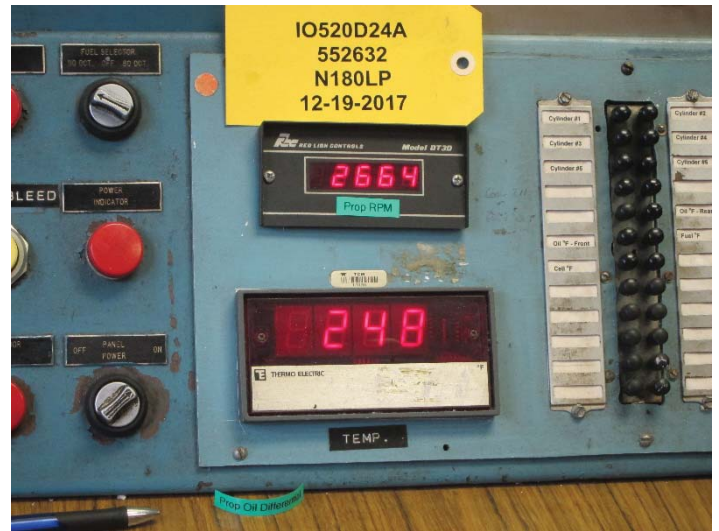
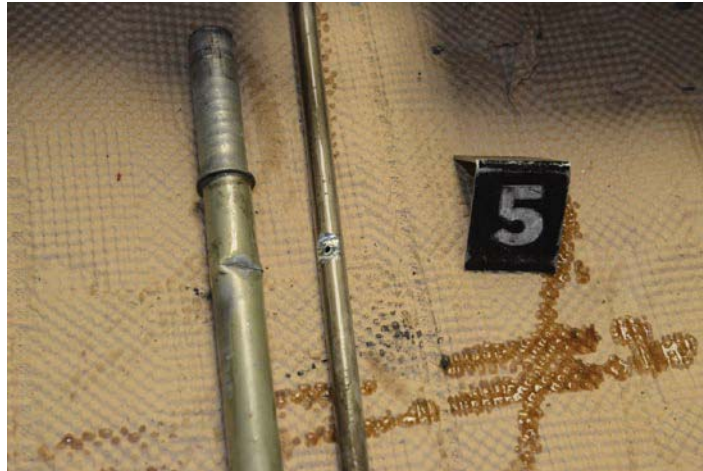
The engine started without hesitation or difficulty. The engine was run through various parameters at 5-minute intervals. Please see the engine test log for more details. The throttle was then moved rapidly from idle to full power on multiple occasions with no interruption or hesitation in power production. No pre-accident anomalies were noted during the engine run. An oil leak was noted, but was a result of a damaged exhaust pushrod and pushrod housing for cylinder #5. The pushrod housing damage was in the same area as the fractured engine mount and punctured oil sump.
