# **N911MK – Serious Incident Investigation**

## **SafranHE Examinations Summary**

(SafranHE ref. RIs 2017/013)

| <b>INVESTIGATION REPORT</b> | <b>Preliminary</b> <input type="checkbox"/><br><b>Final</b> <input checked="" type="checkbox"/> |

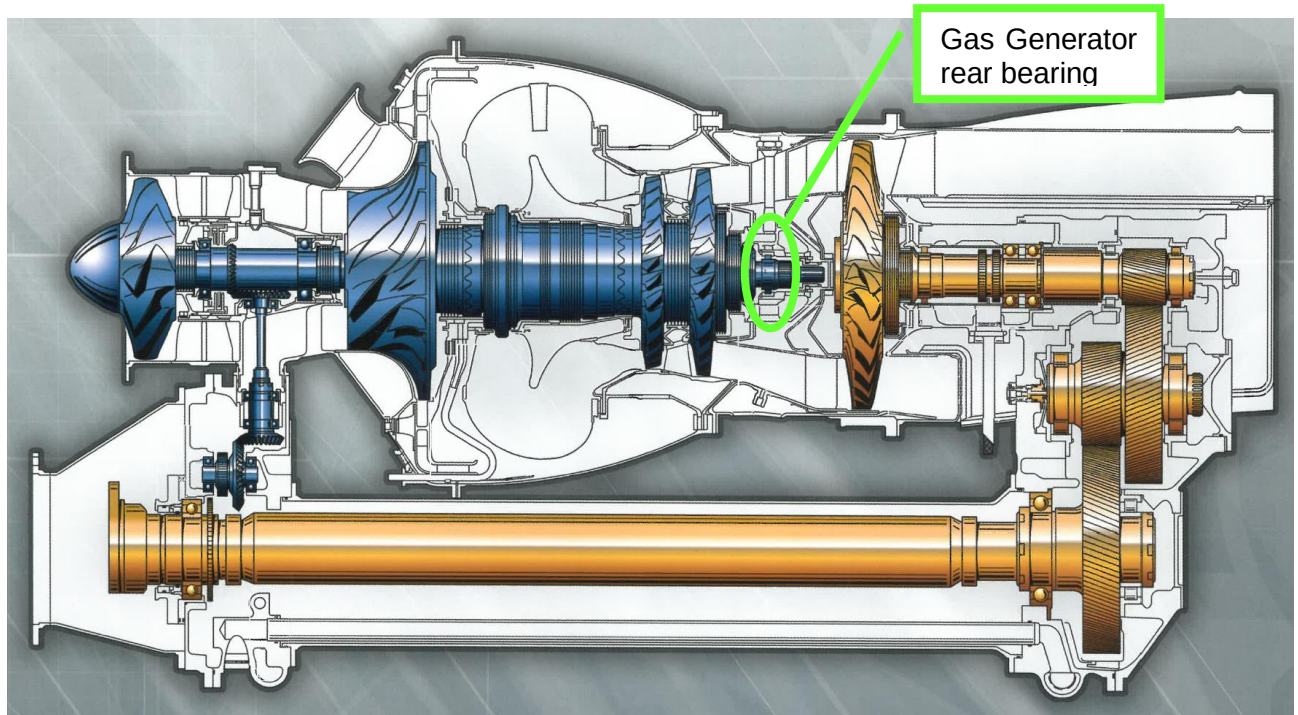
Fig. 1 : ARRIEL 1 Engine General Schematic

The bearing is located at the rear of the Gas Generator spool (in blue on schematic below). The spool is also guided by two ball bearings at the front in the compressor area.

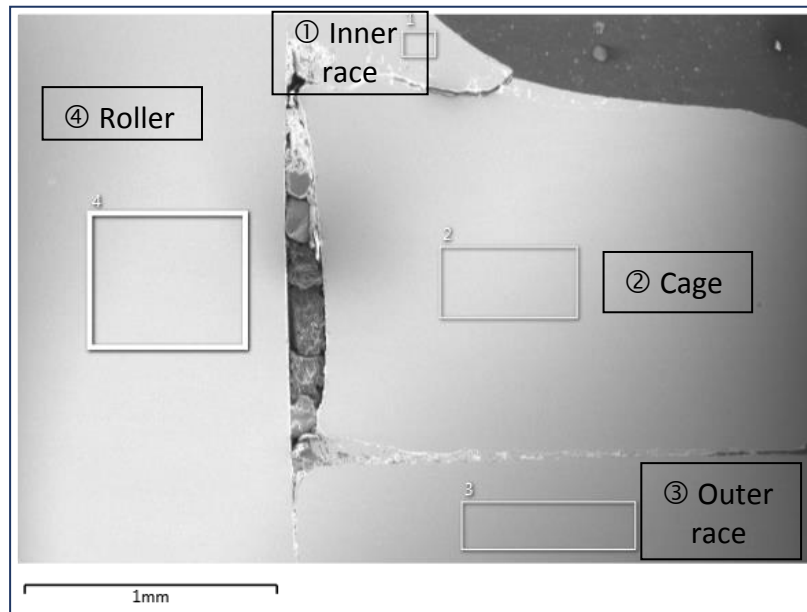
Close-up on bearing's section

A section of the bearing assembly was cut off, wrapped in resin and polished so it could be examined.
