# Continental Motors

## ENGINE FIELD RUN REPORT

| ENGINE MODEL | IO-550-N7B |
| FILE NUMBER | 16-356 |

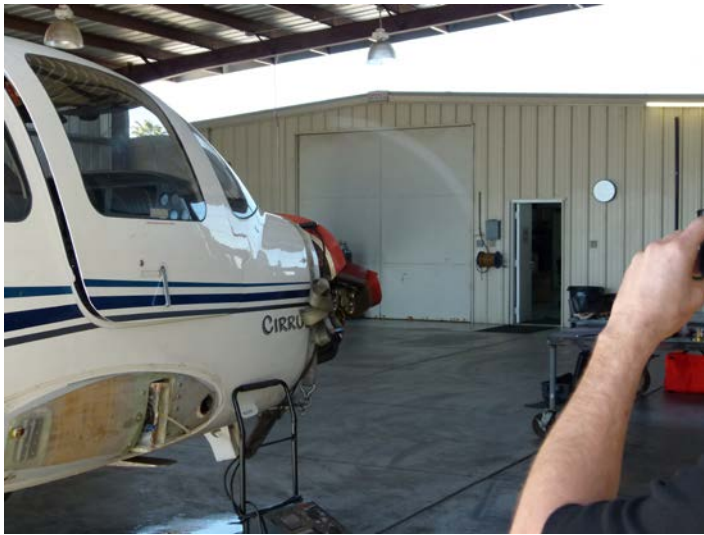
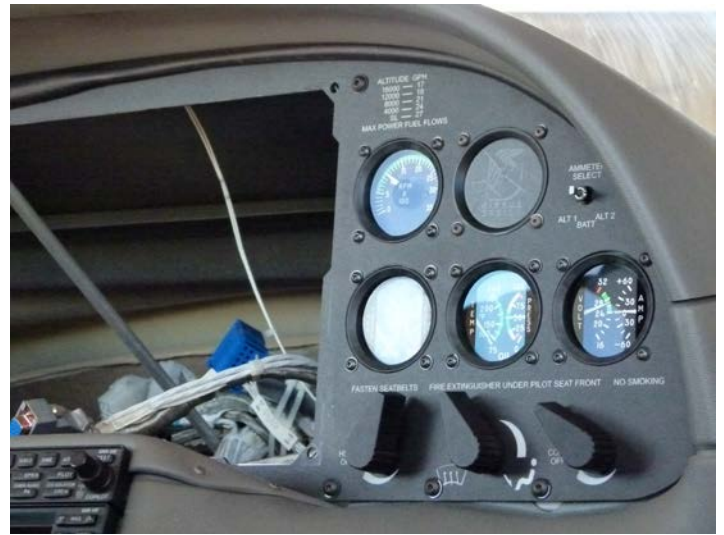
When the engine was primed with the electric fuel boost pump, fuel was observed draining from the fuel gasculator. The gasculator was removed and disassembled and debris and rust were noted in the bowl. A replacement gasculator was installed along with a sump drain. The engine was started normally by recovery company personnel who reported the throttle was gradually advanced to 2300 RPM and approximately 10" Hg. The engine ran smoothly with no interruptions or hesitations. The engine was shut down normally with the mixture control.
