# Continental Motors

## ENGINE FIELD RUN REPORT

| ENGINE MODEL | IO-520-D |
| FILE NUMBER | 16-642 |

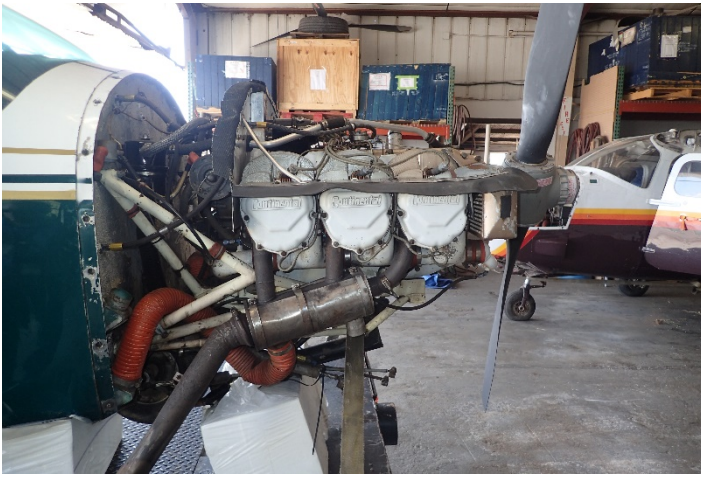
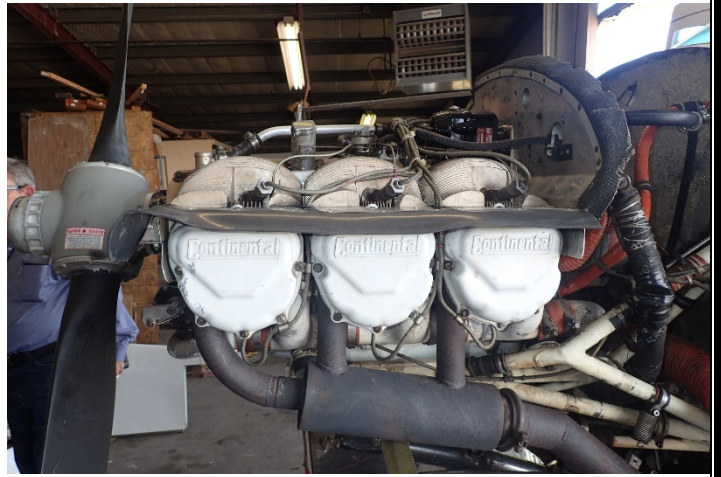
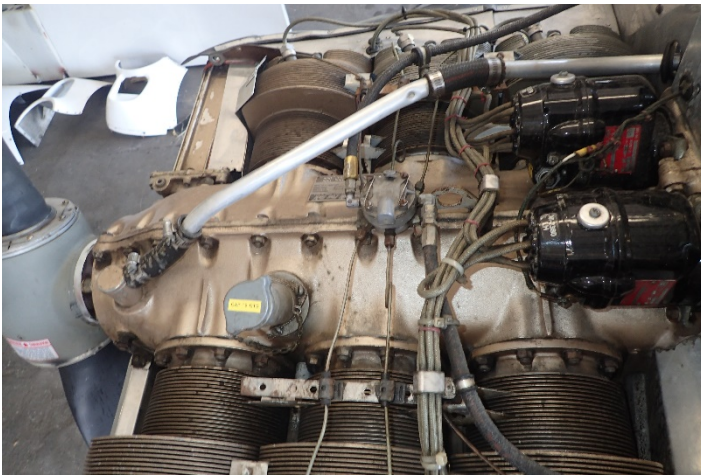
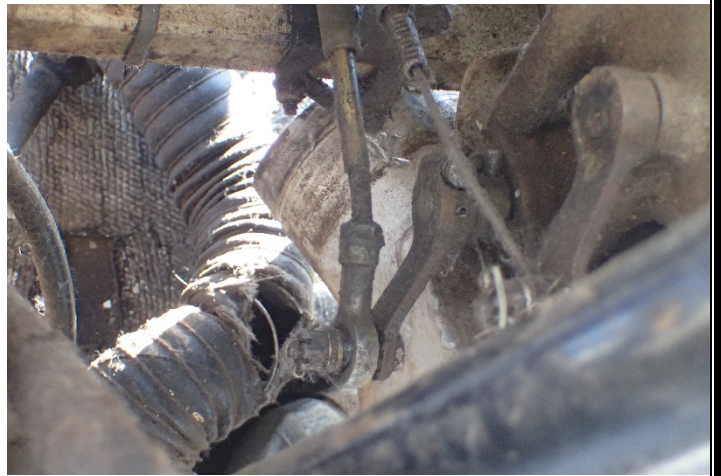
The throttle control cable end displayed impact damage signatures and was bent; during throttle movement, the throttle control arm was noted to be unable to reach the idle stop which was consistent with the impact damage. The mixture and propeller control cables and arms operated normally.

The exhaust system displayed minor impact damage to the exhaust tailpipes; the exhaust risers were undamaged and there were no signs of exhaust leaks. The induction system remained intact and was undamaged; there were no signs of induction leaks noted.

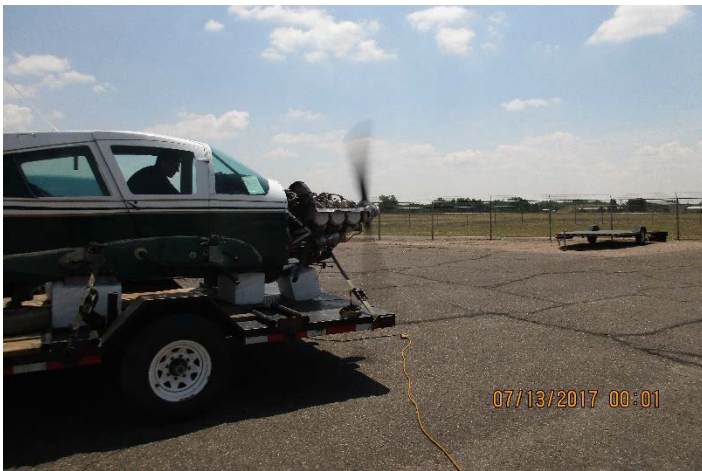
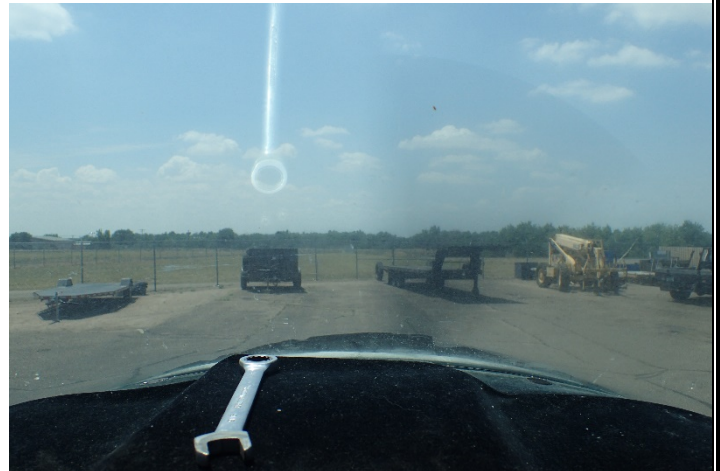
RPM after stabilized by propeller governor
