# NATIONAL TRANSPORTATION SAFETY BOARD

## MATERIALS LABORATORY FACTUAL REPORT

Report No. 17-092

Place : Big Lake, Minnesota  
Date : July 6, 2017  
Vehicle : Bell 47D1, N153B  
NTSB No. : CEN17LA264  
Investigator : Edward Malinowski, AS-CEN

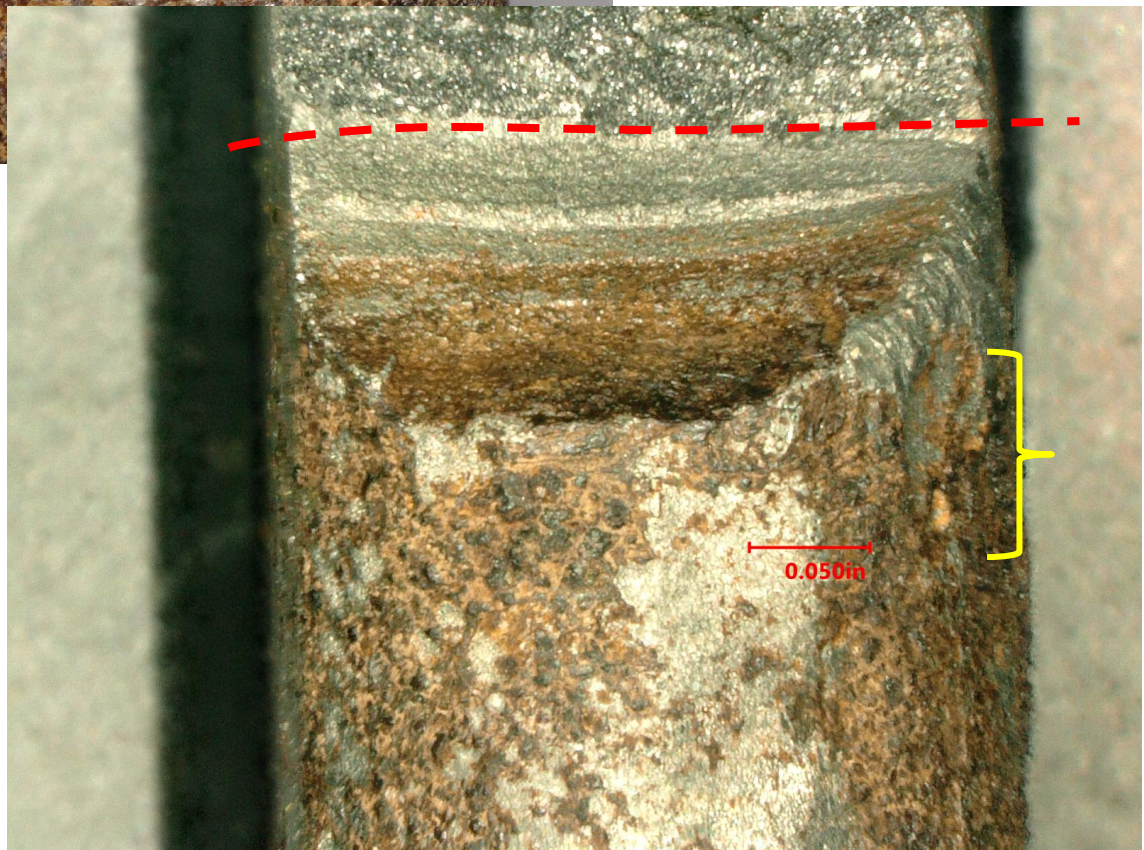
Figure 3 displays the trailing edge of the bar as-received and after ultrasonic cleaning in acetone. The fatigue origin area had some surface corrosion, but no large pits were noted and remnants of the primer remained. Large pits and material removal were seen in the adjacent areas of the upper surface of the bar, denoted by yellow bracket in figure 3.

Figure 3. Views of the trailing edge fatigue initiation area showing corrosion before (left) and after cleaning. Yellow bracket shows area of heaviest corrosion on the upper surface.
