**Air Tractor, Inc.**  
Accident Investigation

**FIELD NOTES**

**CEN17LA284**

**18 Jul 2017**  
**Reyno, Arkansas**

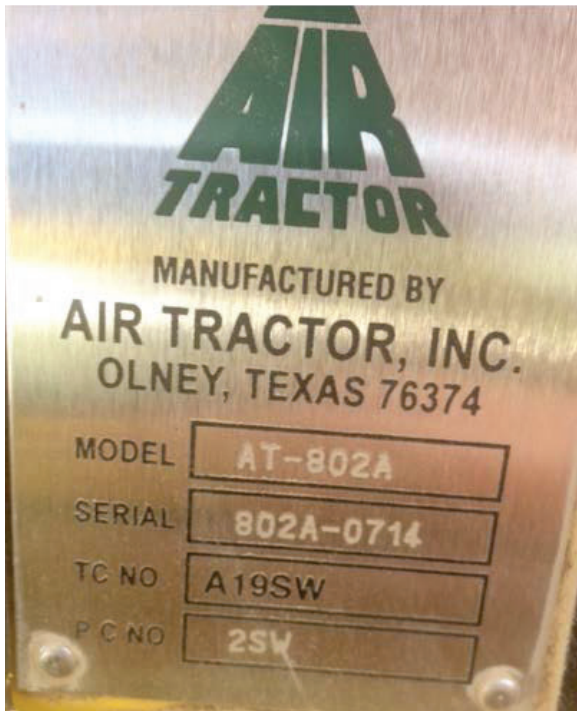
(Photo 2)

The aircraft was confirmed to be an AT-802A serial number 802A-0714 (Photo 2), registered as N816FF (Photo 3). This aircraft was manufactured in 2017. The aircraft hourmeter showed an elapsed time of 8.5 hours (Photo 4). The engine was confirmed to be a PT6A-65AG engine serial number PCE-PN0314 (Photo 5)

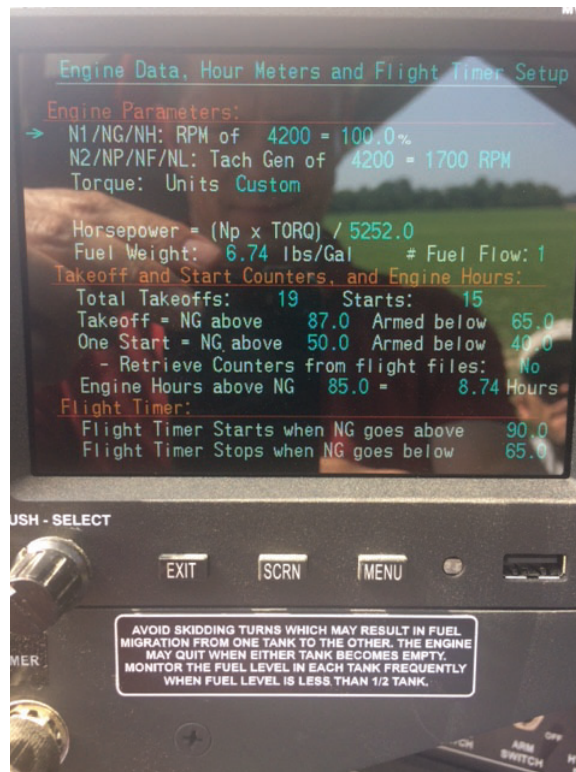
(Photo 6)

The aircraft was fitted with an MVP-50T Digital Engine Monitoring System. The Engine Data, Hour Meter, and Flight Timer Setup page showed the engine to have 8.74 hours of operation above 85% Ng, 19 Total Takeoffs, and 15 Total Starts (See Photo 6). It was verified to be properly programmed for an AT-602 with a PT6A-65AG installed.

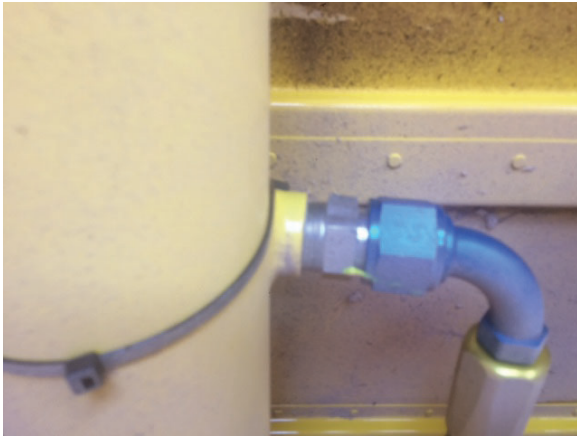
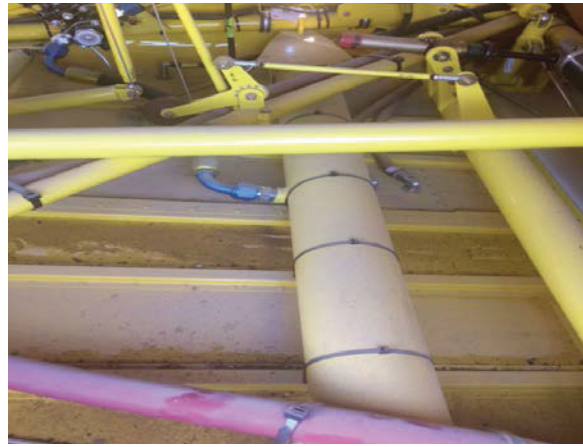
The fuel system was inspected for continuity and component condition. The header tank was intact and fuel lines secure (See photo 27 and 28). The electric boost pump fuel lines were intact and secure (See photo 29). The fuel selector valve was intact and operational with all fuel secure (See photo 31). The engine driven (low pressure) fuel pump was intact and fuel lines secure (See photo 31).

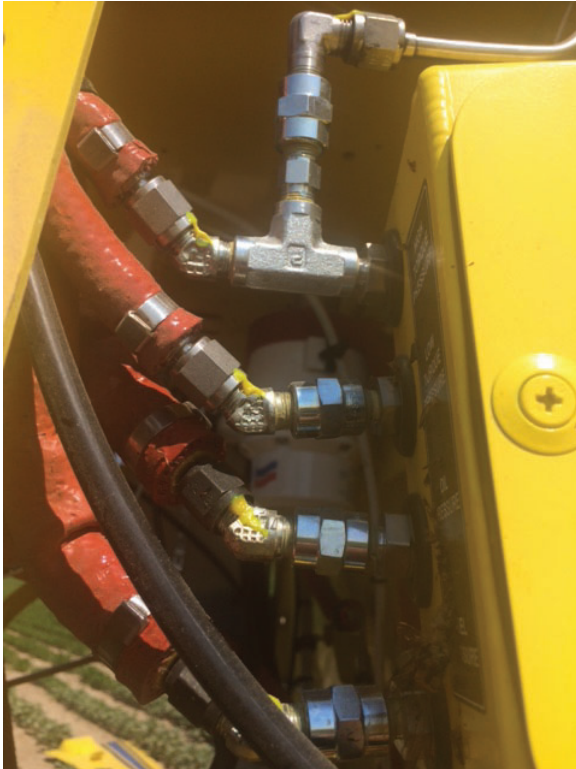
(Photo 32)

The MVP-50T Digital Engine Monitor system was noted to be functional when electrical power was applied with the engine not operating. The fuel and oil lines (IE. Tq.(hi), Tq.(low), Fuel Pressure, and Oil Pressure) leading to the transducers were intact and not damaged (See photo 32). The transducer cannon plugs were properly installed and intact (See photo 33).

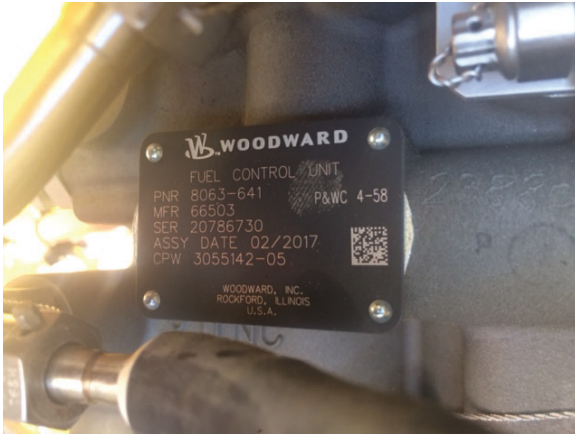
(Photo 34)

The engine fuel control unit was confirmed to be P/N: 8063-641 / CPW 3055142-05, S/N: 20786730 (See Photo 34) inspected with no anomalies noted. The FCU override input arm was safety wired to the “off” position as the aircraft was not equipped with a manual FCU override (See Photo 35). The Py filter bowl was intact and properly safety wired (See Photo 36).

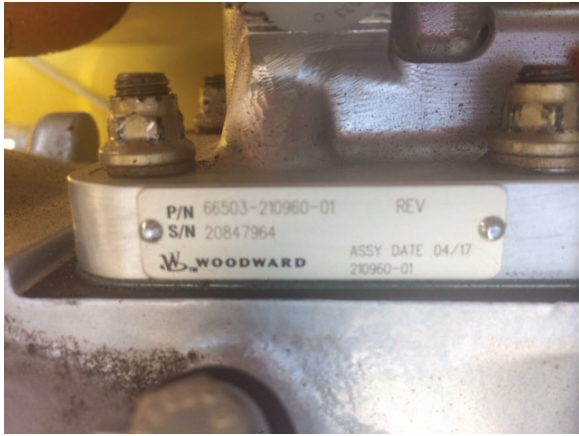
(Photo 37)

The engine primary governor (propeller governor or constant speed unit) was verified to be P/N: 66503-210960-01 (See Photo 37). It was intact with no leakage noted. Input controls operated normally throughout the full range of motion (See Photo 38). The propeller governor Py bleed link was found intact and fully seated against the cut-off stop (See Photo 39). The engine overspeed governor was intact and no damage noted (See Photo 40).

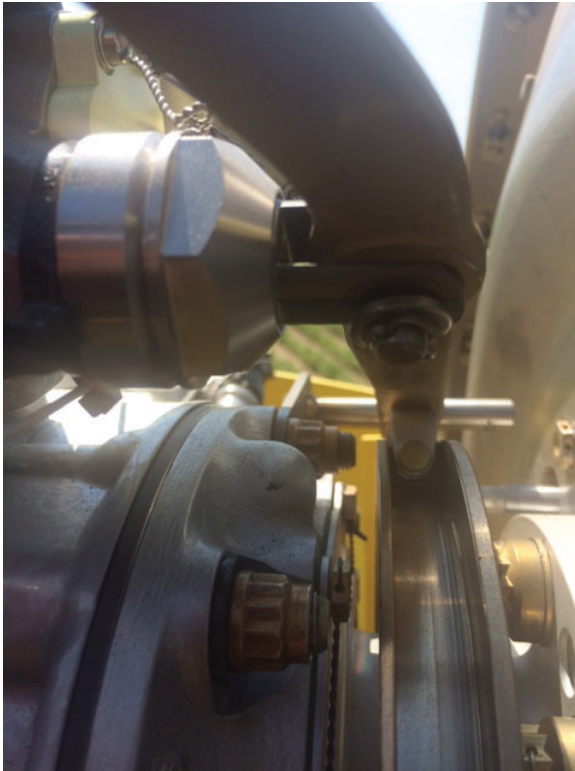
(Photo 41)

The propeller beta system was correctly connected and continuous. The beta plunger appeared properly rigged (flush) and beta block properly seated under the guide pin in the propeller beta ring (See Photo 41). The low pitch “beta nuts” were undisturbed (See Photo 42). The only anomaly noted was slight surface corrosion on propeller counterweight (See Photo 43).

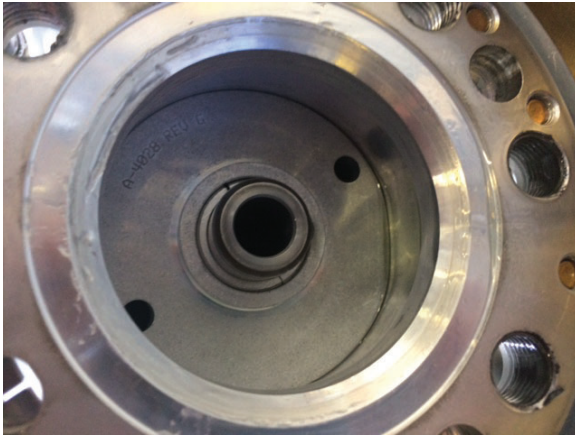
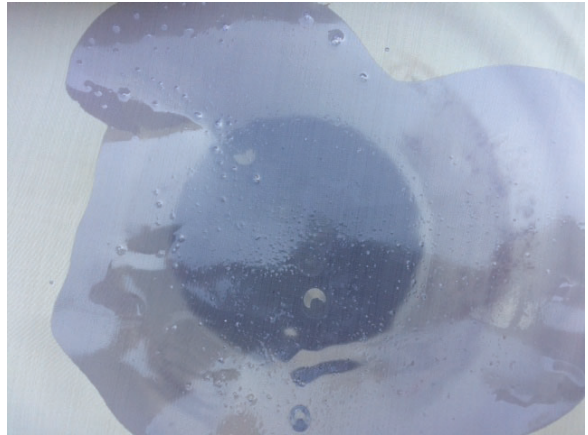
The incident aircraft was relocated to Air Tractor, Inc. located in Olney, Texas and arrived on the morning of July 26, 2017. Technicians removed the propeller. The oil was captured and sifted through a fine mesh screen to inspect for debris. No debris was noted either in the propeller shaft or from the oil drained from the propeller hub (See Photos 44 and 45)
