Service Investigation  
**Accident / Incident Report**

**Report No.: 17-108**

**C & C Flying Service  
Air Tractor AT-802 Registration # N816FF  
Reyno, Arkansas  
18 July 2017  
PT6A-65AG  
S/N PN0314**

**Date of Issue:** 11 April 2018

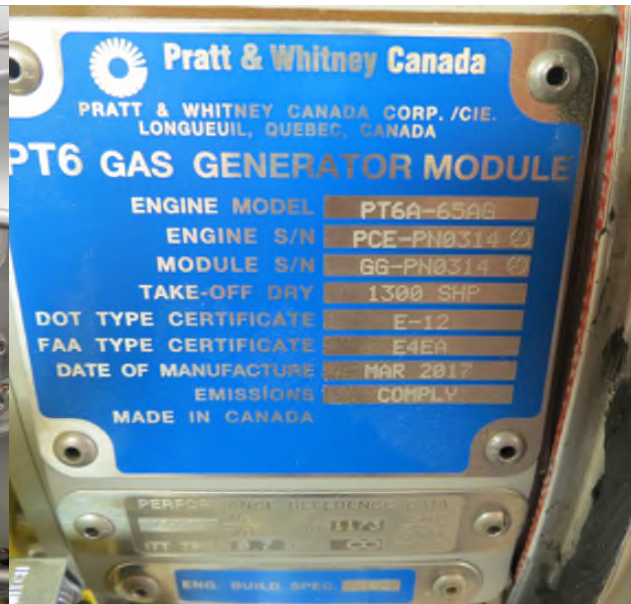
Photo No. 6  
Data plate

**Inlet Case / Oil Tank:** No damage was observed and the inlet screen was intact (Photos No. 1, 2 and 5). Data plat showed the engine S/N (Photo No. 6).

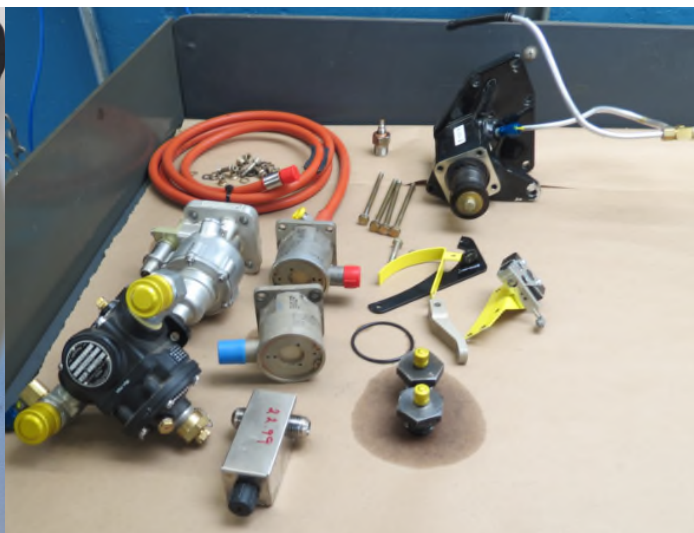
Photo No. 8  
Removed OEM components

Components from the OEM were removed from the engines (Photo No. 8).

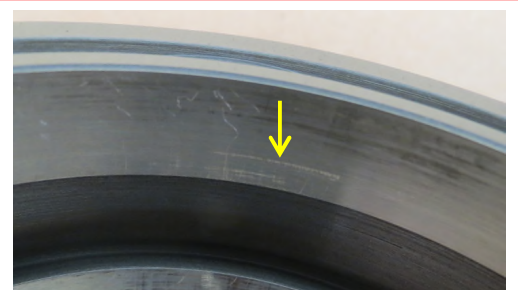
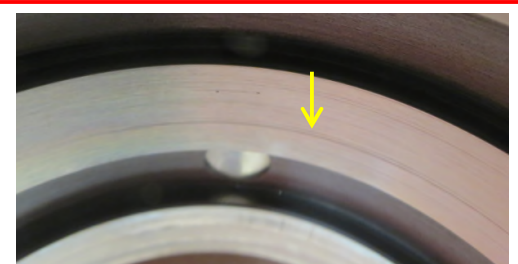
Photo No. 41  
Propeller sleeve  
Score marks (yellow arrows)

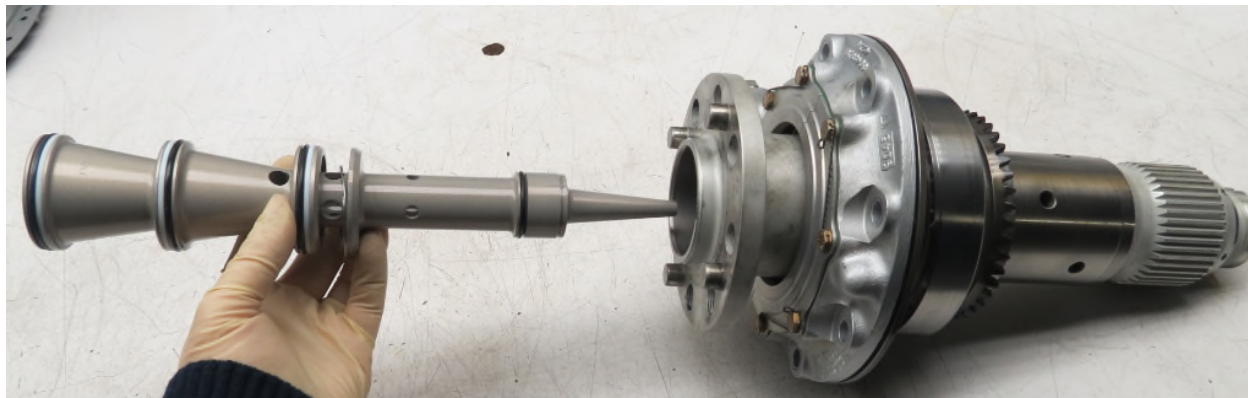
Photo No. 42

Propeller shaft and the internal oil transfer tube/oil jet

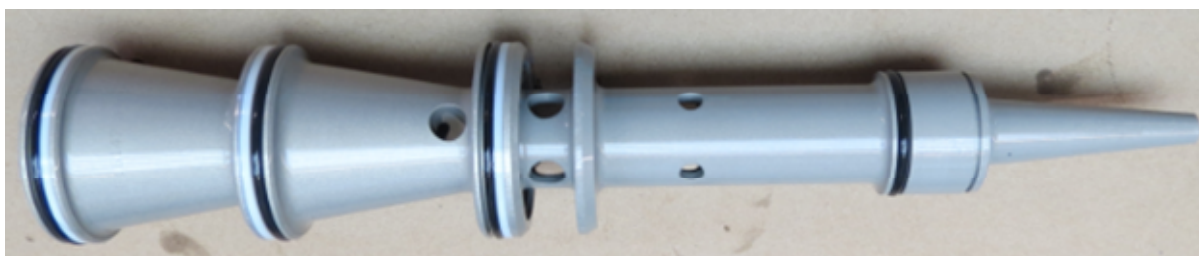
Photo No. 43

Internal oil transfer tube/oil jet

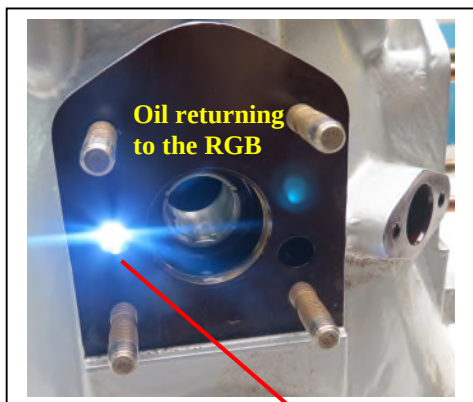
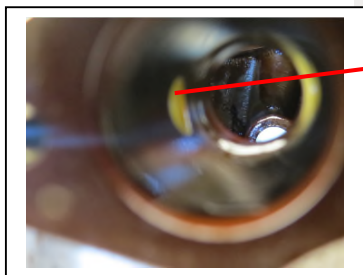
**Front Housing:** All internal oil passages for the propeller governor (CSU) and the overspeed governor (OSG) in the front RGB housing were visually examined and no obstruction was observed (Photo No. 44).

The oil passing at the external of the oil transfer tube is going to the OSG.

The oil passing at the internal of the oil transfer tube is going to the propeller shaft cavity.

Photo No. 44  
Front RGB housing  
Oil passages (yellow arrows)  
for the propeller governor  
and overspeed governor

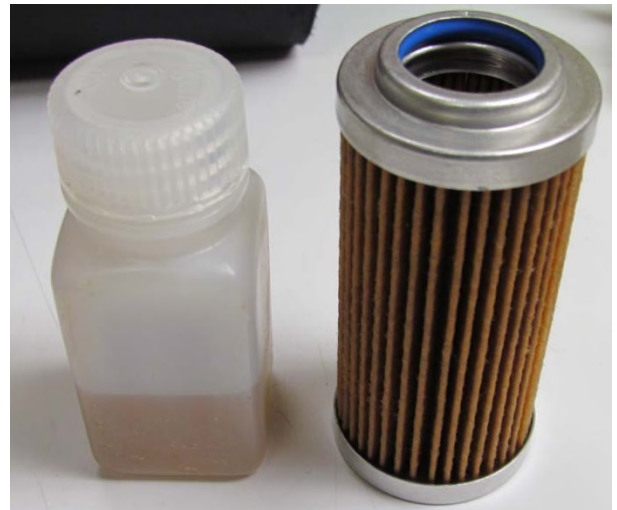
Picture 2

The fuel pump was in good condition (picture 1). The input shaft was rotating without restriction. The lockwire of the filter bowl was missing. Remaining Lock wires/safety cables were present and intact. The lockwire between the motives flow fitting and the cap plug on the filter upstream pressure port looked different. The lockwire was measured and meet the drawing requirement. Prior testing, the filter bowl was removed. The remaining fuel was collected and placed into a plastic container (Picture 2). The fuel within the container was water free. The fuel filter was removed and visually inspected. The filter appeared clean (Picture 2). Examination of the filter bowl revealed traces of dark debris suspended in the fuel (Picture 3). This is not an unusual condition. The inlet screen port cover was removed to allow access to the inlet screen assembly. The screen meshing was clean with the exception of a small piece of black debris. This is not an unusual condition. The debris was collected and placed in a container. The fuel pump was reassembled and was tested satisfactorily (Picture 4). The pressure port plugs and fittings were removed to allow fuel pressure monitoring in the course of the fuel pump fuel filter bypass test (Picture 5). After testing, the fuel pump was returned to its as received condition. As agreed with the NTSB representative, the fuel pump disassembly was not performed.

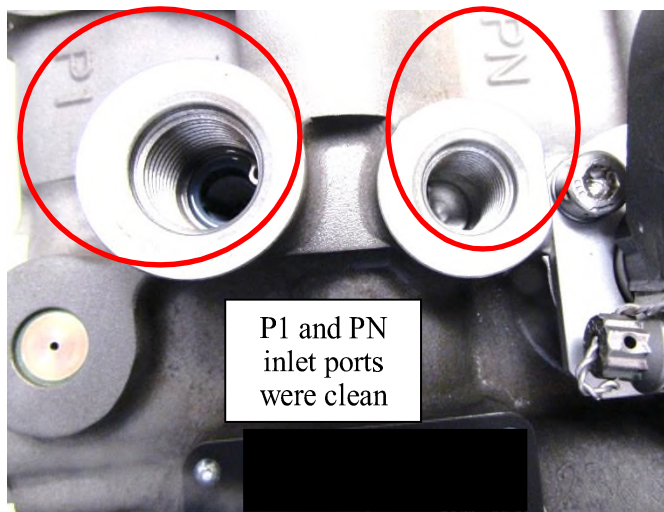
Picture 8

The P3 inlet port was clean (Picture 7). The P1 (fuel inlet) and PN (fuel nozzle flow) fittings were removed. The inlet fuel filter in the P1 port and the PN outlet port were both found uncontaminated (Picture 8). Picture 9 shows the hardware removed from the FCU for installation of the test fixtures (Picture 10). The removed hardware was kept in a seal bag with the FCU. The fuel control was tested in accordance with the [REDACTED]. The FCU operated normally within the test requirements except for the High idle, the maximum reverse and maximum forward speed setting, which were slightly above the maximum limit. These are normal field adjustments. As agreed with the NTSB representative, the FCU disassembly was not performed.

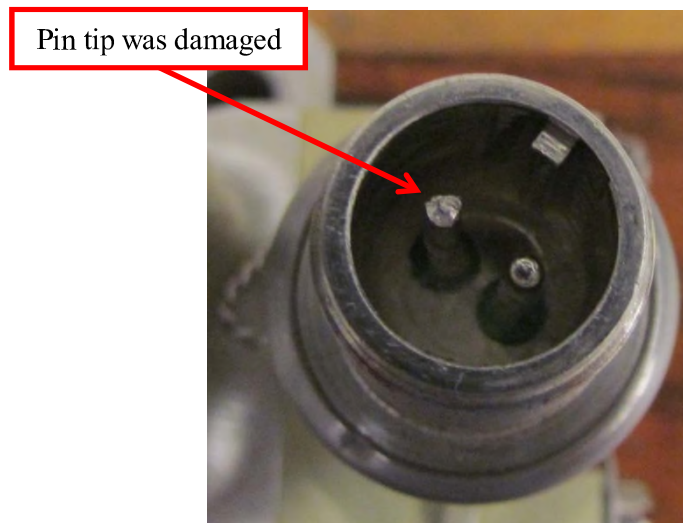
The Overspeed Governor (OSG) was in good condition (Picture 20). The input shaft was rotating without restriction. The electrical connector was clean but there was no protective cap on the connector (Picture 21). One of the contact pin was slightly damaged on the tip (Picture 22). Lockwires were present and intact. The solenoid body was properly secured. White paint was present on the speed adjustment. With the NTSB agreement, the OSG was shipped to [REDACTED] for testing and disassembly. [REDACTED] was created providing the instructions to investigate the OSG. The OSG was sent to [REDACTED] on the P&WC Delivery note [REDACTED] and the [REDACTED]
