CESSNA AIRCRAFT COMPANY  
**MODEL 340**  
SUPPLEMENTAL INSPECTION DOCUMENT

**SUPPLEMENTAL INSPECTION NUMBER: 32-30-00**

Main/Nose Landing Gear Retraction Systems Teardown and Inspection

Main Landing Gear Bell Crank Pivot Bolt

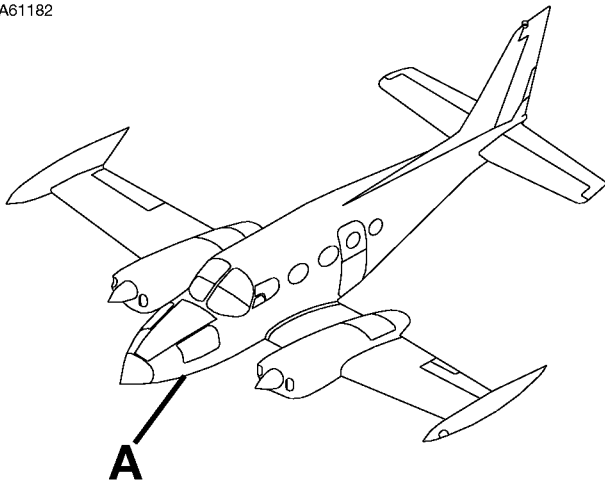
Electromechanical Landing Gear System (Typical)  
Figure 1 (Sheet 1)

**NOTE :** REPLACE ALL HARDWARE  
REMOVED DURING INSPECTION  
PROCEDURE WITH NEW  
ATTACHING HARDWARE AT  
REASSEMBLY/REINSTALLATION.

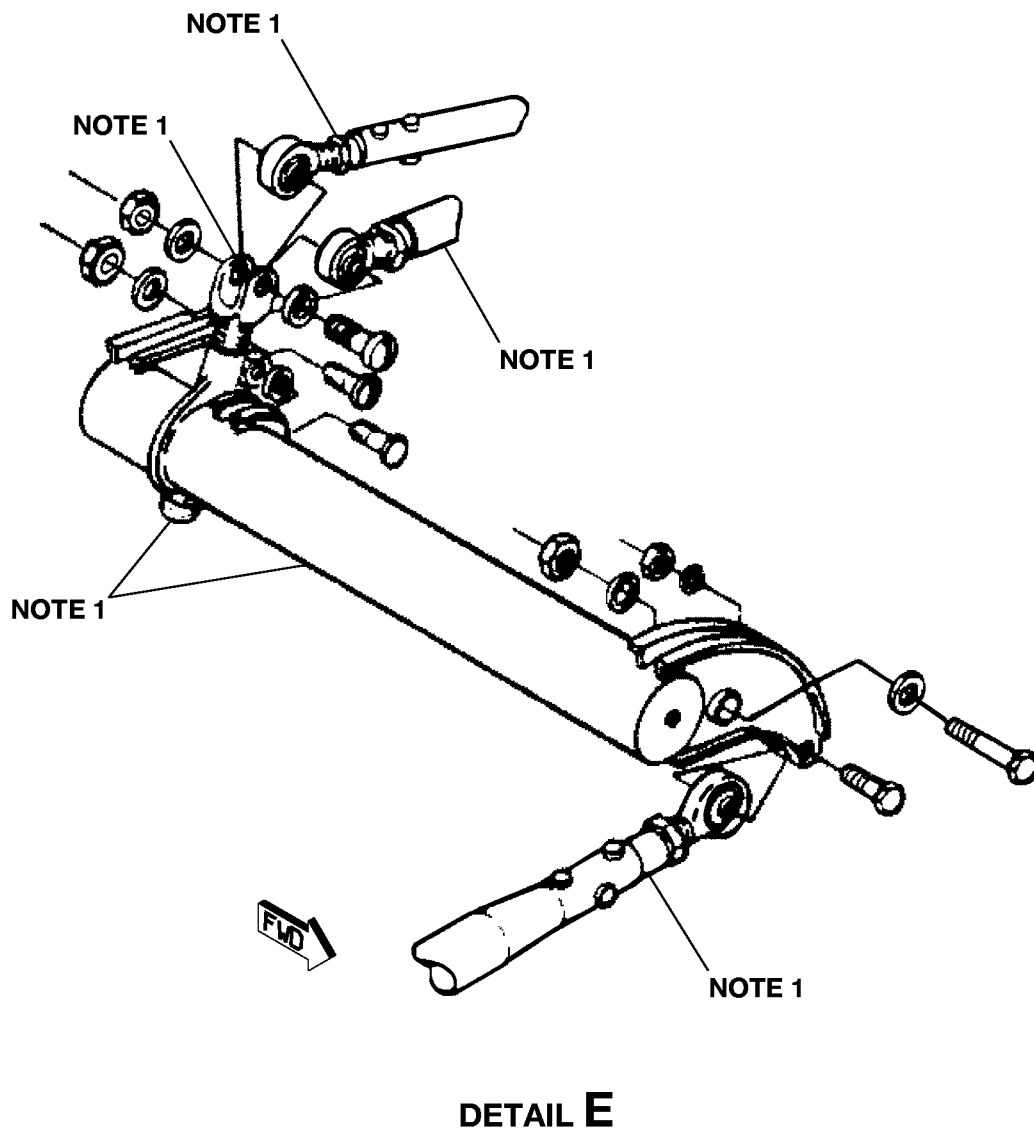
Electromechanical Landing Gear System (Main Landing Gear)  
Figure 3 (Sheet 4)

**NOTE :** INSPECT FOR CRACKS AND CORROSION,  
AND REPLACE WITH NEW PARTS AS REQUIRED.
