# Continental Motors

## ENGINE RUN REPORT

| ENGINE MODEL | TSIO-520-UB17B |
| FILE NUMBER | 17-333 |

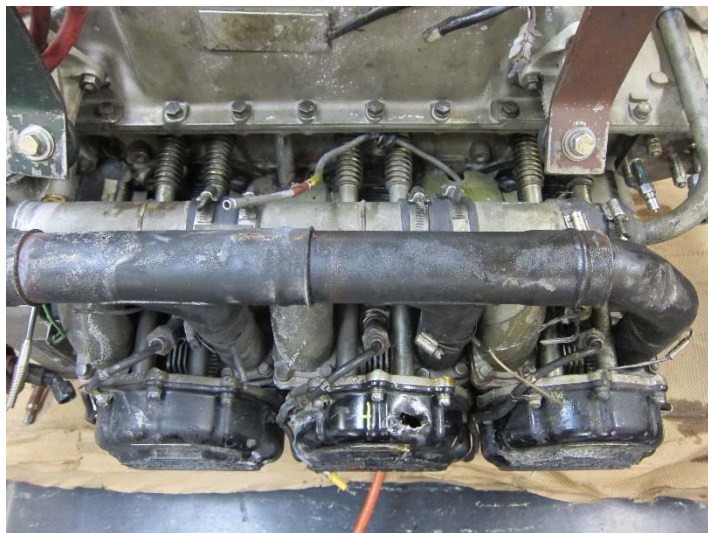
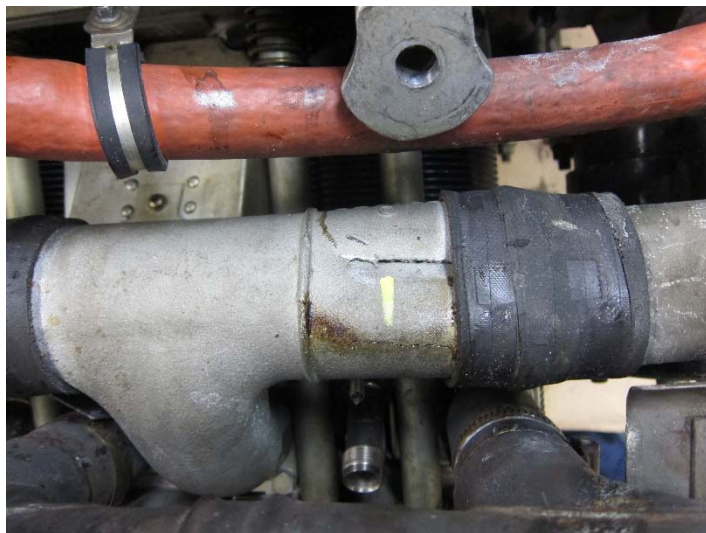
The engine exhibited light thermal damage to the accessory section and residue from fire extinguishing efforts. Three of the engine mount legs were broken. The induction and exhaust systems exhibited slight impact damage. The turbocharger remained attached to the engine and exhibited impact damage to the mount bracket and the turbine housing. The turbocharger did not rotate freely by hand.
