# Continental Motors

## ENGINE EXAMINATION REPORT

| ENGINE MODEL | TSIO-520-NcNB via RAM STC |
| FILE NUMBER | 17-361 |

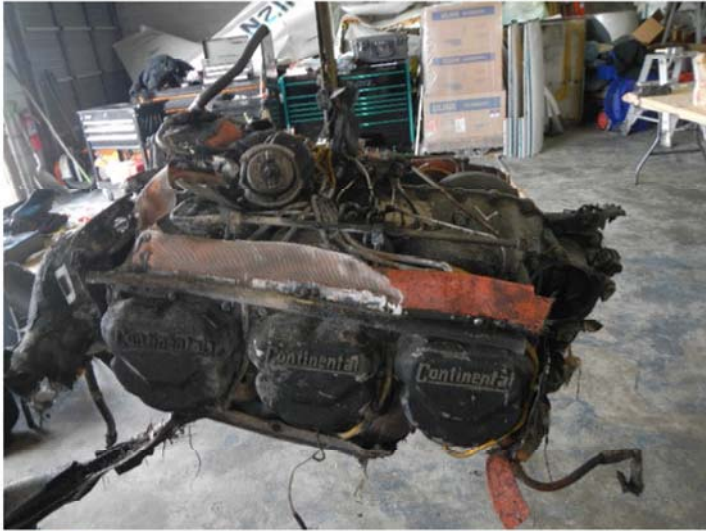
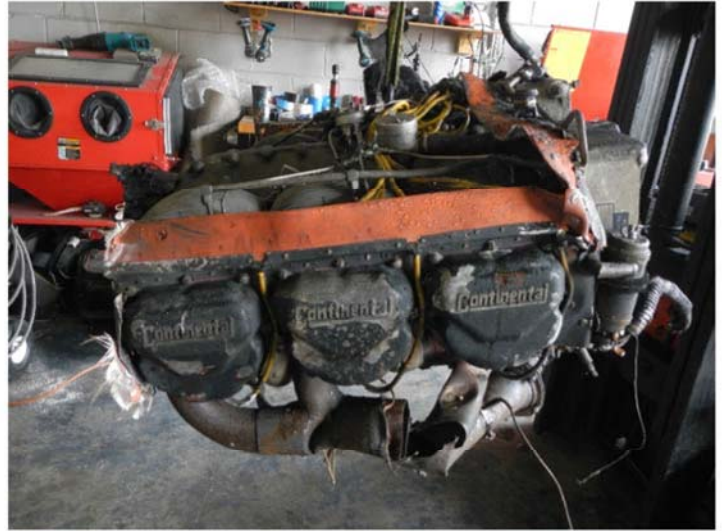
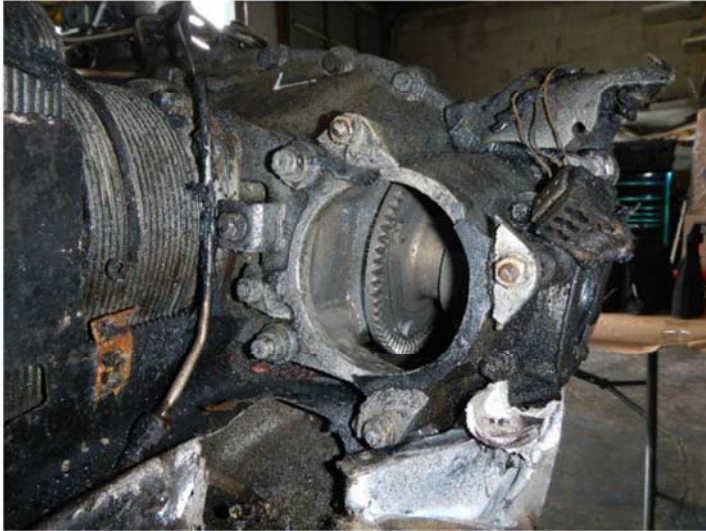
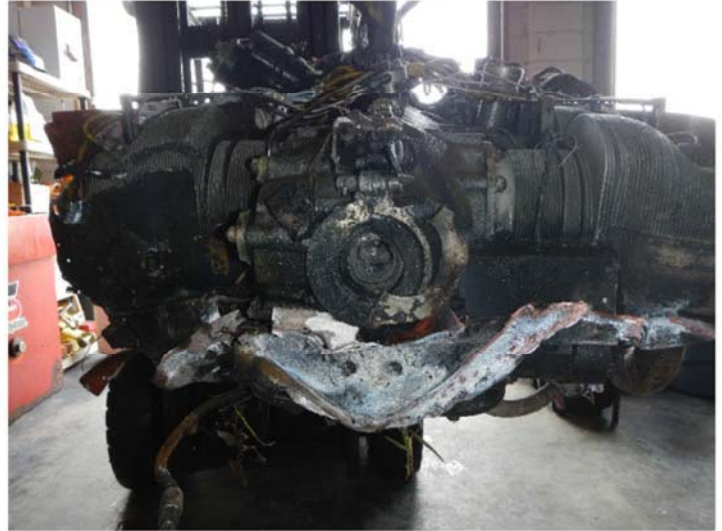
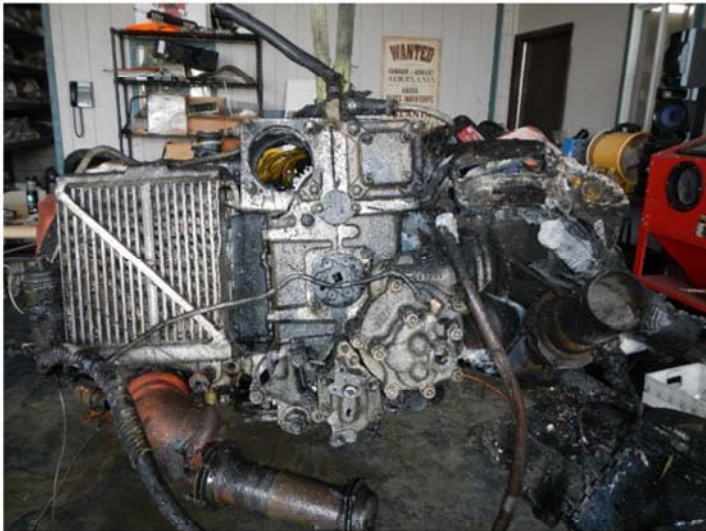
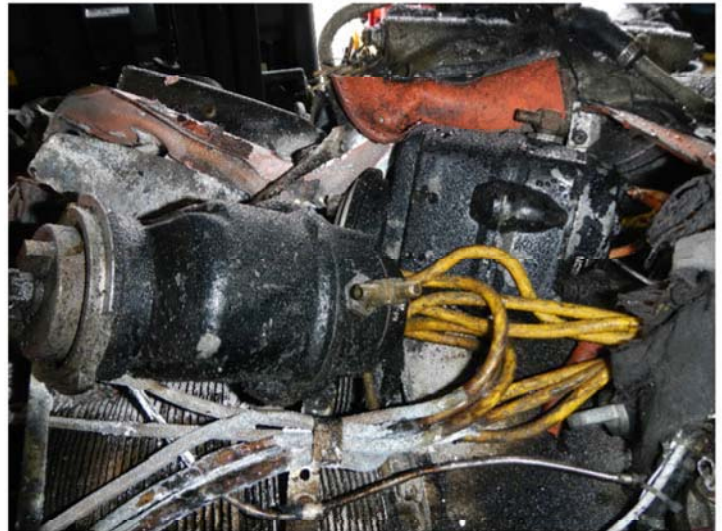
The engine was separated from the airframe and was labeled as the left engine based on the data plate and the aircraft maintenance records. The crankshaft was fractured at the nose oil seal and the propeller flange remained attached to the propeller hub. The crankshaft fracture surface displayed tearing, shear lips, and discoloration features consistent with overload. The alternator was separated from the engine and the alternator face gear, bevel gear, and propeller governor drive gear were visible through the alternator mounting pad. No pre-accident anomalies were noted with the gears. The engine sustained impact and thermal damage.

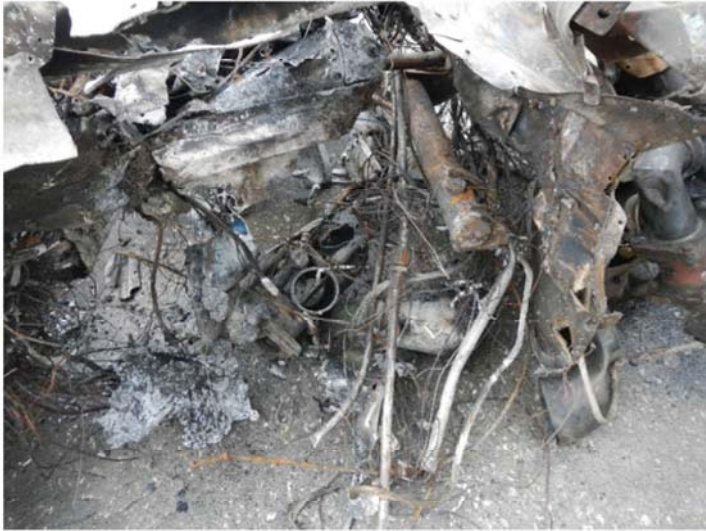
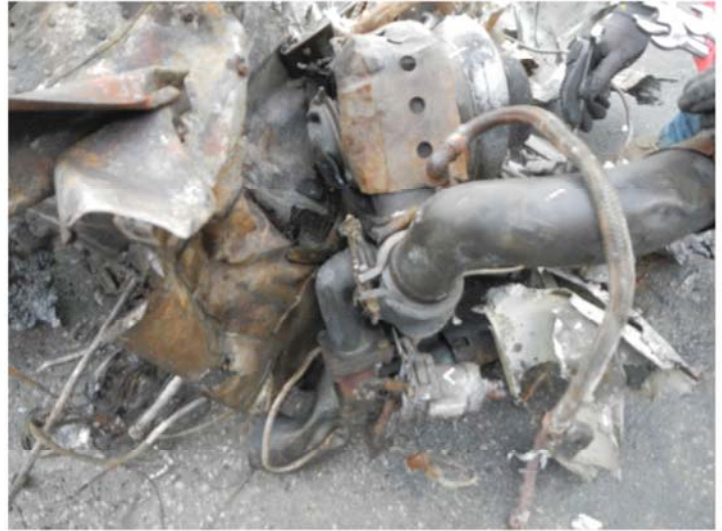
Condition: The exhaust system sustained impact-related deformation and separation damage. There were no pre-accident anomalies noted with the v-band clamps, bolted couplings, or slip joints. The waste gate actuator linkage did not display and pre-accident anomalies. Sand and dirt was impacted in the right side exhaust slip joint and the aft exhaust risers were displaced forward.

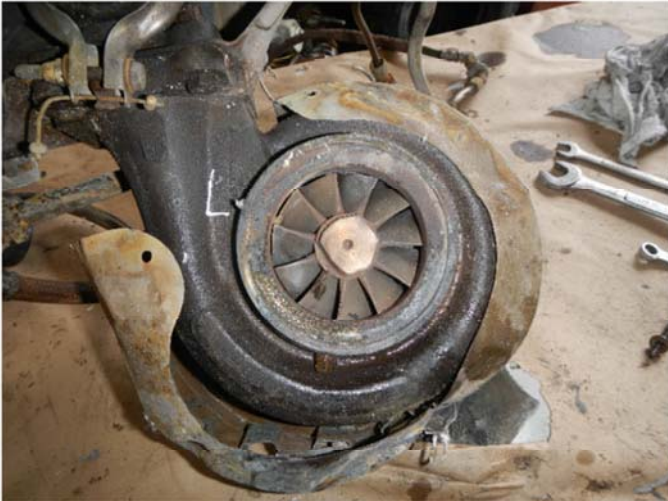
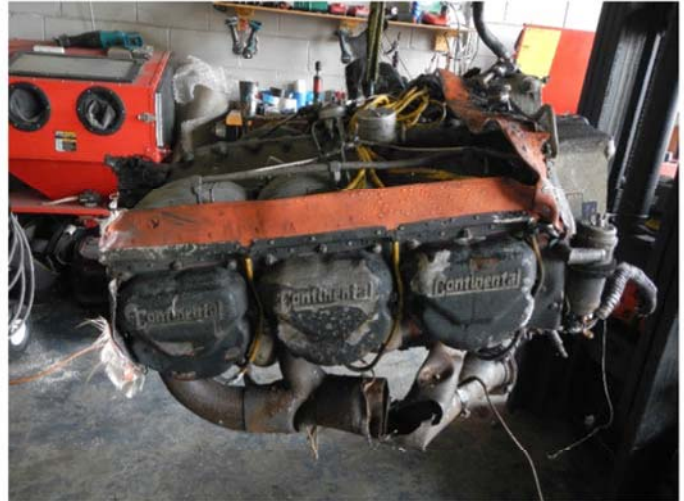
The induction system was impact and thermally damaged. The turbocharger intake was unobstructed. The intercooler was separated from the engine nacelle (it should be noted that the intercooler for both the left and right engines were separated and it was not clear as to which one belonged to which engine. Regardless, they displayed similar impact-related damage with no pre-accident anomalies noted). No pre-accident anomalies were noted with the system.

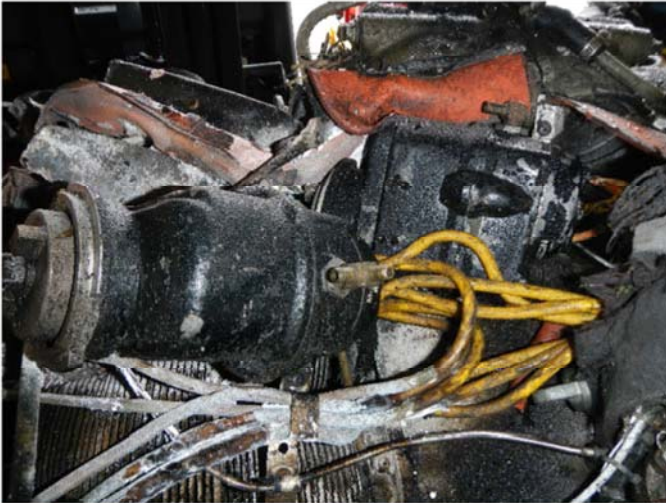
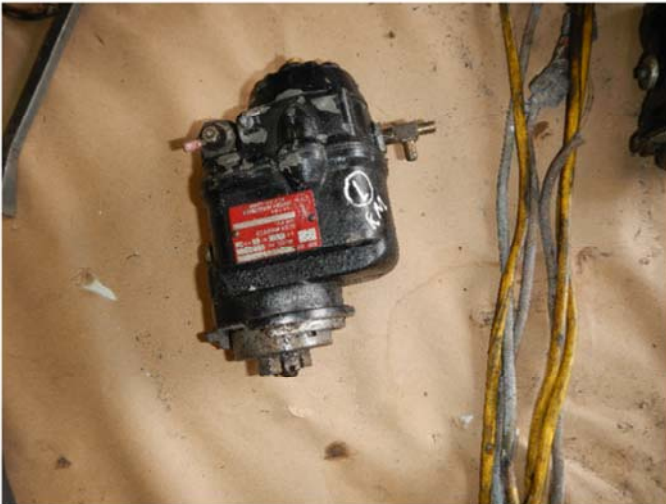
The magneto was separated from the mounting pad but remained attached to the engine via the ignition harness. The magneto drive shaft was manually rotated and it produced a spark from each lead in firing order when an audible snap of the impulse coupling was heard.

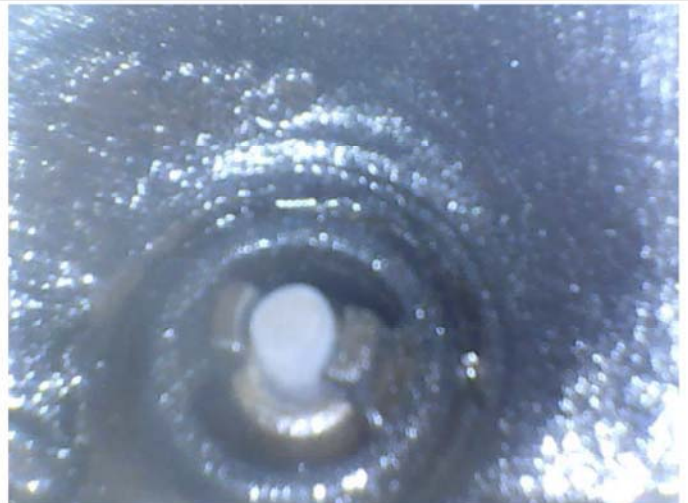
1B

All of the sparkplugs remained secured to their respective cylinders with no pre-accident anomalies noted. The top sparkplugs were removed from the cylinders. All displayed a normal worn appearance with no signs of lead or carbon fouling. The bottom sparkplugs were examined via a lighted borescope with no pre-accident anomalies noted with the electrodes.

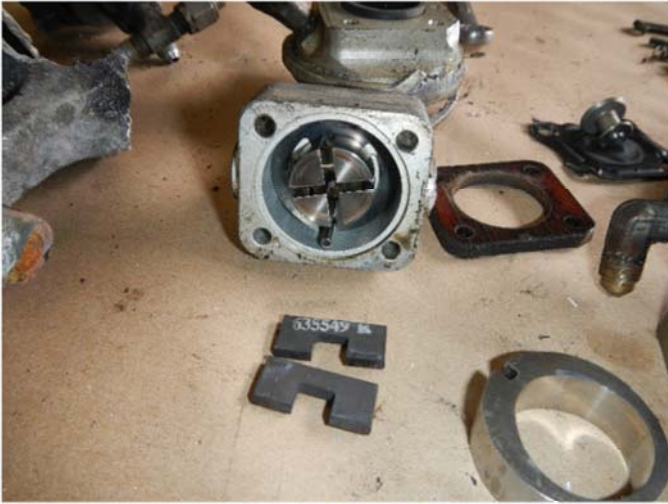
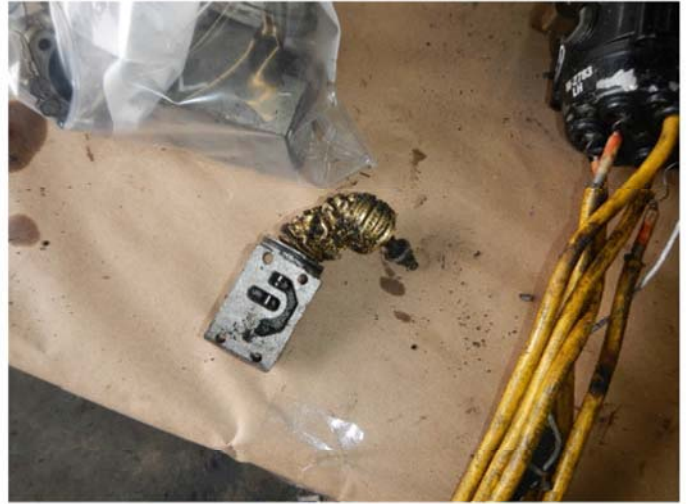
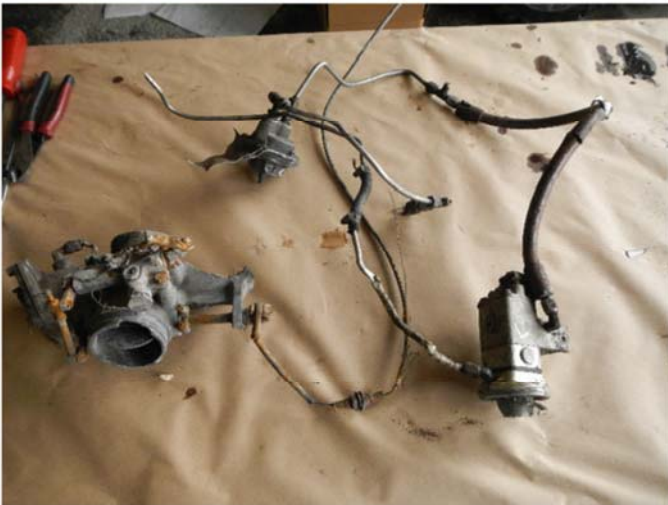
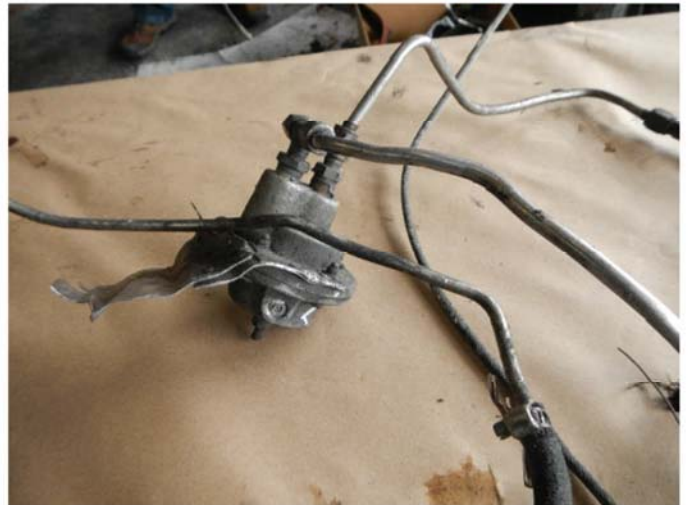
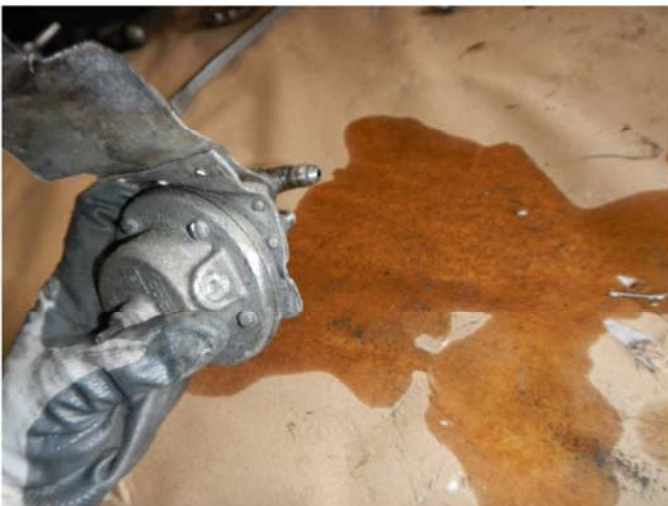
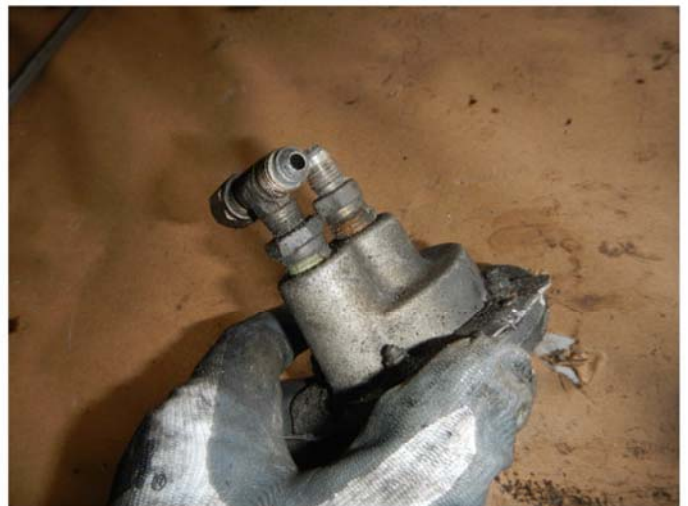
The engine-driven fuel pump was separated from the backside of the engine and the mounting flange and drive coupling were fractured and displaced to one side with the metal was smeared in the same direction. The aneroid bellows and upper deck reference line, vapor return fitting, and fuel inlet line were separated from the pump. The return line from the fuel pressure regulator to the fuel pump remained in place. Removal of the line resulted in residual fuel pouring from the pressure regulator. The pump was disassembled and the pump vanes were intact with no pre-accident anomalies noted with the observed internal components.

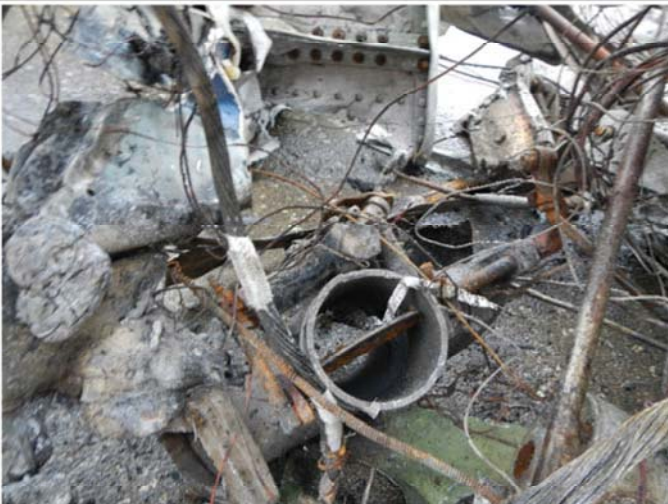
The throttle body/fuel metering unit remained attached to the left engine nacelle and was thermally damaged and fractured. The mixture and throttle control cables remained attached to their respective control levers, both of which sustained deformation damage. The throttle valve was found in the full open position. The interconnect link between the throttle and the turbo wastegate pressure controller was separated. The mixture control shaft was bent. All of the fittings were fractured on the fuel metering unit. The inlet fuel screen was removed and no obstructions were noted.

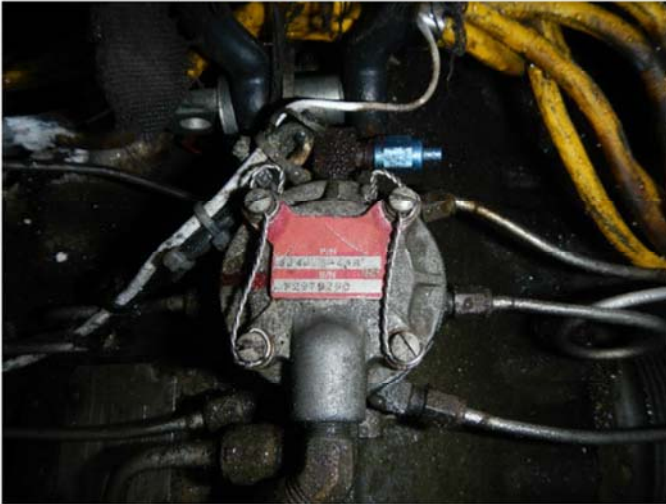
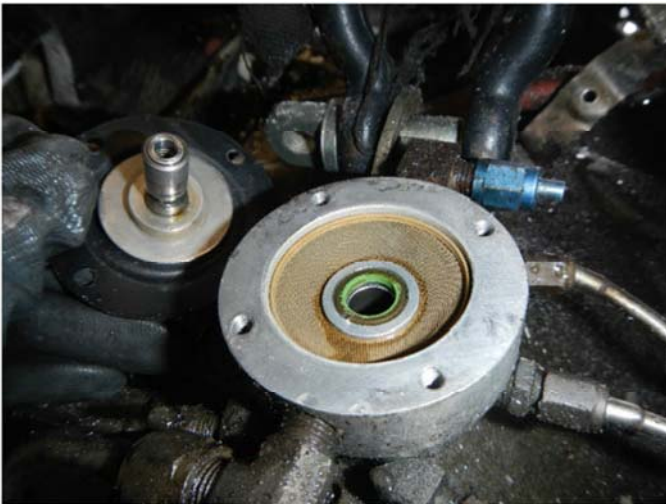
The fuel manifold valve remained secured to the topside of the engine and the fuel lines remained attached to the housing. The fuel manifold valve cap was removed and the screen was free from obstructions. Residual fuel was observed in the housing.

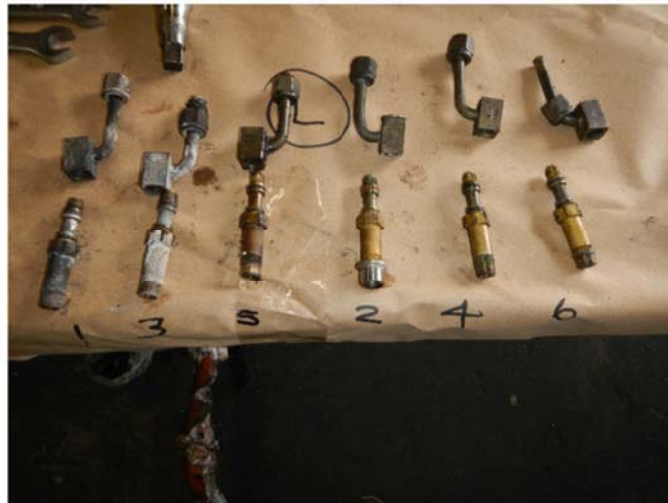
The fuel lines remained secured to their nozzles and the upper deck reference line remained secured to the nozzles. Removal of the nozzles revealed they were clear and unobstructed.

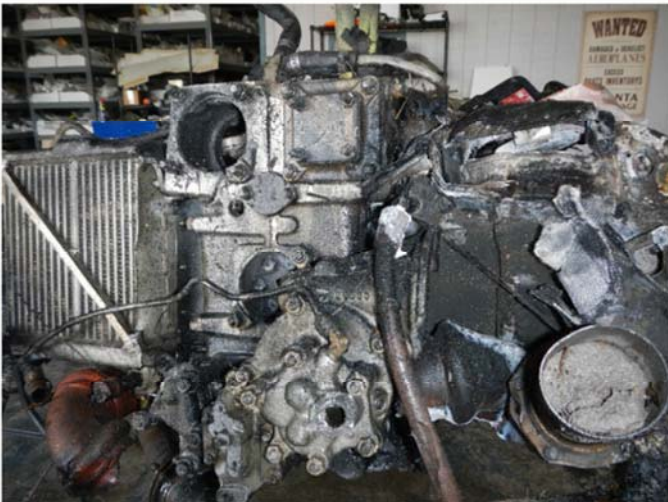
#### OIL PUMP

Condition: The oil pump and scavenge pumps remained intact, but the cap for both were impact damaged. The oil pump and scavenge pump caps were removed. Residual oil was observed on the gears and in the gear housing. Short shavings of metal were observed on the oil pump's gear teeth and coinciding gouges were noted on the housing walls, consistent with rotation at impact. No pre-accident anomalies were noted.

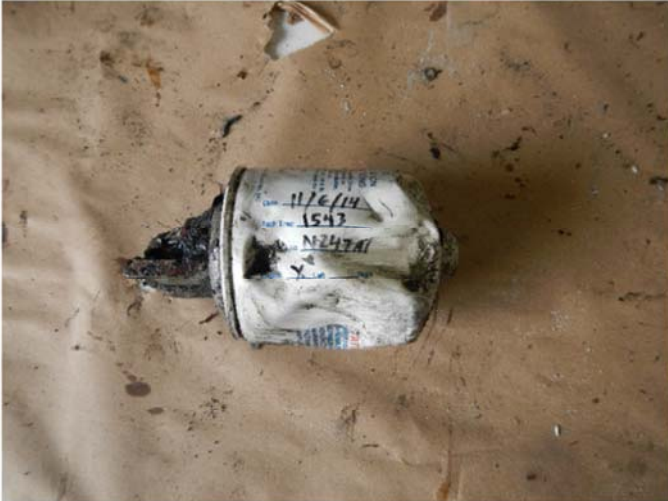
P/N: AA48108-2

Condition: The oil filter remained attached to the adapter, but the adapter was fractured and separated from the engine. The oil filter was deformed and punctured. The following information was hand-written on the side associated with the date and tach time, respectively: 11/6/14 1543.

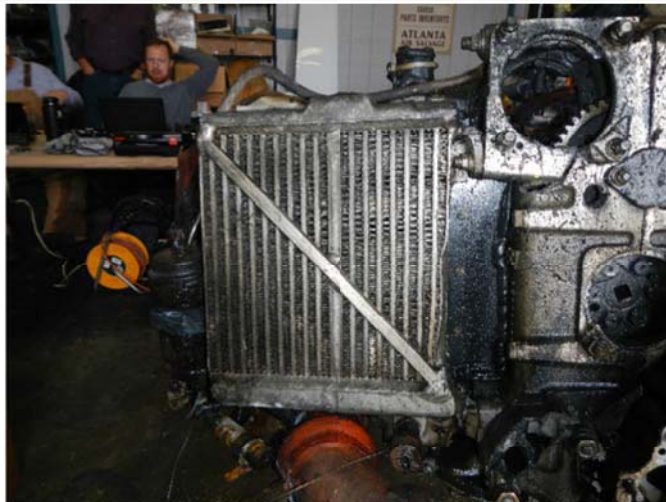
## OIL COOLER

Condition: The oil cooler remained attached to the engine with no pre-accident anomalies noted with the exterior portion.

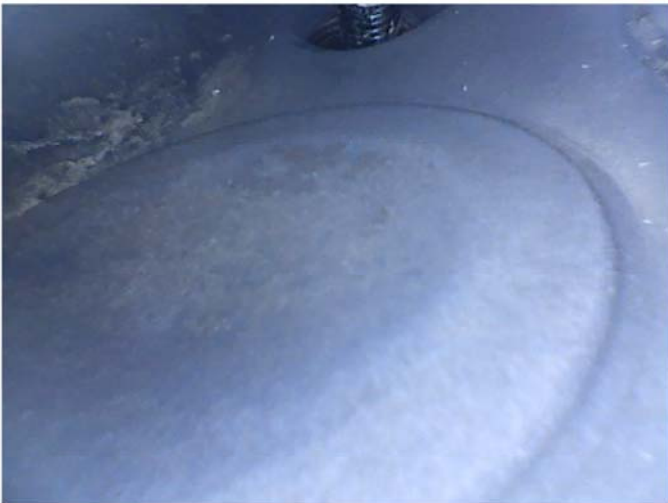
### CYLINDER #3

Condition: The cylinder remained attached to the crankcase with no external signs of operational distress. The rocker cover was removed and the valve springs displayed signs of corrosion. Residual oil was observed in the rocker cover. The cylinder was inspected and documented utilizing a lighted borescope. The #3 exhaust valve displayed two areas of green discoloration consistent with a pre-existing exhaust gas leak (the last three photos in this section consist of different views of the exhaust valve). Otherwise, the piston, valves, and valve seats were unremarkable.

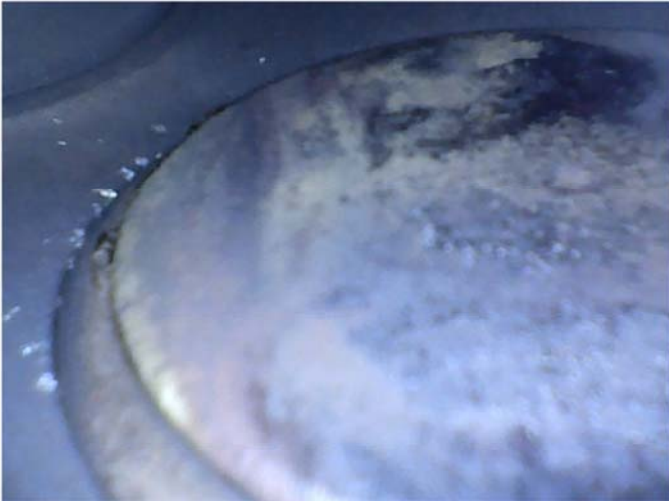
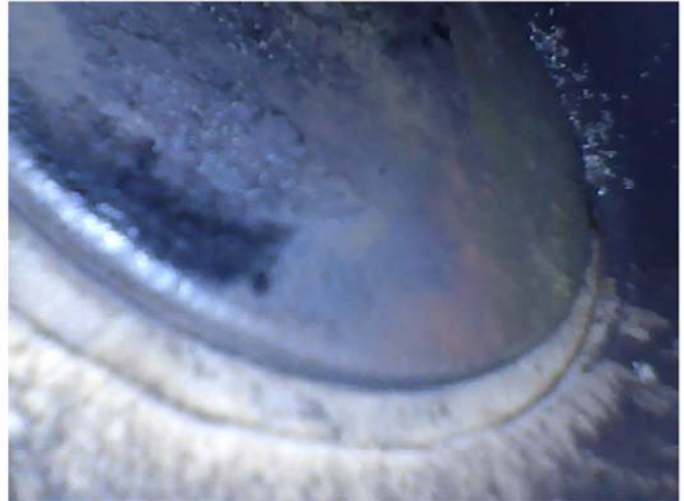
### CYLINDER #5

The cylinder remained attached to the crankcase with no external signs of operational distress. The rocker cover was removed and the valve springs displayed signs of corrosion. Residual oil was observed in the rocker cover. The cylinder was inspected and documented utilizing a lighted borescope. The piston, valves, and valve seats were unremarkable.

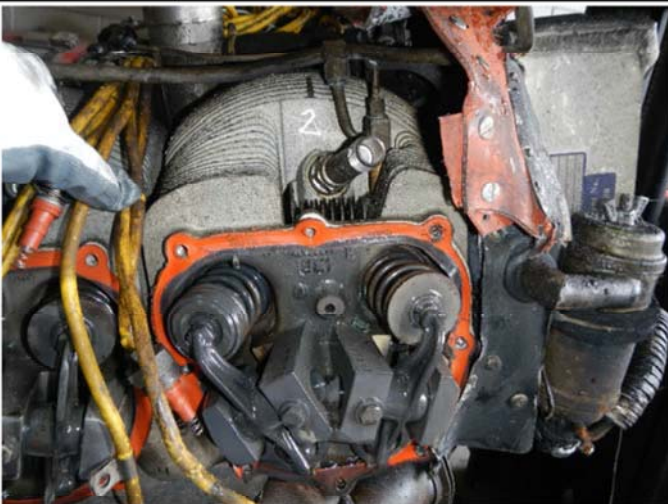
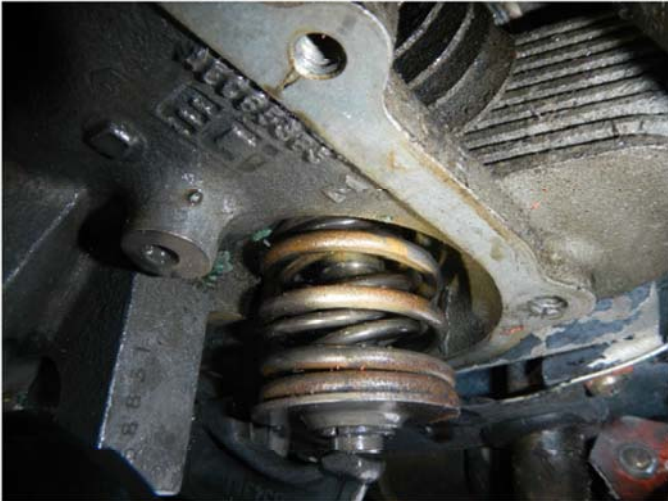
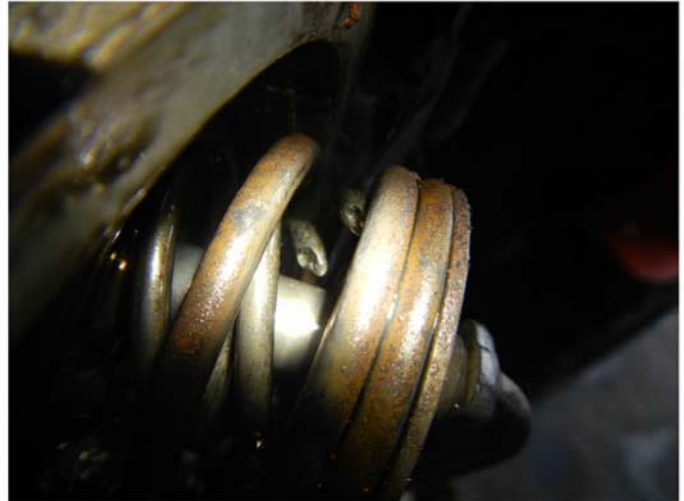
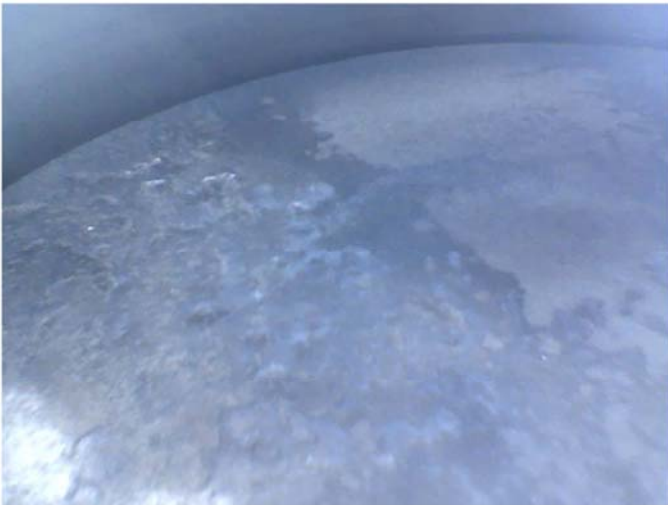
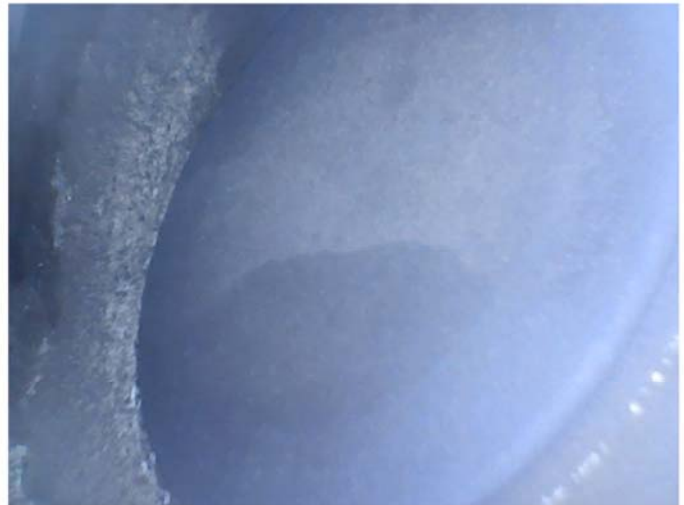
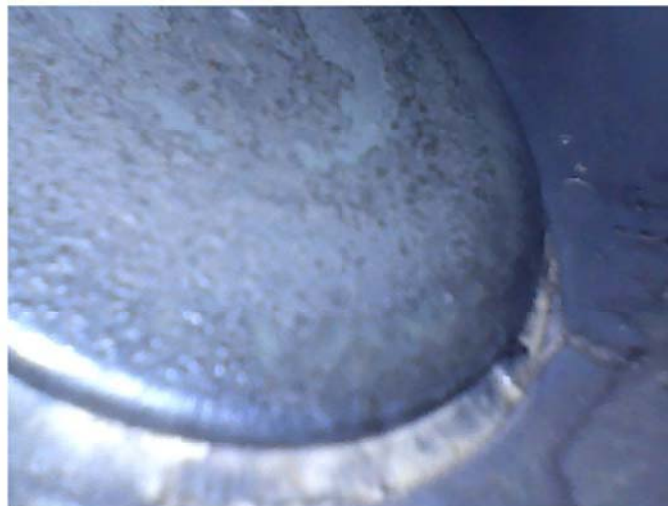
### CYLINDER #2

The cylinder remained attached to the crankcase with no external signs of operational distress. The rocker cover was removed and the valve springs displayed signs of corrosion. The #2 intake inner valve spring was fractured. Residual oil was observed in the rocker cover. The cylinder was inspected and documented utilizing a lighted borescope. The piston, valves, and valve seats were unremarkable. The 2<sup>nd</sup>, 3<sup>rd</sup> and 4<sup>th</sup> photographs below are closer views of the intake valve springs.

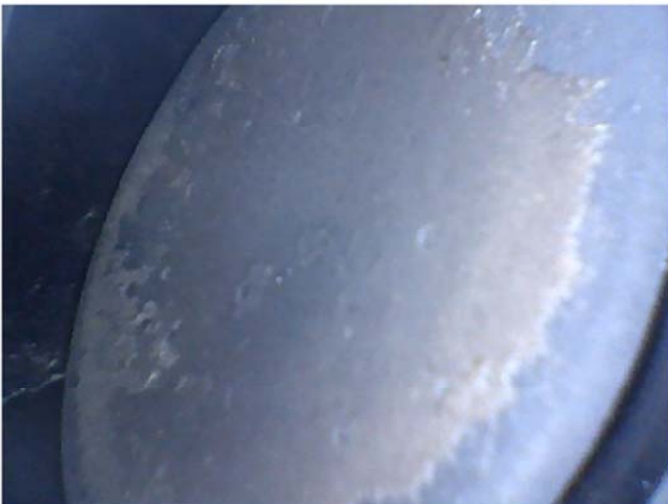
### CYLINDER #4

Condition: The cylinder remained attached to the crankcase with no external signs of operational distress. The rocker cover was removed and the valve springs displayed signs of corrosion. Residual oil was observed in the rocker cover. The cylinder was inspected and documented utilizing a lighted borescope. The piston, valves, and valve seats were unremarkable.

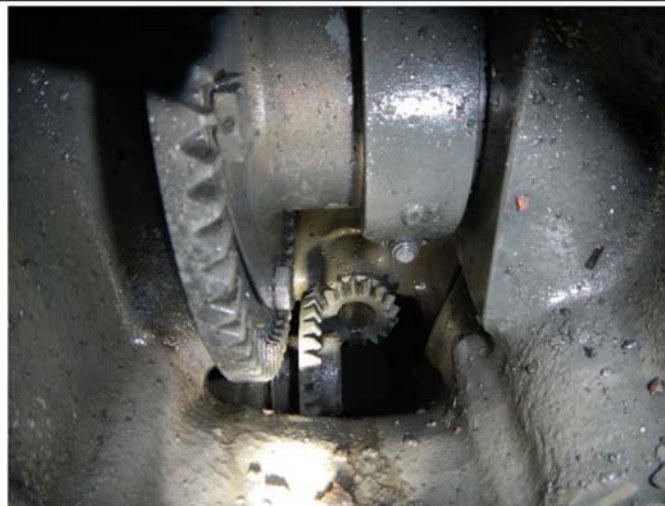
#### CAMSHAFT

The camshaft was not observed in its entirety. The bevel gear was observed through the alternator mounting pad and no pre-accident anomalies were noted. The camshaft gear was impinged upon by the deformed oil sump.

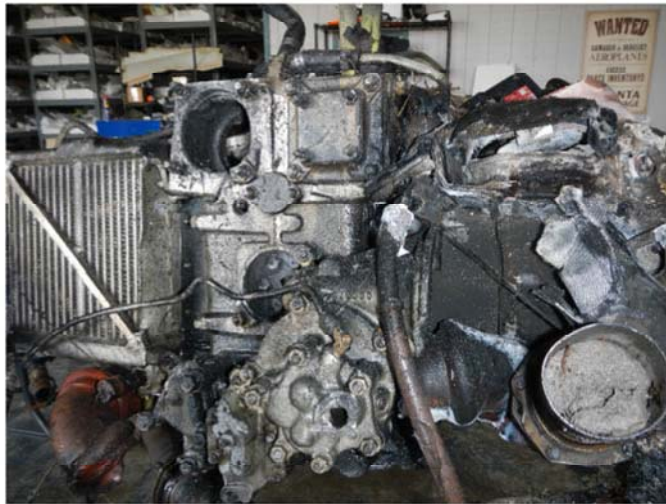
The starter adapter remained attached to the backside of the engine but it was fractured at the motor flange. The scavenge pump remained in place on the adapter. No pre-accident anomalies were noted.

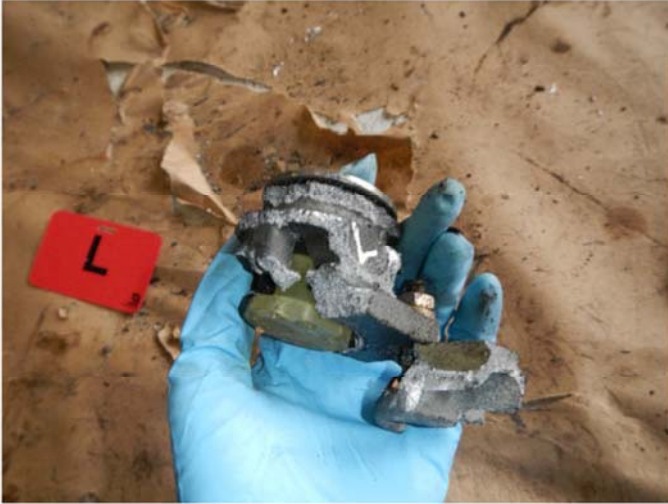
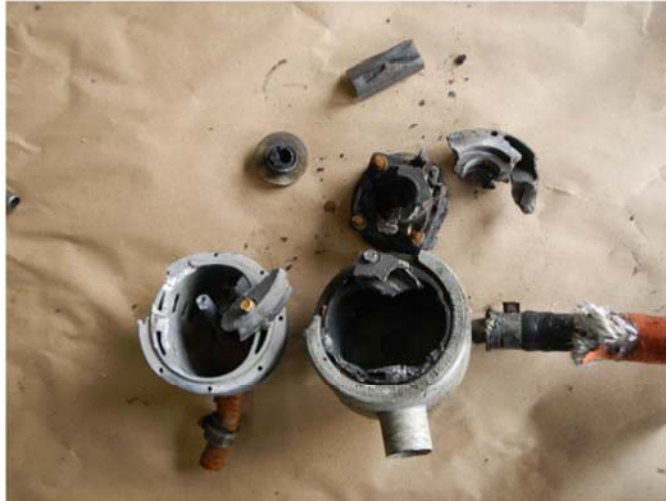
The vacuum pump was separated from the backside of the engine and fragments were noted in the wreckage. The vacuum pump drive coupling was identified and it was intact. The pump housing, rotors, and vanes were fractured (the bottom photo represents the two housings identified in the wreckage).

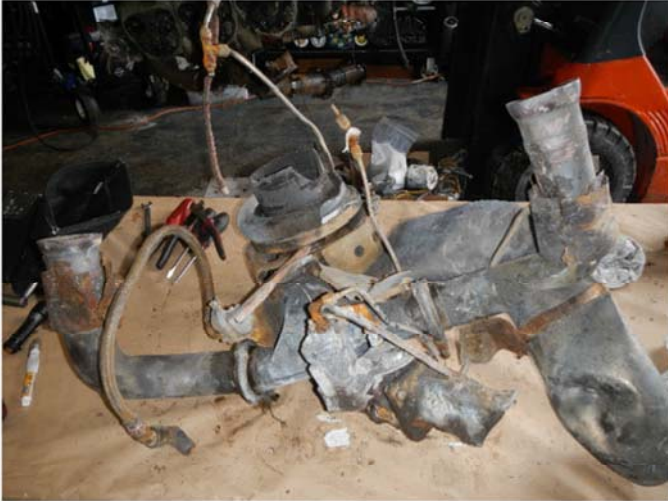
The waste gate actuator linkage remained intact and attached to the wastegate, though deformation and thermal damage were extensive.

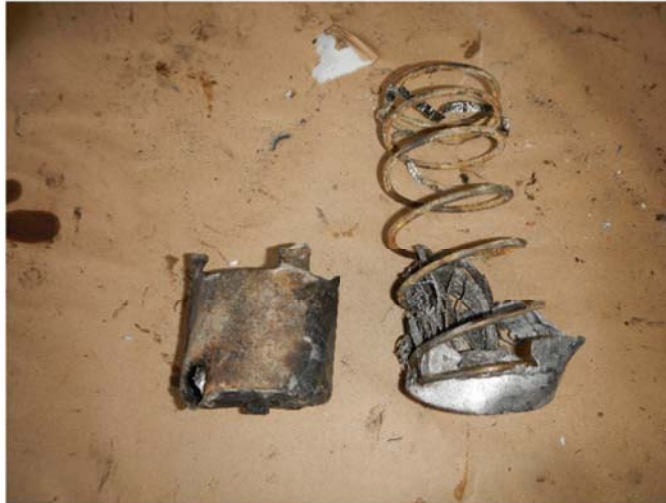
The overboost valve was thermally damaged and separated from the induction system. Remnants of two overboost valves were identified in the wreckage and the photograph below display those components.

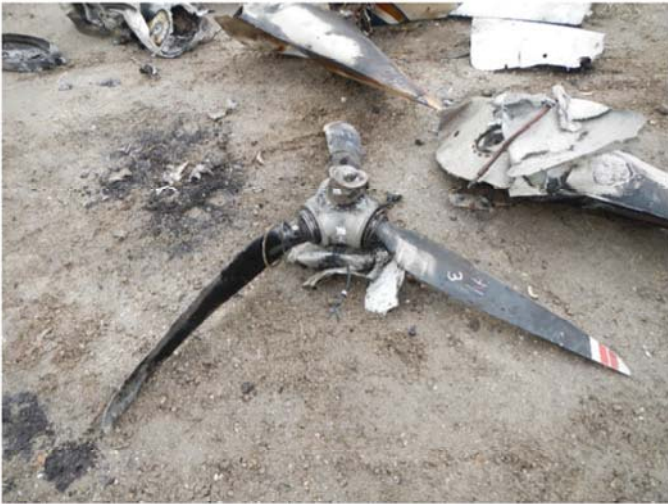
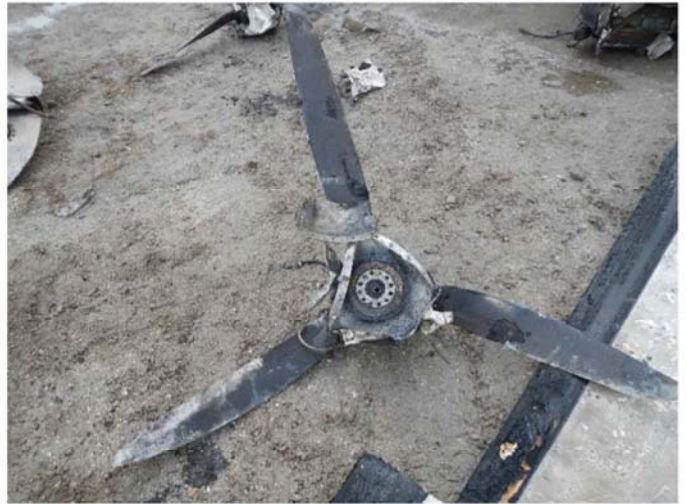
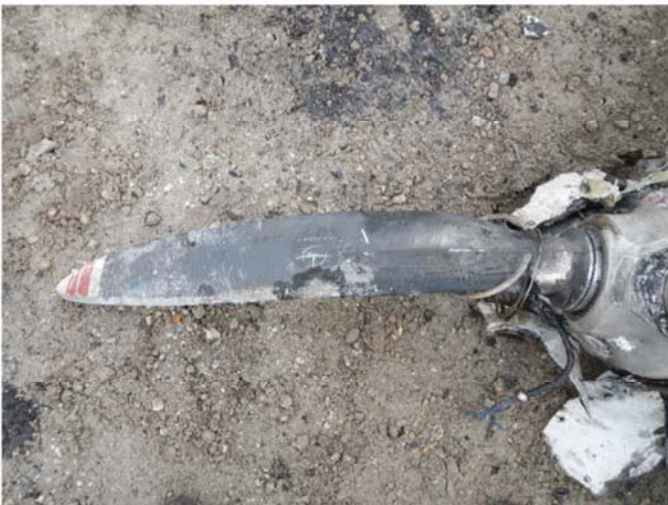
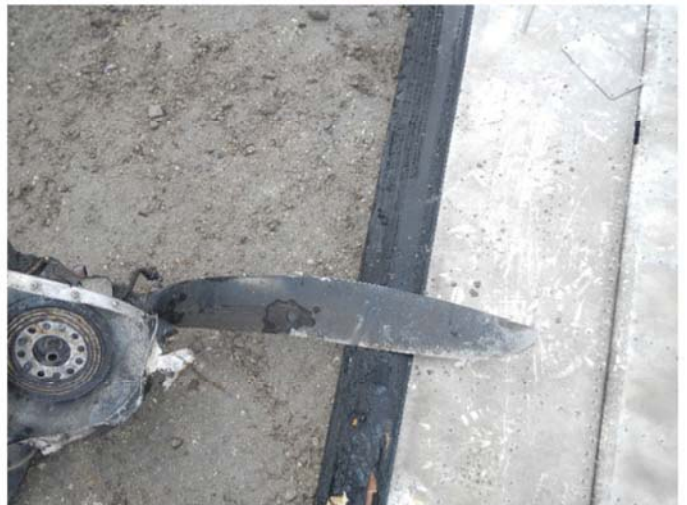
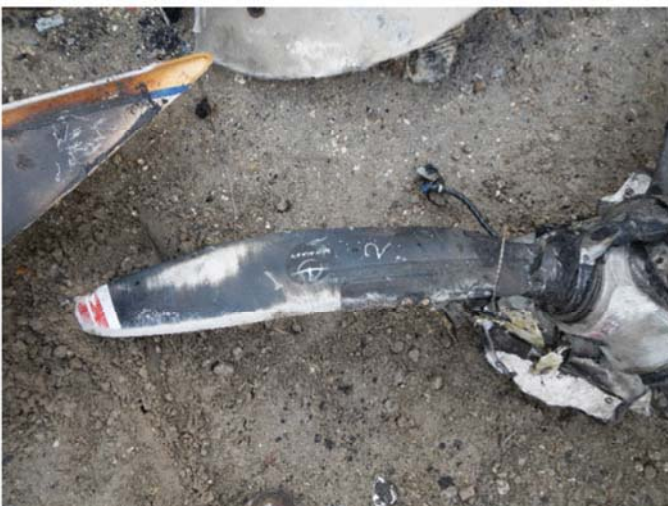
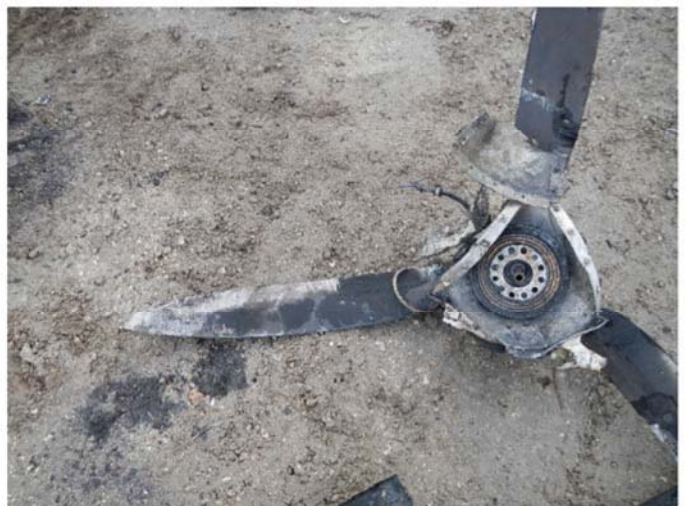
The propeller remained attached to the propeller flange, which was separated from the crankshaft at the engine nose seal. The propeller hub remained intact and the piston housing was compressed aft. All three blades remained attached to the hub, but they were free to rotate, indicative of a pitch change link fractures. The blades were labeled 1, 2, and 3 according to their hub location. Blade 1 was missing its counterweight and was bent aft slightly. The leading edge displayed some light gouging and the cambered side displayed chord-wise scrapes and paint erosion. Blade 2 displayed a small twist toward low pitch, paint erosion on the cambered side and light leading edge gouges. The counterweight remained attached to the blade shank. Blade 3 was missing its counterweight. The blade displayed light chord-wise paint erosion aft of the deice boot, but was otherwise unremarkable.
