# Continental Motors

## ENGINE EXAMINATION REPORT

| ENGINE MODEL | TSIO-520-NB1A |
| FILE NUMBER | 17-361 |

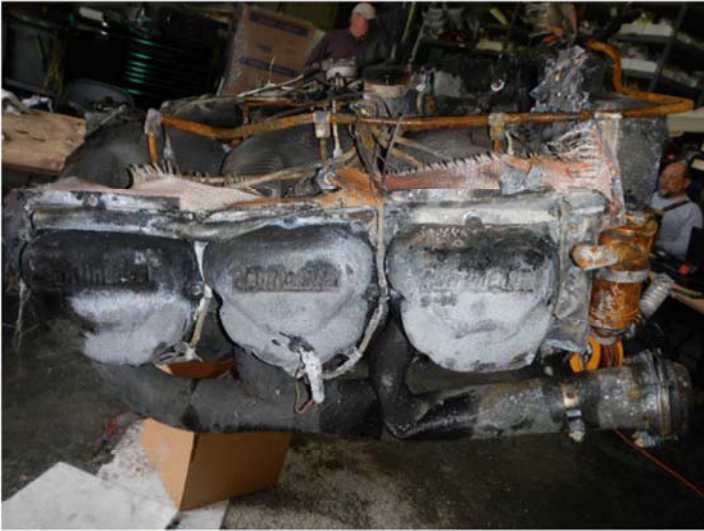
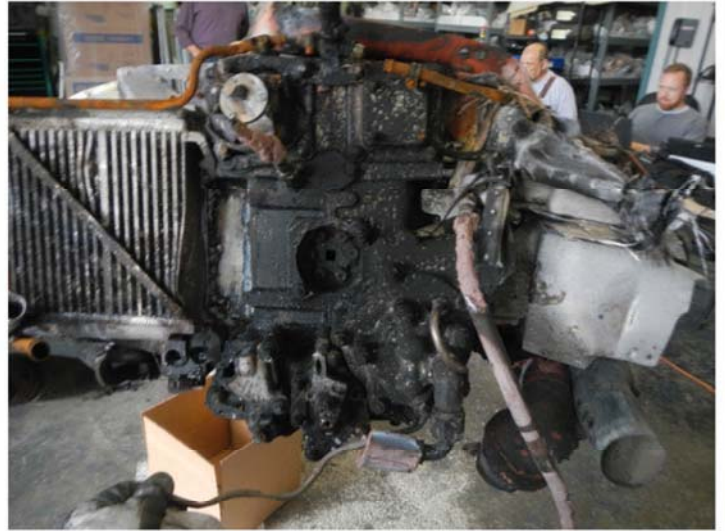
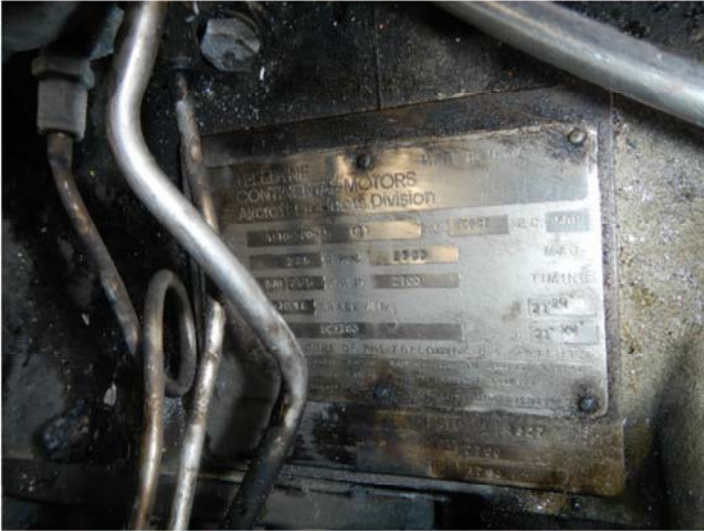
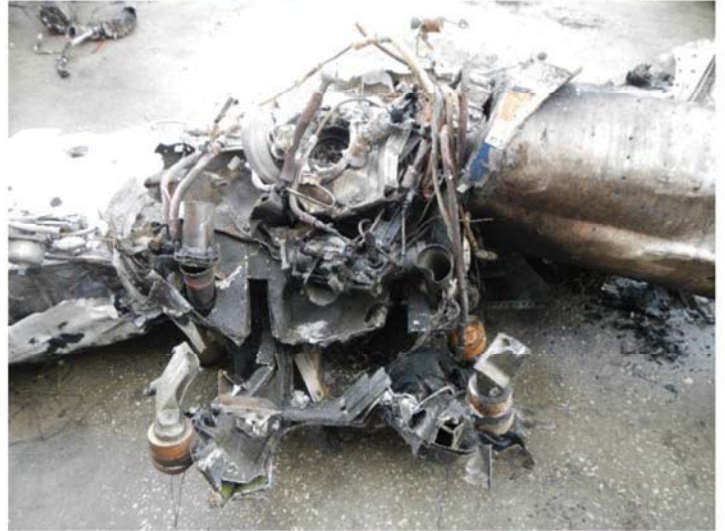
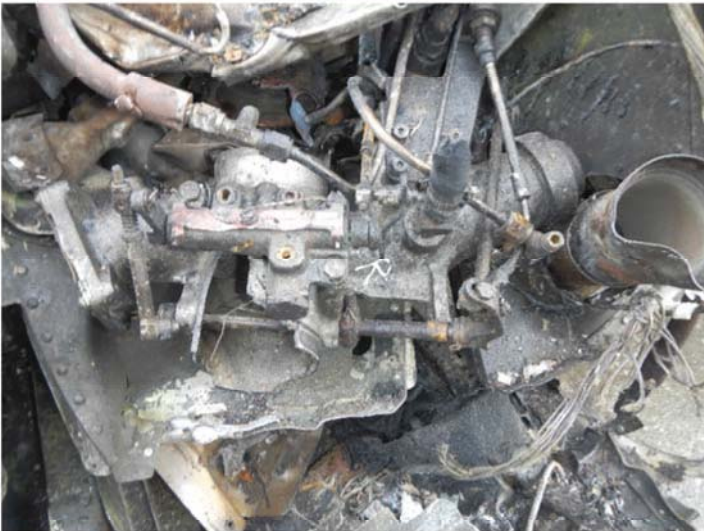
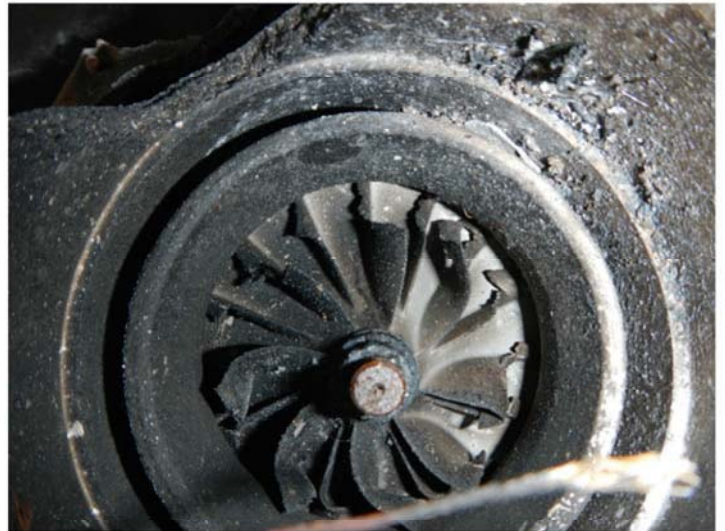
The engine was separated from the airframe and was labeled as the right engine based on the data plate and the aircraft maintenance records. The crankshaft was fractured at the nose oil seal and the propeller flange remained attached to the propeller hub. The crankshaft fracture surface displayed tearing, shear lips, and discoloration features consistent with overload. The engine sustained thermal and impact-related damage.

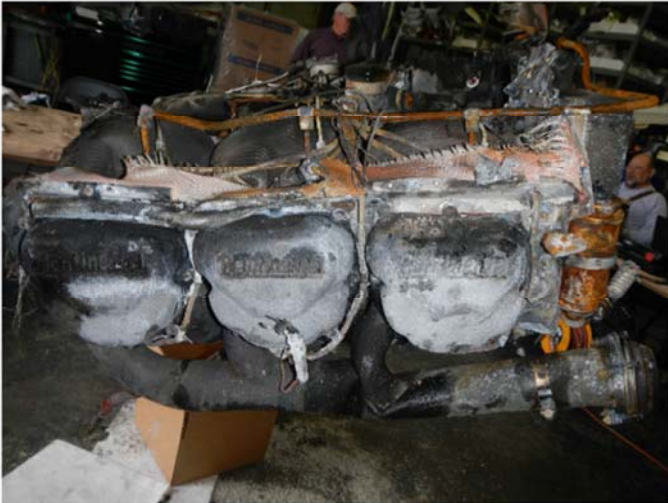
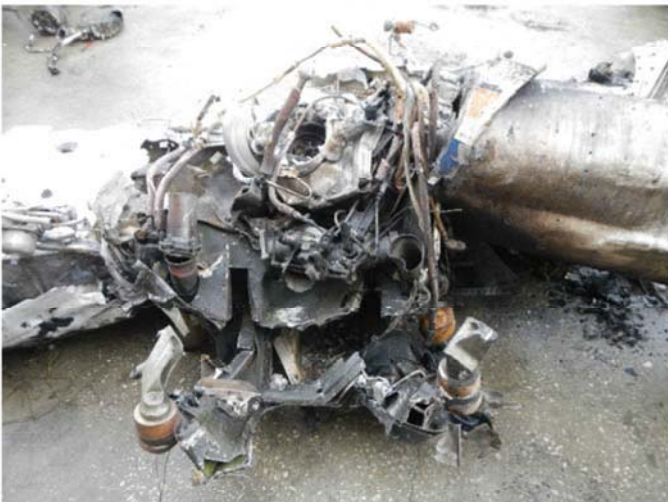
Condition: The exhaust system sustained impact-related deformation and separation damage. There were no pre-accident anomalies noted with the v-band clamps, bolted couplings, or slip joints. The waste gate actuator linkage did not display and pre-accident anomalies. The aft exhaust risers were displaced forward.

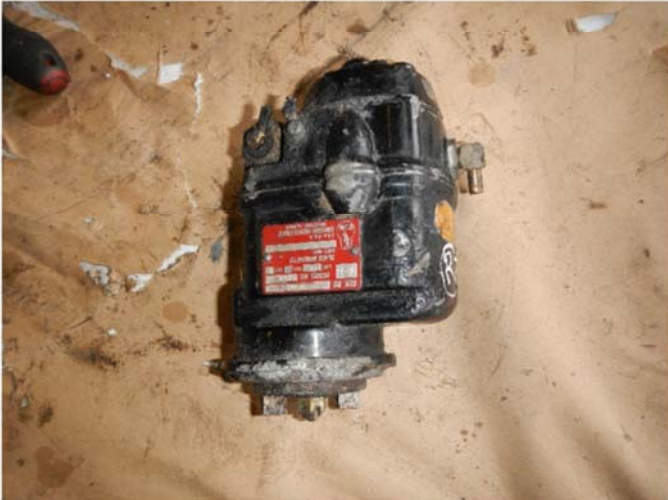
Condition: The magneto was separated from the mounting pad and was located within the wreckage. The magneto drive shaft was manually rotated and it produced a spark from each lead in firing order when an audible snap of the impulse coupling was heard (the left ignition harness cap was removed for the testing due to damage sustained in the accident sequence, and the right engine's right magneto's ignition harness cap was utilized for testing).

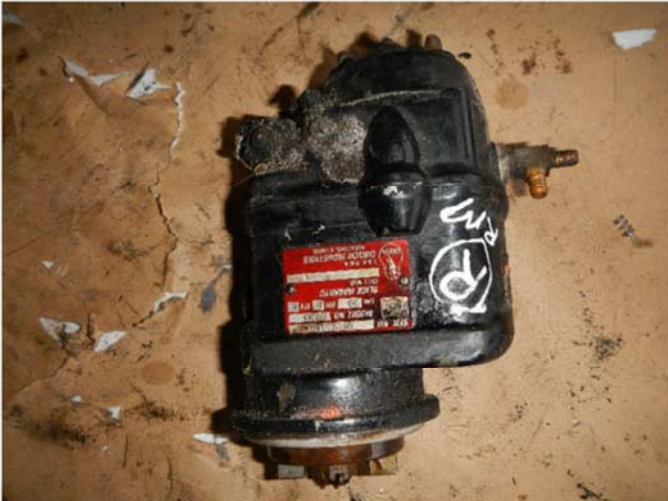
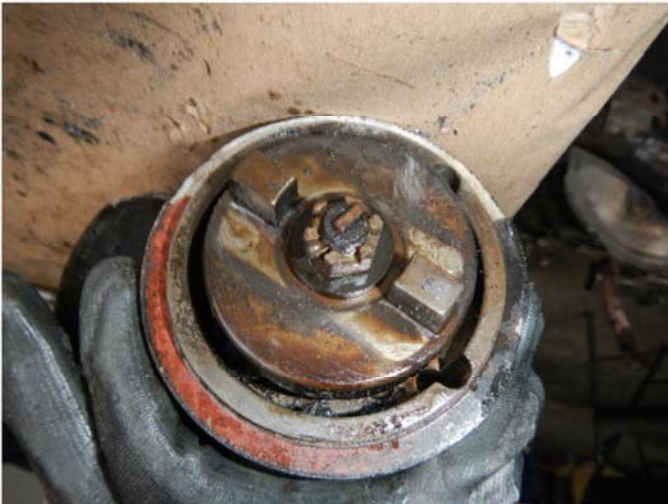
**Condition:** The right magneto remained secured to the top side of the engine with its ignition harness attached. The magneto was removed from the engine and the drive shaft was manually rotated. It produced a spark from each lead in firing order when an audible snap of the impulse coupling was heard.

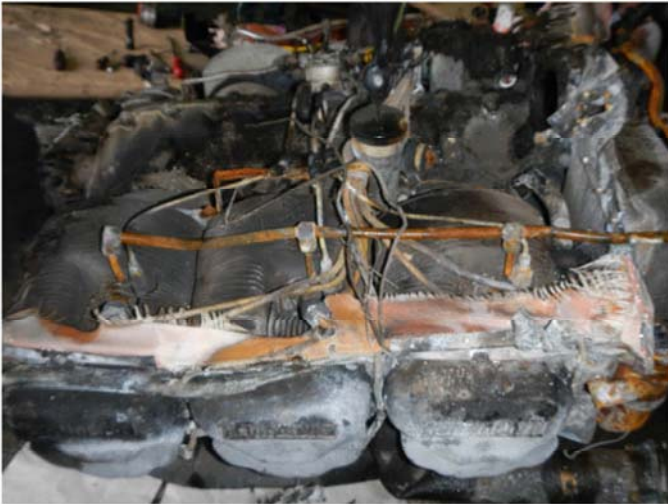
The ignition harnesses caps remained attached to the magnetos, and all terminal remained attached to their respective sparkplugs. However, all of the left magneto's leads were pulled from the cap and many of the leads sustained thermal damage. The leads were cut from the right magneto harness cap for the functional testing of the right magneto. No pre-accident anomalies were noted with either harness/cap.

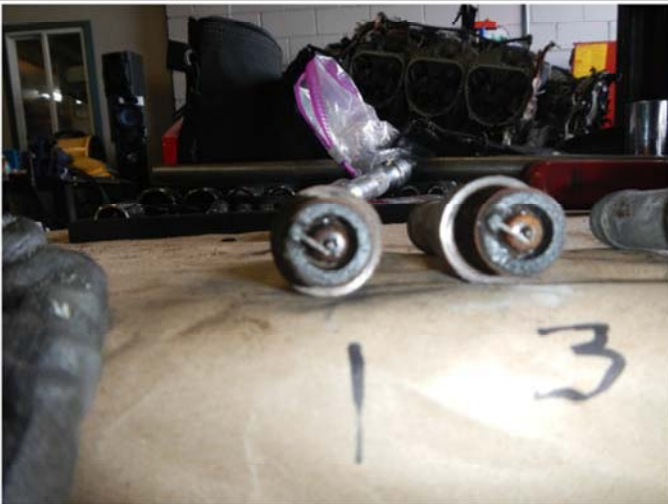
1T

All of the sparkplugs remained secured to their respective cylinders with no pre-accident anomalies noted. The top sparkplugs were removed from the cylinders. All displayed a normal worn appearance with no signs of lead or carbon fouling. The bottom sparkplugs were examined via a lighted borescope with no pre-accident anomalies noted with the electrodes.

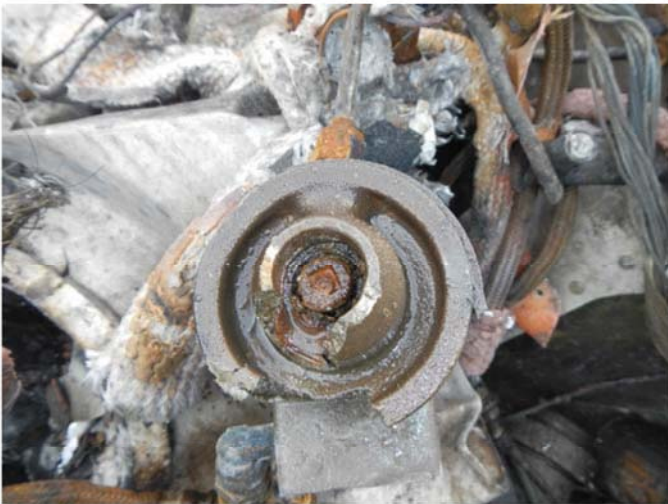
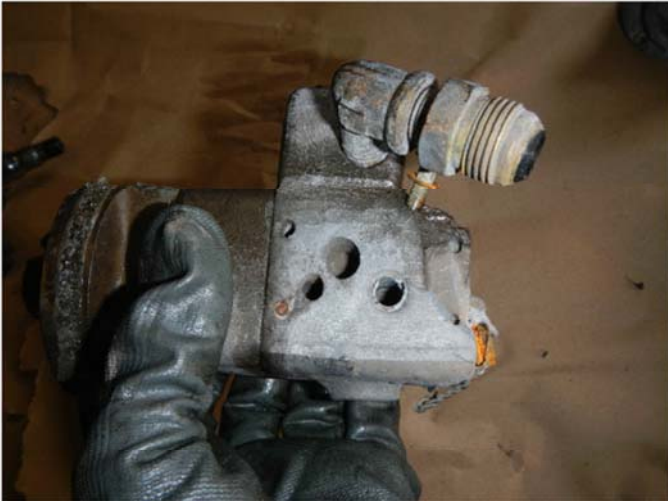
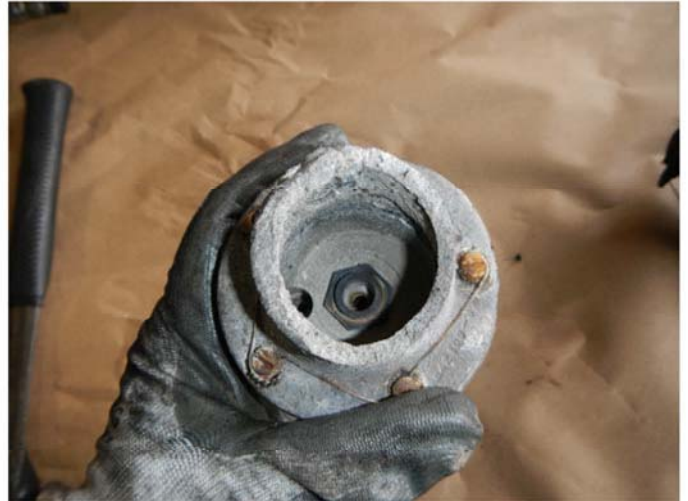
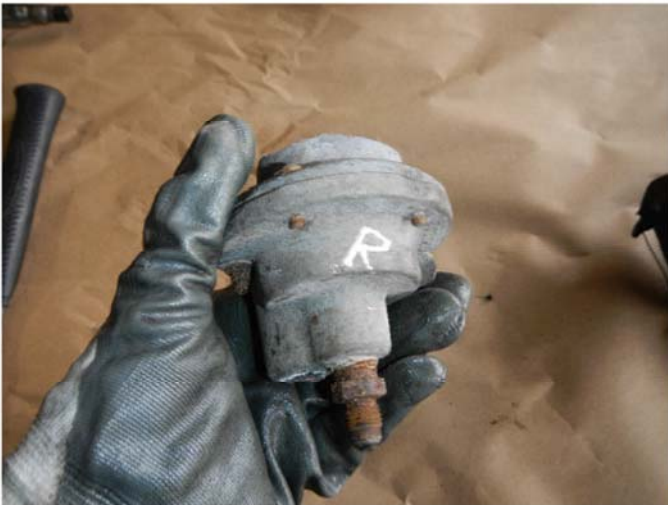
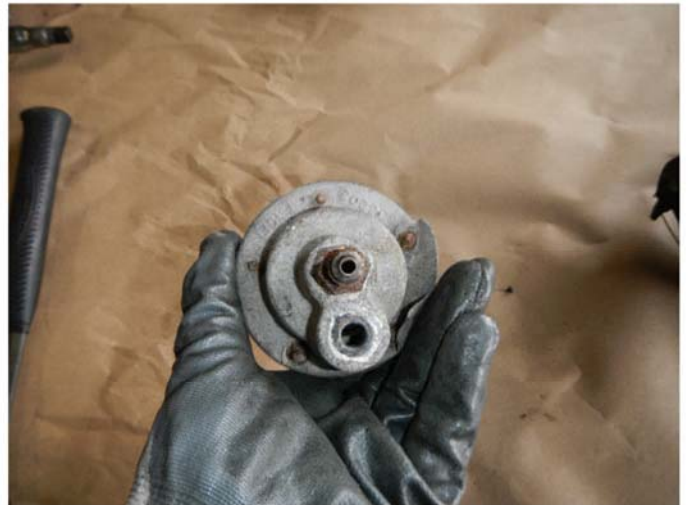
The engine-driven fuel pump was separated from the backside of the engine and the mounting flange and drive coupling were displaced to one side and the metal was smeared in the same direction. The pump remained attached to the engine nacelle via the fuel inlet line. The fuel pump was thermally damaged to such an extent that much of the components were destroyed and the housing could not be disassembled.

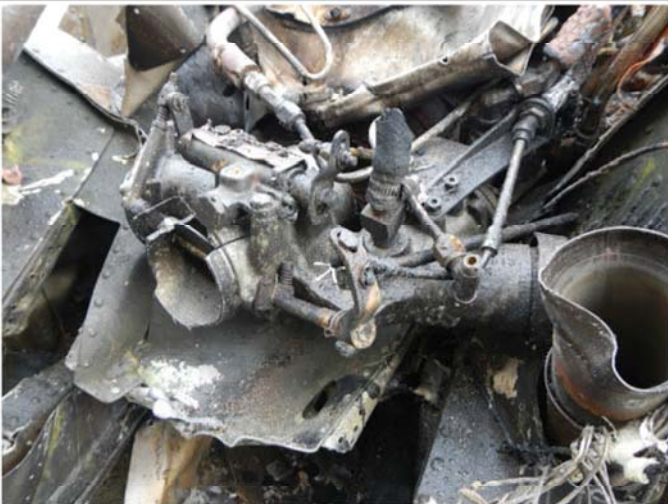
The throttle body/fuel metering unit remained attached to the right engine nacelle and was fractured. The mixture and throttle control cables remained attached to their respective control levers, both of which sustained deformation damage. The throttle valve was found in a near idle position. The interconnect link between the throttle and the turbo wastegate controller was deformed and fractured. The mixture control shaft could be manually manipulated with no binding noted. All of the fittings were fractured on the fuel metering unit. The inlet fuel screen was removed and no obstructions were noted.

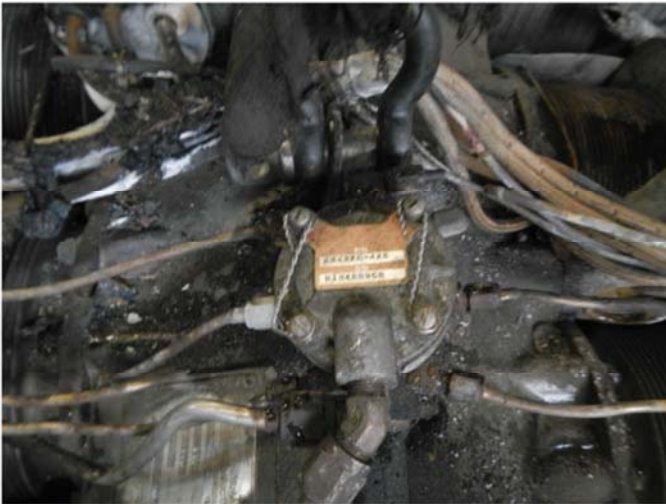
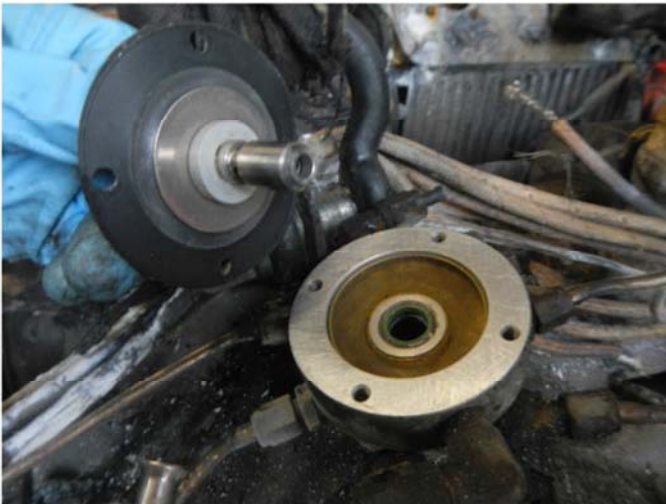
The fuel manifold valve remained secured to the topside of the engine and the fuel lines remained attached to the housing except for the #2. The fuel manifold valve cap was removed and the screen was free from obstructions. Residual fuel was observed in the housing.

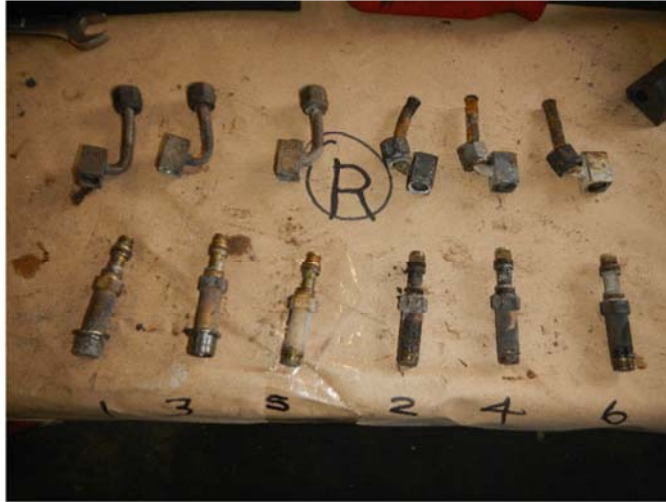
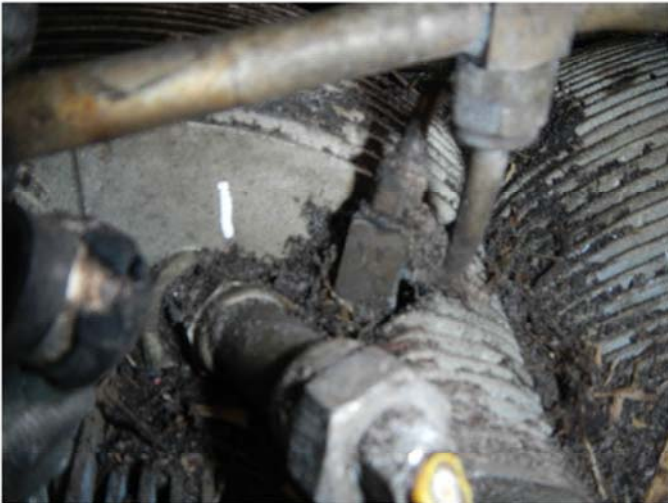
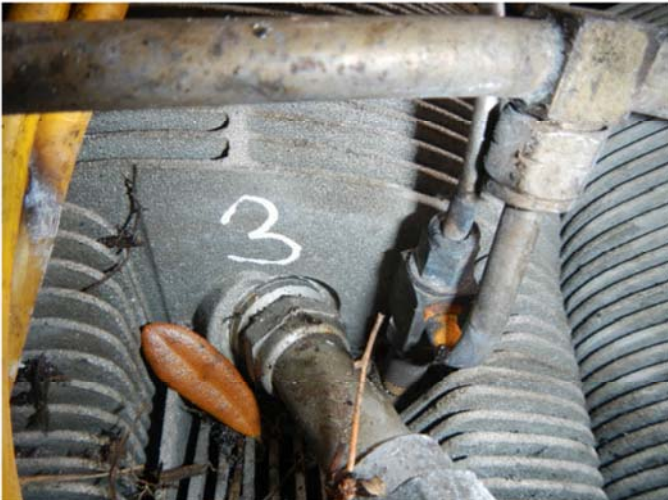
The fuel lines and upper deck reference lines remained secured to their nozzles. Removal of the nozzles revealed they were clear and unobstructed.

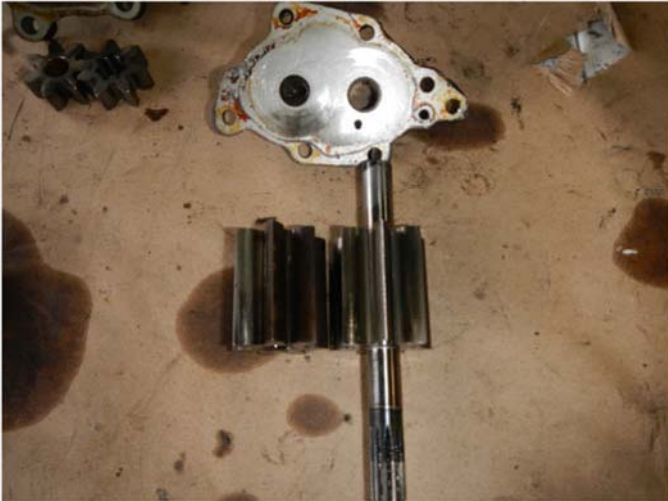
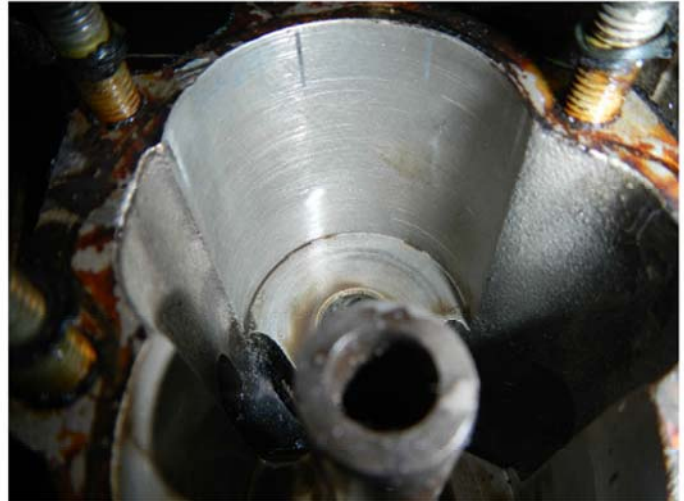
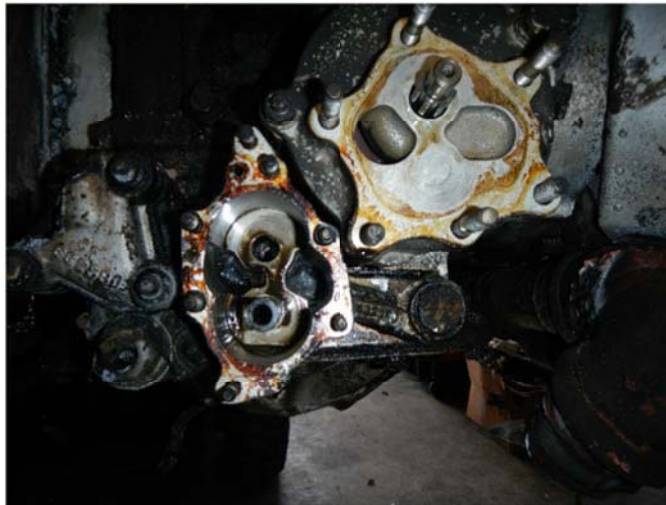
Condition: The oil pump and scavenge pump caps were removed. Residual oil was observed on the gears and in the gear housings. The oil pump housing displayed light circumferential scoring and signs of hard particle passage at some point in the life of the engine.

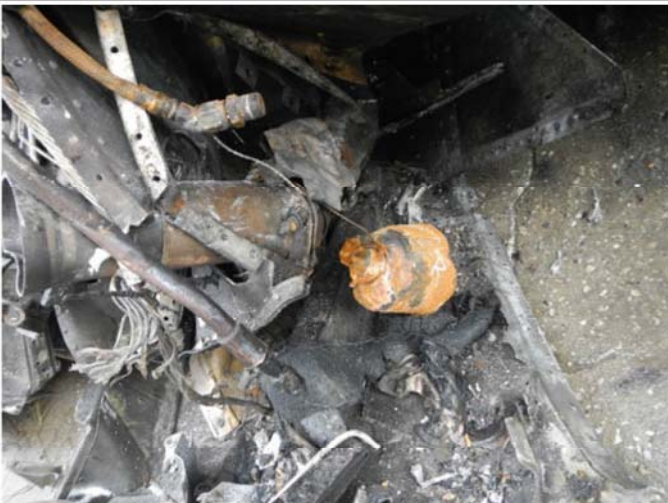
## OIL FILTER

The oil filter was separated from the engine, deformed and thermally damaged.

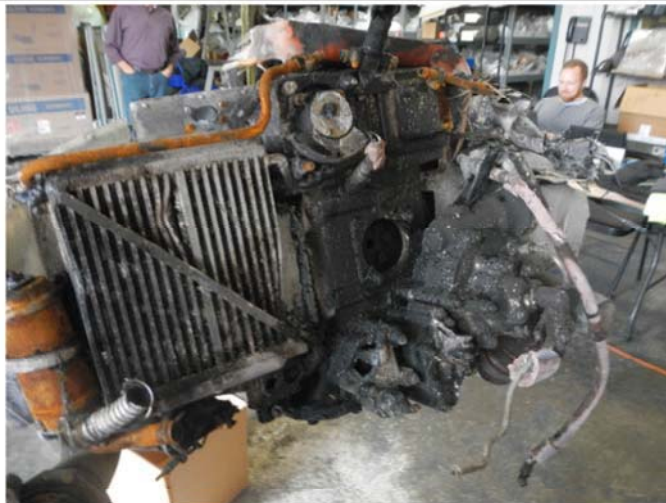
### OIL COOLER

The oil cooler remained attached to the engine with no pre-accident anomalies noted with the exterior portion.

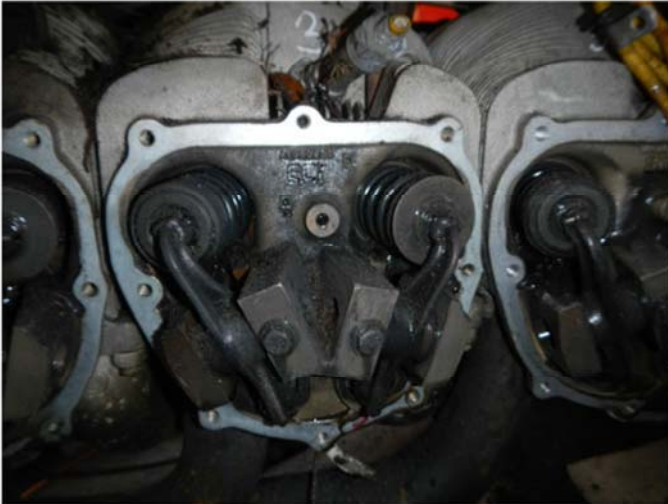
### CYLINDER #3

Condition: The cylinder remained attached to the crankcase with no external signs of operational distress. The rocker cover was removed and the valve springs remained intact. The cylinder was inspected and documented utilizing a lighted borescope. Oil was pooled at the bottom of the cylinder. The piston, valves, and valve seats were unremarkable.

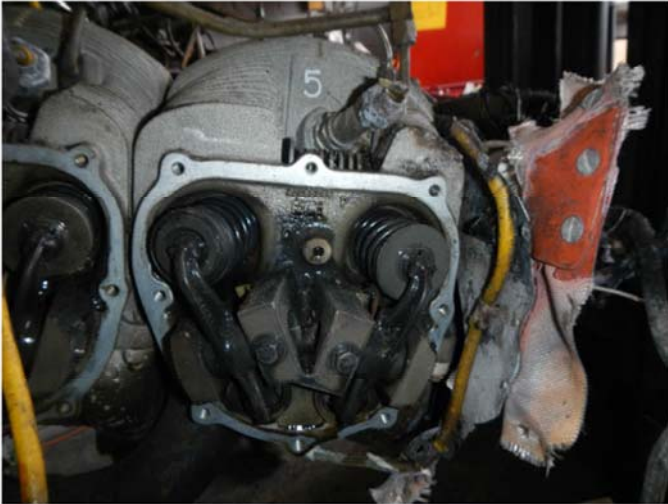
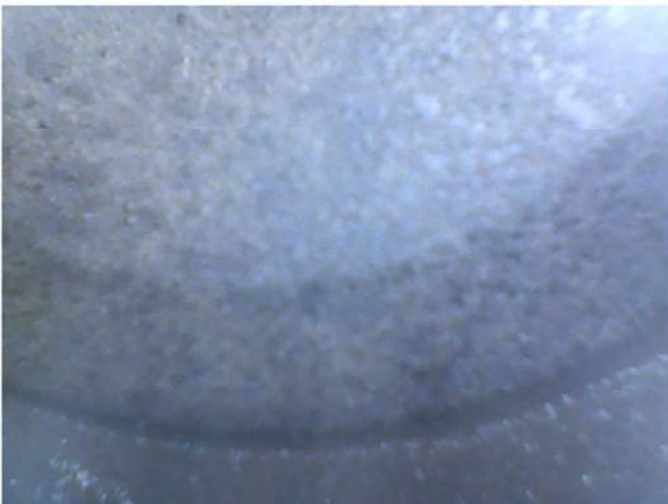
### CYLINDER #5

Condition: The cylinder remained attached to the crankcase with no external signs of operational distress. The rocker cover was removed and the valve springs remained intact. The cylinder was inspected and documented utilizing a lighted borescope. Oil was pooled at the bottom of the cylinder. The piston, valves, and valve seats were unremarkable.

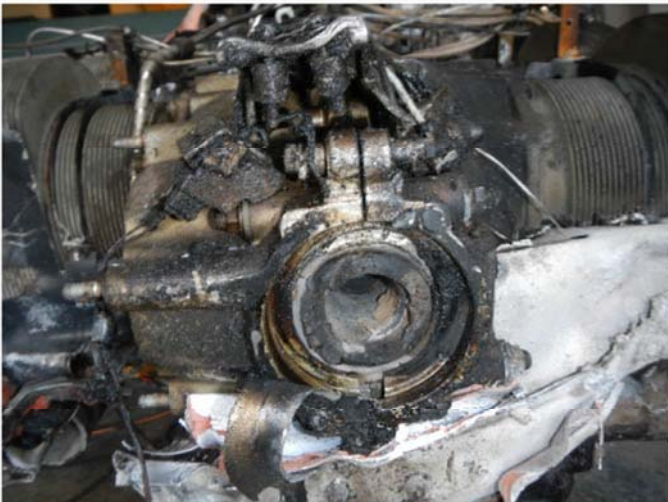
| Condition: | The propeller flange was separated from the crankshaft and the fracture surface displayed tearing, shear lips, and discoloration features consistent with overload. A tool was fitted to the backside of the crankshaft and partial rotation of the crankshaft was achieved with crankshaft continuity confirmed to the front of the engine and out to the connecting rods. Impingements on the crankshaft and camshaft were noted at the front of the crankcase and the oil sump respectively which prevented full crankshaft rotation. | | |

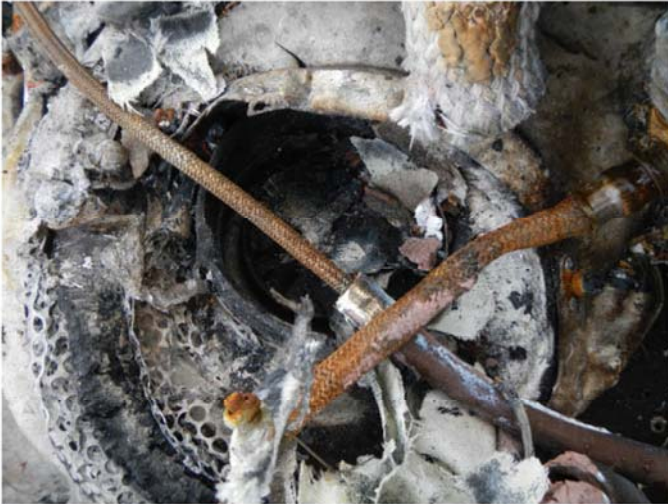
The turbocharger remained with the right nacelle area. The intake filter was burned and the ash was found in the inlet area. The intake impeller blades displayed deformation damage and curling opposite the direction of normal rotation. The turbocharger turbine wheel/blades remained intact.

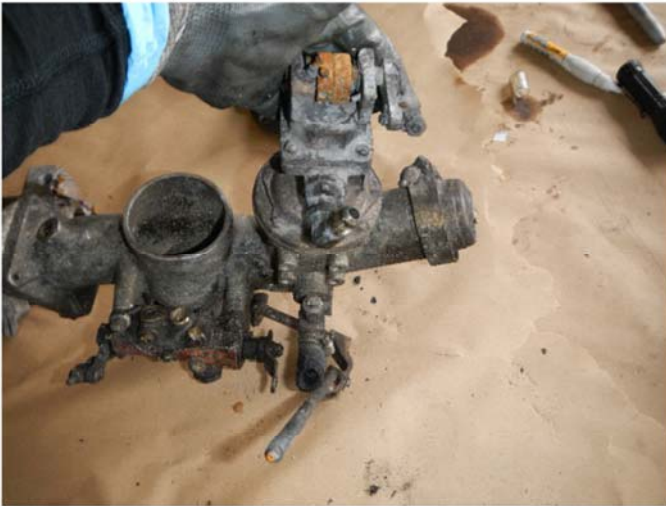
The turbo wastegate controller was thermally damaged and separated from the engine, but it remained attached to the throttle body which was attached to the nacelle.

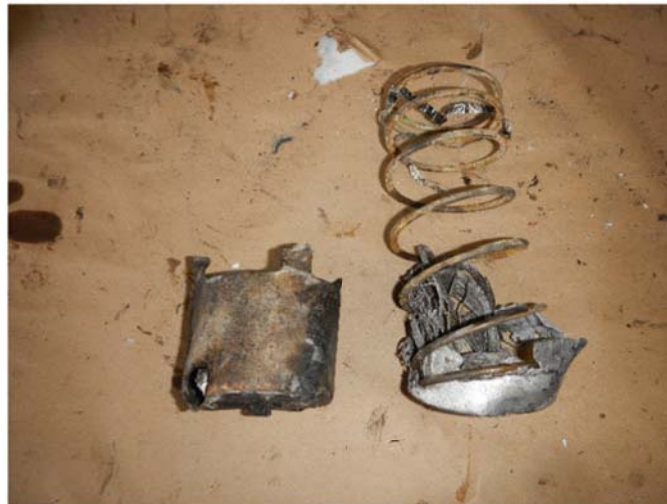
The overboost valve was thermally damaged and separated from the induction system. Remnants of two overboost valves were identified in the wreckage and the bottom photograph displays those components.

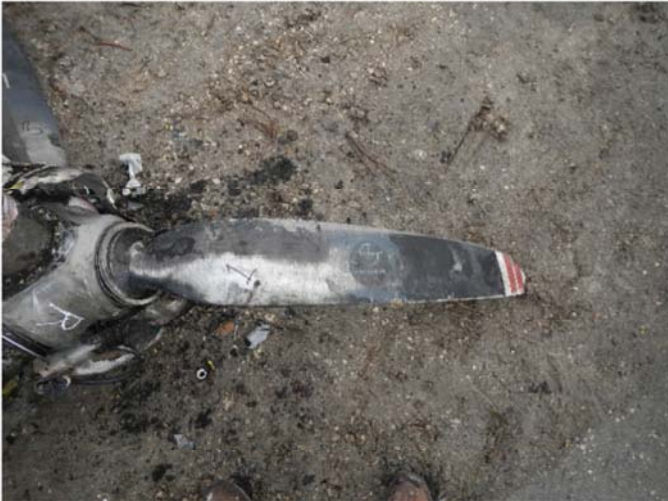
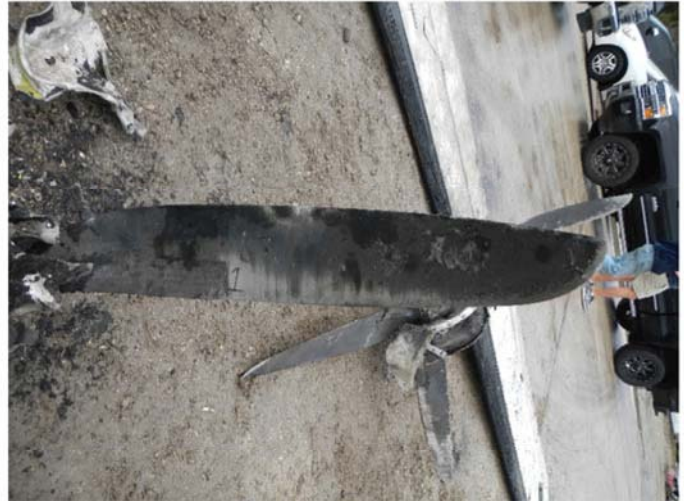
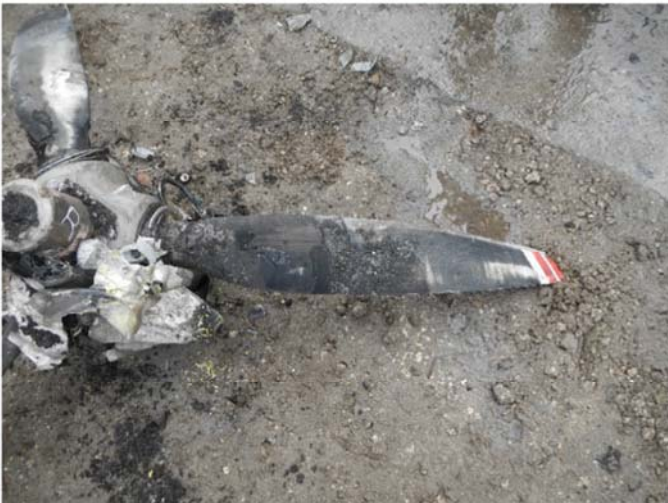
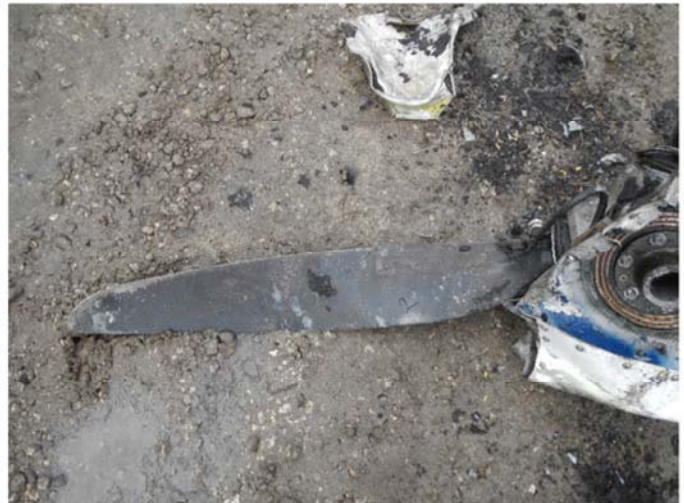
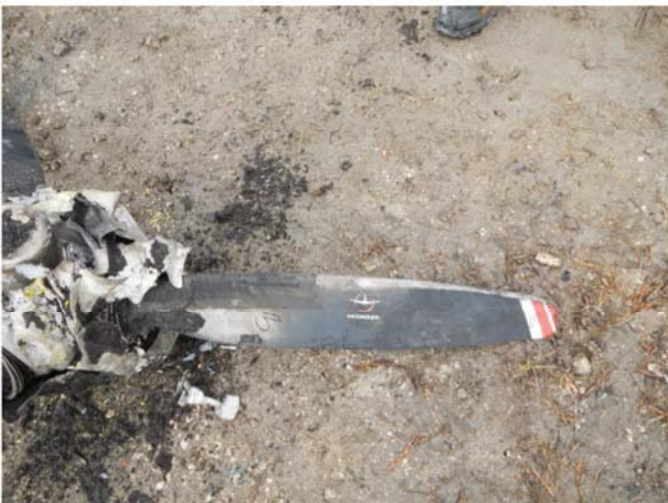
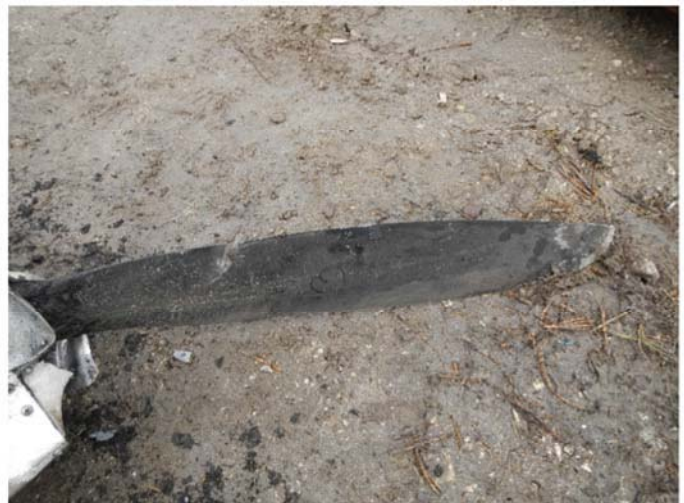
| <b>PROPELLER GOVERNOR</b> | Manufacturer: Not Recorded | P/N: Not Recorded | S/N: Not Recorded |
|---|---|---|---|
| Condition: | The propeller remained attached to the propeller flange, which was separated from the crankshaft at the engine nose seal. The propeller hub remained intact and the spinner dome was crushed aft over the hub. All three blades remained attached to the hub, but they were free to rotate, indicative of a pitch change link fractures. The blades were labeled 1, 2, and 3 according to their hub location. Blade 1 was missing its counterweight and was bent aft slightly. The leading edge displayed some light gouging and the cambered and face sides displayed chord-wise scrapes and paint erosion. Blade 2 displayed a small twist toward low pitch, paint erosion on the cambered side and light leading edge gouges. Blade 3 was missing its counterweight. The blade displayed light chord-wise paint erosion aft of the deice boot, but was otherwise unremarkable. | | |
