## **NATIONAL TRANSPORTATION SAFETY BOARD**

### **Weather Study**

# **METEOROLOGY**

CEN18FA063

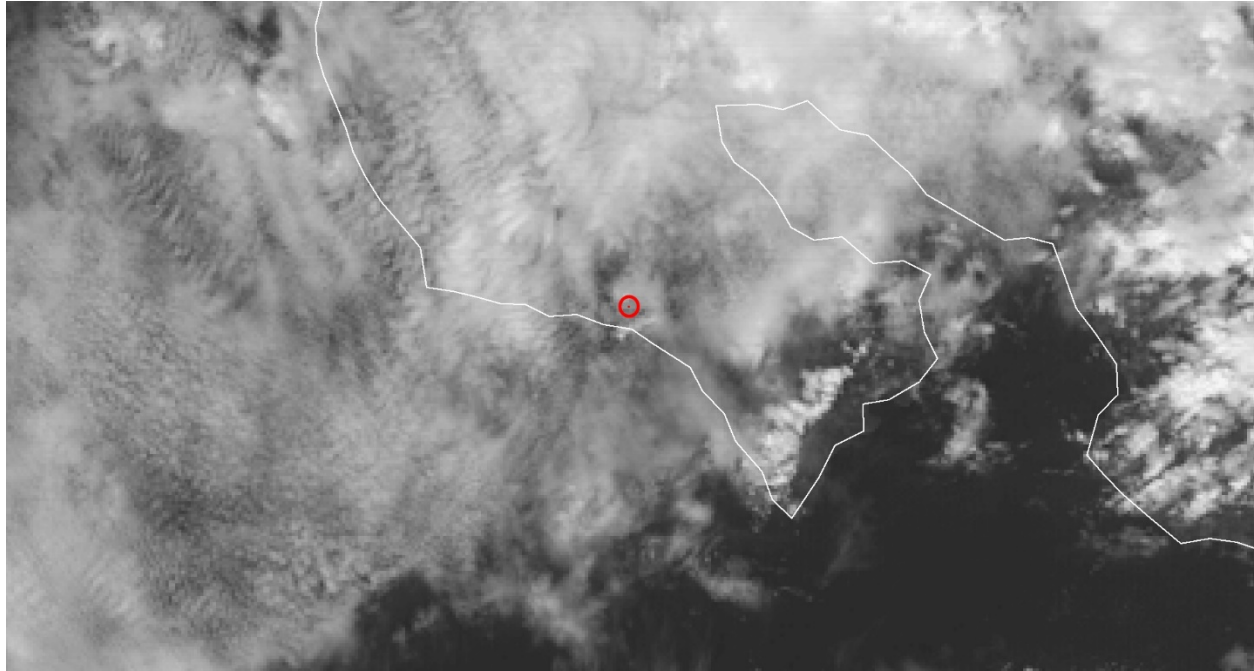
Geostationary Operational Environmental Satellite (GOES)-16 “visible” ( $0.64\mu\text{m}$ ) data were obtained from an archive at the Space Science Engineering Center at the University of Wisconsin-Madison. Imagery from 1200 CST is presented in figure 1. This imagery depicted cloudy conditions across the accident region.

**Figure 1** – GOES-16 visible ( $0.64\mu\text{m}$ ) imagery from 1200 CST. Accident location is denoted by the red circle.

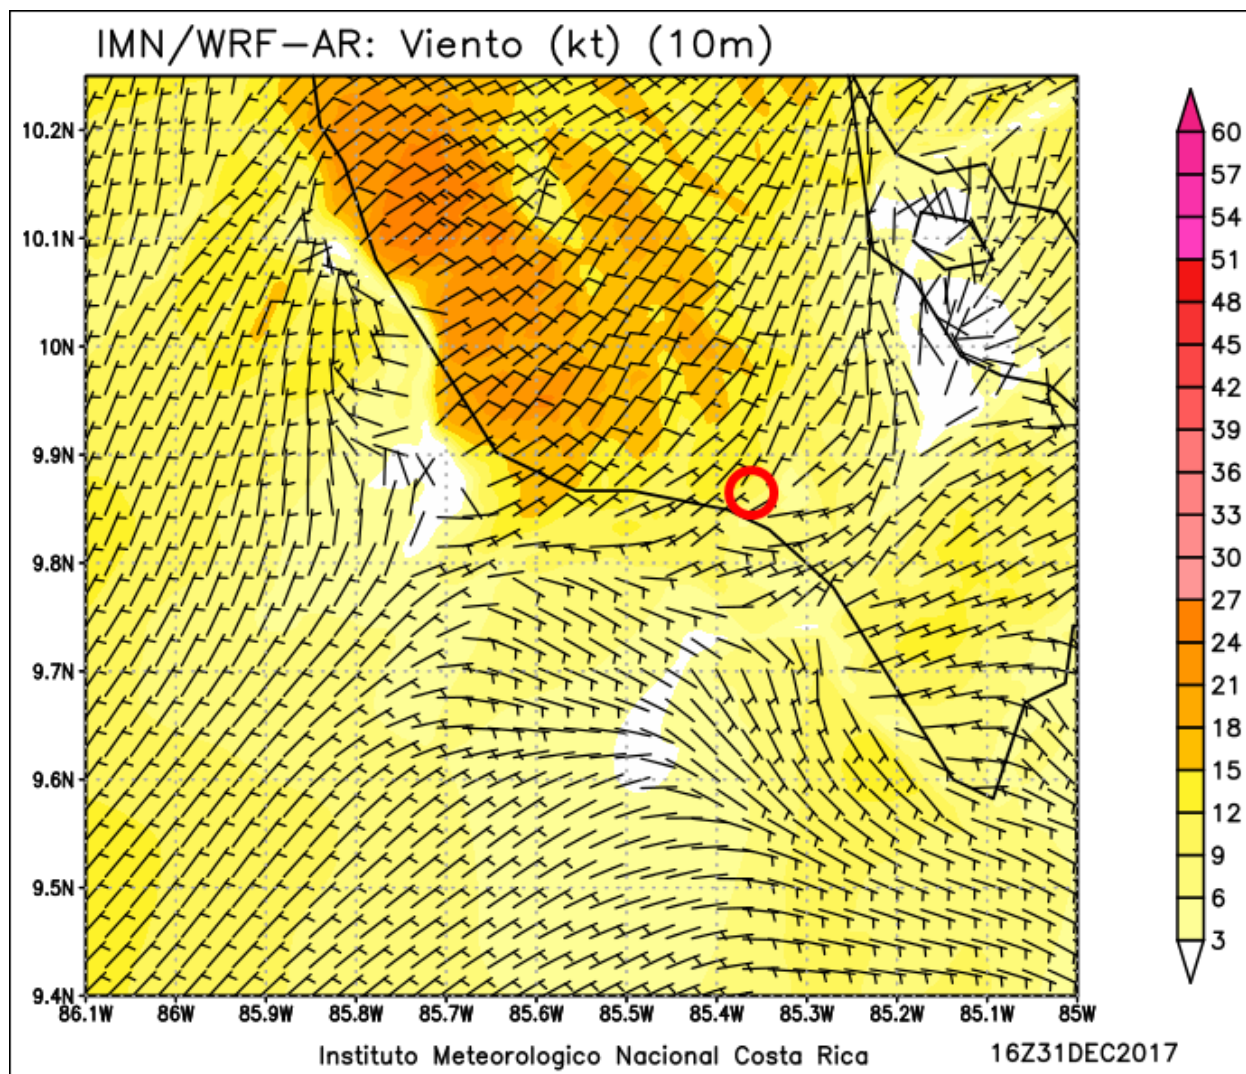
The WRF-AR results for 10-meter winds show that at 1000 CST (figure 2), the wind over the accident area was offshore from the northeast at about 5 knots. By 1100 CST (figure 3), a southerly wind had developed off the coast of Costa Rica to the south of the accident location, but the wind over the accident location remained from the northeast or east at about 5 knots. At 1200 CST (figure 4), onshore flow from the southwest or south had developed along the coast, with the accident site lying along the boundary between the (generally) 5 knot southerly winds to the south and the (generally) 5 knot northeasterly winds to the north.

**Figure 2** – WRF-AR 10-meter wind valid at 1000 CST. The accident site is denoted by the red circle.

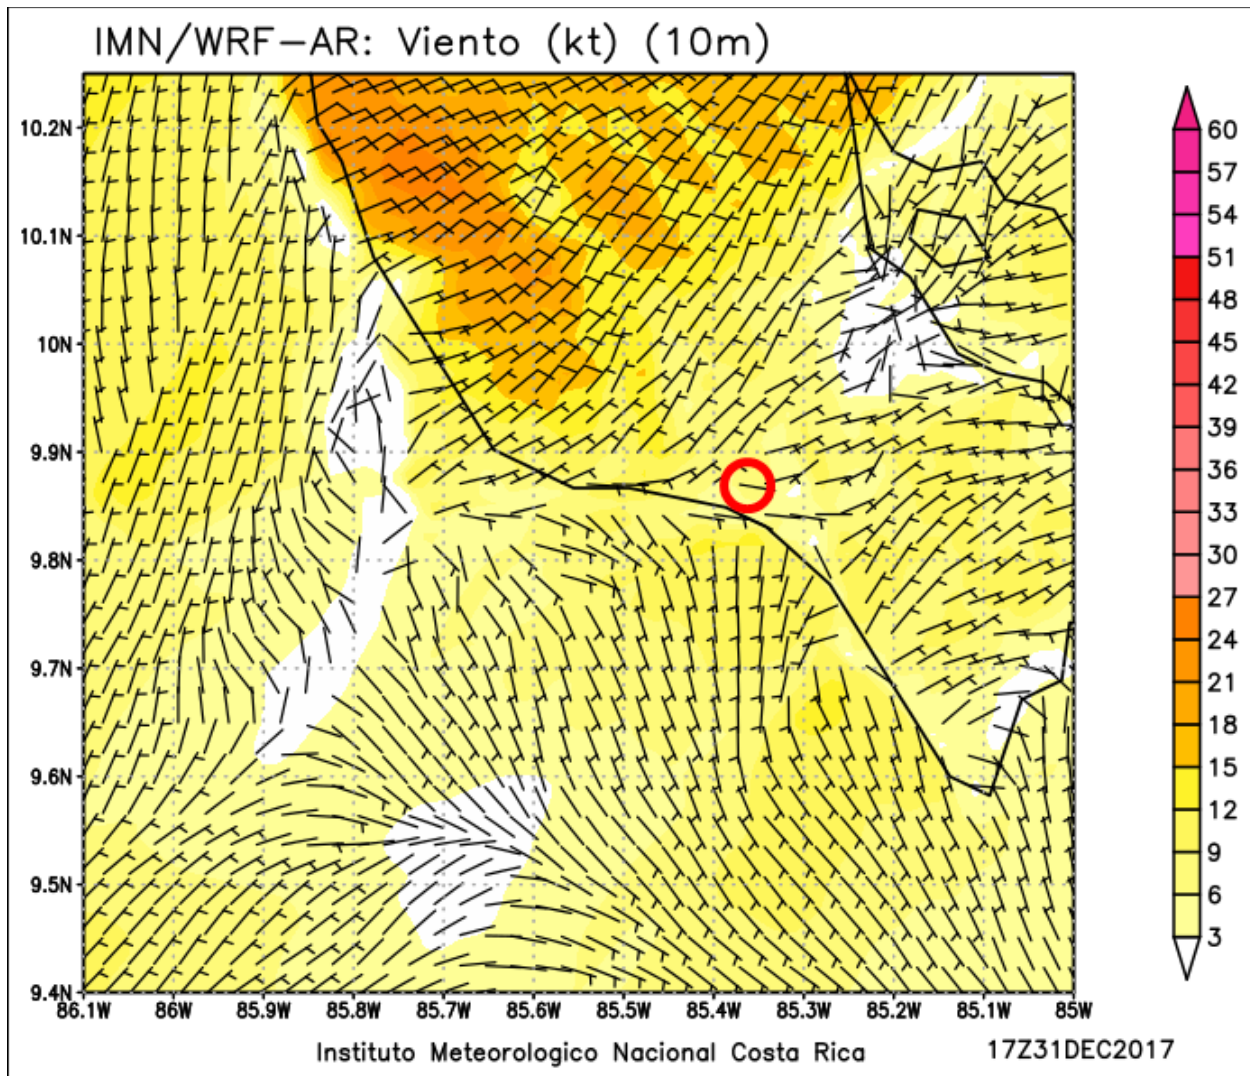
**Figure 3** – WRF-AR 10-meter wind valid at 1100 CST. The accident site is denoted by the red circle.

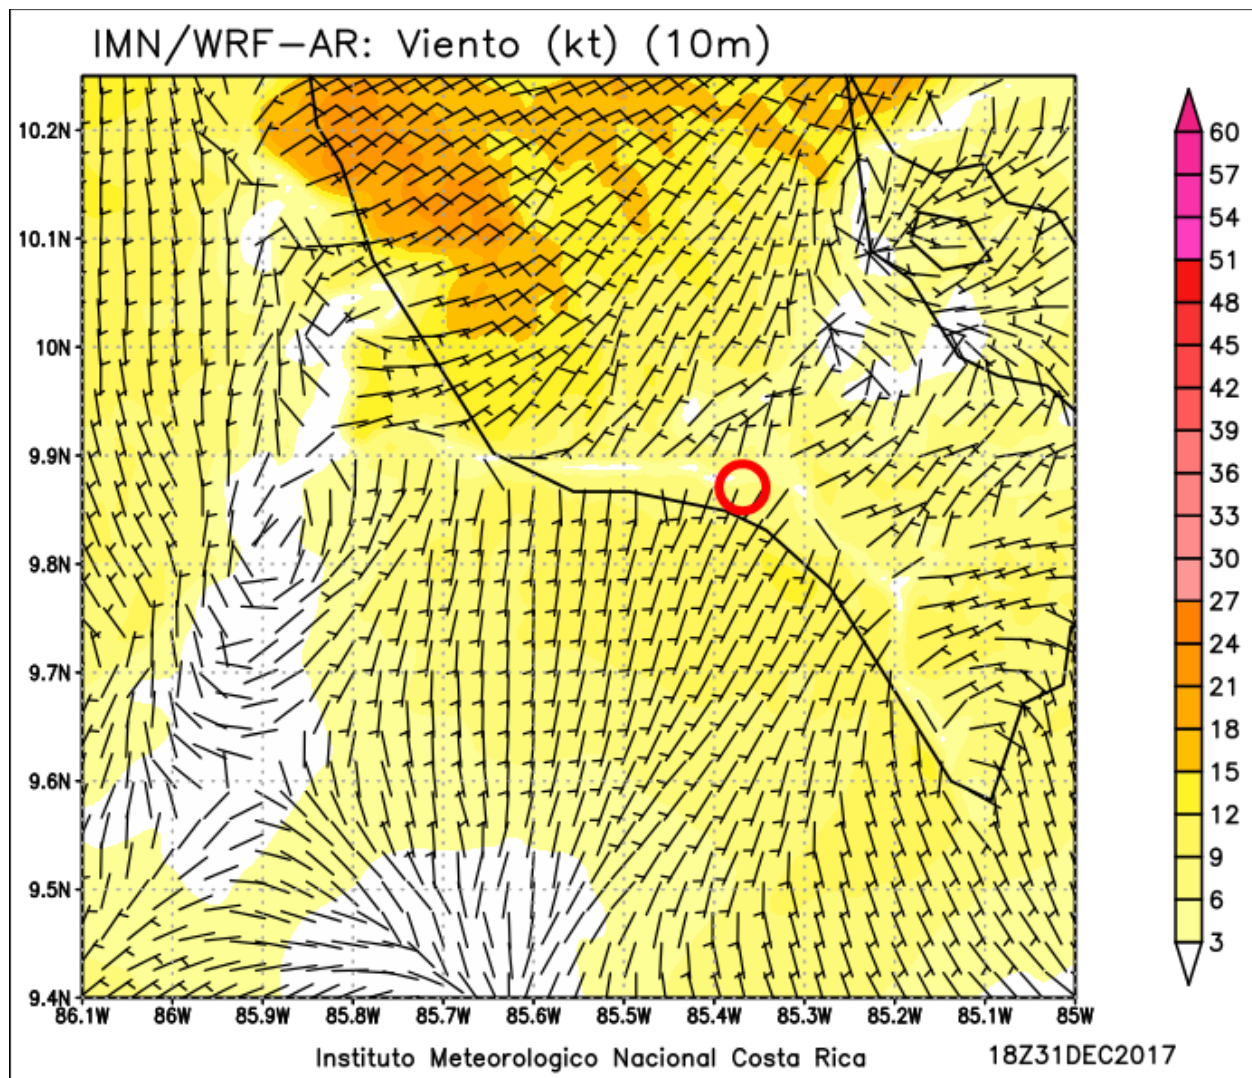
**Figure 4** – WRF-AR 10-meter wind valid at 1200 CST. The accident site is denoted by the red circle.

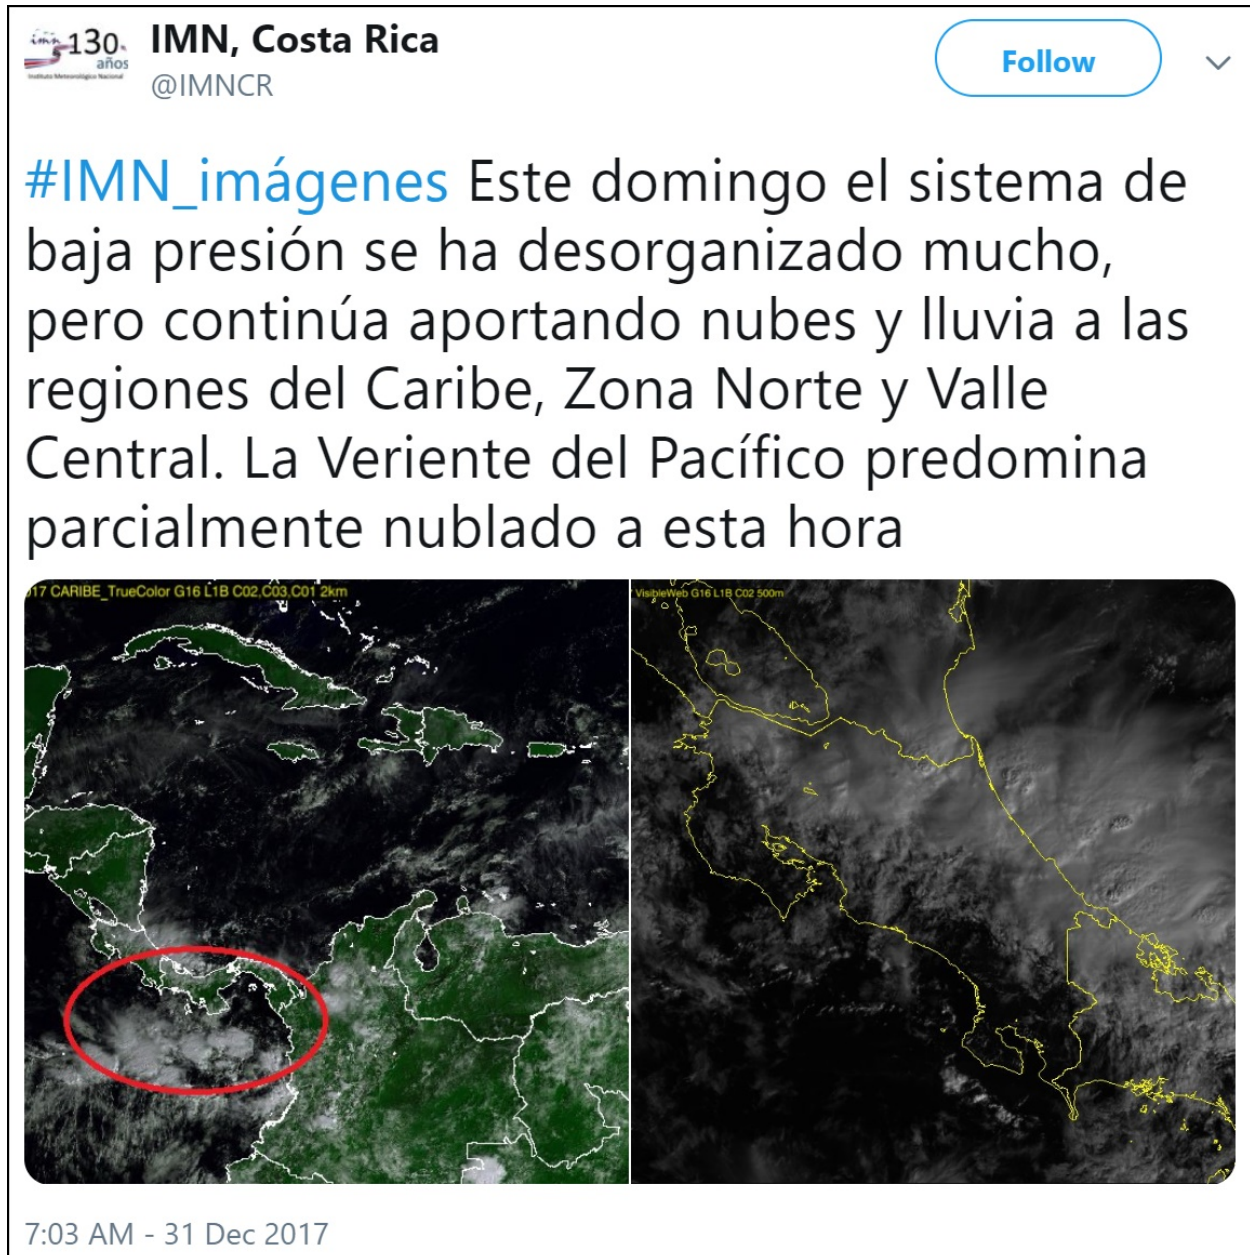
**Figure 6** – IMN Twitter post during the morning of the accident day that presents satellite imagery and indicates that the Caribbean, North Zone and Central Valley regions of Costa Rica are cloudy due to a low pressure system, and the Pacific Slope region is partly cloudy.
