**NATIONAL TRANSPORTATION SAFETY BOARD**  
Office of Research and Engineering  
Washington, D.C. 20594

## **Video Study**

**NTSB Case Number:  
CEN18FA063**

Location: Punta Islita, Costa Rica  
Date: December 31, 2017  
Time: 1756 UTC  
Airplane: Cessna 208B

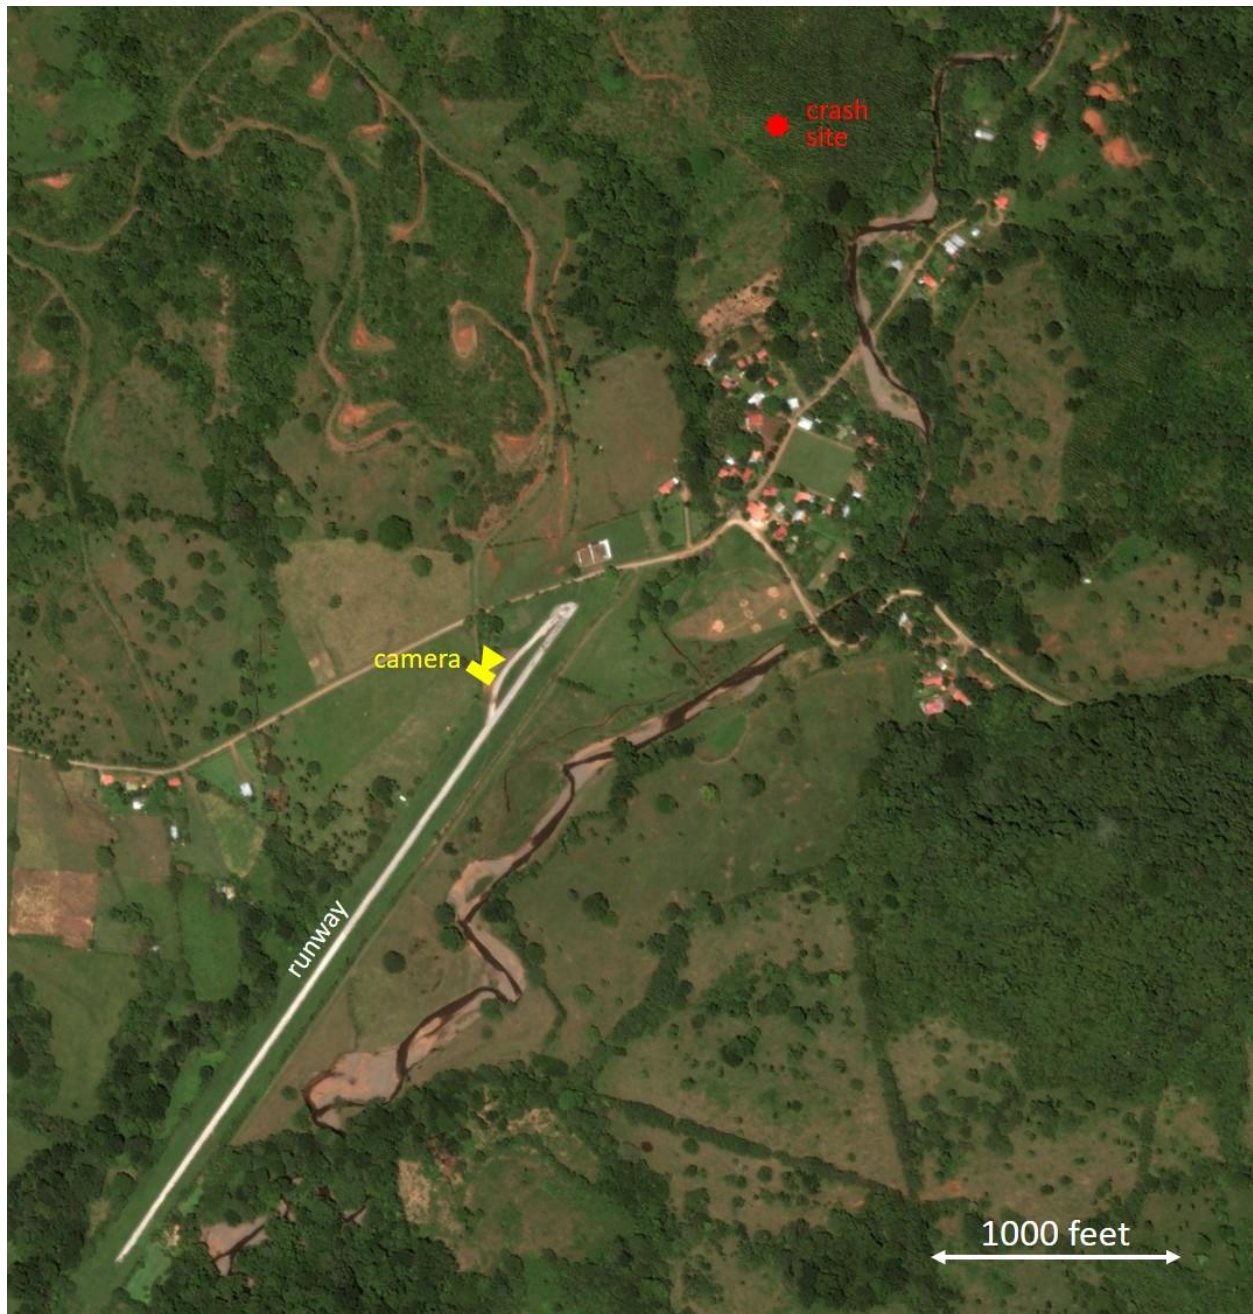
**Figure 1. Aerial View of the Accident Area**

Figure 1 shows an aerial view of the accident area, including the runway, the taxiway between the end of the runway and the airport building, the camera, and the crash site. Figure 2 shows a video frame acquired by the camera shown in Figure 1. The frame shows the northern end of the runway and the taxiway. These details are also seen in Figure 1. A mountain peak P is marked on the video frame in Figure 2. It is not seen in Figure 1 because its location is north of the area shown in the figure.

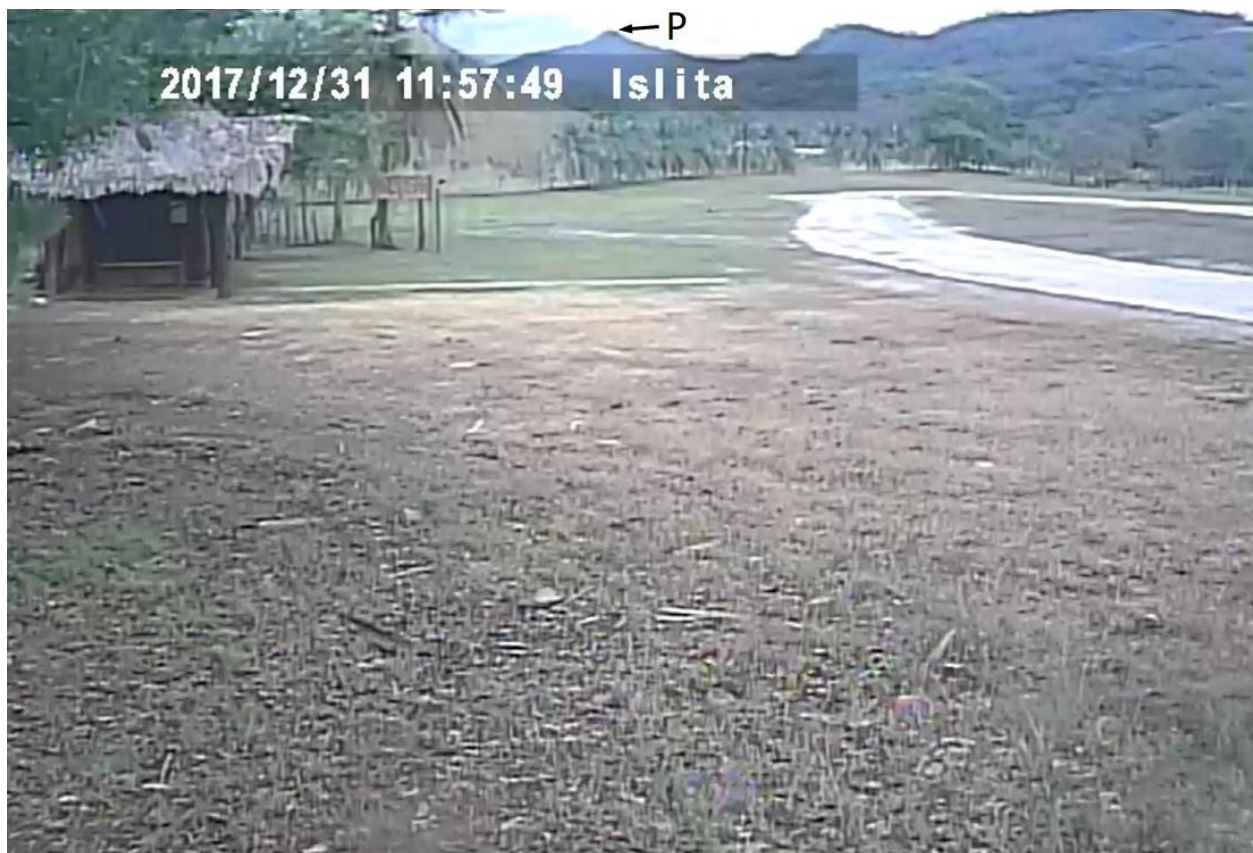
**Figure 2. Video Frame Used for Camera Calibration**

The estimation was based on references that were visible both in aerial images and in video frames. These references were primarily the runway and the taxiway. The mountain peak P marked in Figure 2 was also used as a reference. It was not visible in aerial images and its location was determined based on elevation data extracted from Google Earth.
