**Accident / Incident Report**

**Pratt & Whitney Canada**

**Report No.:18SIE00239**

**Pentastar Aviation Charter Inc (Owner: Bennett Aviation LLC)**  
**EC135P1 & Registration # N312SA**  
**Chicago, Illinois**  
**July7, 2018**  
**PW206B**  
**S/N BB0049 and BB0045**

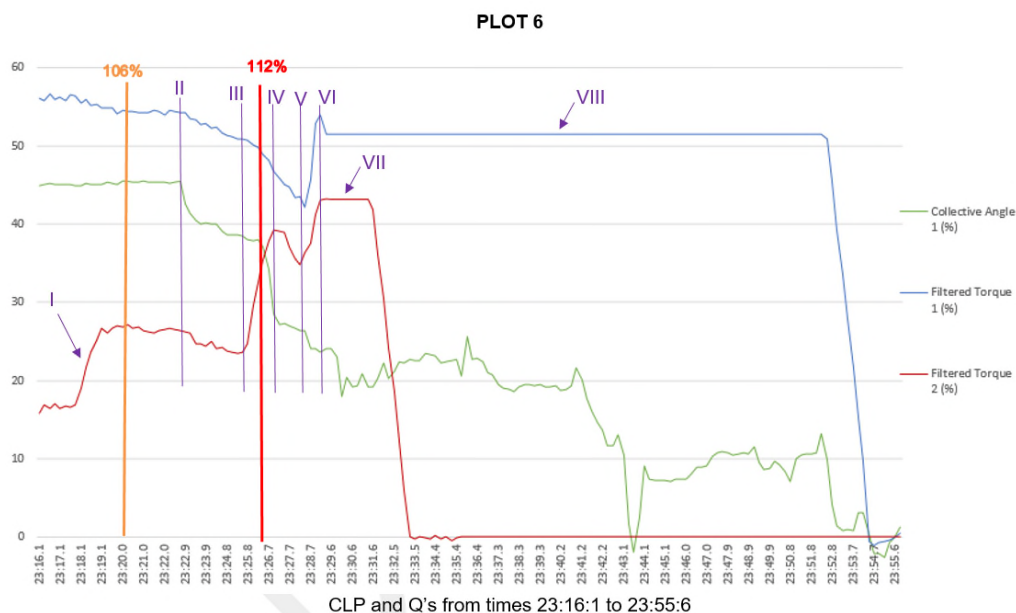
The following Plot 6 (For the full data analysis see Appendix C) shows the final 40s until both engines' torques were at 0.

The orange line at 24min and 1s represents an audible gong from the cockpit (information provided by the NTSB) indicating that the main rotor has reached or exceeded 106% NR. The red line at 23min 26s represents the beginning of the continuous audible high tone from the cockpit (information provided by the NTSB). This tone comes on when NR is greater or equal to 112%, and will stay on until the NR comes back below this range (information on when the tone came off was not provided and thus is not identified on the graph).

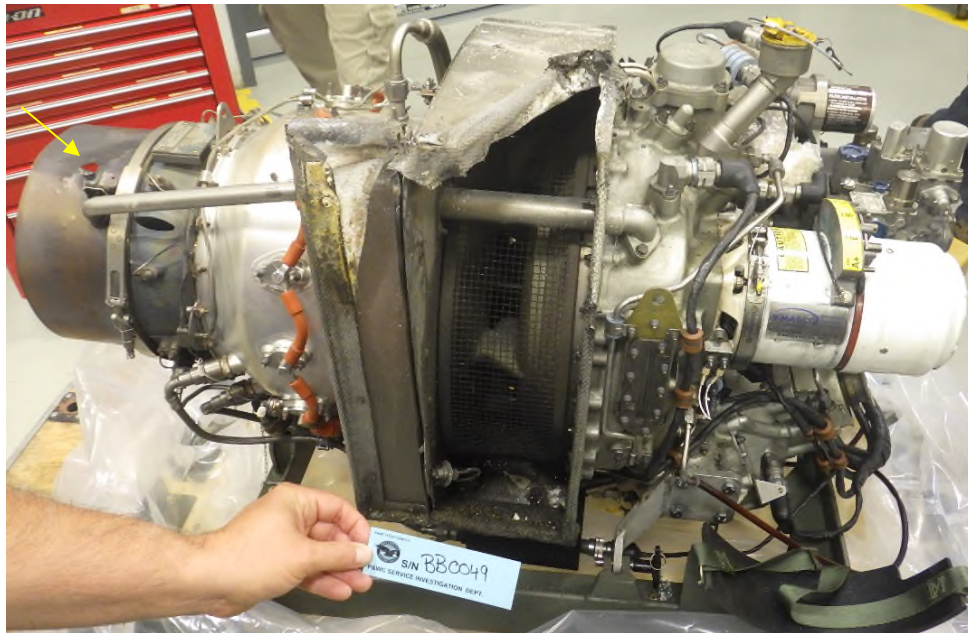
Photo No. 1: BB0049 Right hand side

There was partially separated and dislodged sheet metal from the turbine exhaust cone, which was deformed and partially covering the air flow path of the exhaust duct (see red arrows on Photo No. 4). The exhaust exhibited multiple pock marks consistent with high speed impact from small internal parts (yellow arrows on Photo No. 4). There was one perforation hole noticed at approximately the 1 O'clock location (yellow arrow on Photo No. 1), which exhibited petalling consistent with an inside to outside perforation direction.

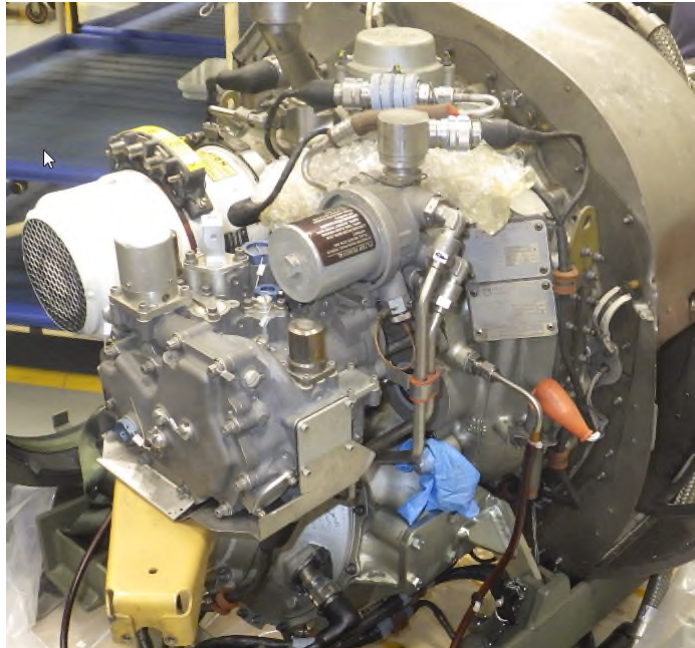
Photo No. 3: RGB

There was no visible damage to the reduction gear box (RGB) as seen in Photo No. 3.

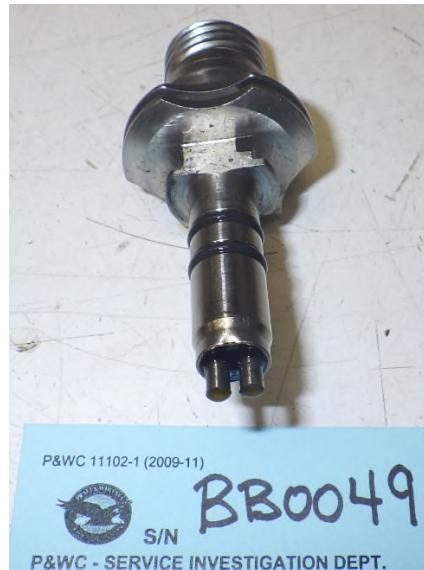
Photo No. 6: chip detector

The chip detector was clean (Photo No. 6).

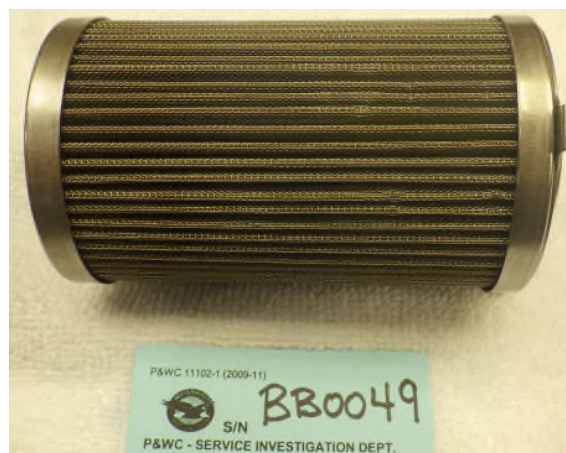
Photo No. 7: Oil Filter

The oil filter was clean (Photo No. 7).

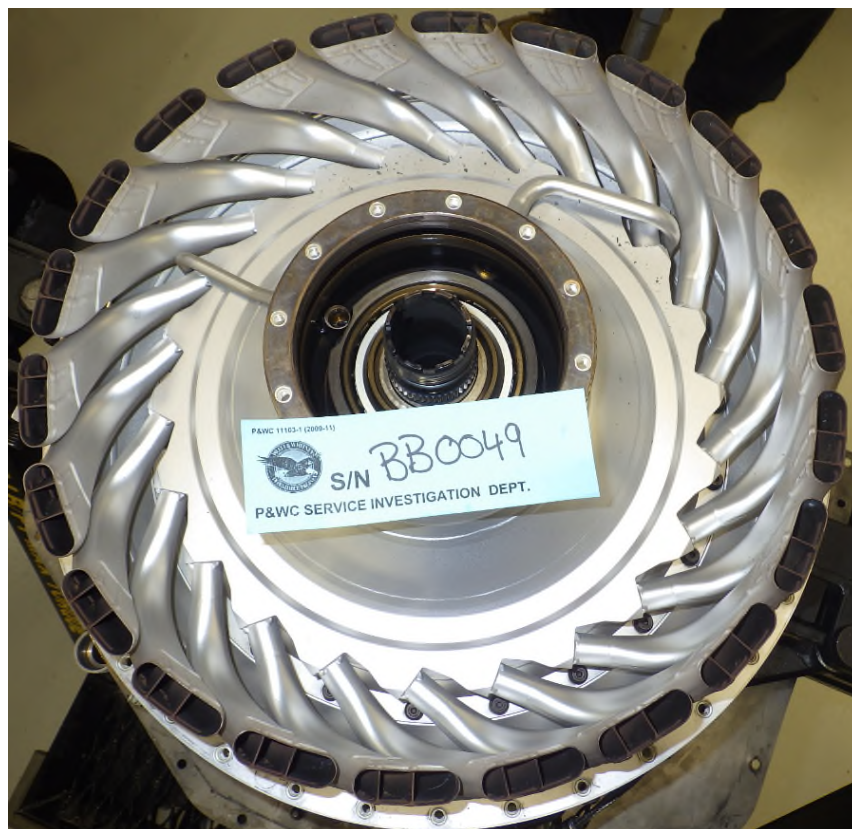
Photo No. 12: Diffuser pipes

The diffuser pipes were intact and undamaged and showing no sign of internal engine fire (Photo No. 12). There was some corrosion present on the diffuser pipes exterior as seen on Photo No. 13.

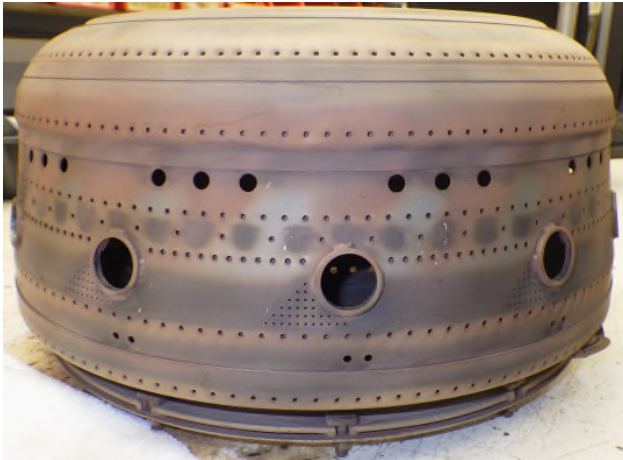
Photo No. 16: Exterior of outer liner

There was no damage noted to the outer liner as seen in Photo's 16 and 17. There were some minor black carbon (see red arrows) deposits near the fuel nozzle bores which aligned with the direction of the fuel nozzles as seen in Photo No. 17.

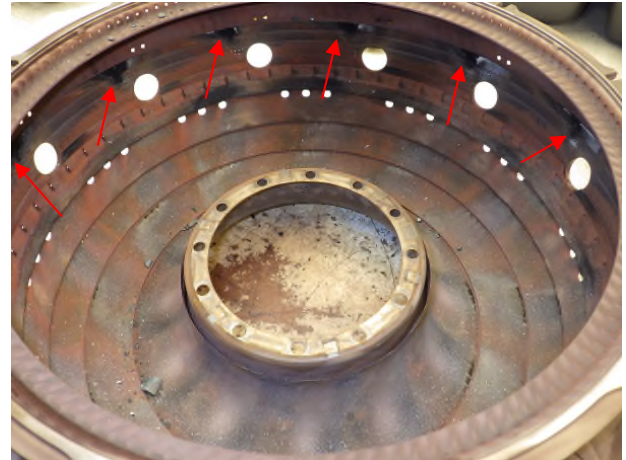
Photo No. 17: Interior with carbon deposit

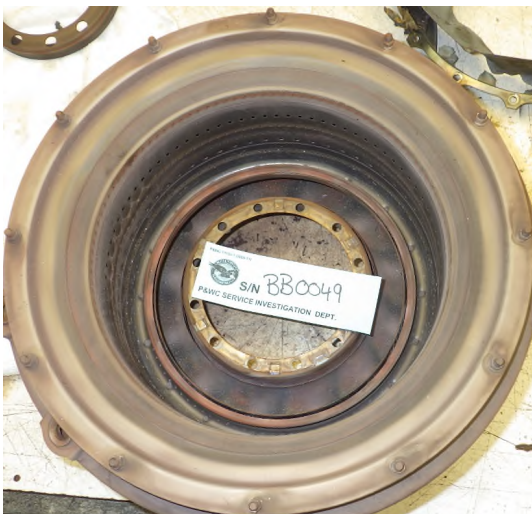
Photo No. 18: Inner liner

The inner liner was intact (Photo's No. 18 and 19) and did not show any damage with the exception of some coating loss, as shown on Photo No. 19 indicated by red arrows.

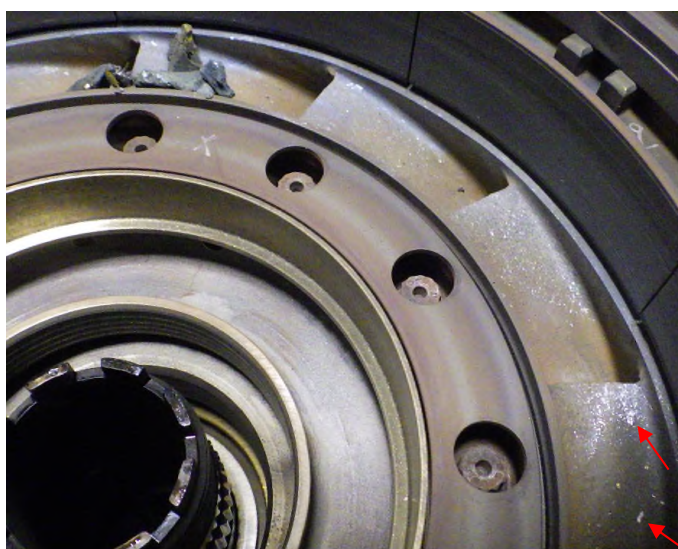
The CT stator was undamaged. It had some bright, shiny metallic particles (see red arrows) that were adhered to the aft, suction side of the vanes (Photo No. 20). This is consistent with metal spray from the impeller shroud coating which was a result of the impeller vane tip rubbing.

Photo No. 20: Metal spray on backside of CT stator

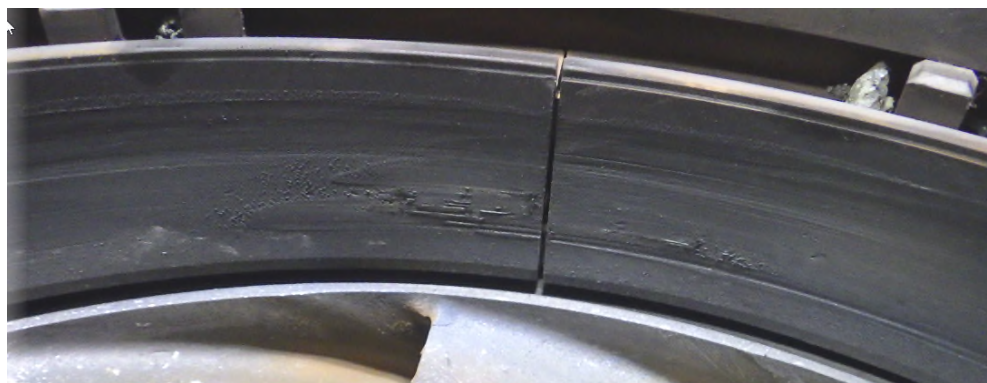
The CT blade shrouds showed rubbing and material transfer due to contact with the CT blades tips as seen on Photo No. 21.

Photo No. 21: CT shroud rubbing

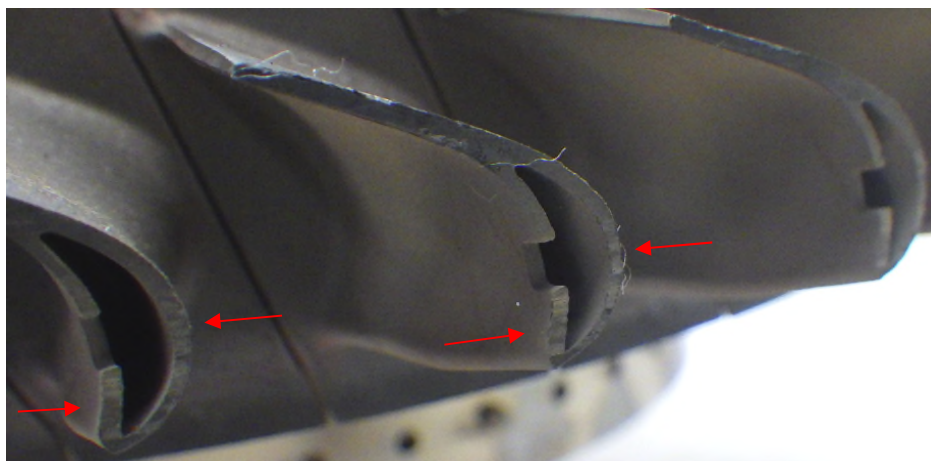
The CT disc and blade assembly was intact and undamaged as seen in Photo No. 22. The CT blade tips showed evidence of rotational scoring as indicated by the red arrows in Photo No. 23. The disc was de-bladed and the blade growth was measured to be an average of 0.0017 inches, which is within the CIR manual (Cleaning, Inspection, and Repair) limit.

Photo No. 23: CT blade tip rubbing

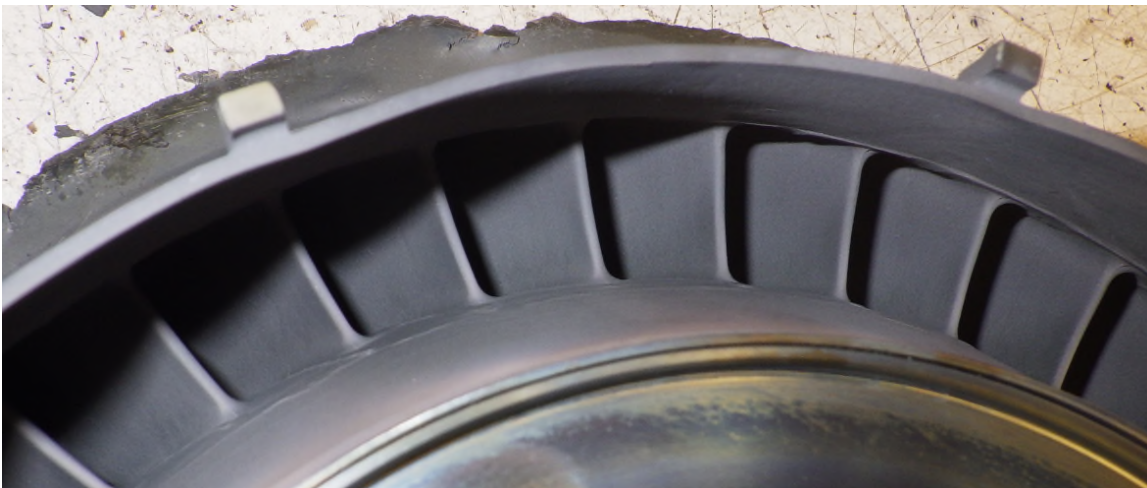
The leading edge of the PT stator vanes were intact and undamaged as seen in Photo No. 27.

Photo No. 27: Leading edge of PT stator vanes

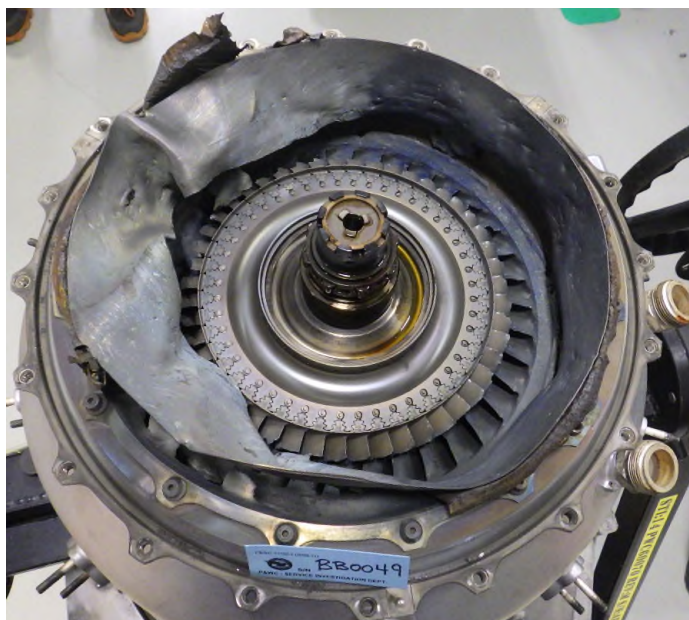
The exhaust was removed at Flange “F” revealing the dislodged turbine exhaust cone deformed sheet metal as seen in Photo 28. This sheet metal is brazed onto the turbine exhaust cone but due to the PT blades release, the sheet metal had torn and dislodged from its original position.

Photo No. 28: PT exhaust cone deformation

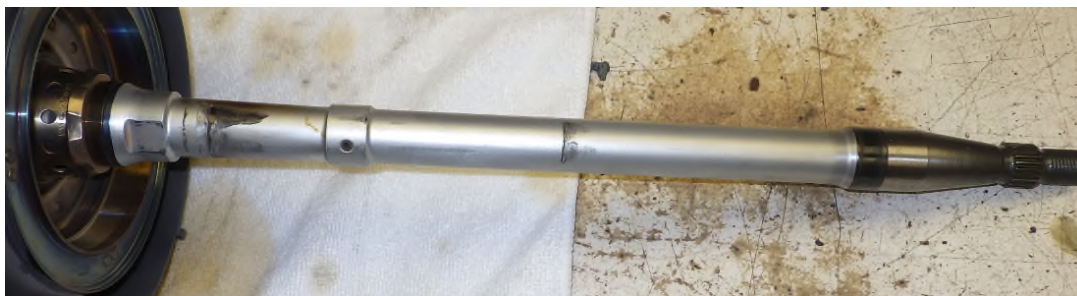
Photo No. 32: PT shaft

The PT shaft had three sets of rotational contact marks along its length, which is consistent with a temporary elastic bending of the shaft (Photo No. 32).

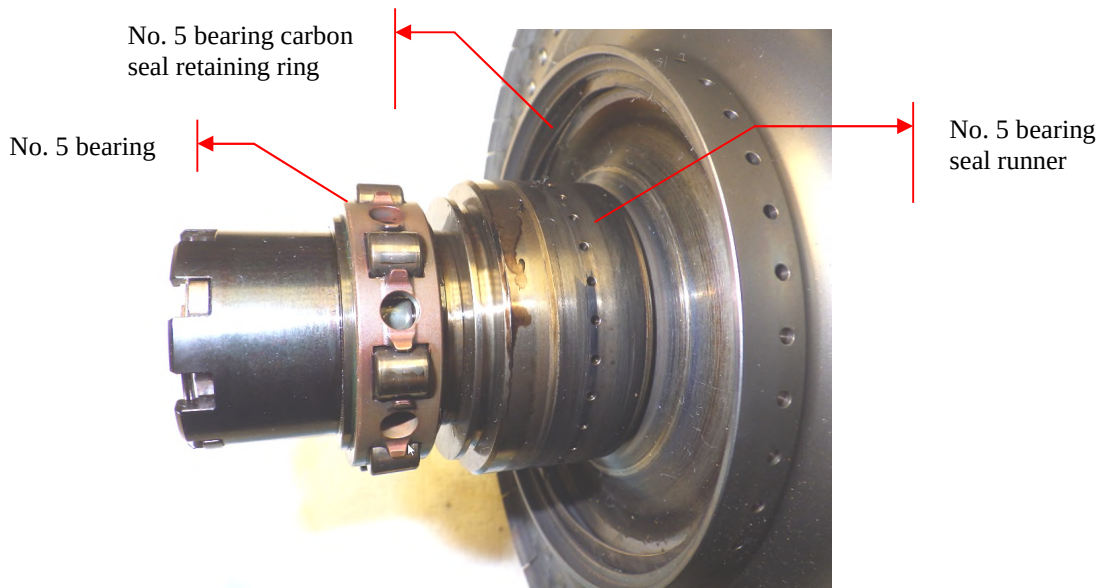
The No. 5 roller bearing was not damaged (Photo No. 33). The No. 5 bearing carbon seal retaining ring had become dislodged from its seat and was found in the downstream side of the balancing rim of the PT disk (Photo No. 33). The No. 5 bearing carbon seal had moved forwards from its seated location by approximately 0.1 inch (Photo No. 34). The seal runner was rotationally scored, which is consistent with an uneven contact against the No. 5 bearing carbon element (Photo No. 33).

Photo No. 33: No. 5 bearing and No. 5 bearing seal runner

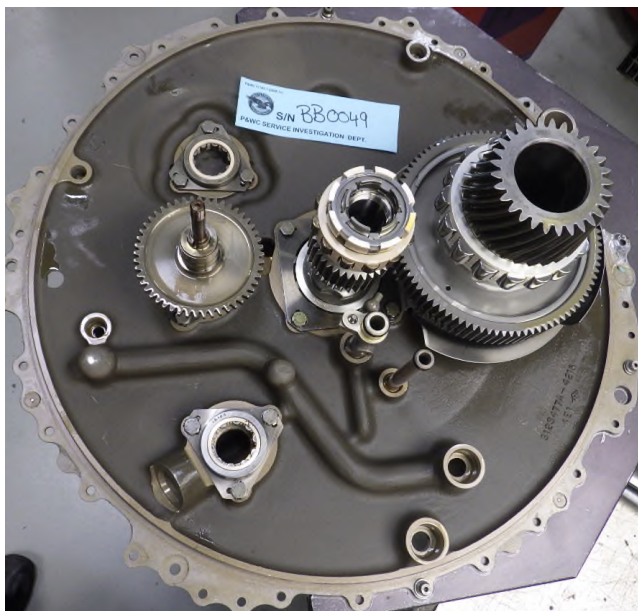
With the removal of the PT stator and PT disk which were seized together, all shafts in the RGB were free to rotate, confirming the internal integrity of the RGB. The RGB was split at Flange “A” (Photo No. 36 and 37), showing that all internal components were oil wetted. The No. 1 roller and No. 2 ball bearings were intact and undamaged, as was the input shaft, 1<sup>st</sup> stage reduction gear, 2<sup>nd</sup> stage reduction gear, accessory gears, and output shaft. Based on this the gearbox was not disassembled further.

Photo No. 36: RGB diaphragm and gears

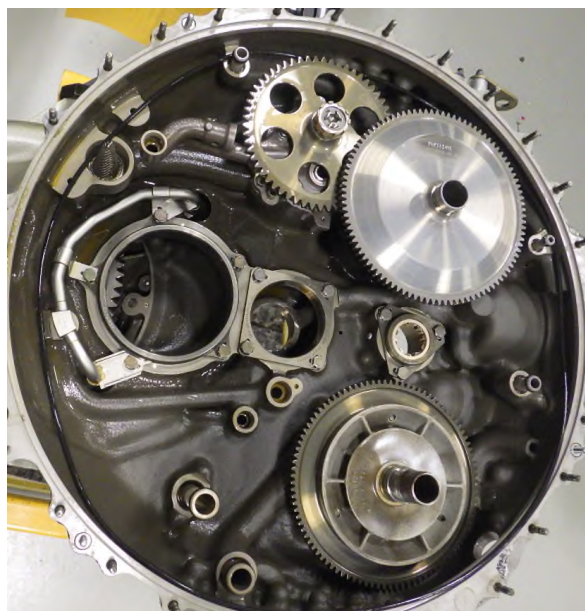
Photo No. 37: RGB housing and gears

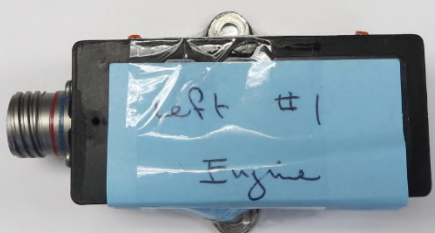
Photo No. 38: DCU

The DCU (Photo No. 38) had been shipped back to P&WC for a download and assessment. The DCU records the engine trim information as well as cycle counting information, but does not record engine faults. The DCU communication was established without problem and the trims and cycles downloaded successfully.

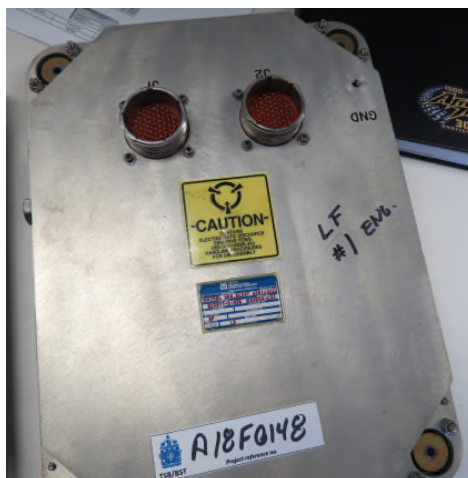
Photo No. 39: EEC

The EEC (Photo No. 39) had previously been shipped back to P&WC for a download and analysis. What was found to be related to this event was a fault on two separate sensors which both showed that the NPT signal exceeded its max range of 127%.

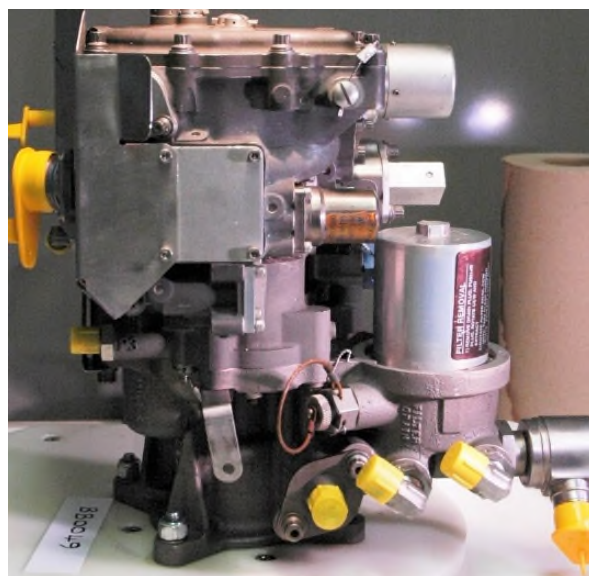
Photo No. 40: FMM

The FMM (Photo No. 40) was inspected externally and was found to have all lockwires intact, with no noticeable damage except for some soil. The Power lever moved freely over the full range and the alignment with the rig-pin was obtainable at the detent. The driveshaft could not be moved by hand, which is normal. The FMM was tested in accordance with the Woodward CM 73-20-14 Rev. 5 and there were minor deviations noted, however nothing that would have effected normal operation. The FMM manual/automatic switch was tested and found to be fully functional.

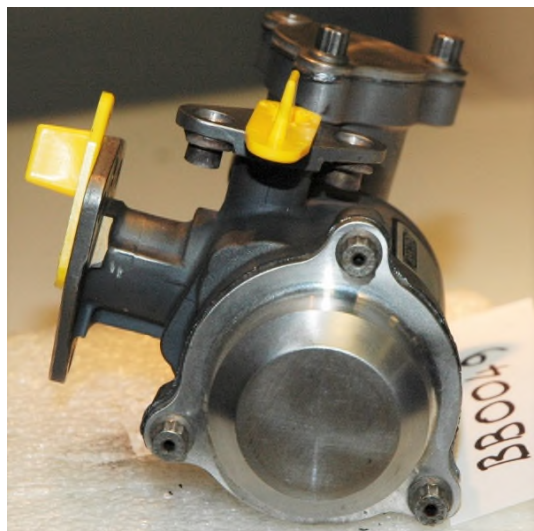
Photo No. 42: Flow Divider Valve

The engine flow divider (Photo No. 42) was tested and the results were satisfactory. There were no findings that would have prevented normal operation.

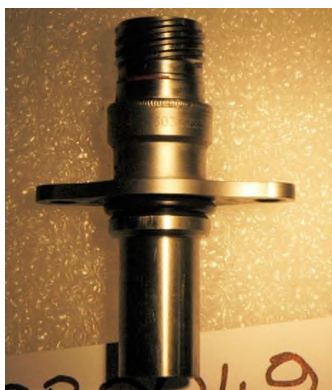
Photo No. 43: Q sensor

Torque sensor: The torque sensor (Photo No. 43) was visually inspected and was found to be in an acceptable condition for further testing. The connector was undamaged, clean and the magnet was not protruding from the sensor body. There was some gold plating material loss which resulted in some black deposits. The sensor was tested, including temperature cycling and dynamic functions, and all tests were satisfactory.

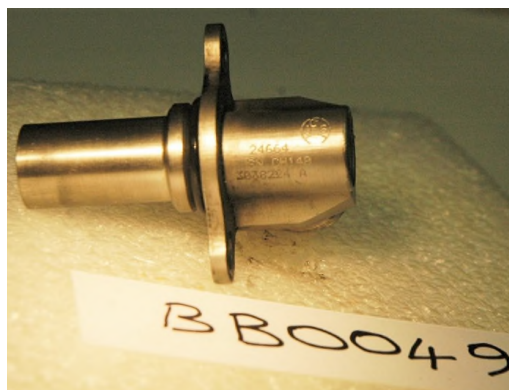
Photo No. 44: Ng sensor

Ng Speed Sensor: The Ng sensor (Photo No. 44) was visually inspected and found to be in an acceptable condition for further testing. The inside of the connector was undamaged, clean and the magnet was not protruding from the sensor body, however there was some black deposits on some of the pins. There was some burnishing on the tip of the sensor which may have occurred during impact. The sensor was tested and the results were satisfactory.

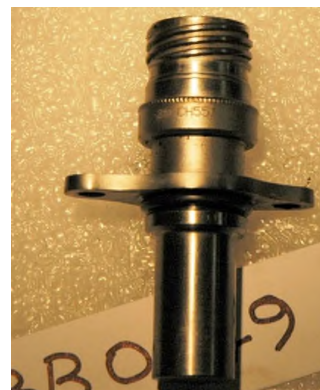
Photo No. 45: NPT sensor

NPT Speed Sensor: The NPT sensor (Photo No. 45) exterior was generally clean and the magnet was not protruding from the sensor body. The electrical connector shell was undamaged however slightly stained, and some gold plating was missing and in its place some black deposit had formed. The sensor was tested and the results were satisfactory.

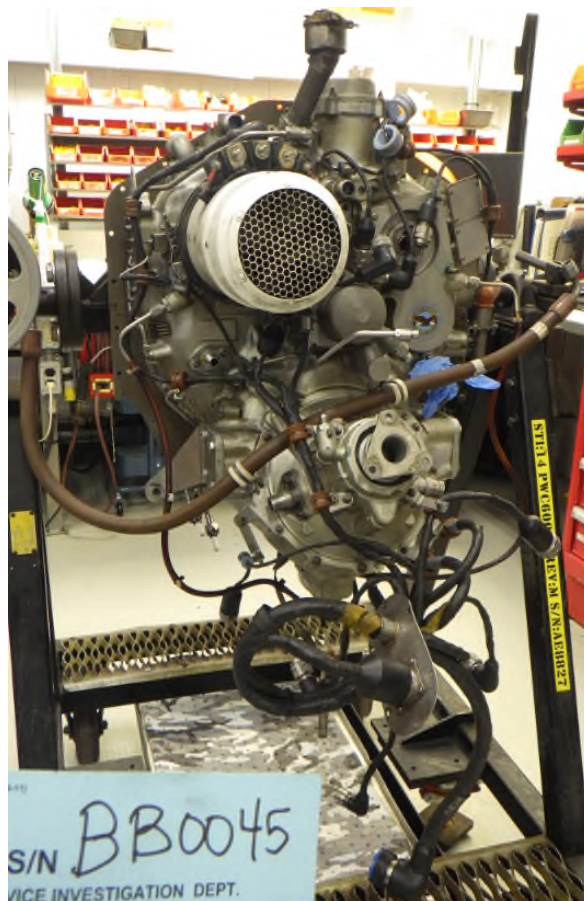
Photo No. 49: RGB

There was no visible damage to the RGB as seen in Photo No. 49.

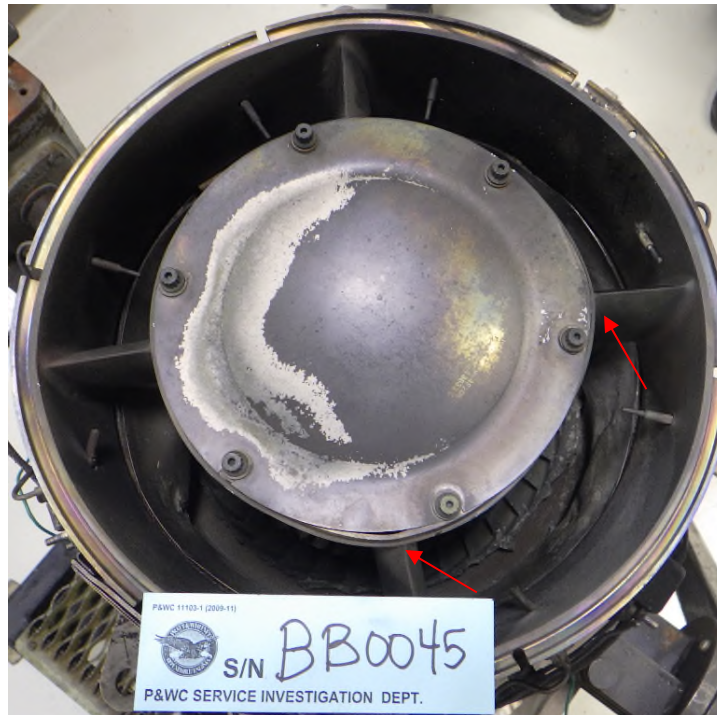
When examining the rear flange of the No. 5 bearing support housing, it was found that it was no longer circular and did not match the round aft cover plate. The red arrows on photo No. 51 show two locations where the support housing has deformed and is no longer circular. A red box was added to Photo No. 52 to show the direction in which the bearing support housing had been stretched to create a more rectangular shape.

Photo No. 51: No. 5 bearing support deformation

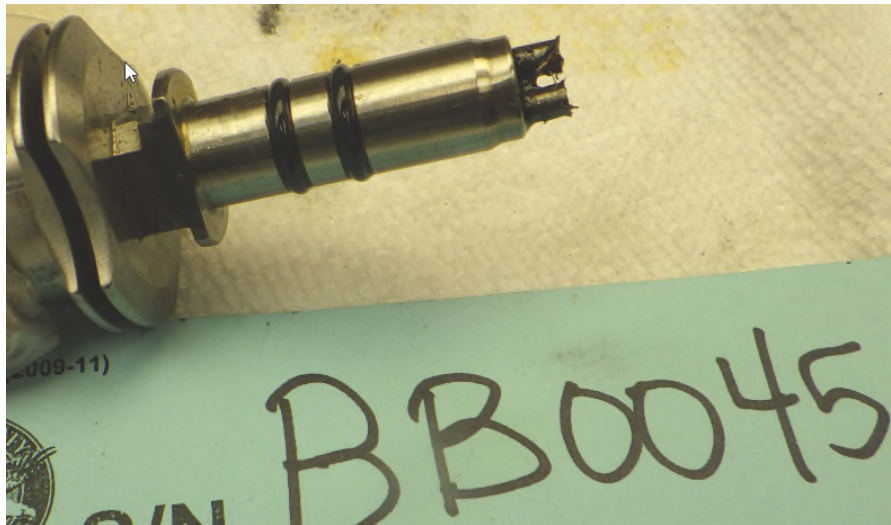
The chip detector revealed small magnetic flakes as seen in Photo No. 54.

Photo No. 54: Chip detector with debris

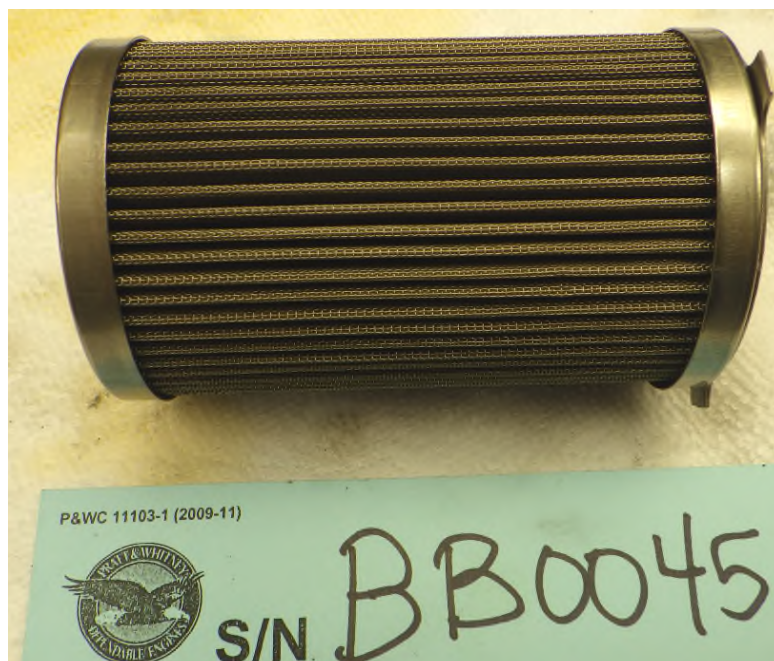
Photo No. 55: Oil filter

The oil filter was clean, as seen in Photo No. 55.

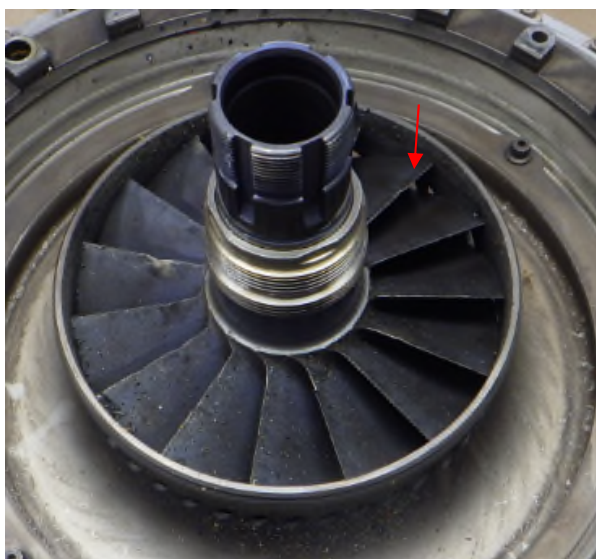
Photo No. 56: As installed impeller

The inlet case was intact and undamaged. The impeller showed minimal damage to the leading edges, however there was evidence of a previous blend repair (yellow arrow) and some minor nicks (red arrows) as seen on Photo's No. 56 and 57. The vanes tips were undamaged although there is some evidence of rubbing due to contact with the impeller shroud. This can be seen in Photo No. 58, where the red arrows point to a few locations where the shiny material represents the location that the impeller vanes tips contacted the impeller shroud.

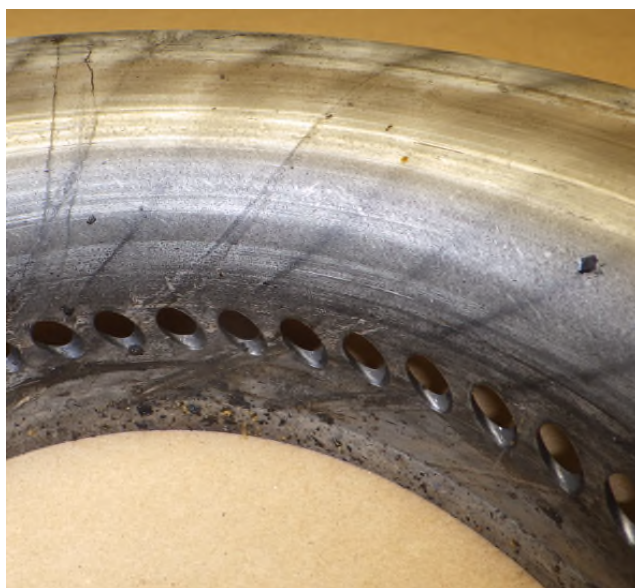
Photo No. 60: Close up of scoring

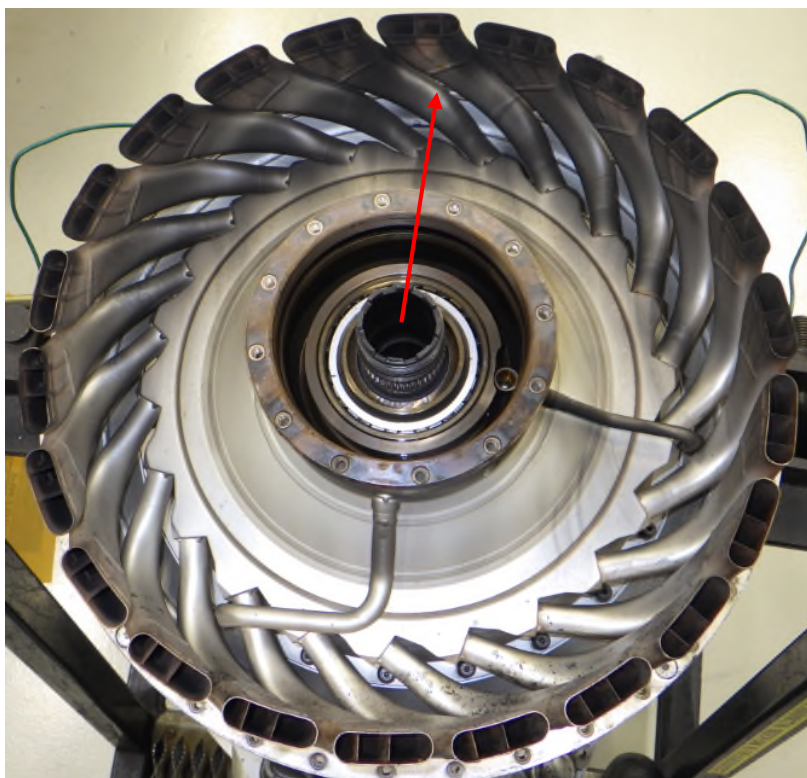
The diffuser entrance openings were unobstructed and undamaged. The diffuser case and diffuser pipes were intact and undamaged, however there was a coating of black sooty material around the 12 O'clock position, consistent with an oxygen-starved fuel fire (red arrow on Photo No. 61). The concentration of black soot was higher at the 12 O'clock position, which is consistent with a post-event fire that occurred after engine shut down.

Photo No. 61: Soot build up on the diffuser tubes at the 12 O'clock position

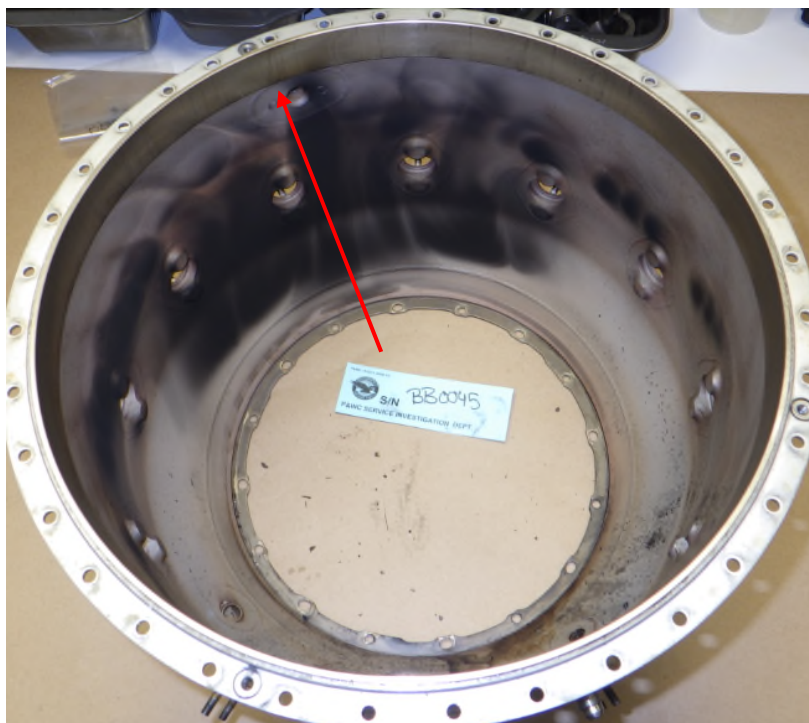
The inner surface of the gas generator case showed evidence of a streaky, sooty deposit which is consistent with an internal oxygen-starved fire occurring post engine shut down. Photo No. 62 shows the soot with a high concentration around the 12 O'clock position as indicated by the red arrow.

Photo No. 62: Gas Gen case with soot around 12 O'clock

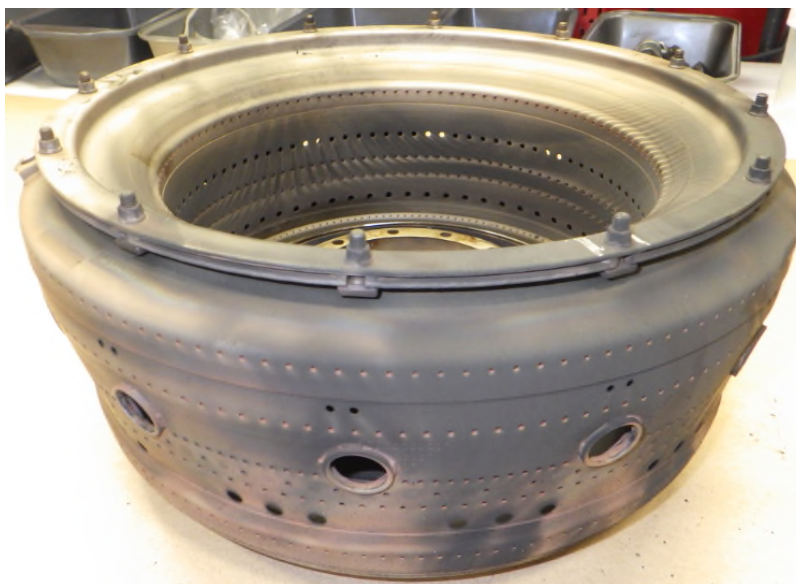
The inner and outer combustor liners were intact and undamaged as seen on Photo No. 63.

Photo No. 63: Combustion chamber

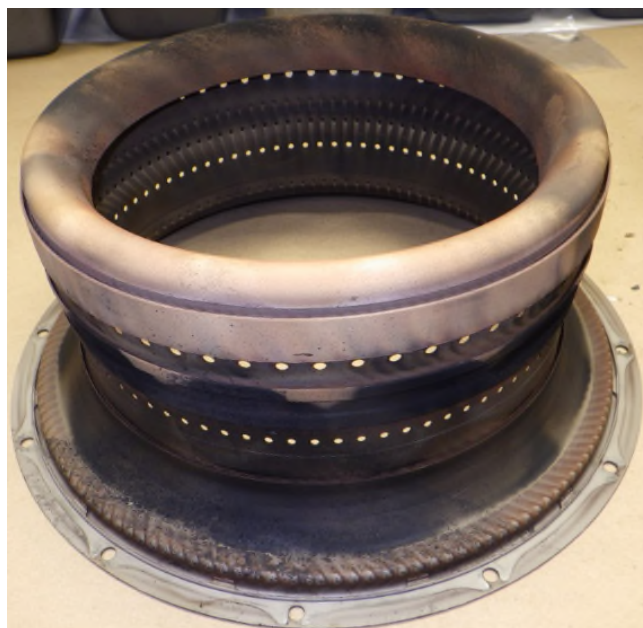
The inner liner also showed an accumulation of soot. The red arrow on Photo No. 65 points to the 12 O'clock position, where it can be seen that there is more apparent soot around this location than the 6 O'clock location. The side view of the inner liner shows further evidence of soot accumulation (Photo No. 66). The ceramic coating was in good condition.

Photo No. 66: Inner liner soot build up

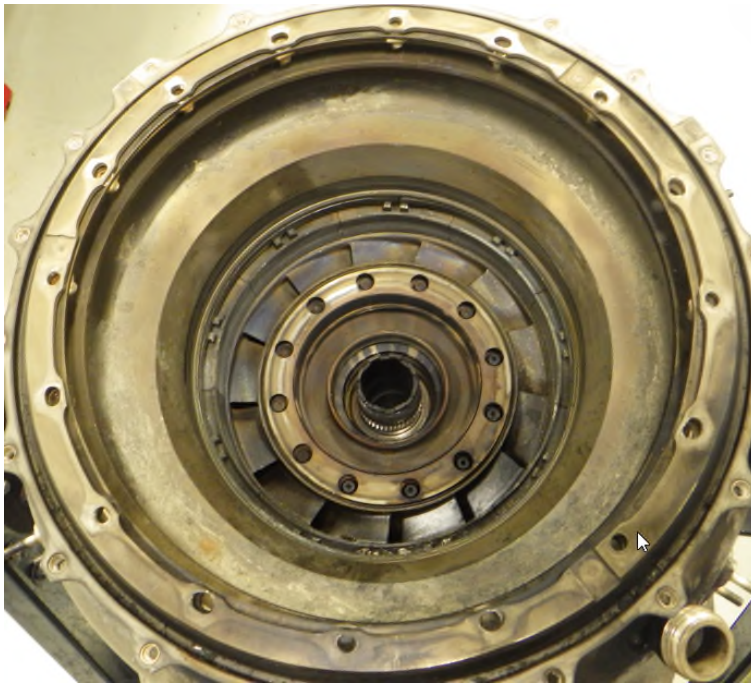
The CT stator vanes were intact and undamaged on both the trailing and leading edges (Photo's No. 67 and 68), however on the aft sections of the vanes there was a slight colour change (bluish colour seen in Photo No. 69) which is consistent with a rapid over-heating event. The compressor turbine vane ring had some bright, shiny metallic particles (some of which are indicated with yellow arrows on Photo No. 70) which had adhered to the aft, suction side of the vanes. This is consistent with metal spray from the impeller shroud coating which was removed by the impeller vane tip rubbing.

Photo No. 67: CT stator trailing edges as installed.

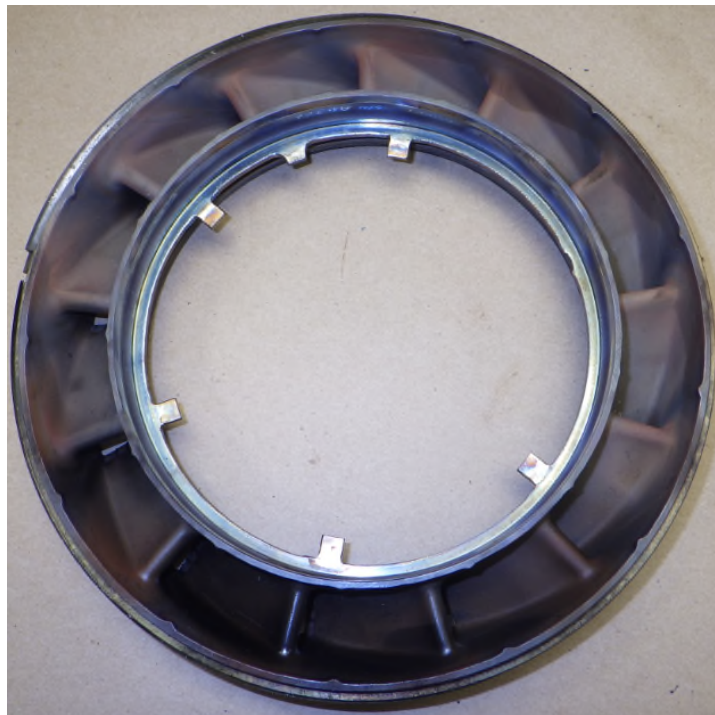
Photo No. 68: CT stator leading edges

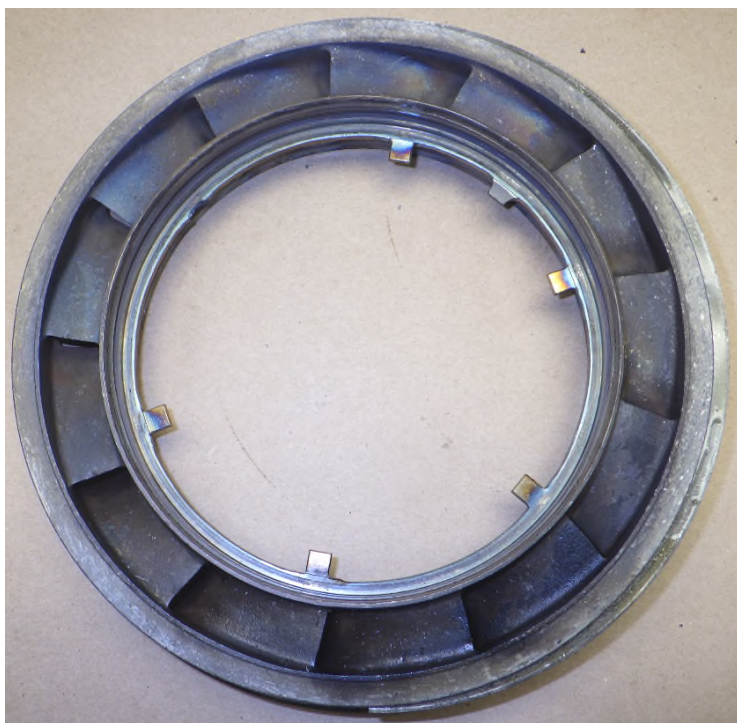
Photo No. 69: CT stator trailing edge

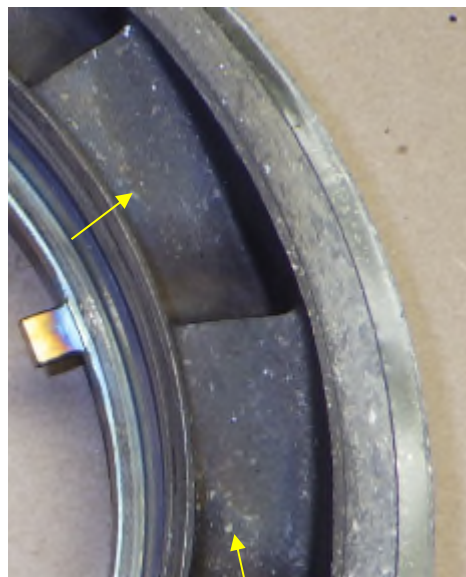
Photo No. 70: Silver specks

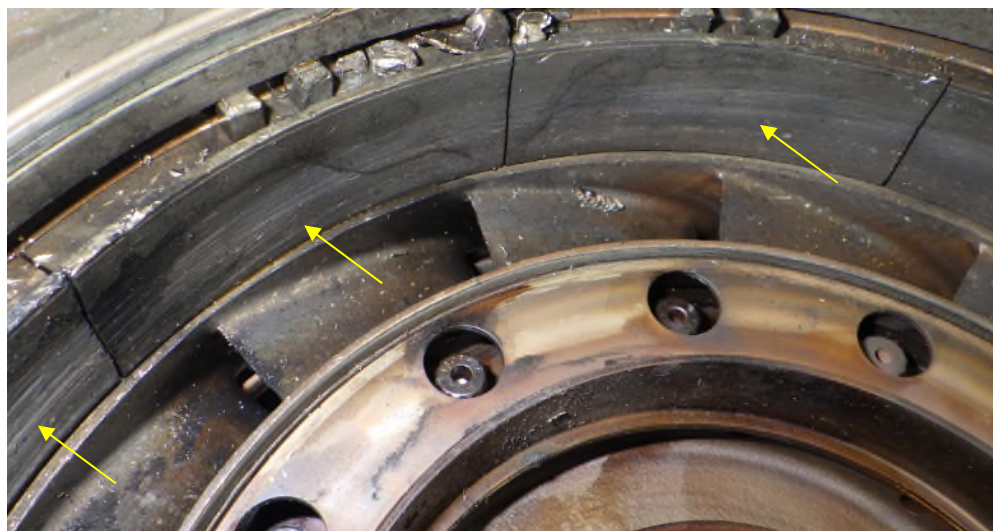
The CT blade shrouds showed significant rubbing and material transfer due to contact with the CT blades tips. The yellow arrows indicate the rub marks on all shroud segments which are shown on Photo No. 71.

Photo No. 71: CT shroud with rubbing marks

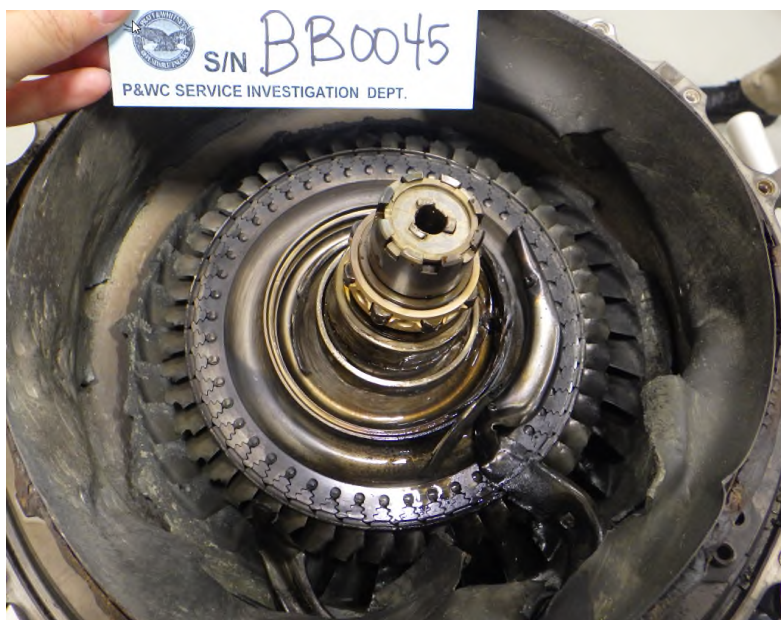
The exhaust was removed at Flange “F”, revealing the dislodged turbine exhaust cone deformed sheet metal as seen in Photo 75. This sheet metal is brazed onto the turbine exhaust cone but due to the PT blades release, the sheet metal had torn and dislodged from its original position.

Photo No. 75: PT exhaust cone deformation

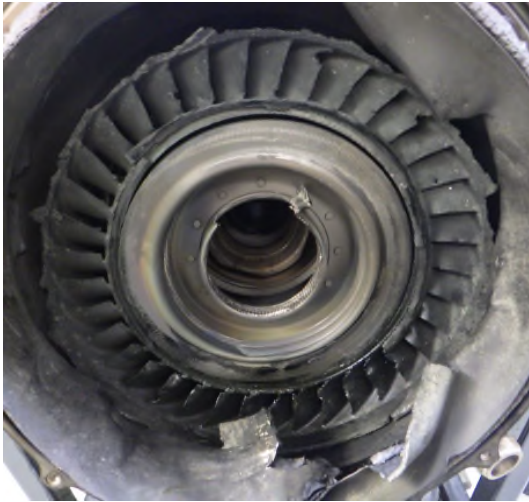
The power turbine stator outer mounting flange was fractured, dented and deformed (Photo No. 77). Consequently, this allowed the vane section to become loose and offset from the core, permitting it to move aft into the PT blade/disk assembly and platforms. After the PT blade fracture, the PT blades contacted and machined a groove into the inner third span of approximately half of the trailing edge of the vane (Photo No. 76). The deepest groove was approximately  $\frac{1}{4}$  inch. The No. 4 bearing front seal was grooved and fractured due to the PT disc assembly unbalance (Photo No. 78).

Photo No. 77: PT stator trailing edges

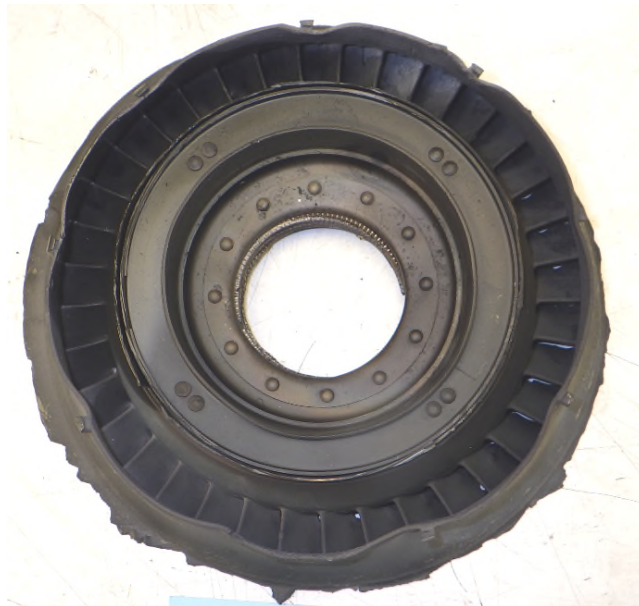
The leading edges of the PT stator vanes were all intact and undamaged (Photo No. 79).

Photo No. 79: PT stator leading edges

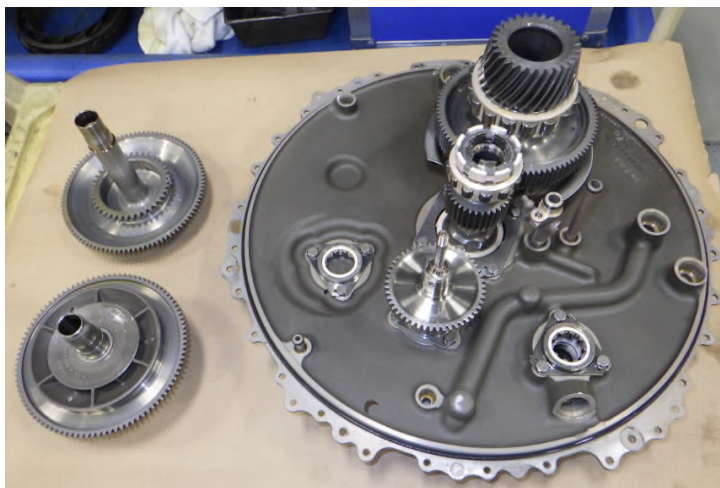
All of the shafts in the RGB were free to rotate, confirming the internal integrity of the RGB. The RGB was split at Flange “A”, showing that all internal components were oil wetted (Photo’s No. 90 and 91). The No. 1 and No. 2 bearings were intact and undamaged, as was the input shaft, 1<sup>st</sup> stage reduction gear, 2<sup>nd</sup> stage reduction gear, accessory gears, and output shaft. Based on this the gearbox was not disassembled further.

Photo No. 90: RGB diaphragm and gears

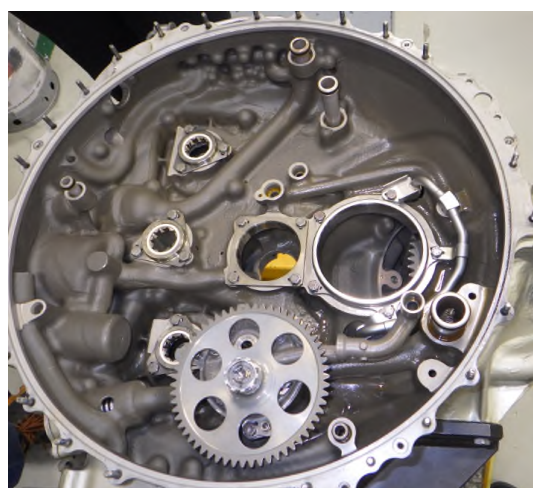
Photo No. 91: RGB housing

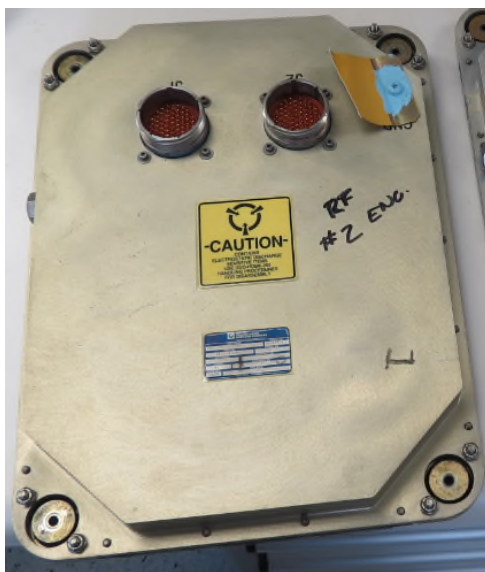
Photo No. 93: EEC

The EEC (Photo No. 93) had previously been shipped back to P&WC for a download and analysis. What was found to be related to this event was a fault on two separate sensors which both showed that the NPT signal had exceeded its max range of 127%.

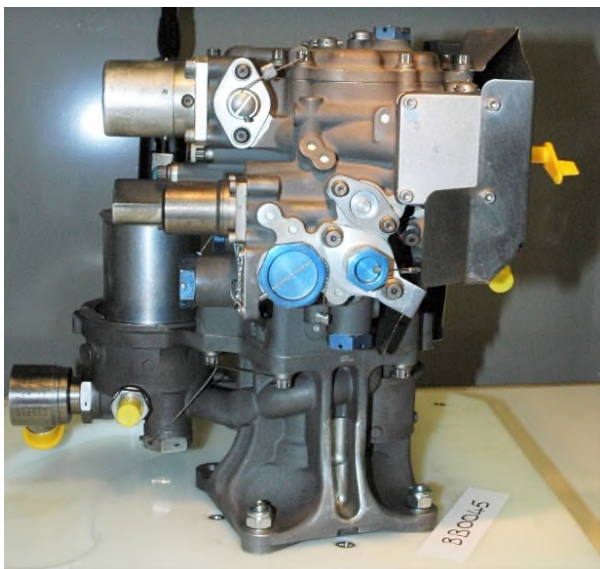
Photo No. 94: FMM

When the unit S/N 11522498 (SB016), as seen in Photo No. 94, was removed from the engine fuel was present and exited the ports. The exterior of this unit was slightly soiled, however all lockwire was present. The power lever moved freely over its full range and the alignment with the rig-pin location was obtained at the detent. The driveshaft could not be turned by hand, which is normal. The FMM was tested in accordance with the Woodward CMM 73-20-14 Rev 5 and there were minor deviations noted, however nothing that would have effected normal operation. The FMM was able to transition between auto and manual mode without problem.

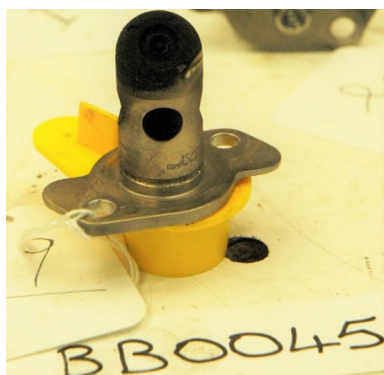
Photo No. 96: Nozzle 9

The 12 fuel nozzles were removed from the gas generator case and found undamaged but with heavy sooting/carbon. It was decided not to test the nozzles due to the carbon present on the nozzles, which may have affected the flow test results. Three nozzles are shown in Photo's No. 95 through 97.
