**Accident / Incident Report**

**Pratt & Whitney Canada**

**Report No.:18SIE00239**

**Pentastar Aviation Charter Inc (Owner: Bennett Aviation LLC)**  
**EC135P1 & Registration # N312SA**  
**Chicago, Illinois**  
**July7, 2018**  
**PW206B**  
**S/N BB0049 and BB0045**

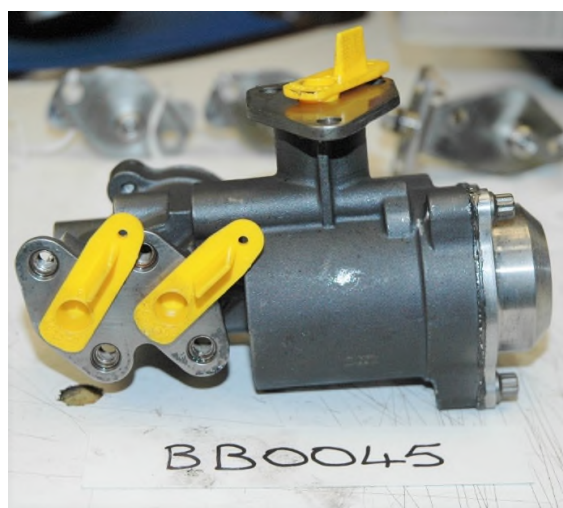
Photo No. 98: Flow divider valve

The exterior was inspected (Photo No. 98) and the unit was generally clean and had the sealing compound present at the end-caps. Based on the visual results and condition of the engine, the investigation team agreed not to carry out further testing on this unit.

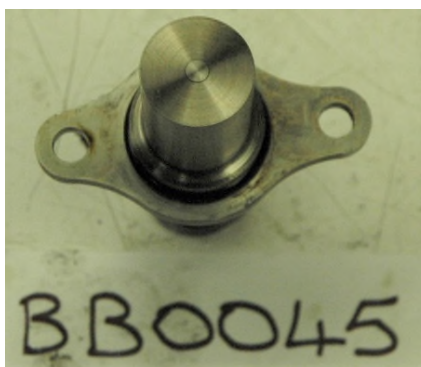
Photo No. 99: Q sensor

Torque sensor: The torque sensor (Photo No. 99) was visually inspected and was found to be in an acceptable condition for further testing. The connector had fluid present inside it, as well as black deposits on the contacts. The sensor was tested, including temperature cycling and dynamic functions and results satisfactory, with only minor deviations that would not have affect the sensor functionality during operation.

Note: It is possible that the fluid found on the connectors of multiple sensors may have been a result of extinguishing the reported fire on this engine, and this may have also influenced the test results.

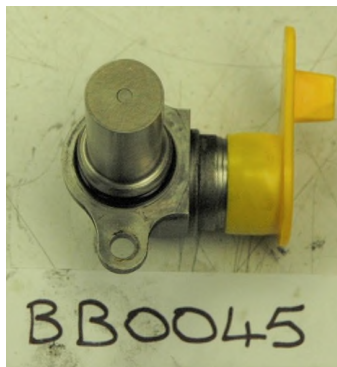
Photo No. 100: Ng sensor

Ng Speed Sensor: The Ng sensor (Photo No. 100) was visually inspected and found to be in acceptable condition for further testing. The inside of the connector was undamaged and clean but had a few black deposits and the magnet was very slightly recessed into the sensor body. The sensor was tested and the results were satisfactory, thus confirming the recessing of the magnet had no operational effect.

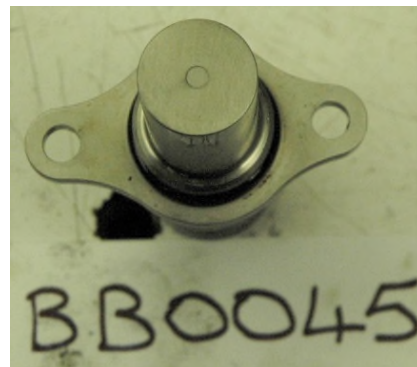
Photo No. 101: NPT sensor

NPT Speed Sensor: The exterior of the NPT sensor (Photo No. 101) was generally clean and the magnet was not protruding from the sensor body. The electrical connector shell was undamaged, however, it was slightly stained with some fluid inside. The gold plating was slightly worn at the base of contact F. The sensor was tested and the results satisfactory.

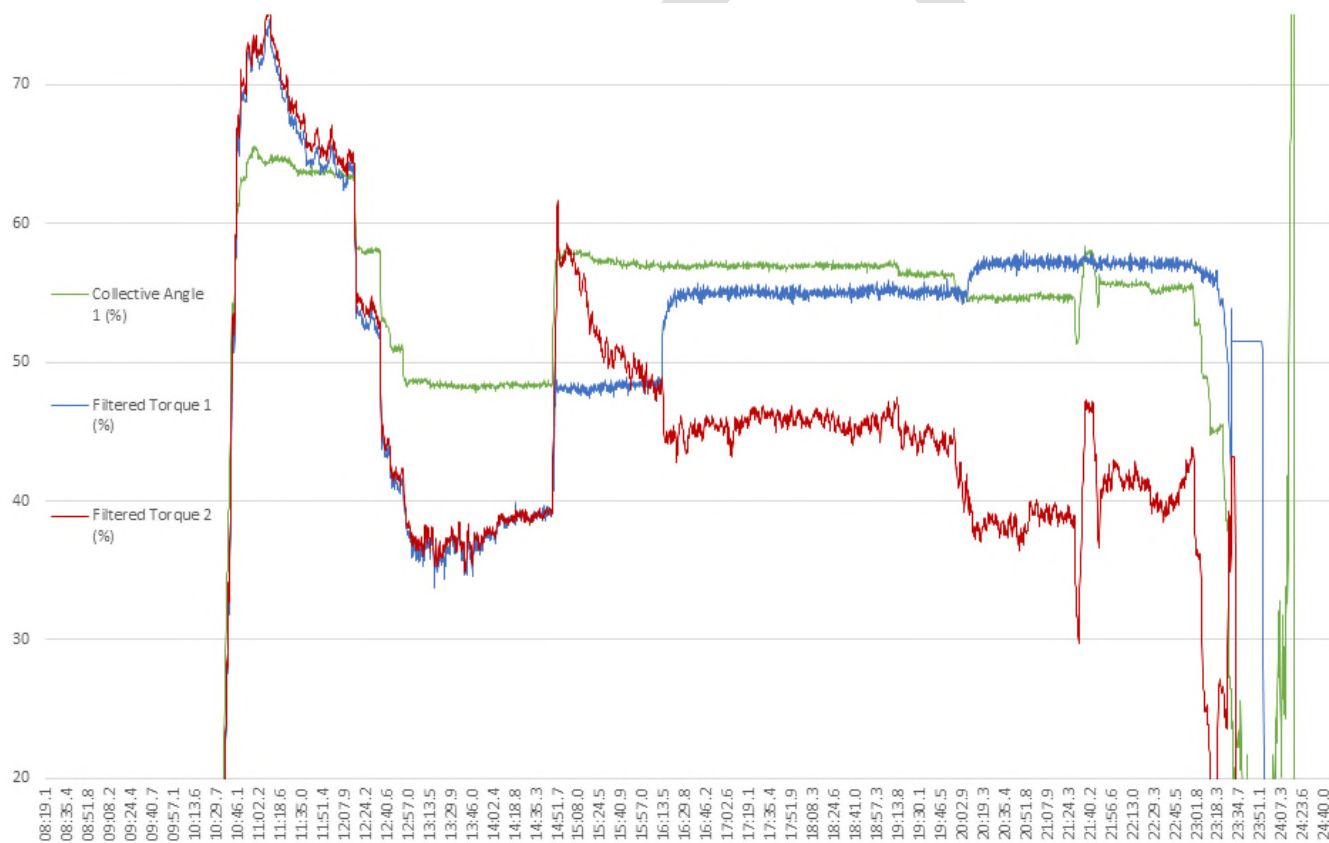
**PLOT 3**

In order to more clearly understand the governing of the two engines, and their reactions to the collective movement the two filtered torques and the CLP have been re-plotted with a range of 20% to 75%, on plot 3. The engine 2 torque (shown in red) is reacting to the CLP inputs until the time 23:17.0. At time 14:29:5 the #1 engine (blue) is believed to have been switched into manual mode and from this point on reacts to twist grip inputs which explains why it is not following the CLP inputs.

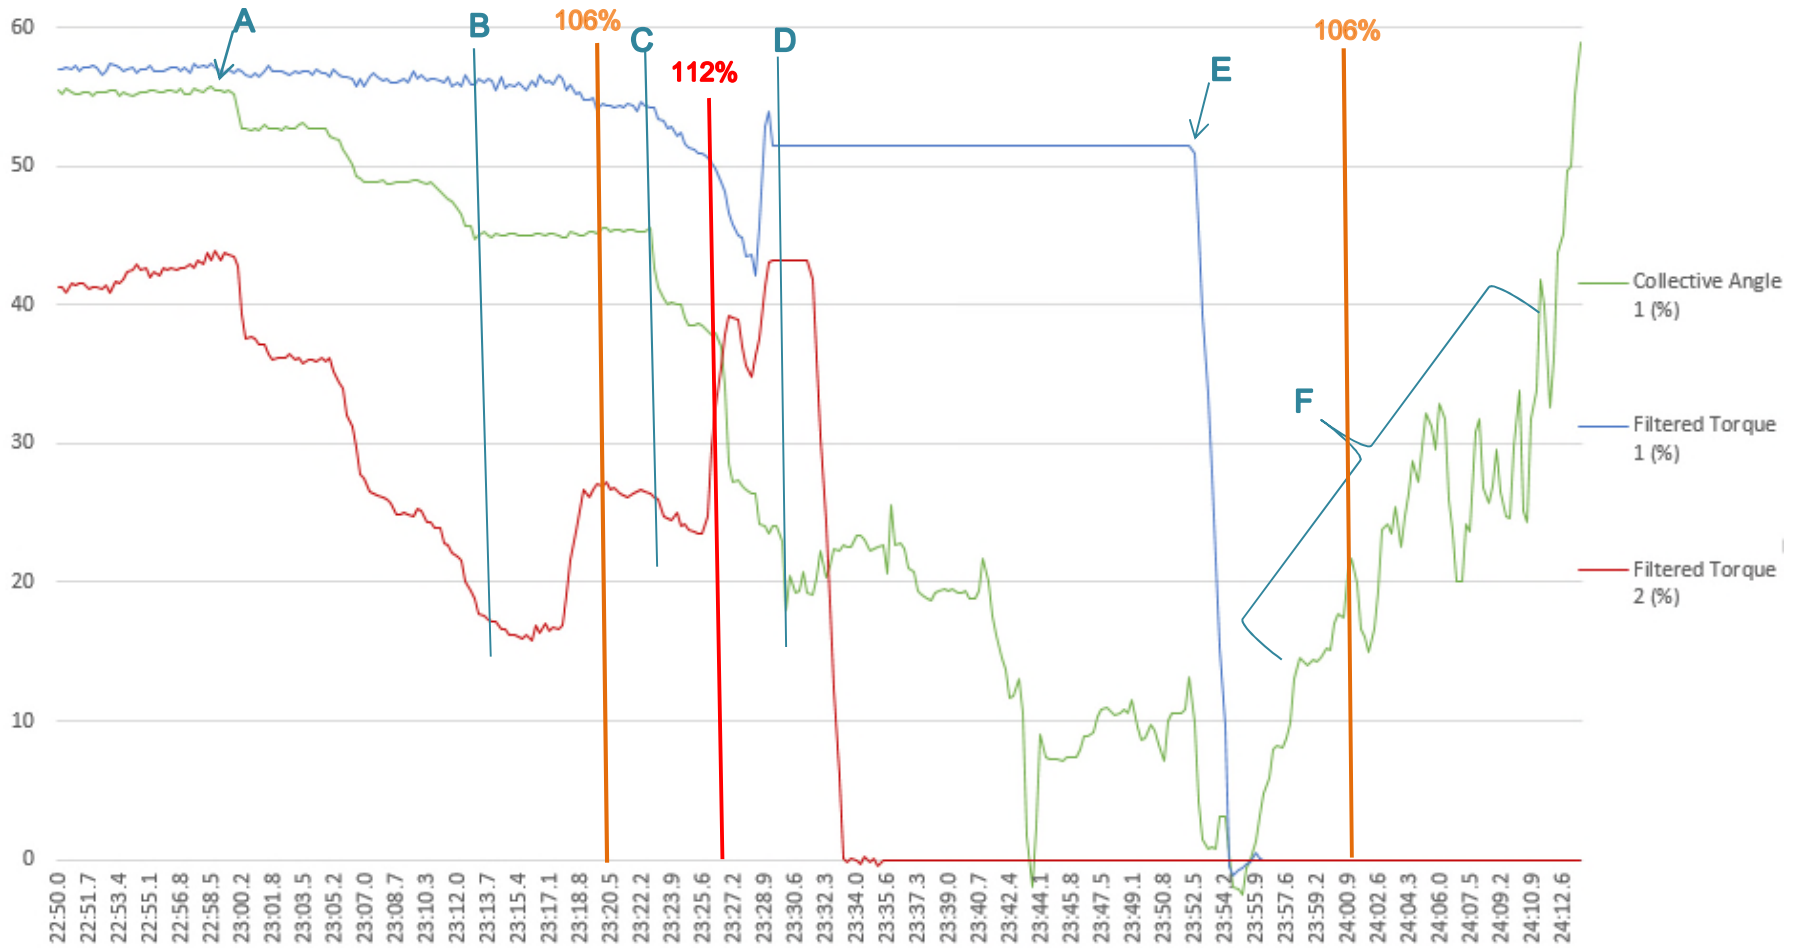
## PLOT 5

A – Up to this point the CLP has very little movement and the torques of both engines are constant.

C to D – Between lines C and D the CLP is reduced by 25%, so it would be expected that the torques of both engines should also drop if they were in auto mode, however this did not occur – the torque of the number 1 engine is initially decreasing somewhat but this can be explained by an increase in NR speed caused by the reduction of CLP. The increase in torque from engine number 2 when CLP is concurrently being reduced can only be explained by an increase in twist grip position. Prior to line D both engine torques are increasing while CLP is decreasing. The engine reactions are examined further on plot 6.

D – Prior to line D there had been an increase in the torque on both engines, following which they were both held constant. It is deduced that the pilot used the twist grips to manually increase the power on both. With the collective around 20% and with the engine 1 and 2 torques at 51.5 and 43% respectively, this would cause the rotor and NPT speeds to increase (with a collective position around 20% in automatic governing mode the torques of the engines should have been at very low torque value, moving towards 0%). Based on the high torque values and low CLP, the conclusion is that both engines were in manual mode.

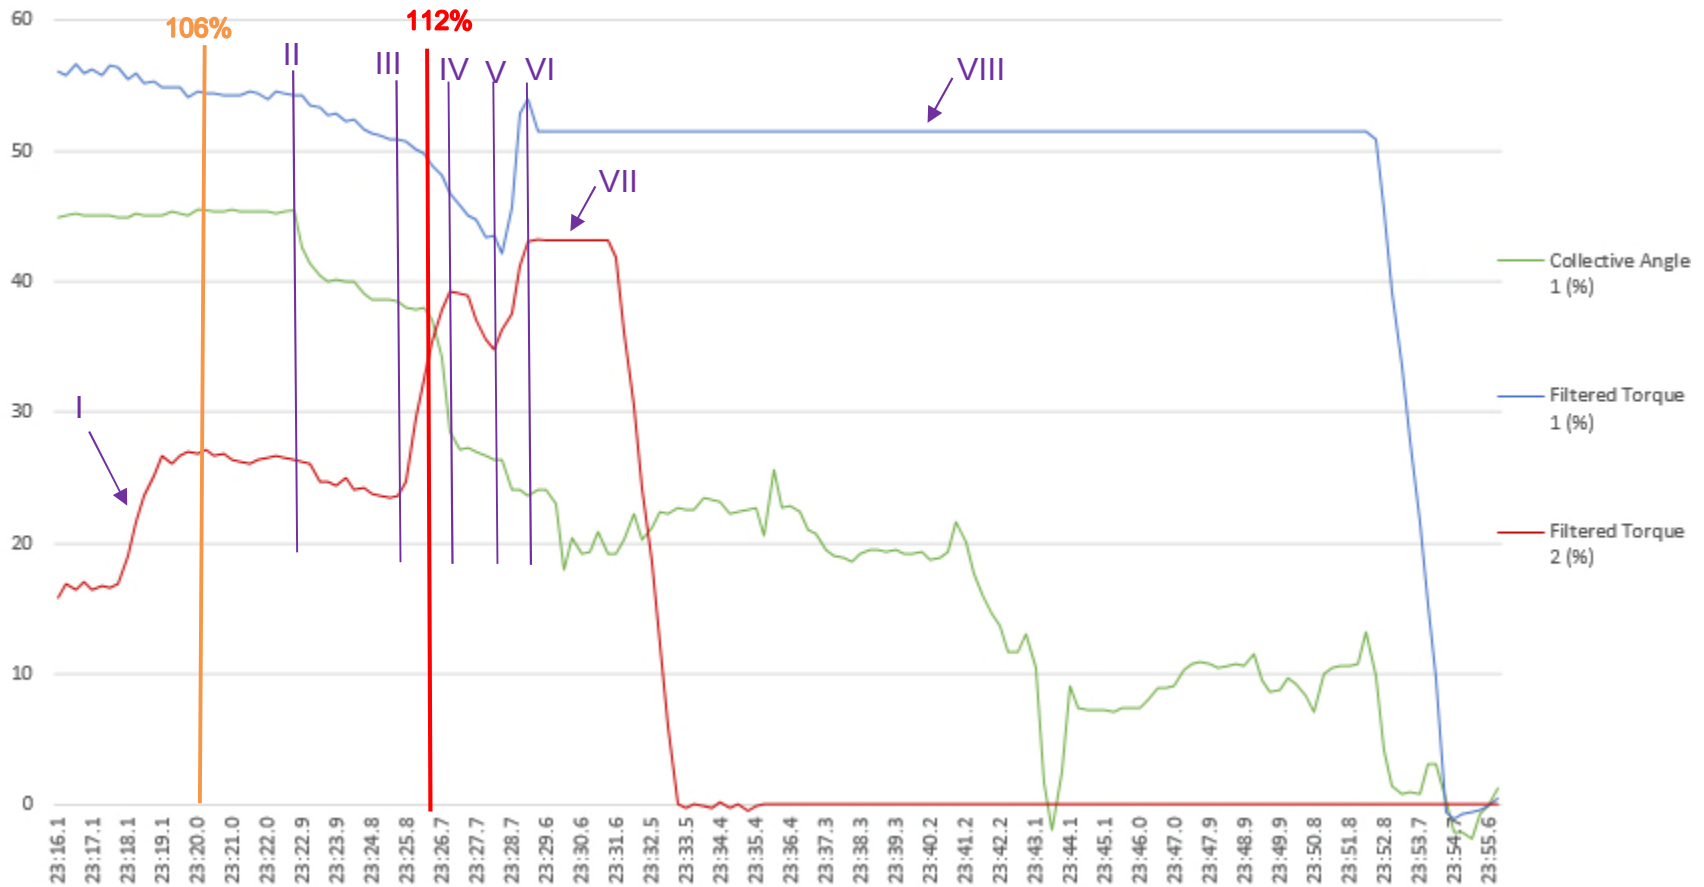
## PLOT 6

I – The filtered torque on the number 2 engine was increased, which is suspected be a result of the engine twist grip because there was no apparent CLP input at that time. It is thus possible that from this point forwards the pilot had both engines in manual mode.

III – IV – During this period the CLP continues to decrease (down to 27%), as does the torque of the number 1 engine which could be caused from a main rotor speed increase. The torque of the number 2 engine increases quickly by over 10% which we conclude to be due to the pilot manipulating the twist grip of this engine to get more power (with a CLP decreasing the only way to get a torque increase is with an increase fuel flow using the twist grip). As the CLP is decreasing towards 20% the torques should be dropping towards 0% while at point IV engine 1 had a torque of approximately 46% while engine 2 had a torque of approximately 39%. With the torques at these values and the CLP dropping both engines would still be clutched and the power turbines and main rotor would be increasing in speed, likely in an overspeed condition.

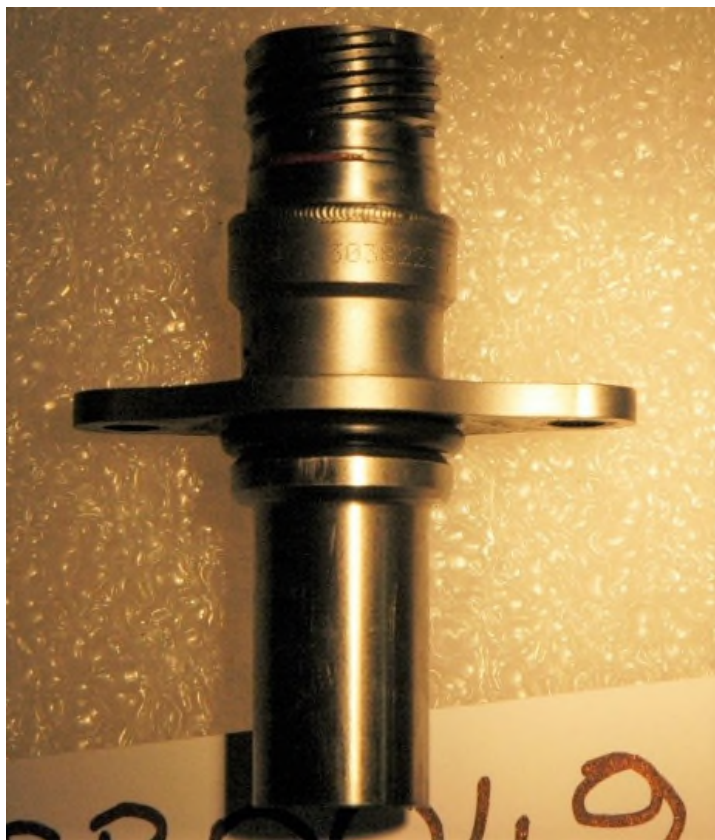
The exterior of the torque sensor was generally clean. The end of the magnet was not protruding from the sensor body. There was a darkened ring around the tip of the magnet. The inside of the electrical connector was clean. Gold plating was peeling and black deposits were present on some of the contacts.

The torque sensor was tested in accordance with P&WC ACMM 3045330 Rev. 05. The tests, including temperature cycling and dynamic functions was satisfactory.

Figure 1  
No. 1 engine torque sensor as received

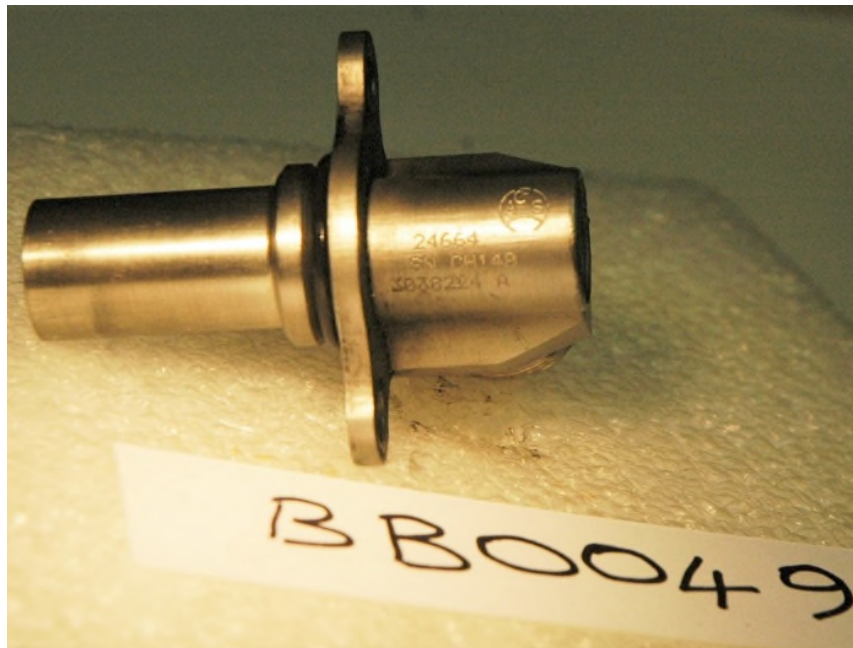
The exterior of the compressor turbine speed sensor was generally clean. The end of the magnet was not protruding from the sensor body. There was burnishing at the tip of the sensor. The inside of the electrical connector was clean. Black deposits were observed on some of the contacts.

The compressor speed sensor was tested in accordance with P&WC ACMM 3043640 Rev. 04. The test was satisfactory.

Figure 2  
No. 1 engine compressor turbine speed sensor as received

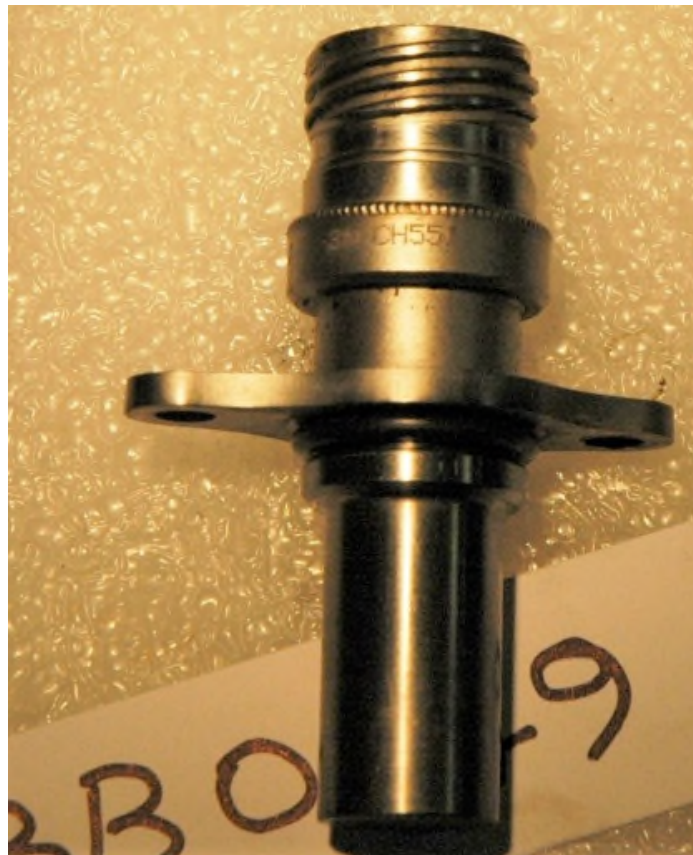
The exterior of the power turbine speed sensor was generally clean. The end of the magnet was not protruding from the sensor body. The inside of the electrical connector shell was stained. Gold plating was missing and black deposits were present on some of the contacts.

The power turbine speed sensor was tested in accordance with P&WC ACMM 3043640 Rev. 04. The test was satisfactory.

Figure 3  
No. 1 engine power turbine speed sensor as received

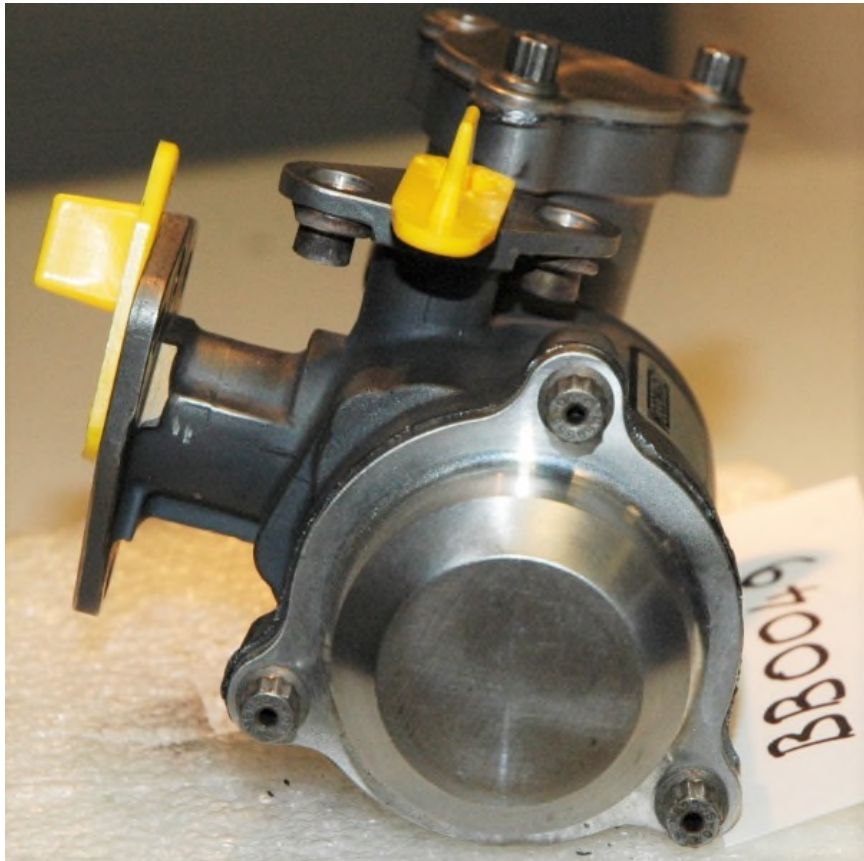
Test step C Reset flow and accuracy: the primary fuel flow was below the test point minimum limit. However this was a consequence of the test set-up and not an indication of the performance of the FDV. All other test recordings were satisfactory.

Figure 4  
No. 1 engine flow divider valve as received

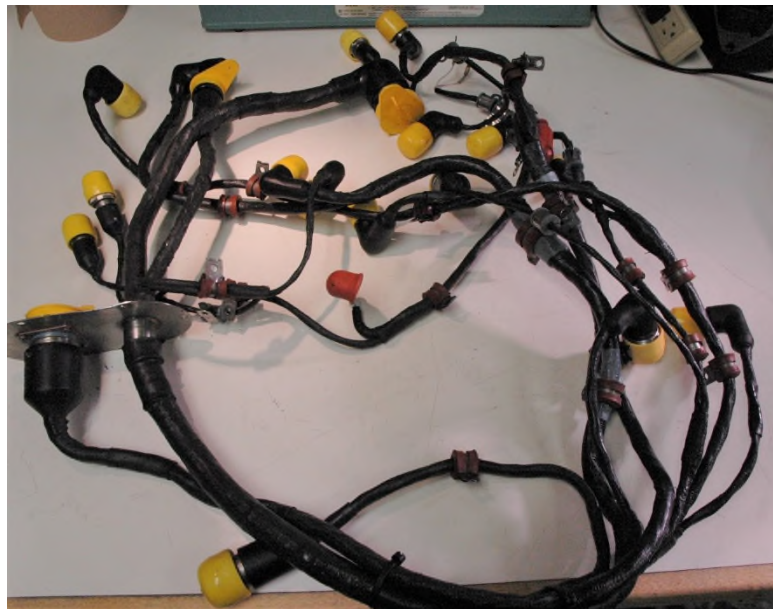
The resistance between connector J14 shield to P21 socket ZZ (main oil pressure sensor) was open.  
The resistance between connector J14 pin 54 to P21 socket ZZ (main oil pressure sensor) was above the test point maximum limit.

The isolation resistance between connector J14 pin 55 and 23 was below the test point limit.

Figure 6  
No 1 engine wiring harnesses as received

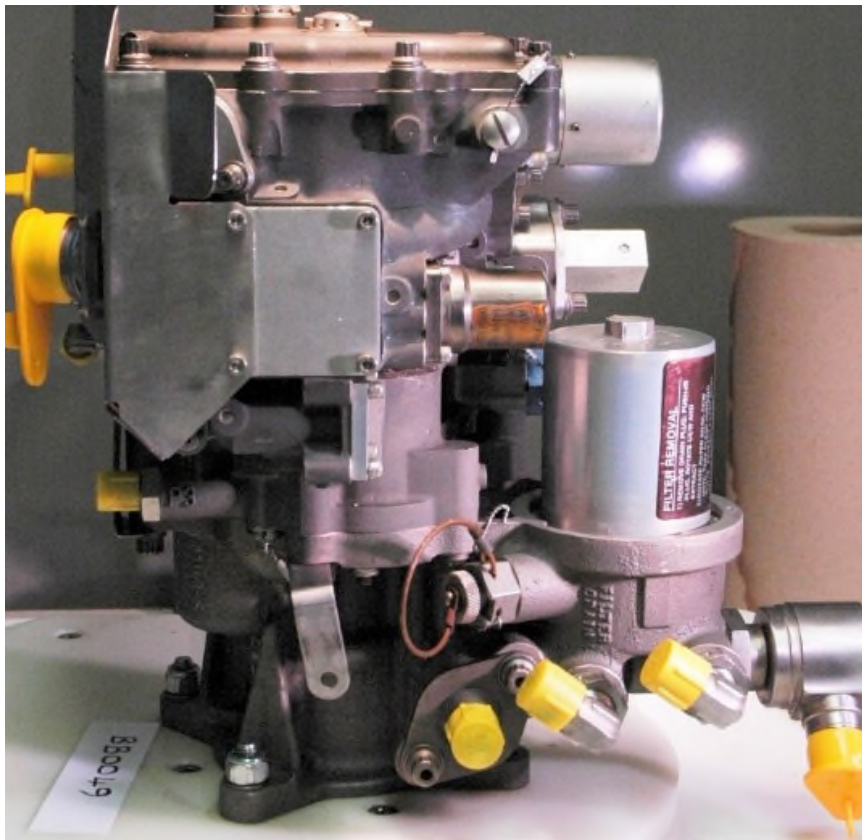
Test point AU high speed governor gain check: the fuel outlet flow was 8 and 13pph below the test point minimum limits.

Test point AW neutral switch check: the power lever angle was 1 degree and 0.2 degrees above the test point maximum limits.

Figure 7  
No. 1 engine fuel management module as received

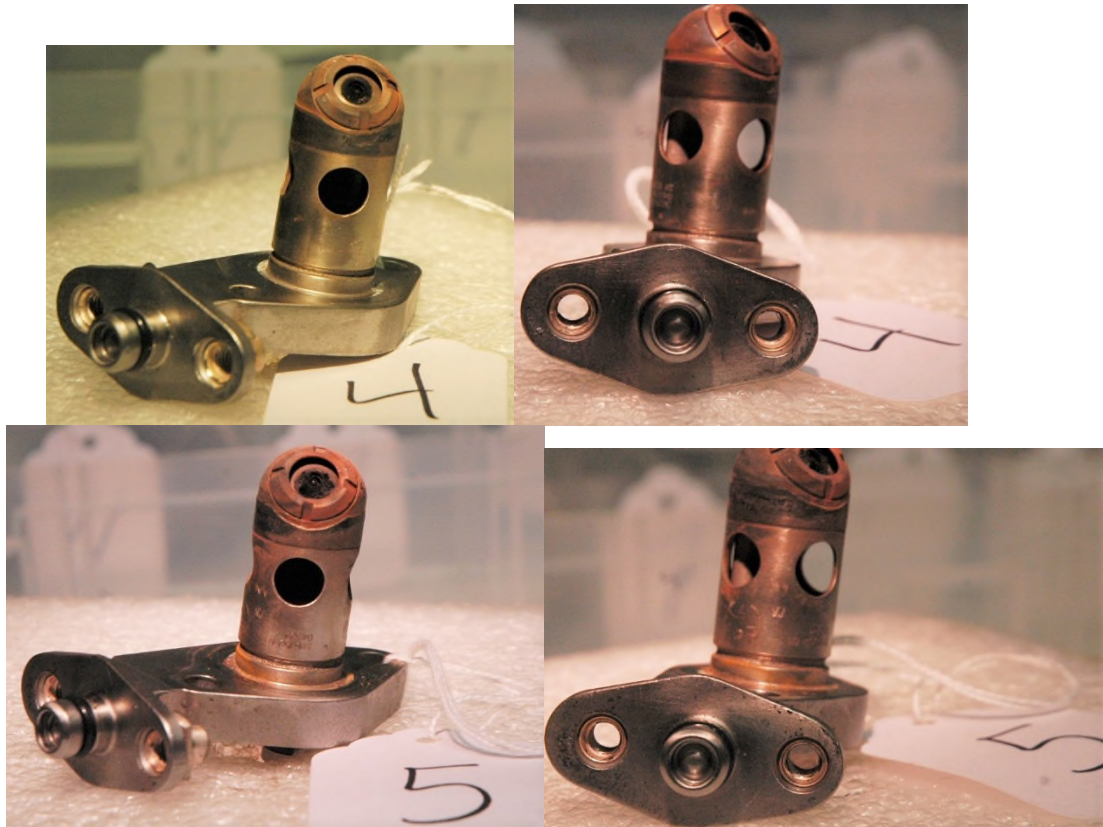
| Nozzle position | Observation |
|---|---|
| 4 | The secondary spray pattern was not optimal. Streaks and voids were present in the primary flow. |
| 5 | The secondary spray pattern was not optimal. The primary spray was uneven. |

Figure 8  
No. 1 engine No. 4 (top) and 5 (bottom) fuel nozzles as received

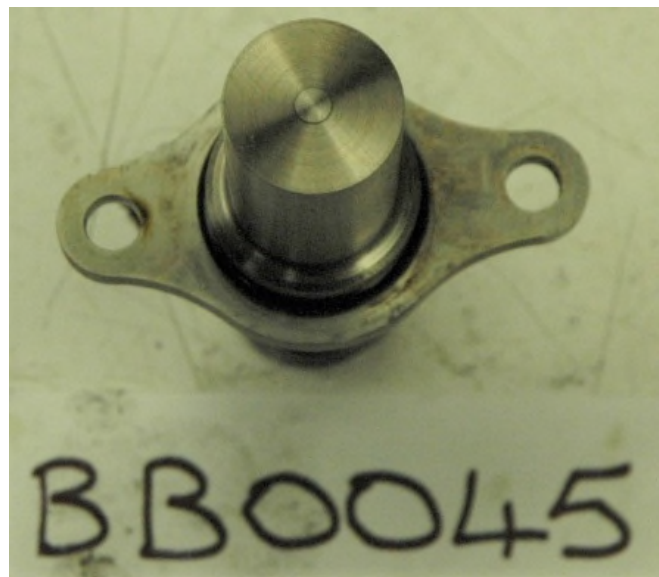
The exterior of the torque sensor was generally clean. The end of the magnet was protruding slightly from the sensor body. Fluid was present inside of the electrical connector. Black deposits were present on the contacts.

The torque sensor was tested in accordance with P&WC ACMM 3045330 Rev. 05. The static and temperature cycling tests were satisfactory. However the voltage recorded during the dynamic testing was 0.037volts below the minimum limit at 1200RPM and 0.648 volts below the minimum limit at 7200RPM.

Figure 9  
No. 2 engine torque sensor as received

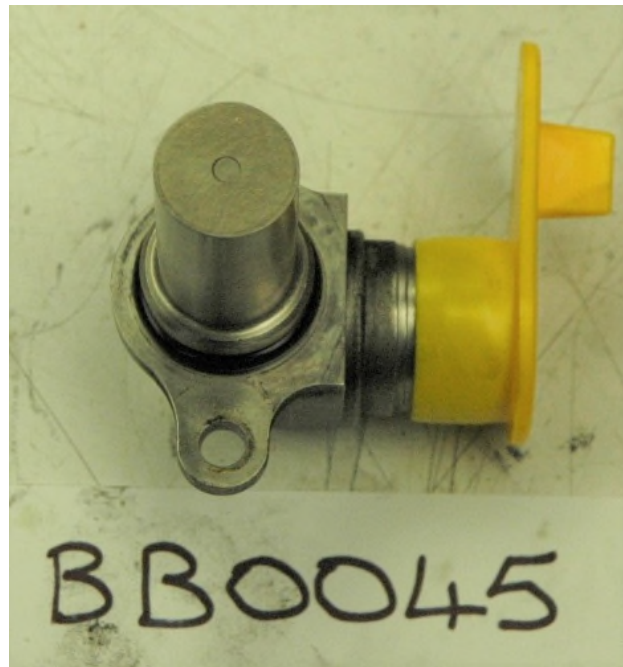
The exterior of the compressor turbine speed sensor was generally clean. The end of the magnet was recessed slightly into the sensor body. The inside of the electrical connector was clean. Black deposits were present on some of the contacts.

The compressor speed sensor was tested in accordance with P&WC ACMM 3043640 Rev. 04. The test was satisfactory.

Figure 10  
No. 2 engine compressor speed sensor as received

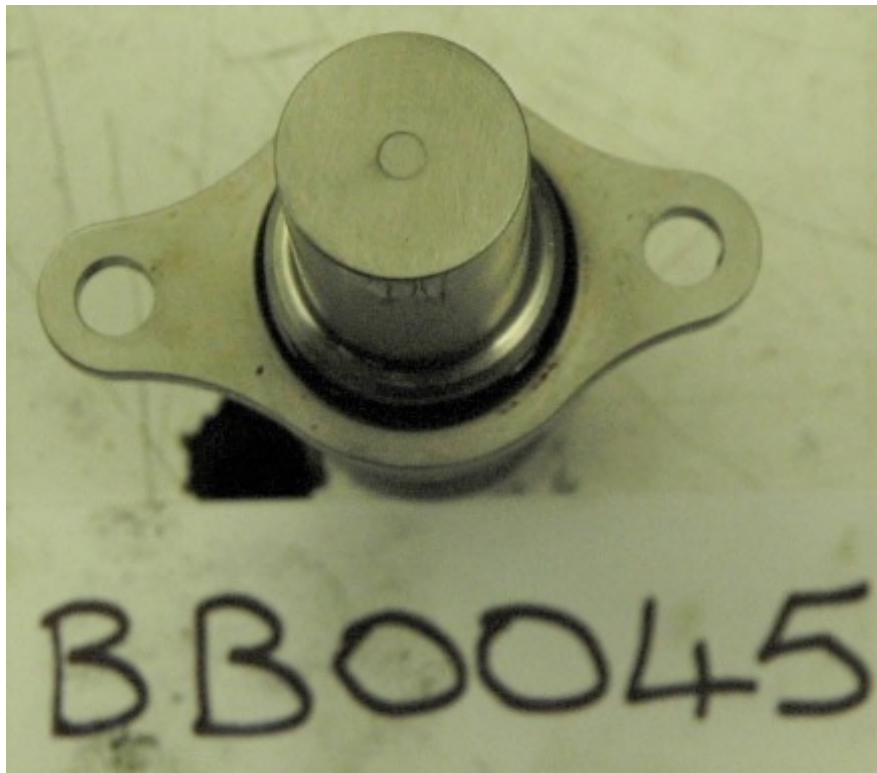
The exterior of the speed sensor was generally clean. The end of the magnet was not protruding from the sensor body. The inside of the electrical connector shell was stained and fluid was present inside the shell. Gold plating was worn at the base of contact F.

The power turbine speed sensor was tested in accordance with P&WC ACMM 3043640 Rev. 04. The test was satisfactory.

Figure 11  
No. 2 engine power turbine speed sensor as received

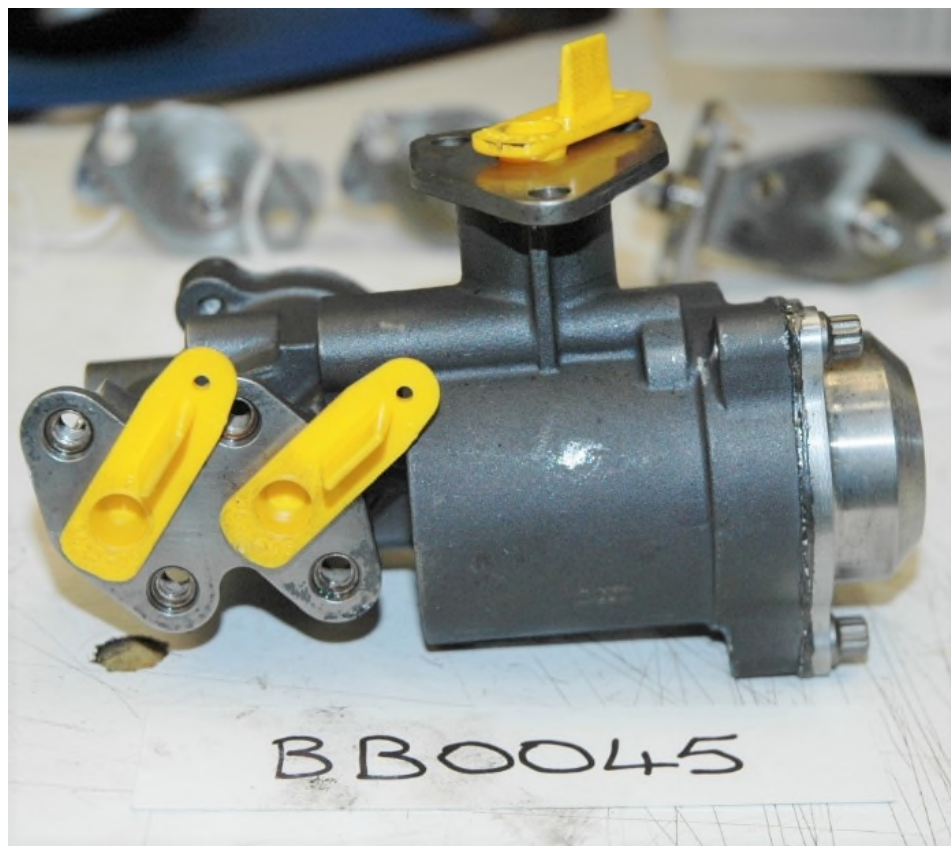
The exterior of the flow divider valve was generally clean. Sealing compound was present at the end-cap. It was agreed by the investigation team that testing of the No. 2 engine FDV was not required.

Figure 12  
No. 2 engine flow divider valve as received

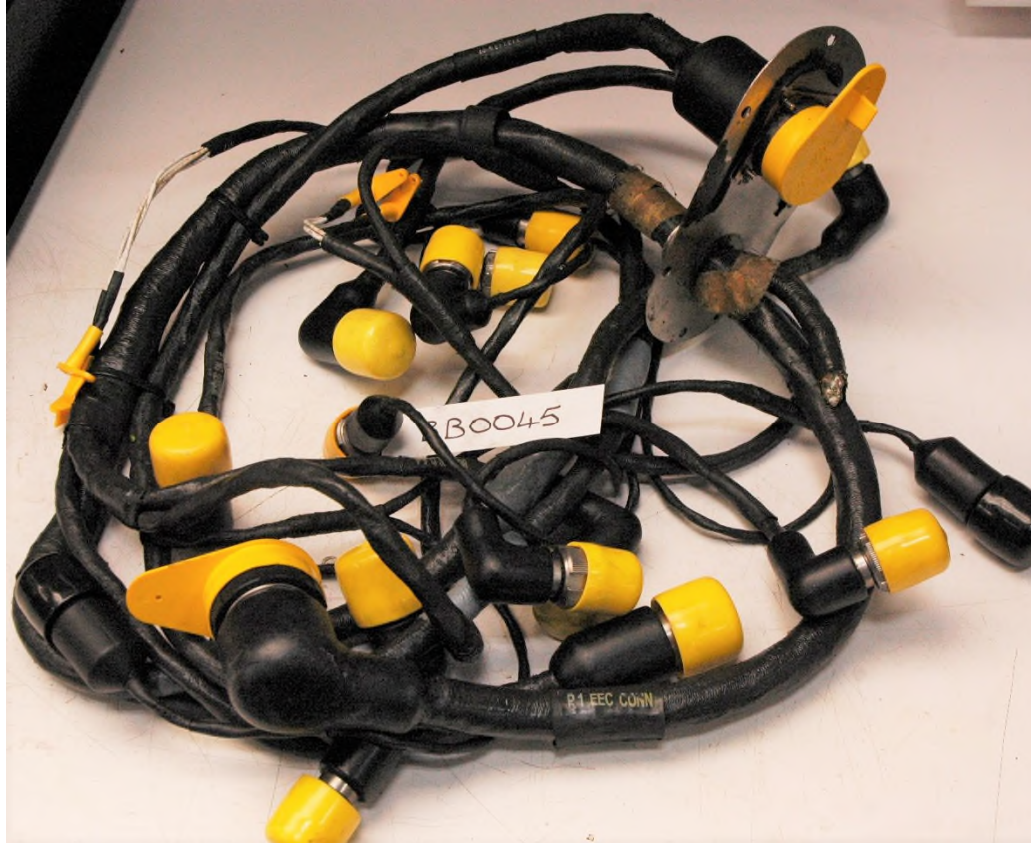
Figure 13  
No. 2 engine wiring harnesses as received

The exterior of the wiring harness was generally clean. Some of the identification sleeves had faded. The mount flange was present and securely attached. Connector P23 was not present (the harness had been cut to facilitate removal of the engine from the airframe). Fluid residue was present inside of connector P10 and P11. A piece of a packing was present inside connector P11. It was not possible to test this harness because connector P23 was missing.

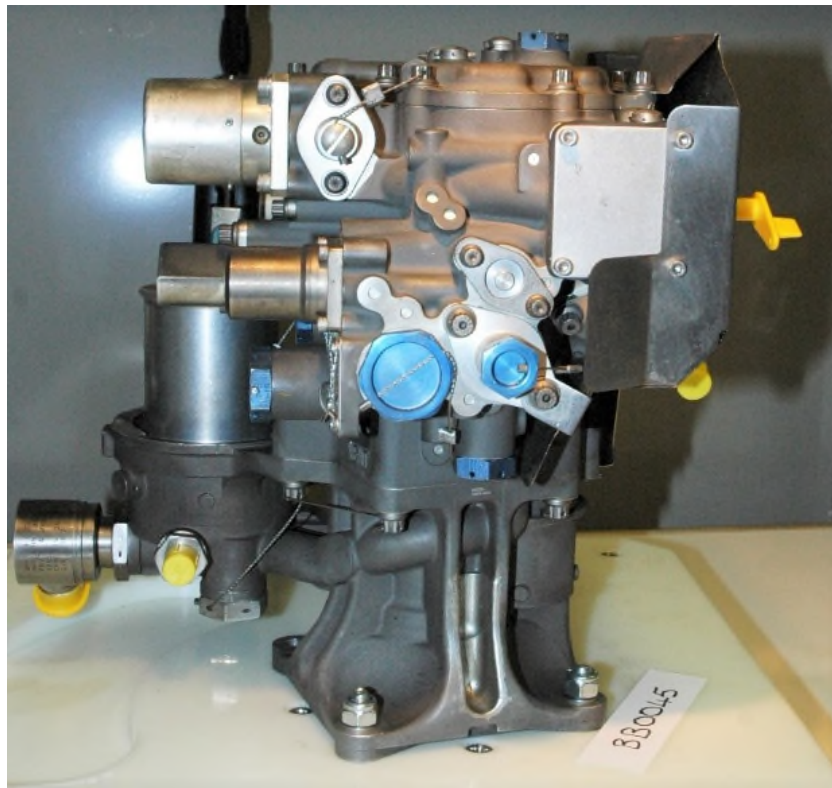
Figure 14  
No. 2 engine fuel management module as received

Test point AU2 high speed governor gain: the fuel outlet flow was 5pph above the test point maximum limit.

Test point AU4 high speed governor gain: the fuel outlet flow was 8pph and 9pph below the test point minimum limit.

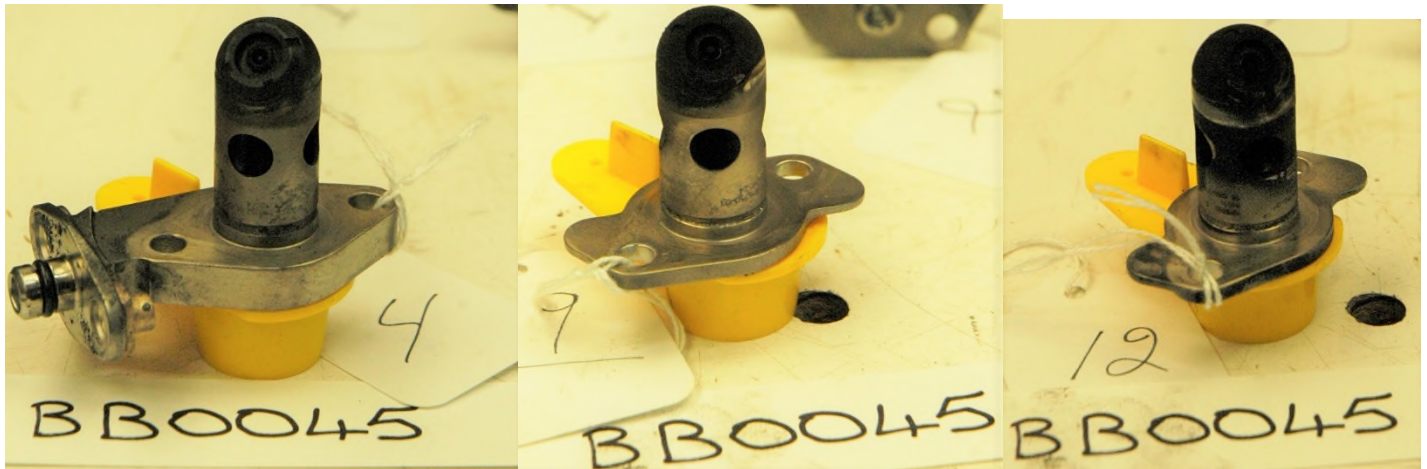
Figure 15  
No. 2 engine fuel nozzle examples as received

Carbon deposits were present at each nozzle tip. It was agreed by the investigation team that testing of the fuel nozzles was not required.
