# NATIONAL TRANSPORTATION SAFETY BOARD

## Global Positioning System Device

### Specialist's Factual Report

Location: Bronson, Michigan  
Date: August 18, 2018  
Aircraft: Air Tractor 502B  
Registration: N502RL  
Operator: Lutes Flying Service  
NTSB Number: CEN18FA339

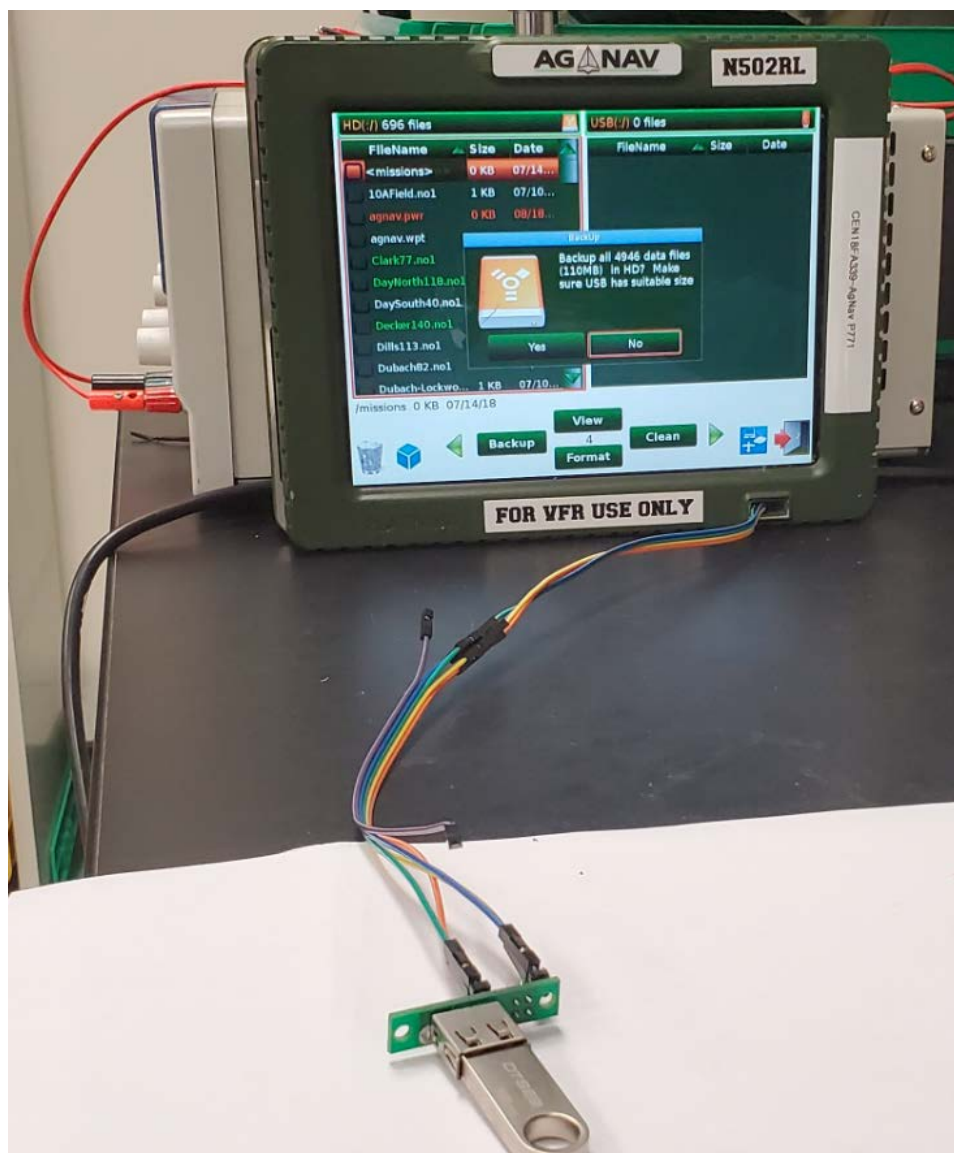
Figure 2: Transfer of Stored Data.

After further examination, several internal wire connections were found disconnected, and the USB port was broken internally as well. After repairing the damaged parts, the device powered on normally and data was downloaded via USB, as shown in Figure 2.
