# Continental Motors

## ENGINE EXAMINATION REPORT

| ENGINE MODEL | IO-550-P (converted to turbo-normalized by Vitatoe) |
| FILE NUMBER | 17-294 |

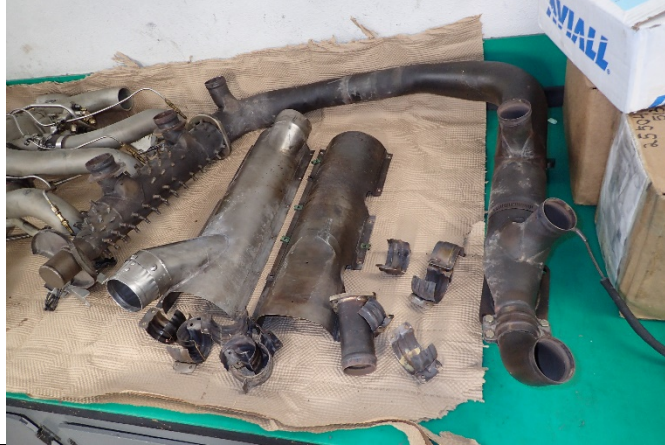
The exhaust system remained intact. There were no signs of exhaust leaks or other anomalies noted with the exhaust system.

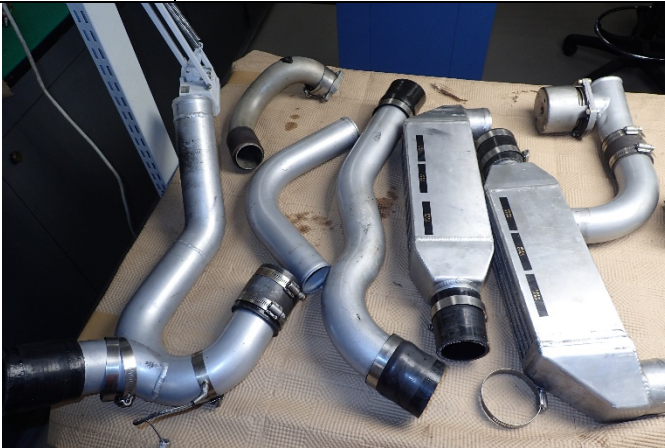
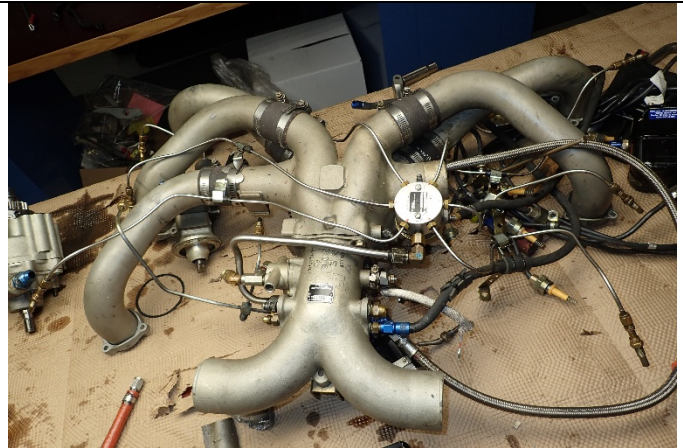
#### INDUCTION SYSTEM

The induction system remained intact and was undamaged. There were no signs of induction leaks or any other anomalies noted.

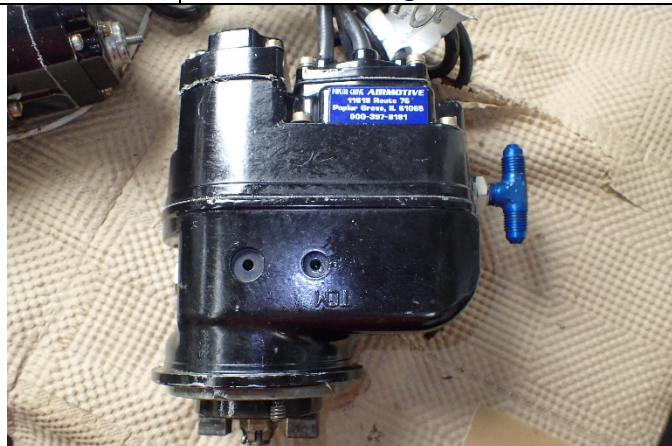
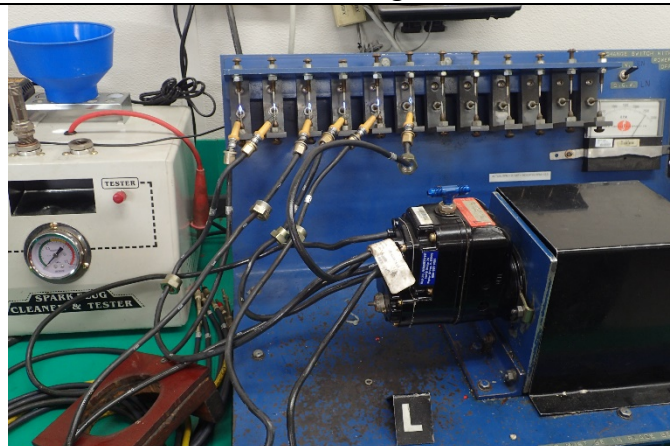
The magneto remained attached to its installation point and was undamaged. The magneto was removed and placed on a test bench. The magneto operated normally and was capable of producing a spark across an approximate 7mm gap on all six posts and in the correct firing order. There were no anomalies noted with the magneto.

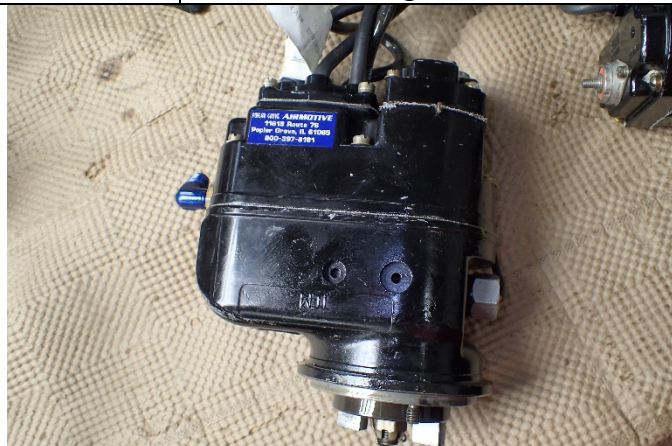
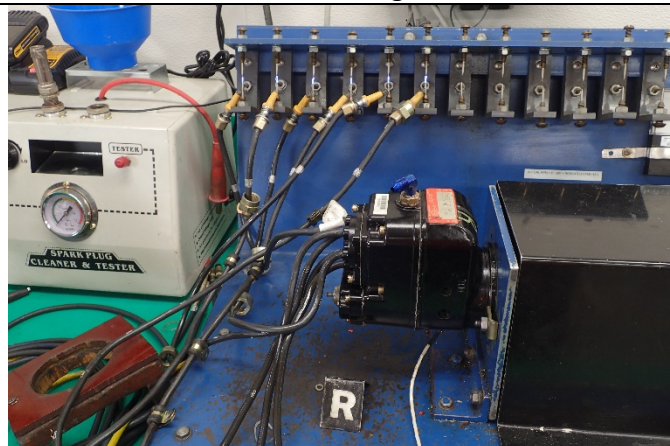
### RIGHT MAGNETO

The magneto remained attached to its installation point and was undamaged. The magneto was removed and placed on a test bench. The magneto operated normally and was capable of producing a spark across an approximate 7mm gap on all six posts and in the correct firing order. There were no anomalies noted with the magneto.

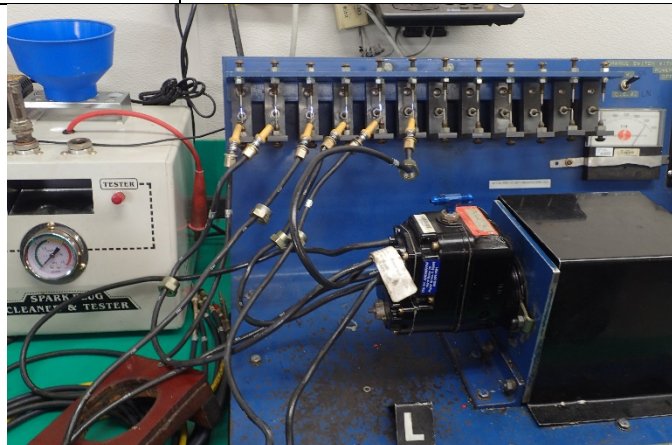
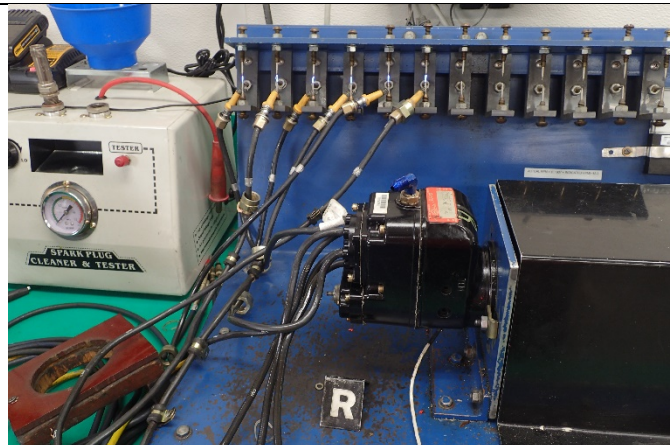
The ignition harness remained intact and was secured to both magnetos as well as each spark plug. The ignition harness was tested during the magneto bench tests; the ignition harness was capable of conducting a spark from the magneto post to each ignition lead end. There were no anomalies noted with the ignition harness.

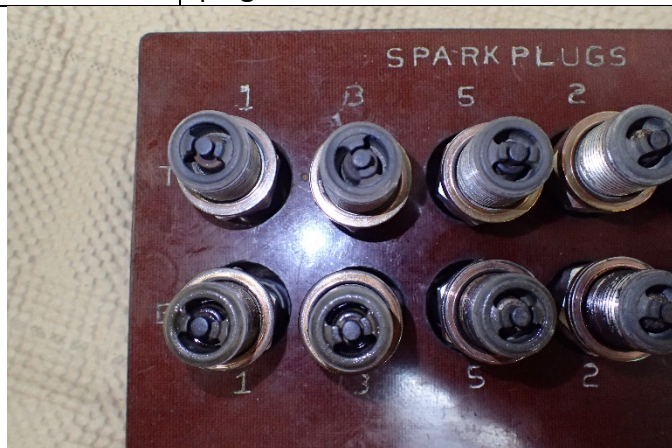
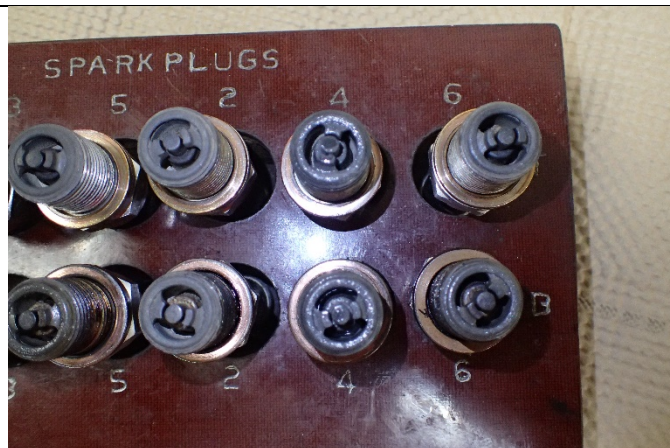
## SPARK PLUGS

All of the spark plugs remained installed in their cylinders and were undamaged. The spark plugs were removed and visually inspected. The spark plugs displayed normal operating and combustion signatures. There were no anomalies noted with the spark plugs.

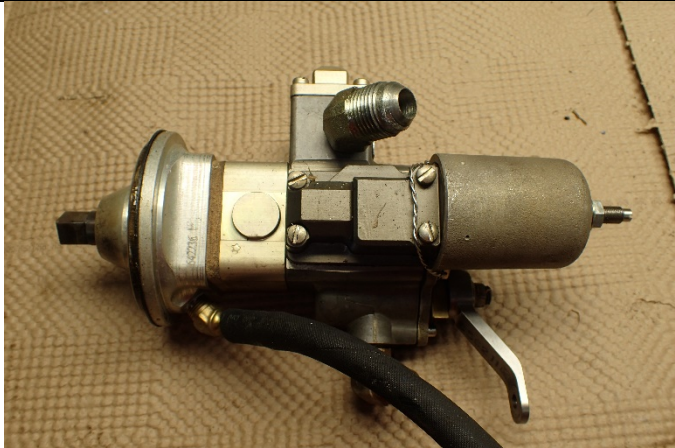
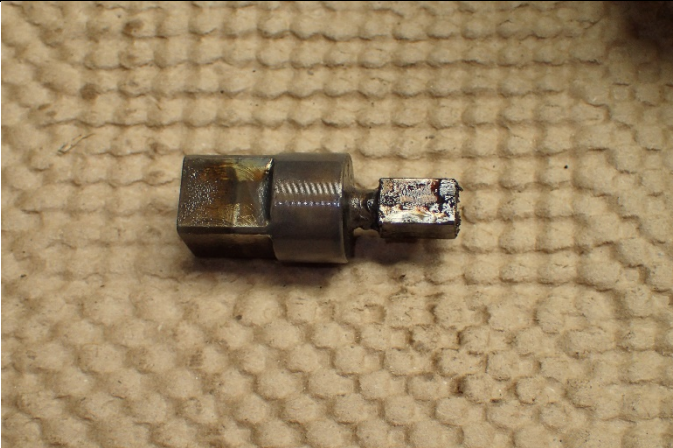
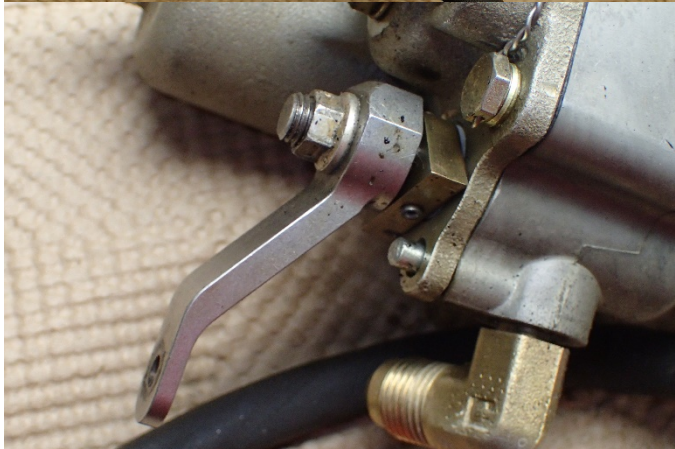
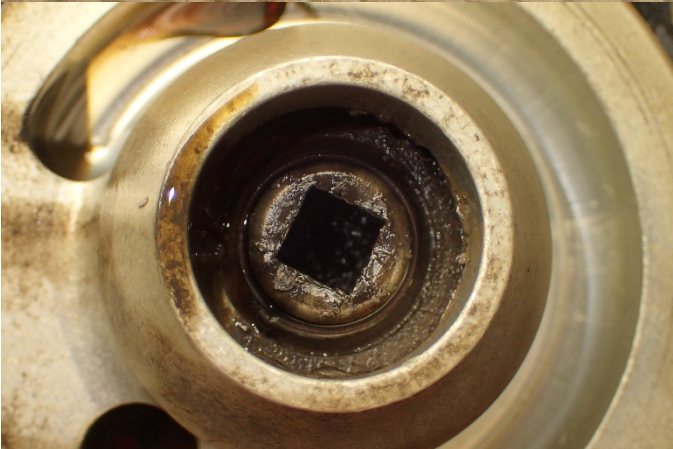
| Condition: | The fuel pump remained attached to its installation point and was undamaged. The fuel pump was removed and it was noted that the fuel pump drive coupling remained intact and the fuel pump drive was capable of normal rotation. The mixture control arm remained secured to the mixture control shaft and was capable of normal movement. There were no anomalies noted with the fuel pump. | | |

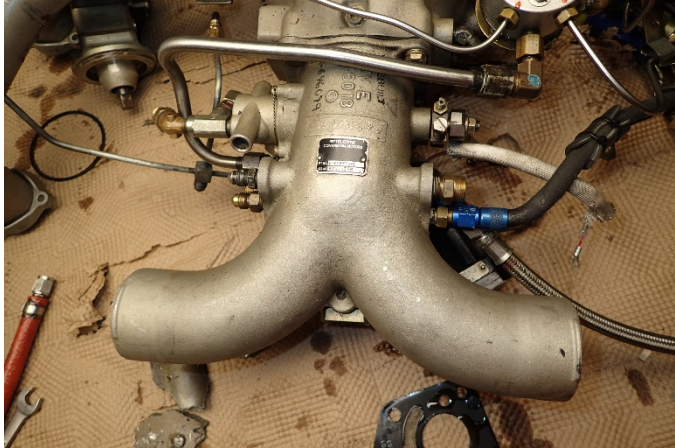
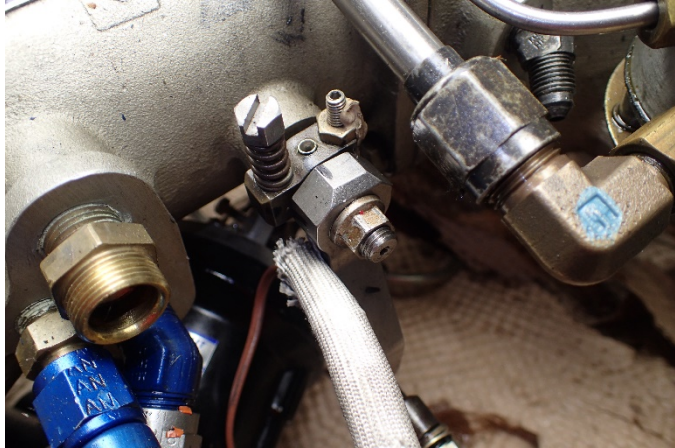
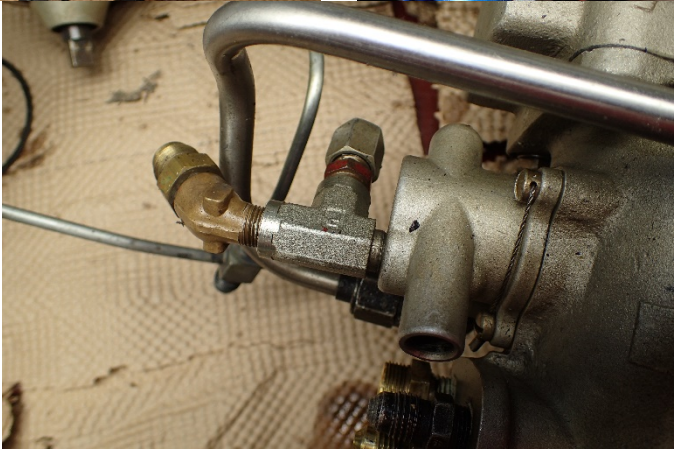
| THROTTLE BODY<br>METERING UNIT | Manufacturer: CMI | P/N: R-656785-1 | S/N: A111A139R |
|---|---|---|---|
| Condition: | The throttle and metering assembly remained intact and was undamaged. The throttle control arm remained secured to the throttle valve shaft and was capable of normal movement. There were no anomalies noted with the throttle and fuel metering assembly. | | |

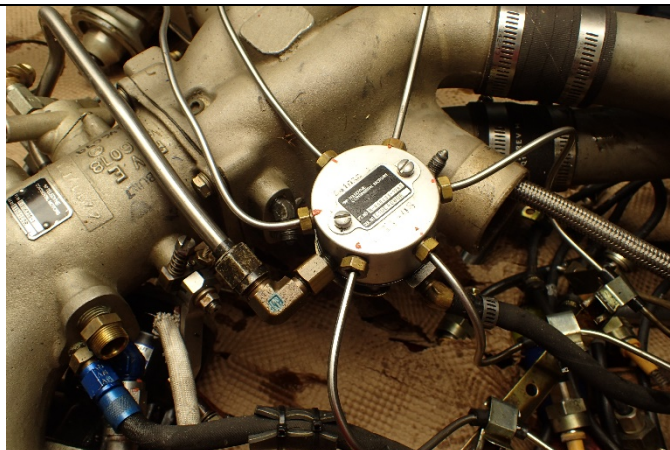
The manifold valve remained attached to its installation point and was undamaged. There were no signs of fuel leaks noted around the manifold valve. There were no anomalies noted.

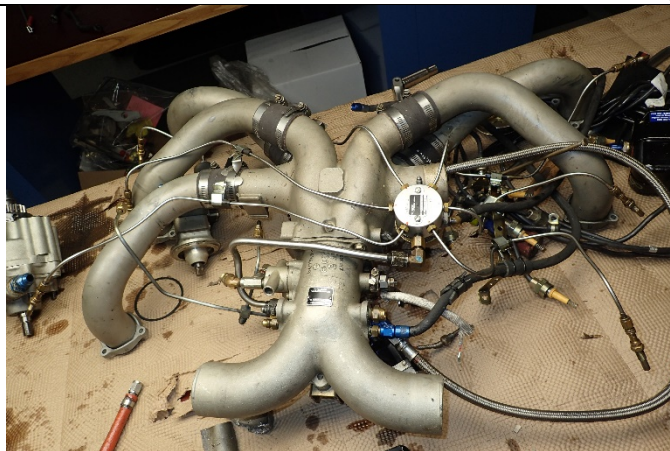
## FUEL NOZZLES AND LINES

All of the fuel nozzles remained installed in their cylinders and were undamaged. It was noted that some of the nozzles were installed in the incorrect cylinders.

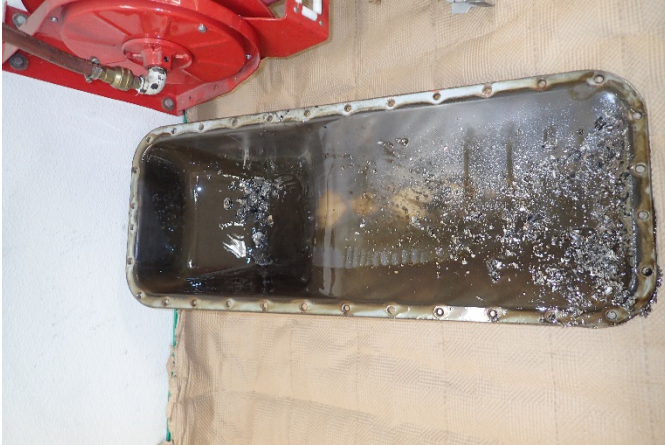
The oil sump remained intact and was undamaged. The oil sump was removed and it was noted that the oil sump contained a significant amount of metallic material within the oil sump.

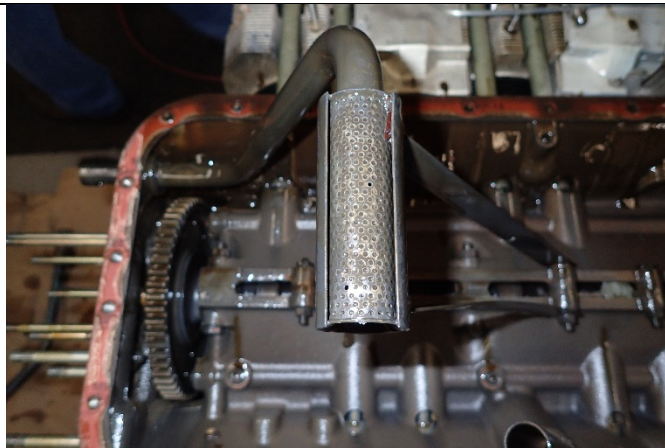
#### OIL PICK-UP TUBE & SCREEN

The oil pickup tube and screen remained intact and undamaged. The pick-up screen contained metallic material within the screen.

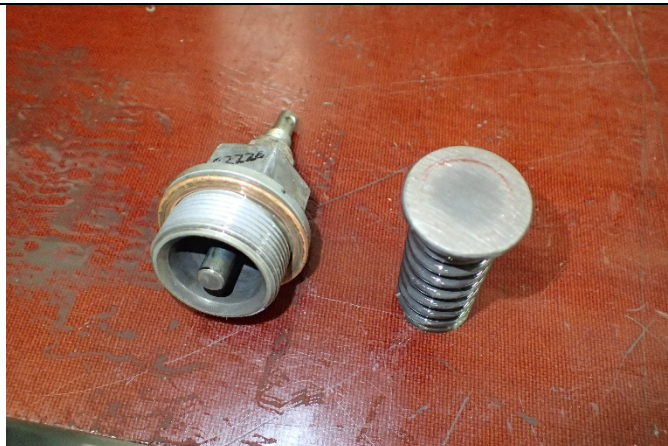
The oil pump remained intact and undamaged. The oil pump was disassembled and the internal components were visually inspected. There were a few flakes of metallic material within the oil pump and a small amount of gouging along the oil pump housing consistent with hard particle passage.

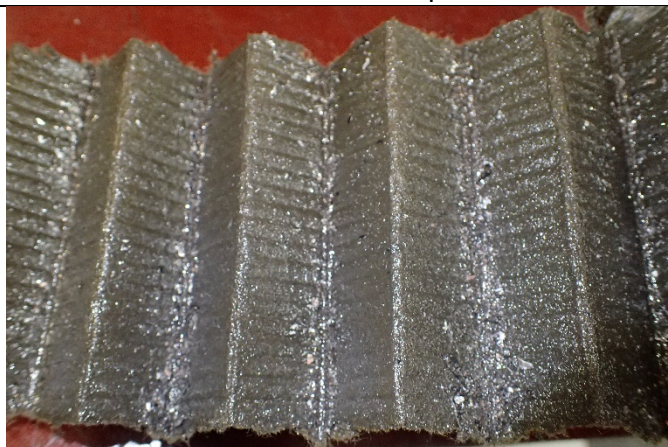
## OIL FILTER

The oil filter remained attached to the oil filter adapter and was undamaged. The oil filter was removed and the filter housing was cut open. The oil filter pleats were visually inspected; there was significant metallic material noted within the filter pleats.

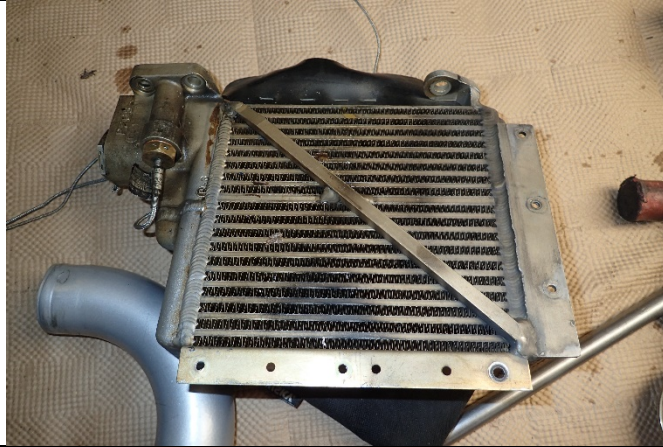
The oil cooler remained intact and undamaged. There were no signs of oil leaks around the cool cooler; there were no anomalies noted.

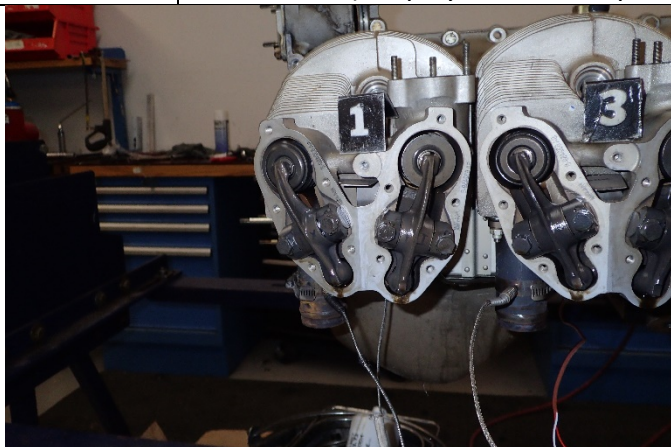
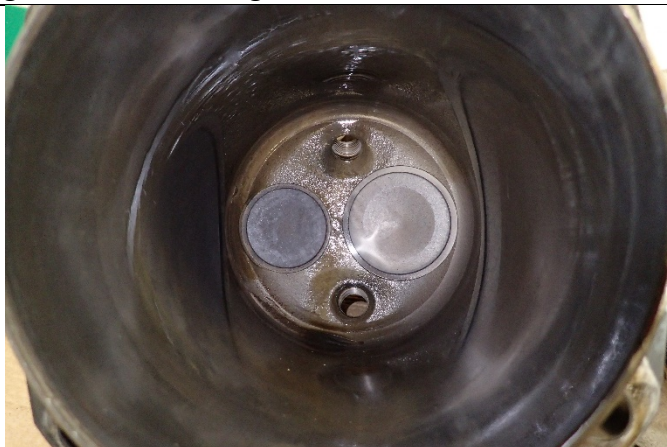
| CYLINDER #1 | P/N: 658595A1 | S/N: AC16GB292 | Head Date: Not observed |
|---|---|---|---|
| Condition: | The cylinder remained attached to its installation point and was undamaged. The cylinder was removed and visually inspected. The cylinder bore and valve heads displayed normal operating and combustion signatures. The overhead components (valves, springs, and rocker arms) displayed normal operating and lubrication signatures. | | |

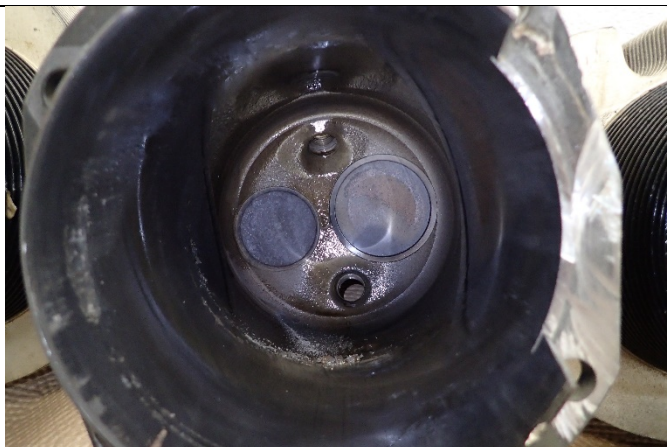
| CYLINDER #3 | P/N: 658595A1 | S/N: AC16GB331 | Head Date: Not observed |
|---|---|---|---|
| Condition: | The cylinder remained attached to its installation point and displayed mechanical damage to the cylinder skirt. The cylinder was removed and visually inspected. The cylinder bore and valve heads displayed normal operating and combustion signatures. The overhead components (valves, springs, and rocker arms) displayed normal operating and lubrication signatures. | | |

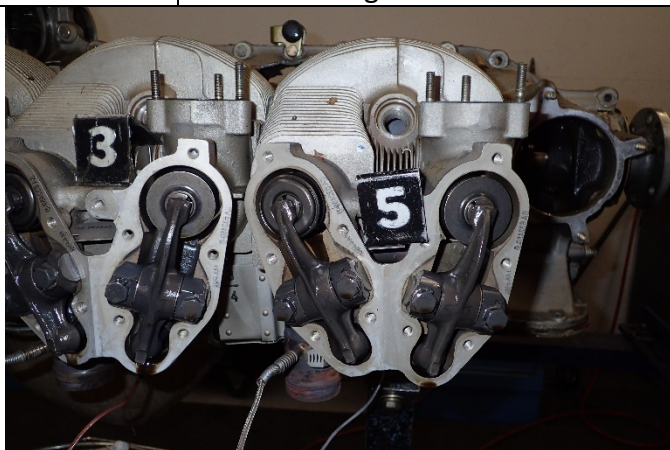
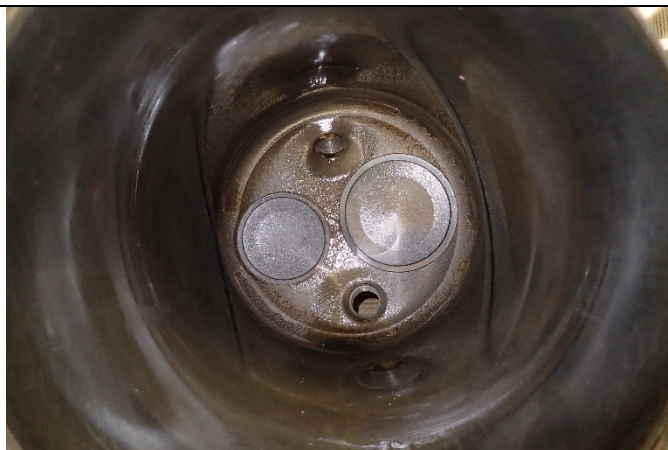
The cylinder remained attached to its installation point and displayed minor mechanical damage to the cylinder skirt. The cylinder was removed and visually inspected. The cylinder bore and valve heads displayed normal operating and combustion signatures. The overhead components (valves, springs, and rocker arms) displayed normal operating and lubrication signatures.

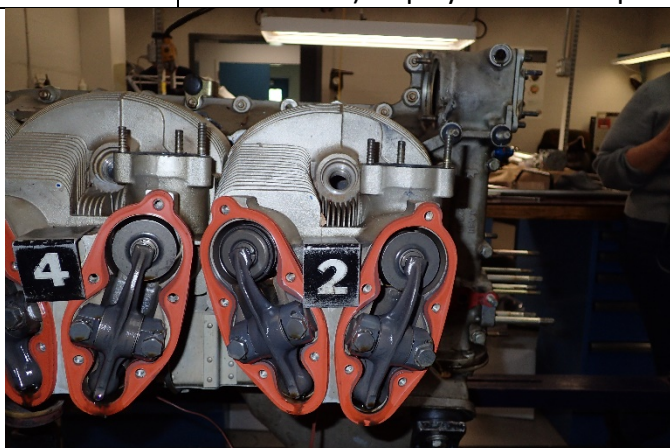
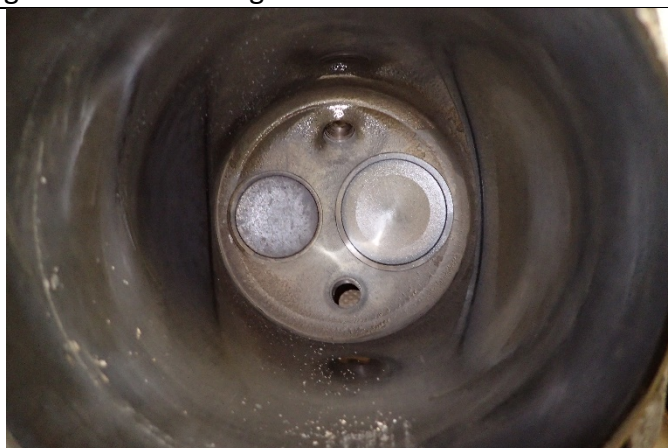
## CYLINDER #2

The cylinder remained attached to its installation point and was undamaged. The cylinder was removed and visually inspected. The cylinder bore and valve heads displayed normal operating and combustion signatures. The overhead components (valves, springs, and rocker arms) displayed normal operating and lubrication signatures.

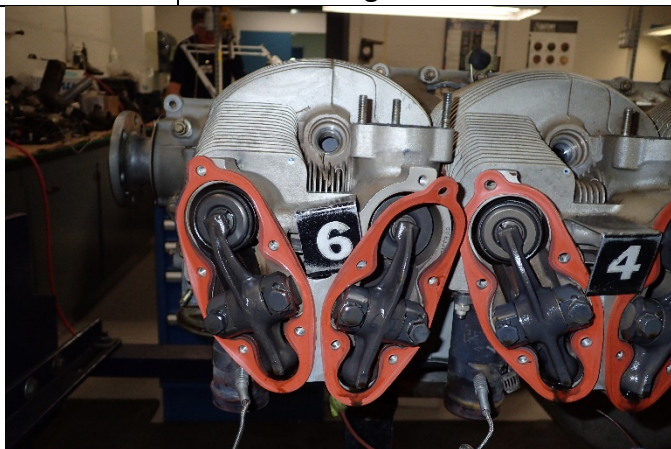
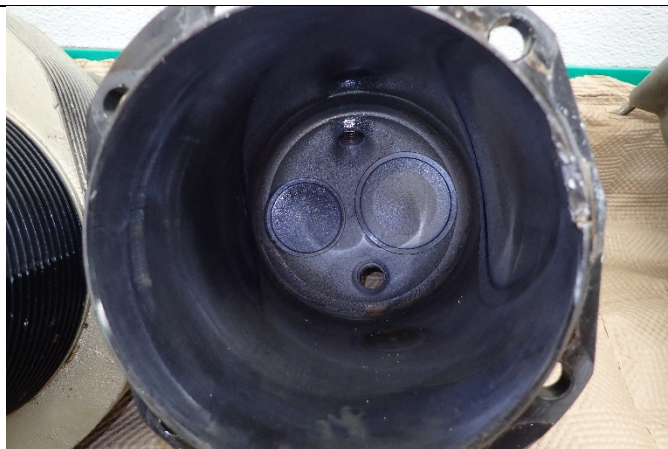
The cylinder remained attached to its installation point and displayed minor mechanical damage to the cylinder skirt. The cylinder was removed and visually inspected. The cylinder bore and valve heads displayed normal operating and combustion signatures. The overhead components (valves, springs, and rocker arms) displayed normal operating and lubrication signatures.

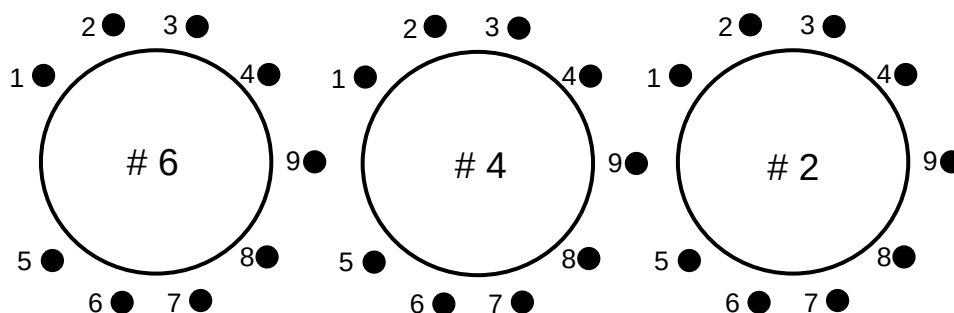
| | Bolt<br>1 | Stud<br>2 | Stud<br>3 | Stud<br>4 | Bolt<br>5 | Stud<br>6 | Stud<br>7 | Stud<br>8 | Stud<br>9 |
|---|---|---|---|---|---|---|---|---|---|
| Cylinder #4 | 968/848 | Case Fracture | Case Fracture | 697/570 | 941/765 | 772/567 | 718/548 | 743/595 | 540/415 |
| Cylinder #6 | 940/755 | 804/687 | 822/658 | 730/592 | 922/695 | 779/475 | 699/581 | 713/<br>Error | 691/517 |

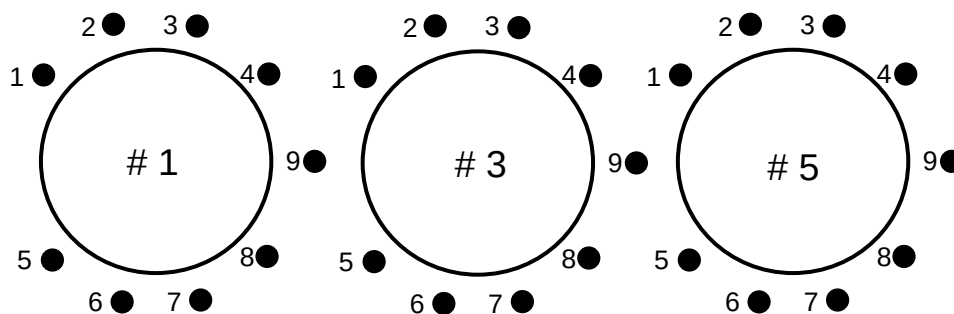
| | Bolt<br>1 | Stud<br>2 | Stud<br>3 | Stud<br>4 | Bolt<br>5 | Stud<br>6 | Stud<br>7 | Stud<br>8 | Stud<br>9 |
|---|---|---|---|---|---|---|---|---|---|
| Cylinder # 3 | 1111/<br>898 | 719/604 | 726/597 | 564/480 | 1064/<br>847 | 827/684 | 852/766 | 588/439 | 511/422 |
| Cylinder # 5 | 840/649 | 724/585 | 740/605 | 717/580 | 1116/<br>911 | 834/701 | 844/686 | 776/633 | 660/539 |

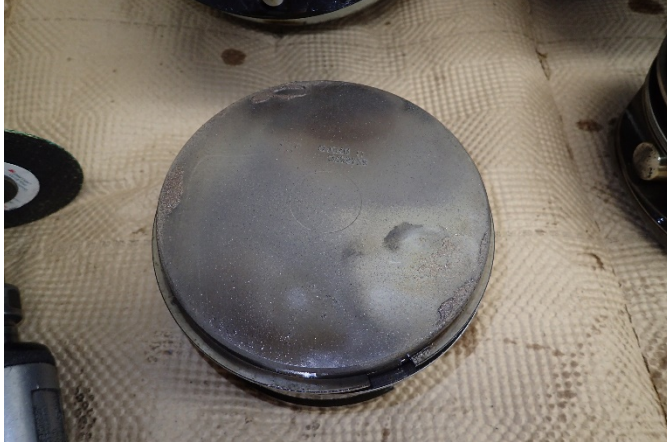
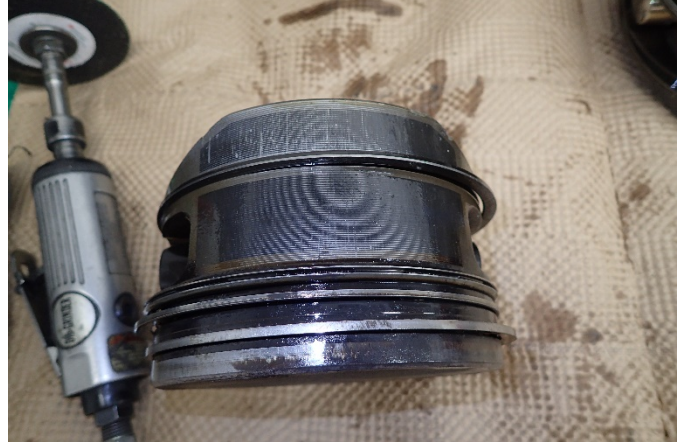
The piston remained attached to the connecting rod and displayed mechanical damage to the rear of the piston. All of the piston rings remained installed in their grooves and were capable of normal movement. There were no anomalies noted with the piston.

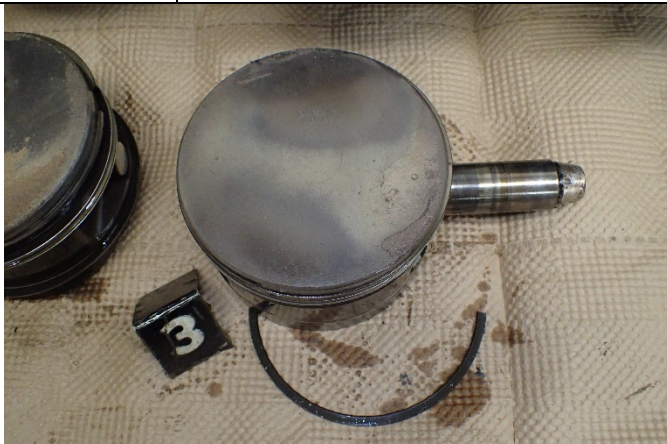
## #3 PISTON, RINGS AND PIN

The piston remained attached to its connecting rod and displayed a significant amount of mechanical damage to the rear of the piston as well as the piston skirt. The rear piston ring was broken; however, the remaining piston rings remained installed in their grooves, were undamaged, and were capable of normal movement. There were no anomalies noted with the piston.

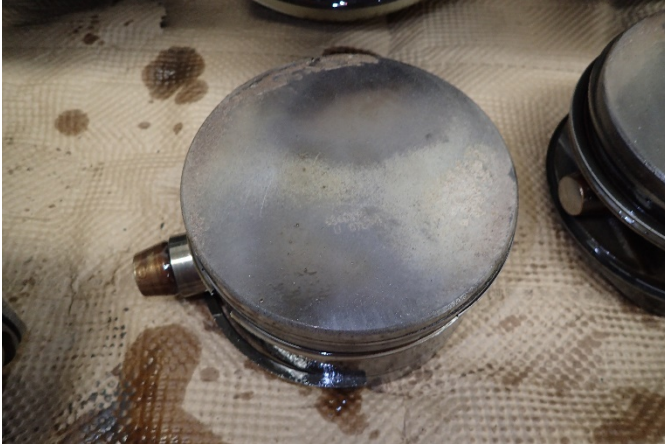
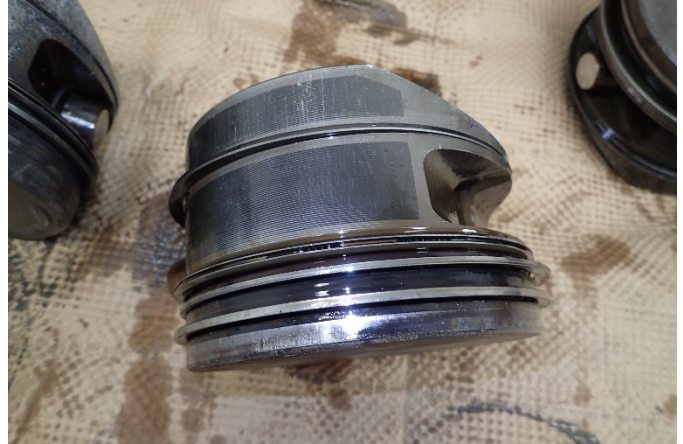
The piston remained attached to the connecting rod and displayed mechanical damage to the rear of the piston. All of the piston rings remained installed in their grooves and were capable of normal movement. There were no anomalies noted with the piston.

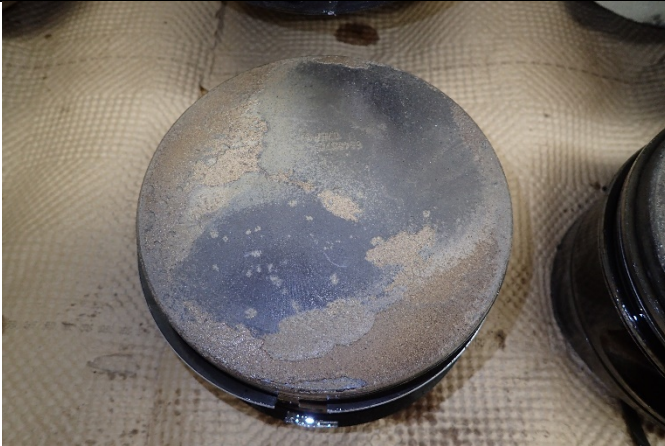
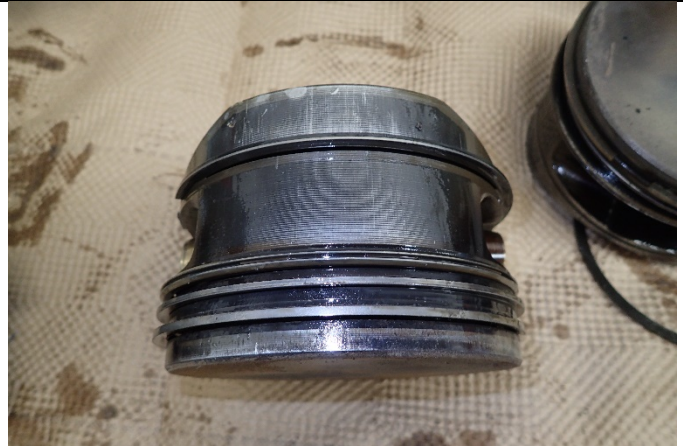
**#2 PISTON, RINGS  
AND PIN**

The piston remained attached to the connecting rod and displayed mechanical damage to the rear of the piston. All of the piston rings remained installed in their grooves and were capable of normal movement. There were no anomalies noted with the piston.

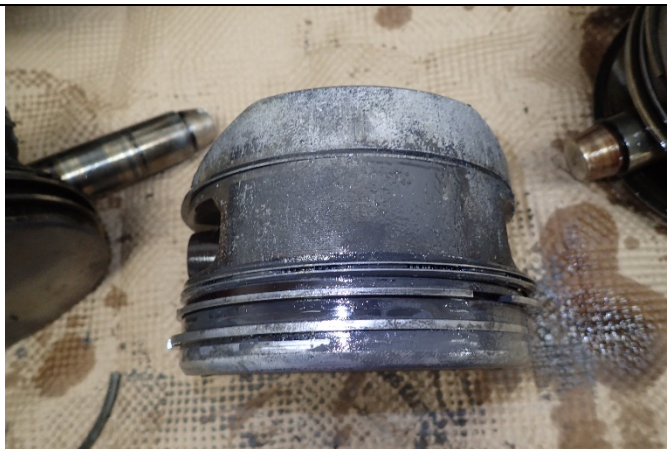
The piston remained attached to its connecting rod; however, the connecting rod had separated from the crankshaft. The piston displayed a significant amount of mechanical damage to the rear of the piston as well as the piston skirt. There were two semi-circular indentations on the piston face consistent with valve strikes. The rear piston ring displayed mechanical damage; the remaining piston rings were undamaged and displayed normal operating signatures.

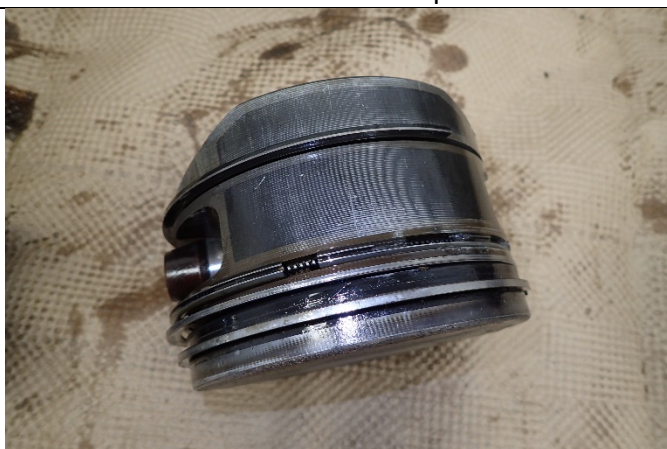
## #6 PISTON, RINGS AND PIN

The piston remained attached to its connecting rod and displayed mechanical damage to the rear of the piston as well as the piston skirt. The rear piston ring was broken; however, the remaining piston rings remained installed in their grooves, were undamaged, and were capable of normal movement. There were no anomalies noted with the piston.

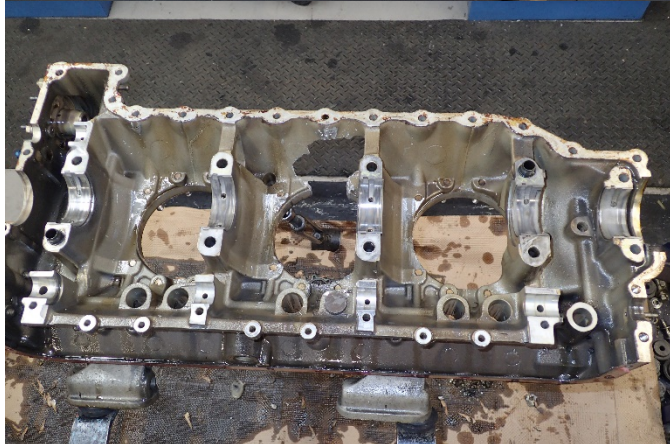
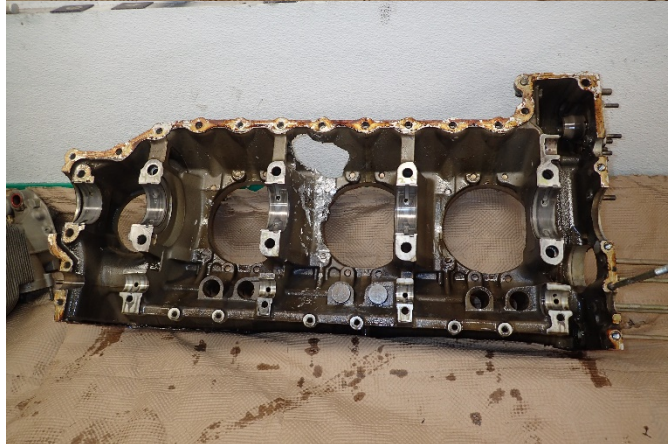
The crankcase had two holes in the top of the crankcase; one hole was adjacent to the #4 cylinder, the other hole was located near the data plate installation point. The inside of both of the crankcase halves displayed mechanical damage with the most damage concentrated near the two holes. There were no signs of fretting on the bearing supports or signs of bearing shift. The oil galley were checked for blockages; there were no blockages found.

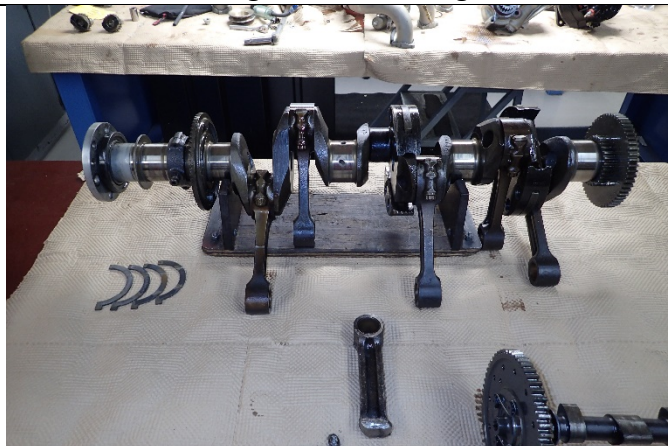
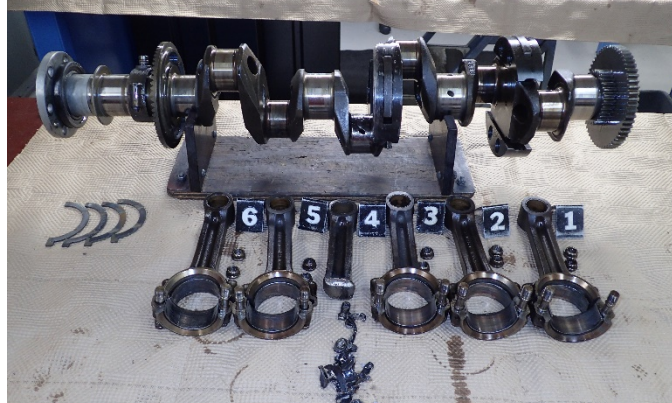
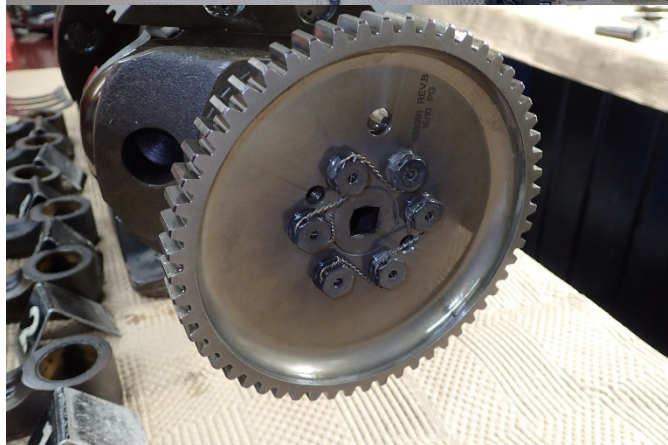
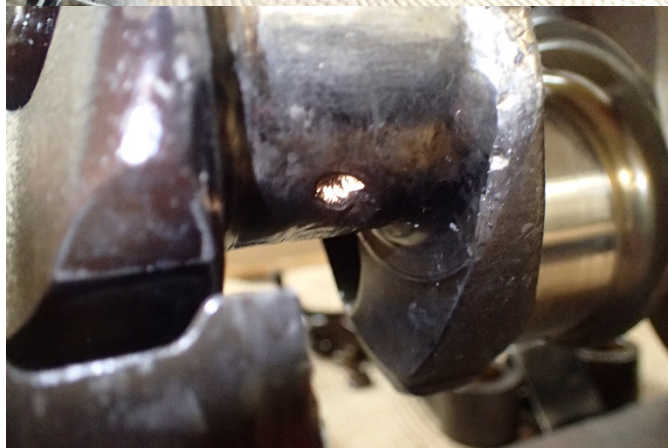
The crankshaft remained intact and displayed varying amounts of thermal damage to the connecting rod journals with the #4 connecting rod journal displaying the most thermal damage; the #4 connecting rod journal also displayed mechanical damage. The oil galleries were inspected using a light and all the galleries were found to be clear of obstructions. The crankshaft gear remained secured and there was no damage noted to the gear teeth.

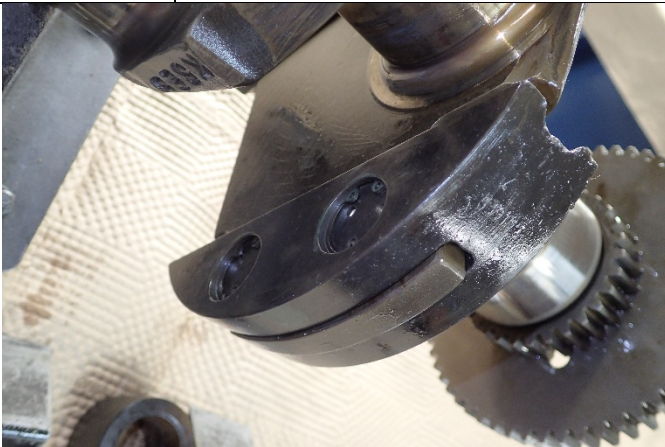
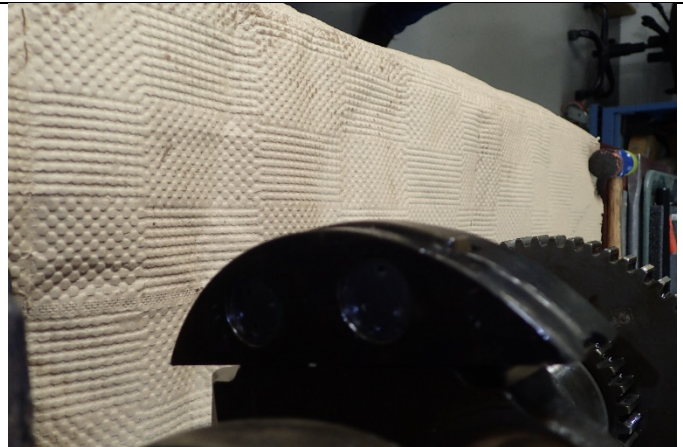
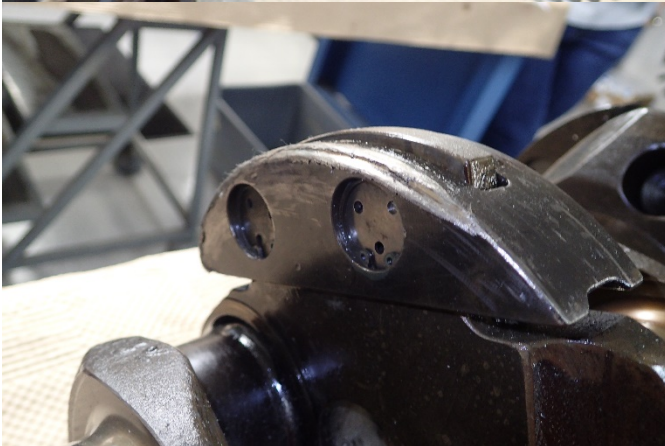
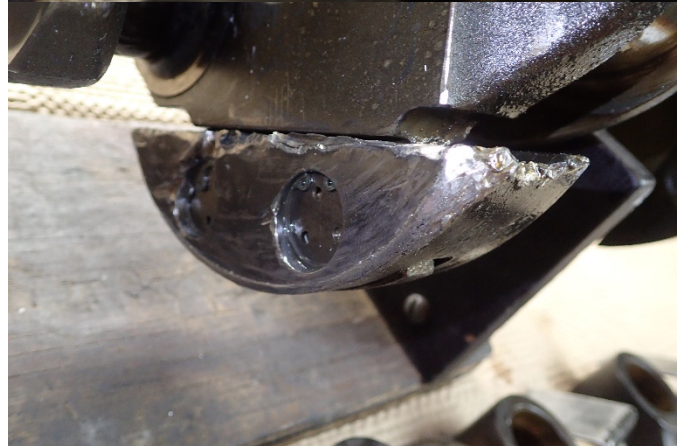
## COUNTER WEIGHTS

All of the counterweights remained attached to their hangers and displayed varying amounts of mechanical damage. All of the counterweights were capable of normal movement on their hangers.

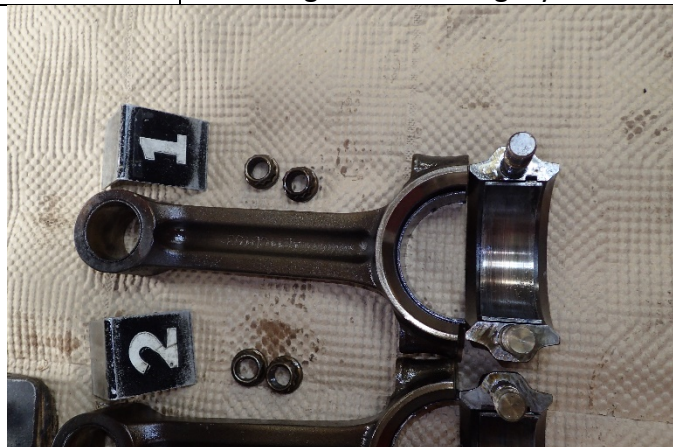
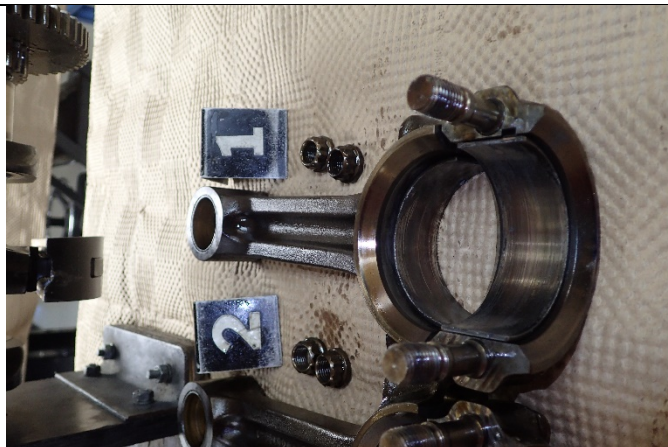
The bearings remained within the bearing supports. The bearing displayed wiping and smearing of the bearing layers which is consistent with lubrication distress.

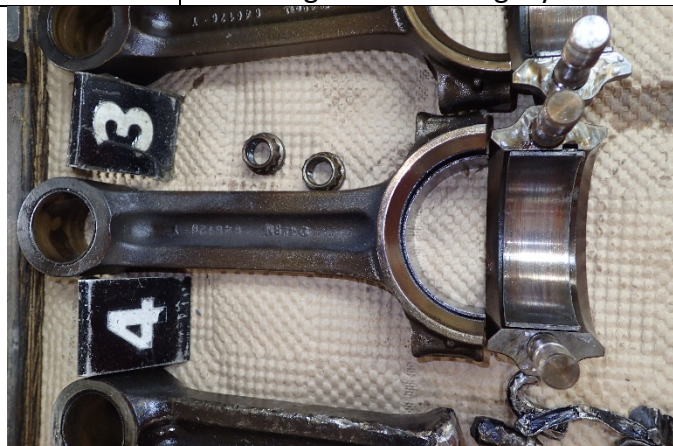
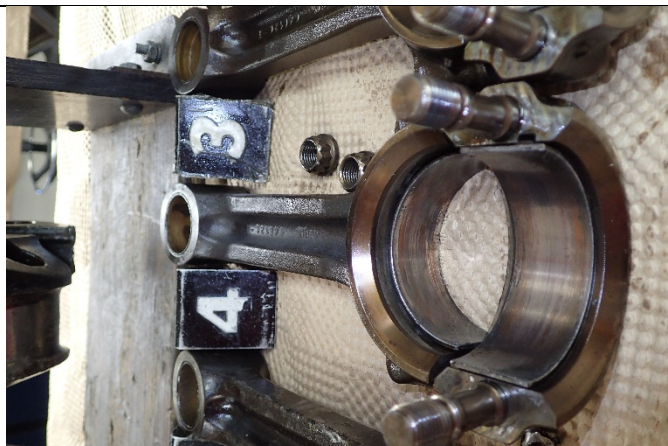
The bearings remained within the bearing supports. The bearing displayed wiping and smearing of the bearing layers which is consistent with lubrication distress.

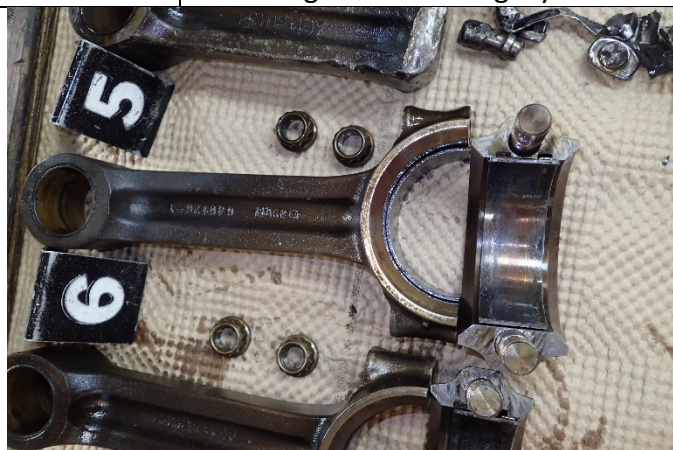
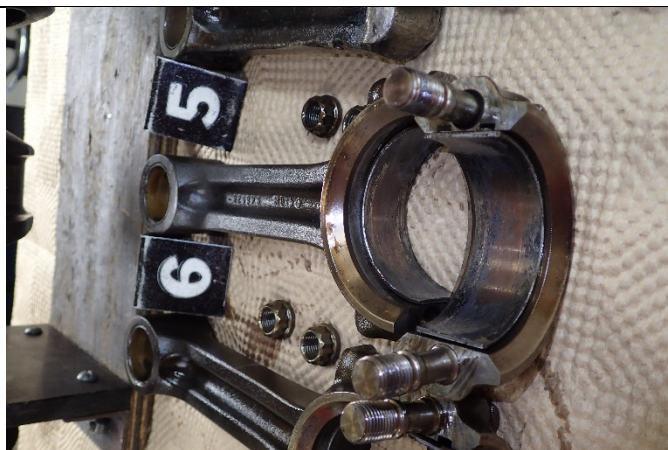
The bearings remained within the bearing supports. The bearing displayed wiping and smearing of the bearing layers which is consistent with lubrication distress.

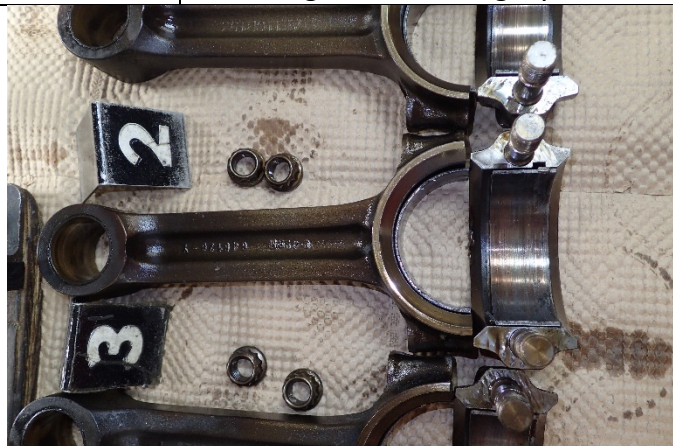
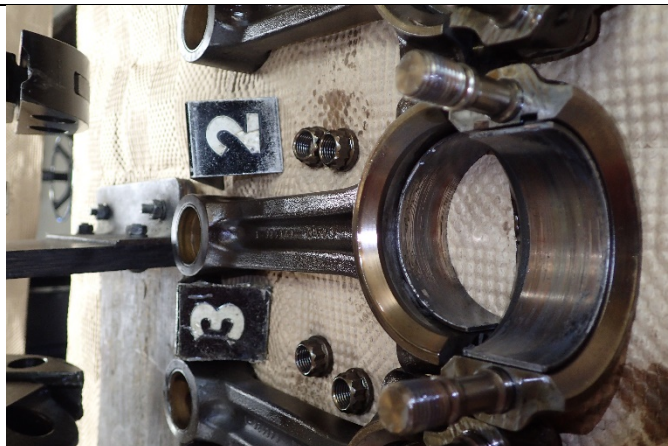
The bearings remained within the bearing supports. The bearing displayed wiping and smearing of the bearing layers which is consistent with lubrication distress.

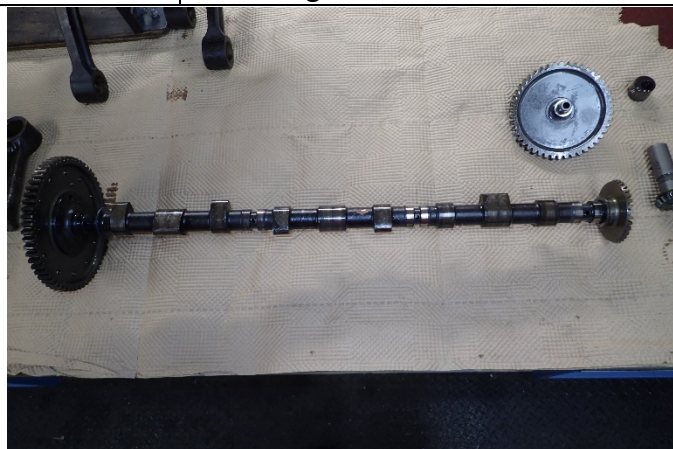
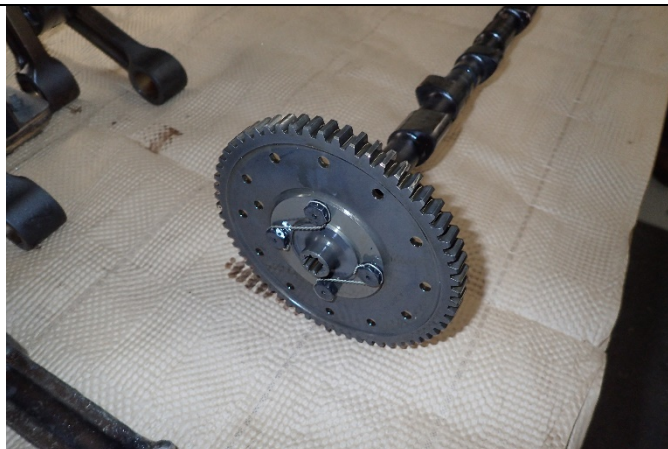
The camshaft remained intact and displayed minor mechanical damage. The camshaft lobes displayed normal operating and lubrication signatures. The camshaft gear was undamaged and remained secured to the camshaft.
