# Continental Motors

## ENGINE EXAMINATION REPORT

| ENGINE MODEL | IO-550-P (converted to turbo-normalized by Vitatoe) |
| FILE NUMBER | 17-294 |

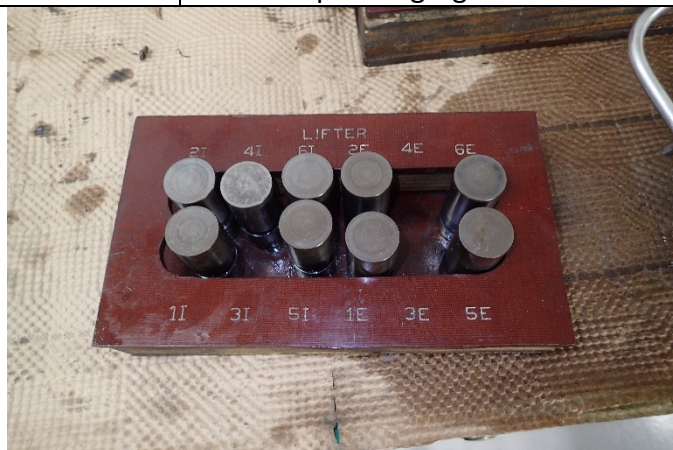
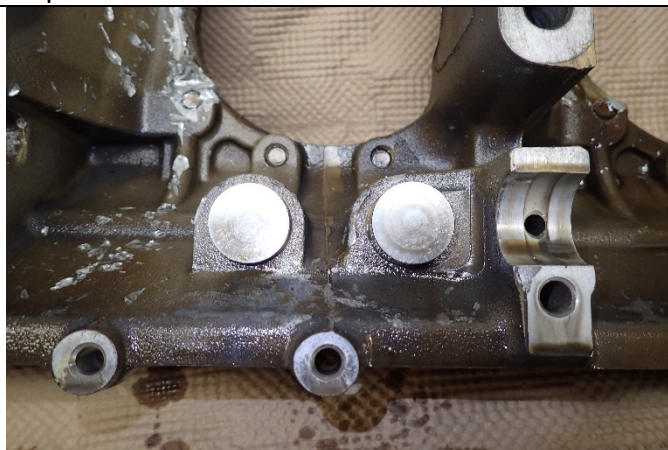
All of the lifters remained installed in their installation points. The #3 intake and exhaust as well as the #4 exhaust lifters could not be removed from their installation points due to mechanical damage to the surrounding crankcase. The remaining lifters were removed and displayed normal operating signatures; the lifters that could not be removed displayed normal operating signatures on the visible portions of the lifters.

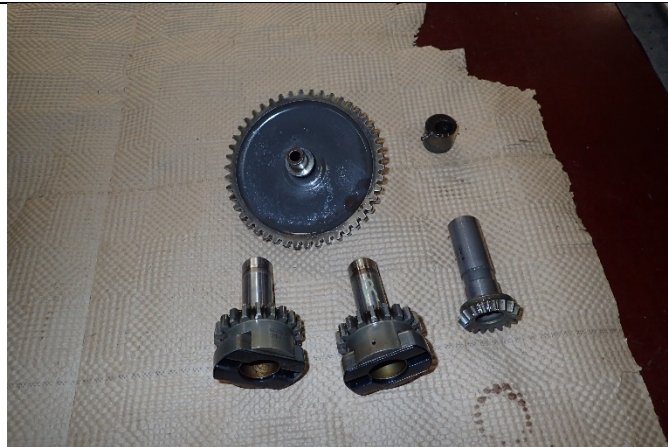
All of the accessory gears remained installed in their installation points and were undamaged. The gears displayed normal operating signatures; there were no anomalies noted.

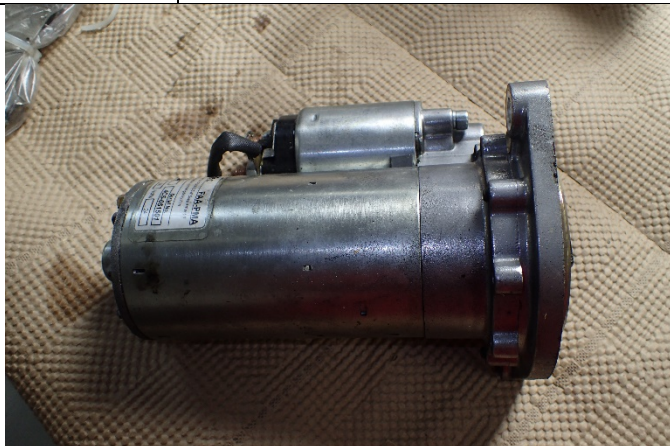
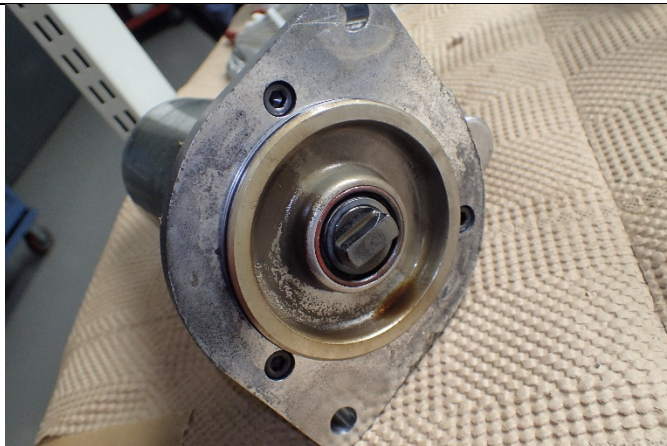
The starter remained intact and undamaged. There were no anomalies noted with the starters.

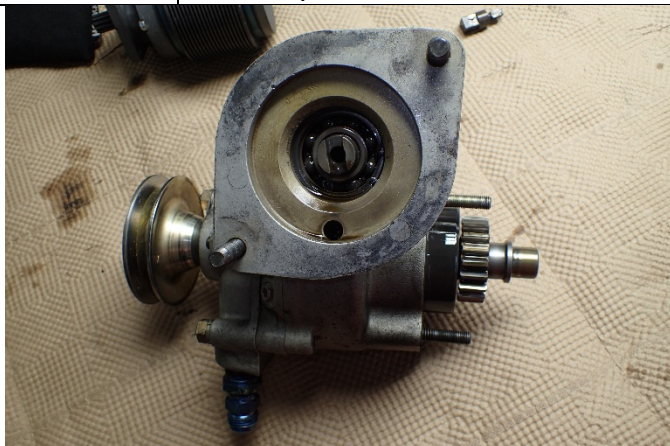
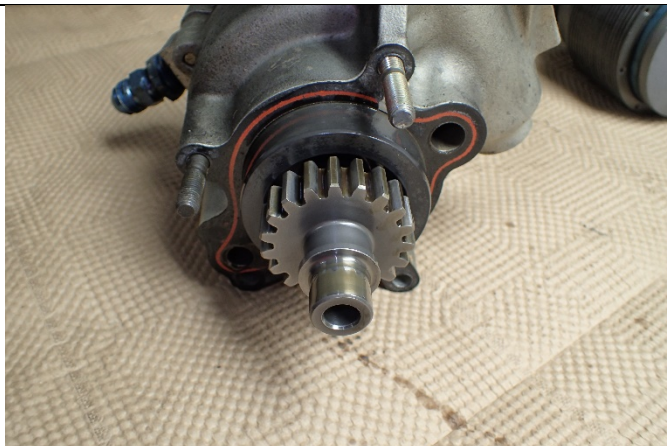
The starter adapter remained attached to its installation point and was undamaged. The starter gear was capable of normal movement. The adapter was partially disassembled to allow to view the operation of the scavenge pump; the scavenge pump gears operated normally. There were no anomalies noted.

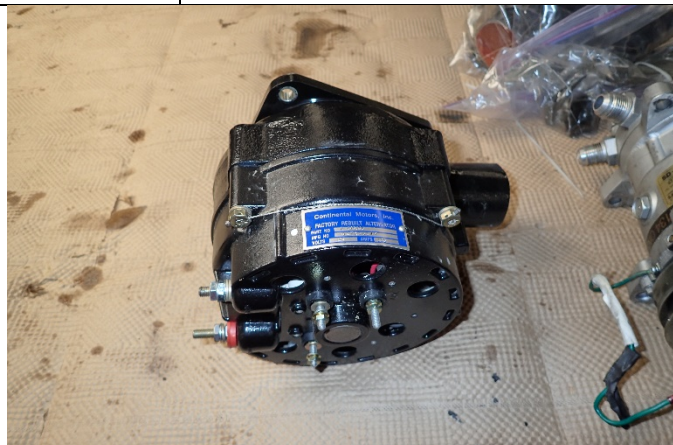
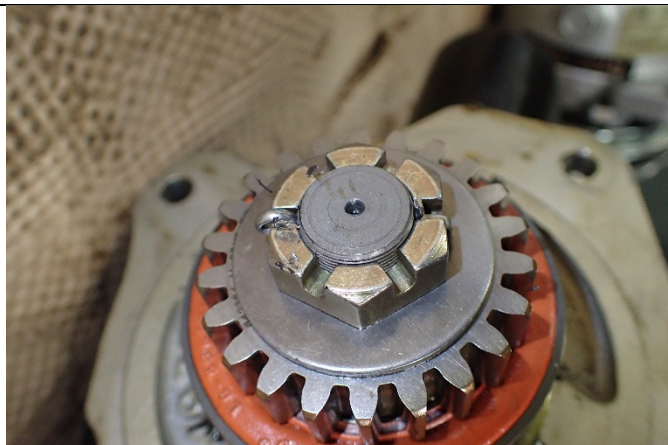
The alternator remained attached to its installation point and was undamaged. There were no anomalies noted with the alternator.

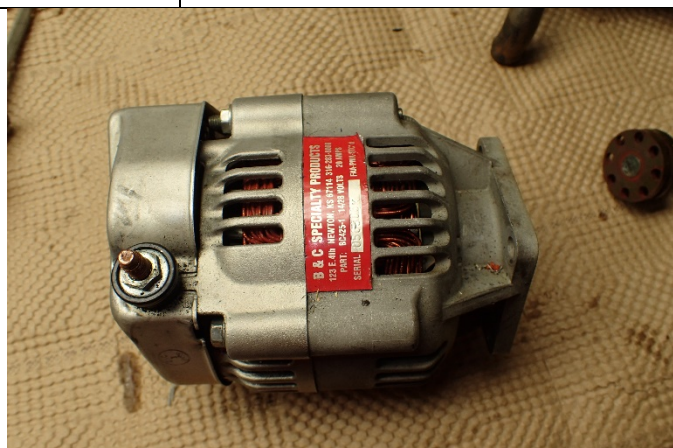
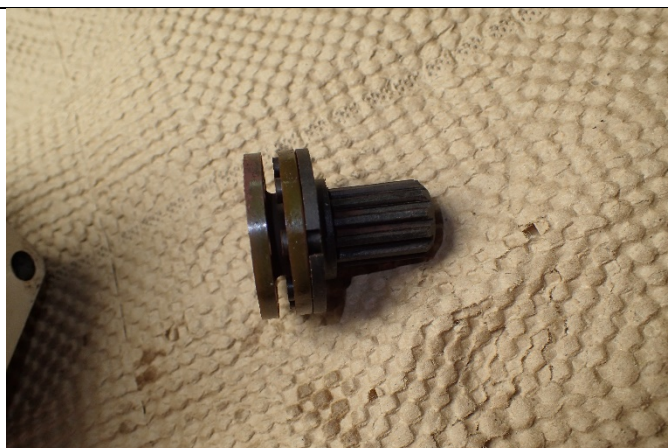
The backup alternator remained attached to its installation point and was undamaged. There were no anomalies noted with the alternator.

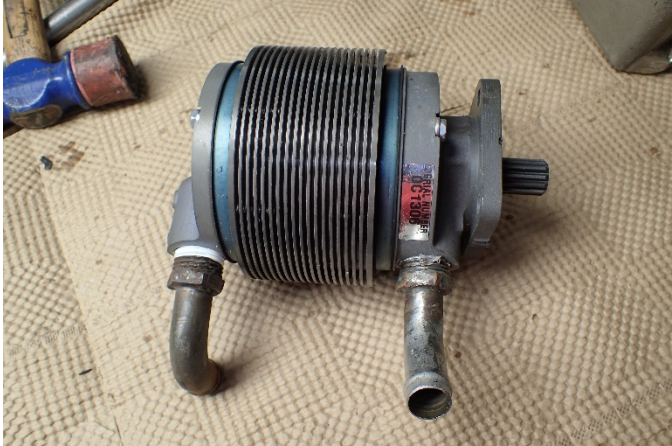
| Condition: | The vacuum pump remained attached to its installation point and was undamaged. The pump was removed and the sheer coupling was noted to be intact. There were no anomalies noted with the vacuum pump. | | |

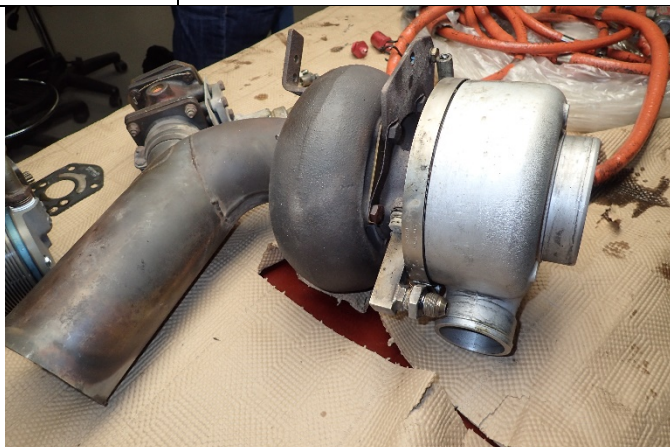
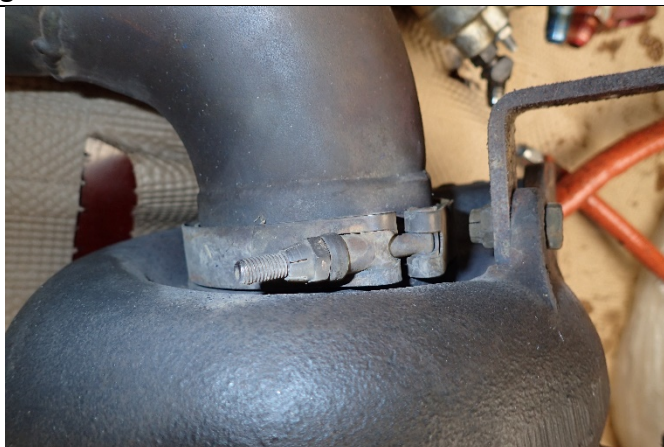
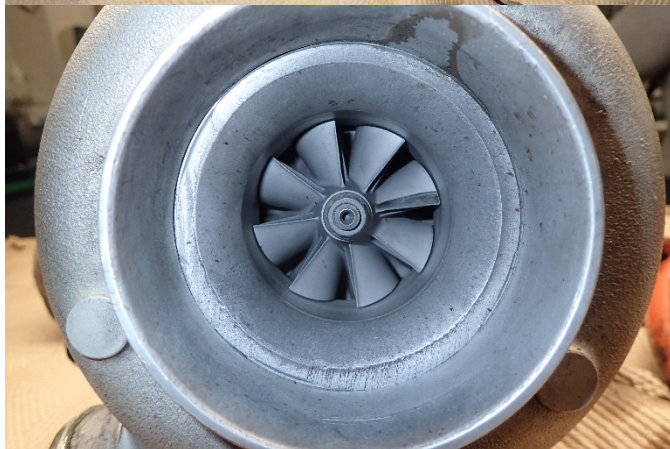
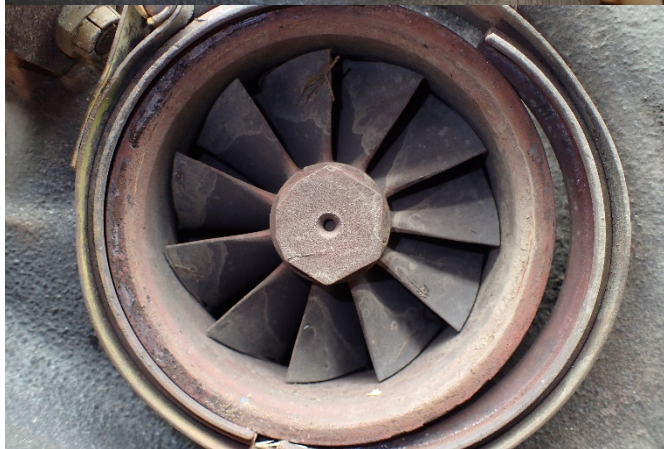
The turbocharger remained intact and was undamaged. The compressor and turbine blades displayed normal operating signatures and were capable of rotation. There were no anomalies noted with the turbocharger.

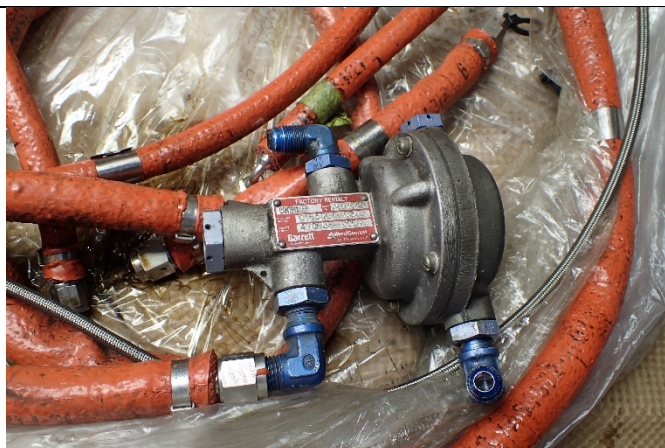
The turbocharger controller remained intact and was undamaged. There were no anomalies noted with the controller.

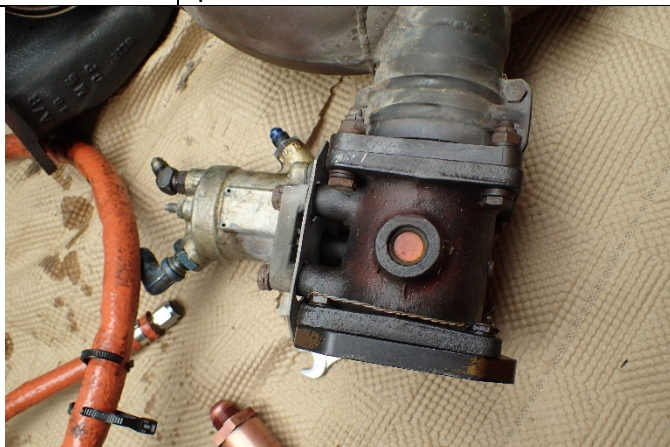
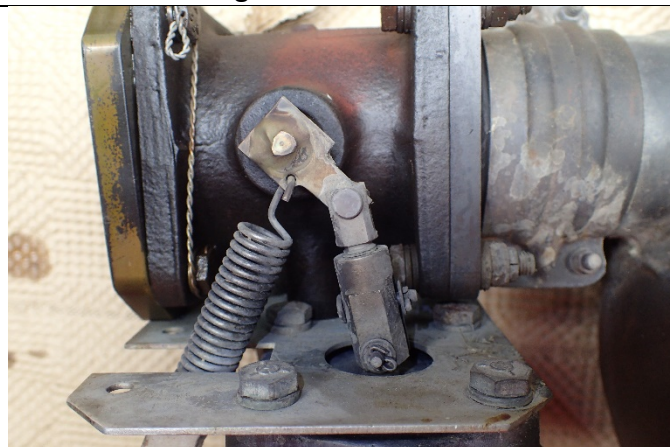
The wastegate remained intact and was undamaged. The wastegate was in the open position. There were no anomalies noted with the wastegate.

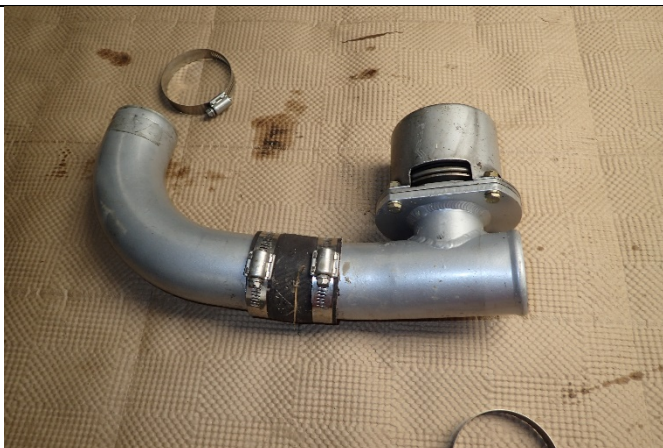
The overboost valve remained attached to its installation point and was undamaged. There were no anomalies noted with the overboost valve.

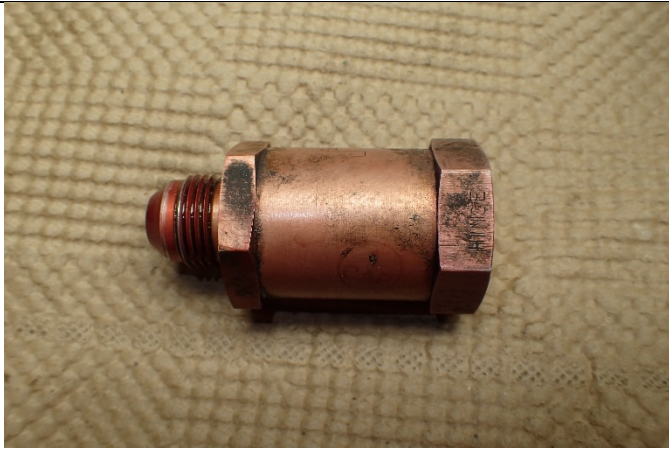
Scavenge Oil Check Valve

Both of the check valves remained attached to their installation points and were undamaged. The check valves were removed and disassembled. The check valve for the turbocharger scavenge oil was found to have a broken spring causing the valve to not close automatically; however, the valve was able to move freely. The inlet check valve was disassembled and was capable of normal operation.

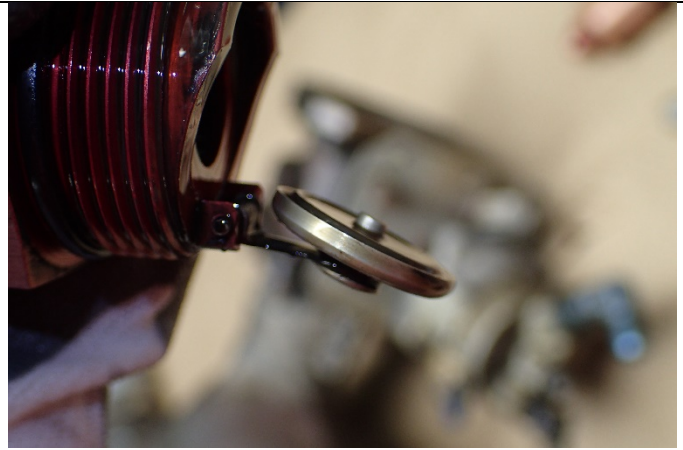
Scavenge oil check valve not closing automatically

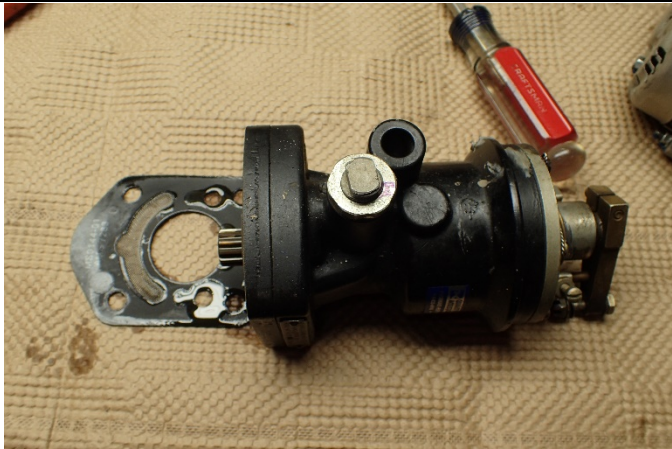
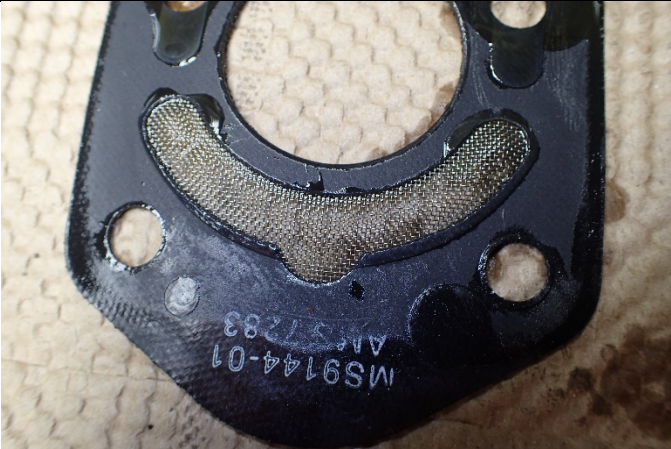
| Condition: | The propeller governor remained attached to its installation point and was undamaged. The governor was removed and the gasket screen was noted to be clear of any contaminates. There were no anomalies noted with the governor. | | |
