# NATIONAL TRANSPORTATION SAFETY BOARD

## MATERIALS LABORATORY FACTUAL REPORT

Report No. 17-094

Place : Harvard, Illinois  
Date : November 8, 2017  
Vehicle : Cessna 170  
NTSB No. : CEN18LA044  
Investigator : Jennifer Rodi

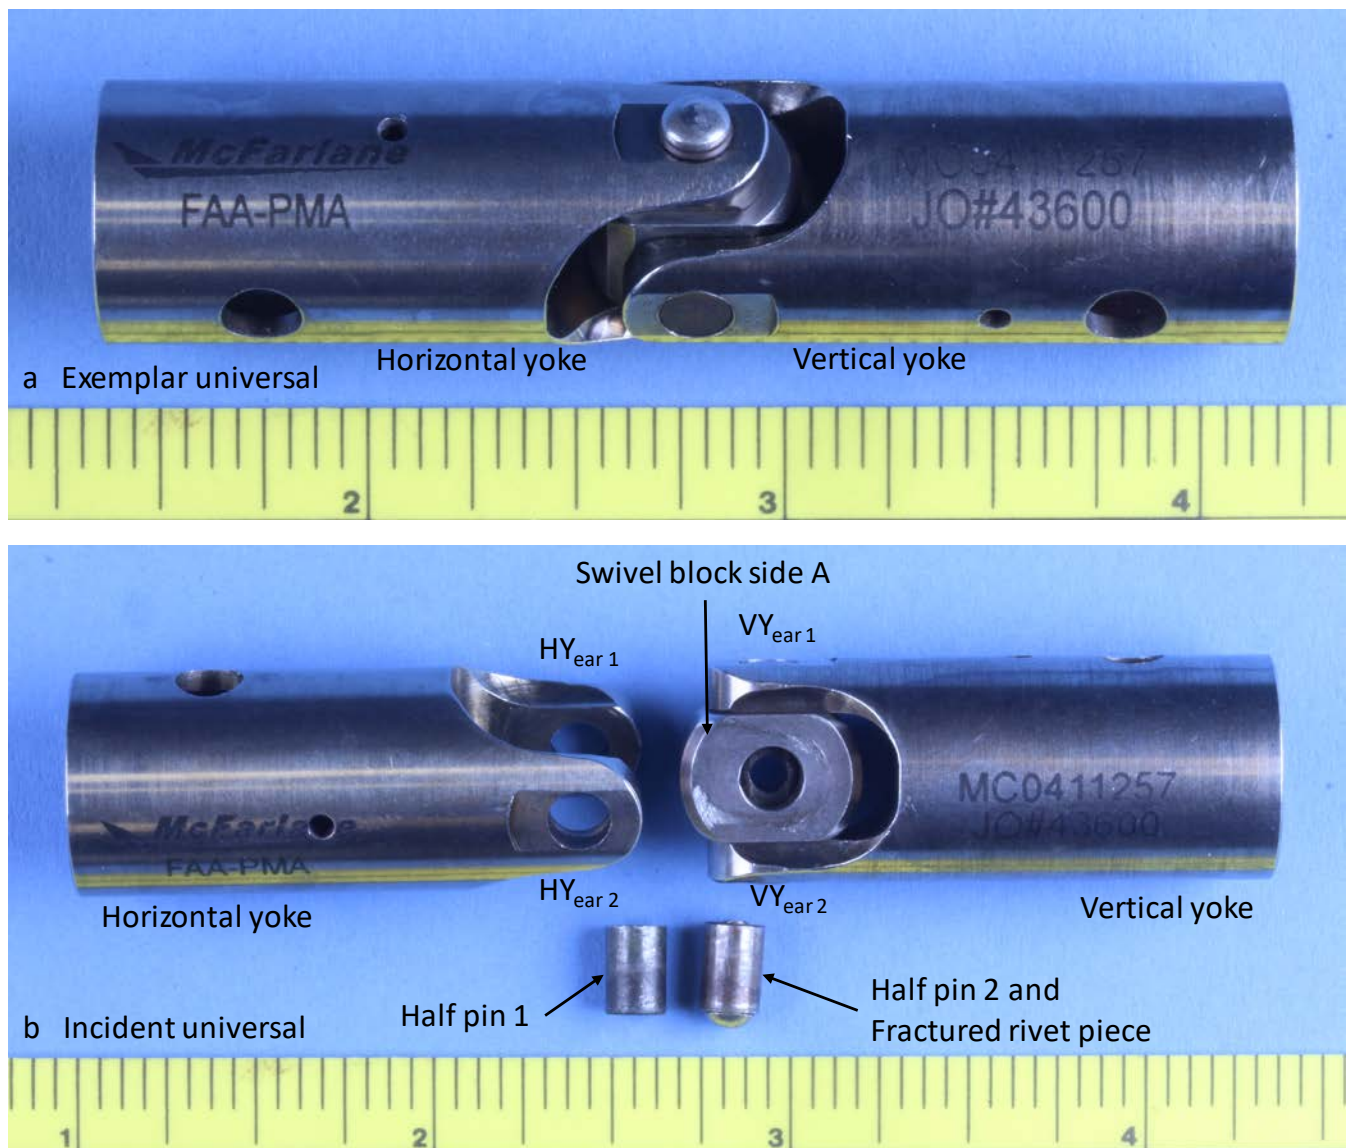
An exploded diagram of the universal joint is shown in Figure 1, with each key component labelled. The exemplar universal joint and the incident universal joint pieces are shown in Figure 2. Figure 2b shows labels for each key feature identified on the incident universal. For report purposes, each yoke ear has been given a unique identifier. As received, the incident universal pieces were visually examined using a 5X to 50X stereo-zoom microscope for the presence of a light oil lubricant. No lubricant film was observed on any surface.

Figure 2 View a is an image of the exemplar universal. View b is an image of the pieces recovered from the incident universal.
