**Accident / Incident Report**

**Report No.: 17-183**

[REDACTED]  
Beech C90, N500KR  
Rockford, Illinois  
December 4<sup>th</sup> 2017  
PT6A-21  
Left-hand S/N 24390  
Right-hand S/N 24387

**Date of Issue:** May 25, 2018

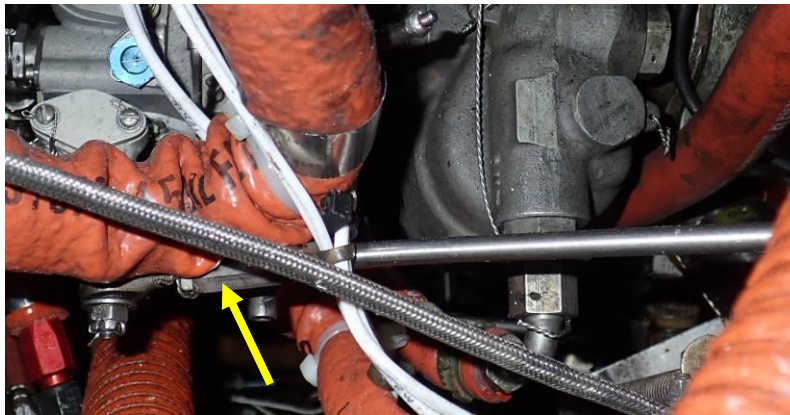
Photo No. 49

**5.1.2 Power Control and Reversing Linkage:** The propeller reversing lever was in place (Ref. Photo No. 47, red arrow). The front linkage was in place (Ref. Photo No. 47, blue arrow). The rear linkage was in place (Ref. Photo No. 48, red arrow). The end of the fuel control connection rod was bent (Ref. Photo No. 49, yellow arrow).
