## **INVESTIGATION REPORT**

| <b>Aircraft Make:</b> | Pipistrel | <b>Aircraft registration:</b> | N4JW |
| <b>Aircraft Model:</b> | Virus SW | <b>Aircraft S/N</b> | 877 SWN 100 iS |

| <b>Engine Type:</b> | Rotax 912 iS 3 Sport | <b>Engine TTSN</b> | 54 |

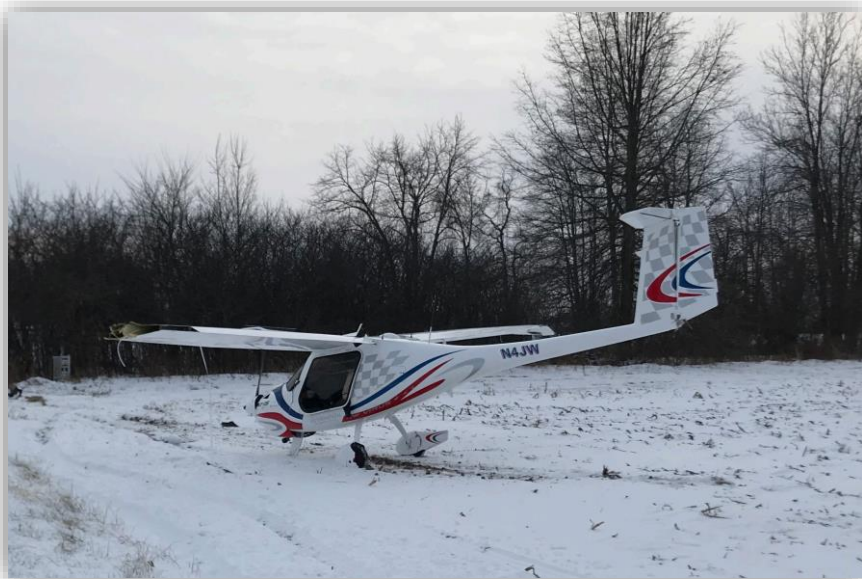
The pilot tried to reach a private airstrip about 3 miles east of his location. He was not able to reach the airstrip, given the local wind and airplane altitude, so he selected a nearby road for a forced landing. The road was ice covered and provided very little braking. During rollout, the pilot was concerned about approaching railroad crossing signs and a tall bush. The airplane's left wing impacted the bush just before the airplane crossed the railroad. The airplane subsequently swerved to the left and the nose wheel broke off when the airplane impacted the ditch on the northwest side of the railroad. The airplane stopped on the north side of the railroad about 30 ft off the road.

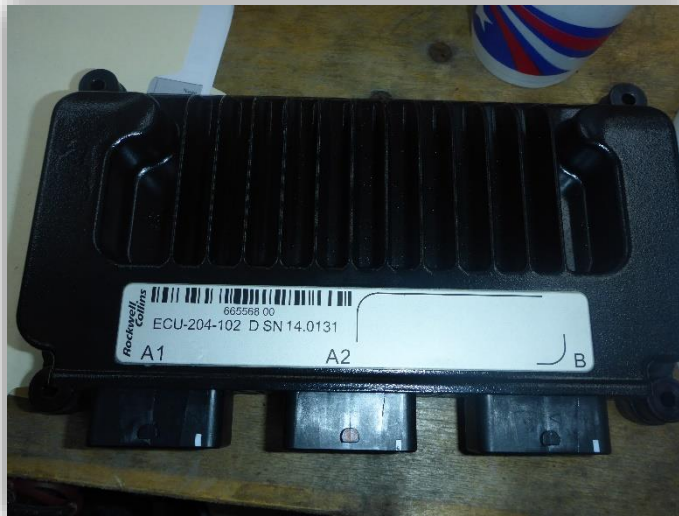
The Rotax 912iS engine comes equipped with an engine control unit (ECU) that captured and recorded engine parameters at the time of the loss of engine power and forced landing . The ECU data was downloaded and saved for future analyses.

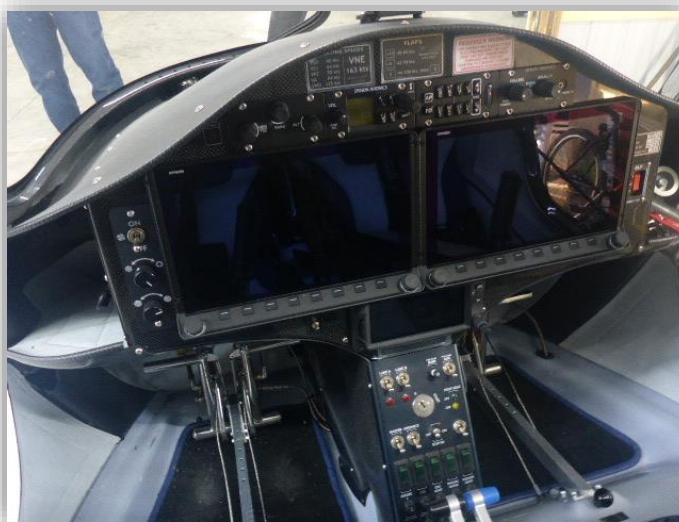
The aircraft is equipped with a Dynon flight instrument that also captured and recorded engine parameters at the time of the loss of engine power and forced landing. The Dynon unit was removed from aircraft and sent to the NTSB lab for data extraction.

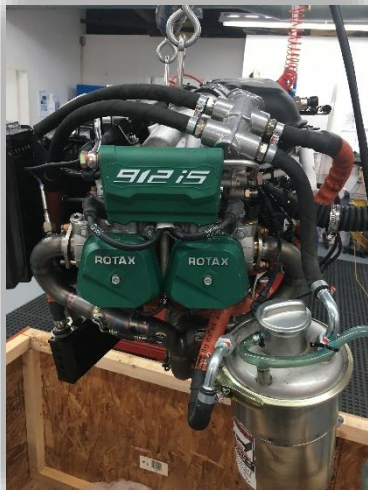
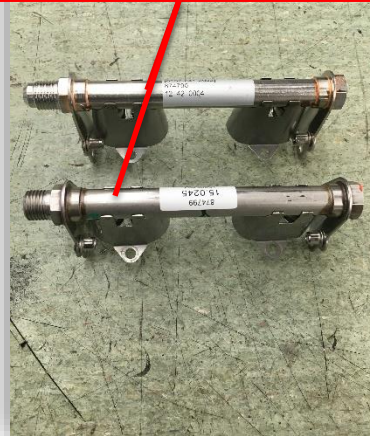
Fuel injection rail housings

This configuration consisted of changing fuel injection rail housing, water pump housing, propeller governor and engine mount. The ignition wiring harness was not shipped with the engine, therefore a new 912iS ignition wiring harness was installed.

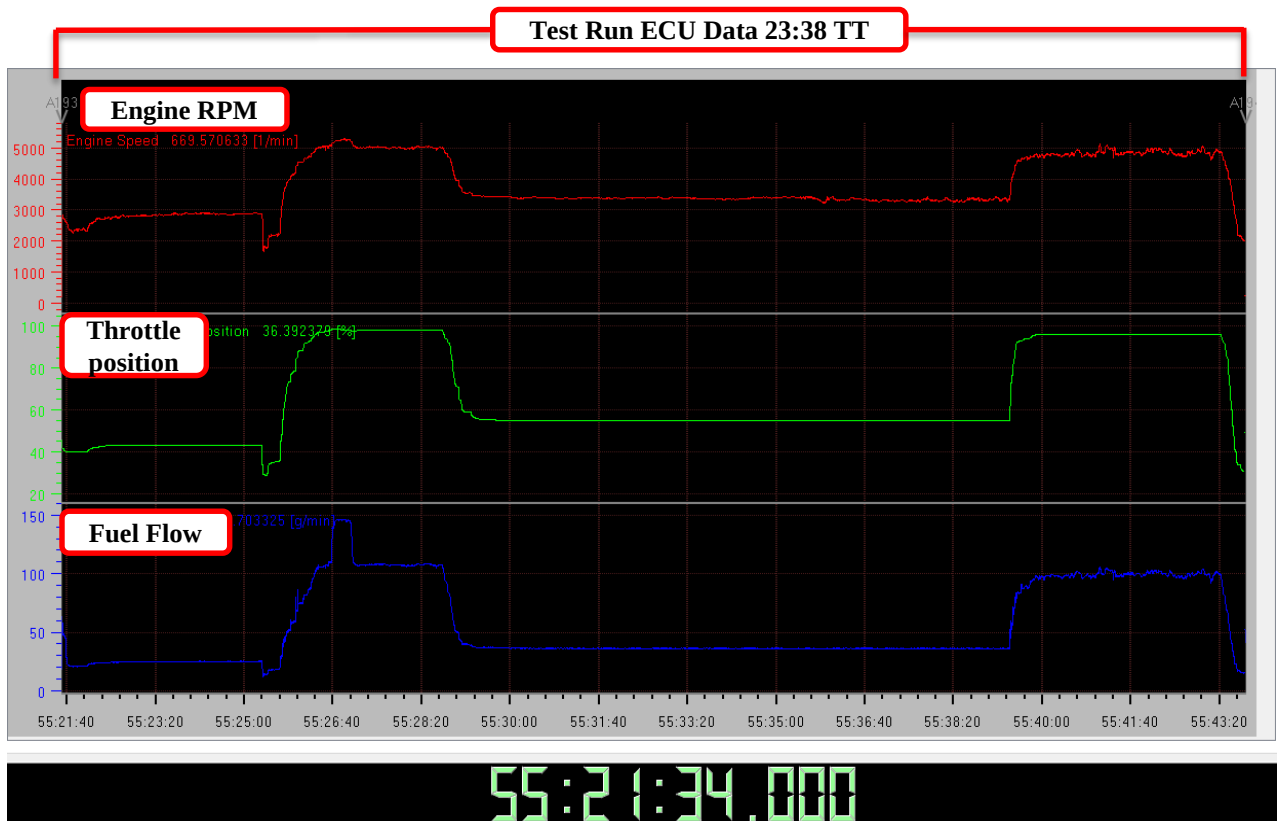
A calibrated test propeller was installed on the 912iS accident engine for the test run. The coolant system, oil system, fuel system, ignition systems and wiring harness were connected to the Rotax 912iS engine and test stand. The engine was then started and ran at idle for several minutes until the operating temperatures were within normal operational range. The first engine test run lasted approximately 23 min and 38 seconds. Below is the engine parameters graph that was captured by the accident engine ECU. This graph shows engine RPM, Throttle Position and Fuel Flow for the duration of the engine test run.

During the first test run, no anomalies were noted and all engine parameters were normal.

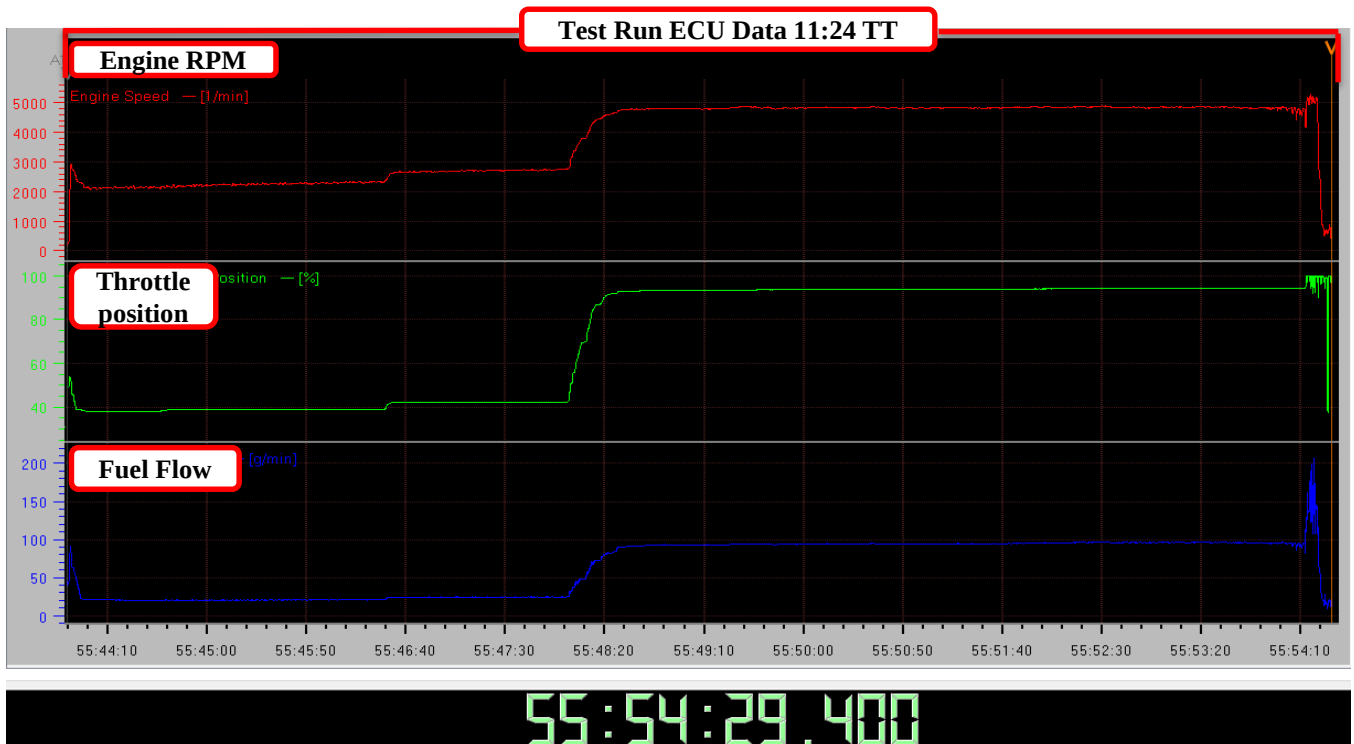
A second engine test run was conducted with reduced amount of fuel in fuel tank. The purpose of this second test run was to see how the 912iS would react when it was ran out of fuel and to see what the ECU data would indicate. The second engine test run lasted for approximately 11 minuets and 24 seconds.

During this second test run, no anomalies were noted and all engine parameters were normal until engine began to run rough due to running out of fuel. A video recording was done during this second test run.

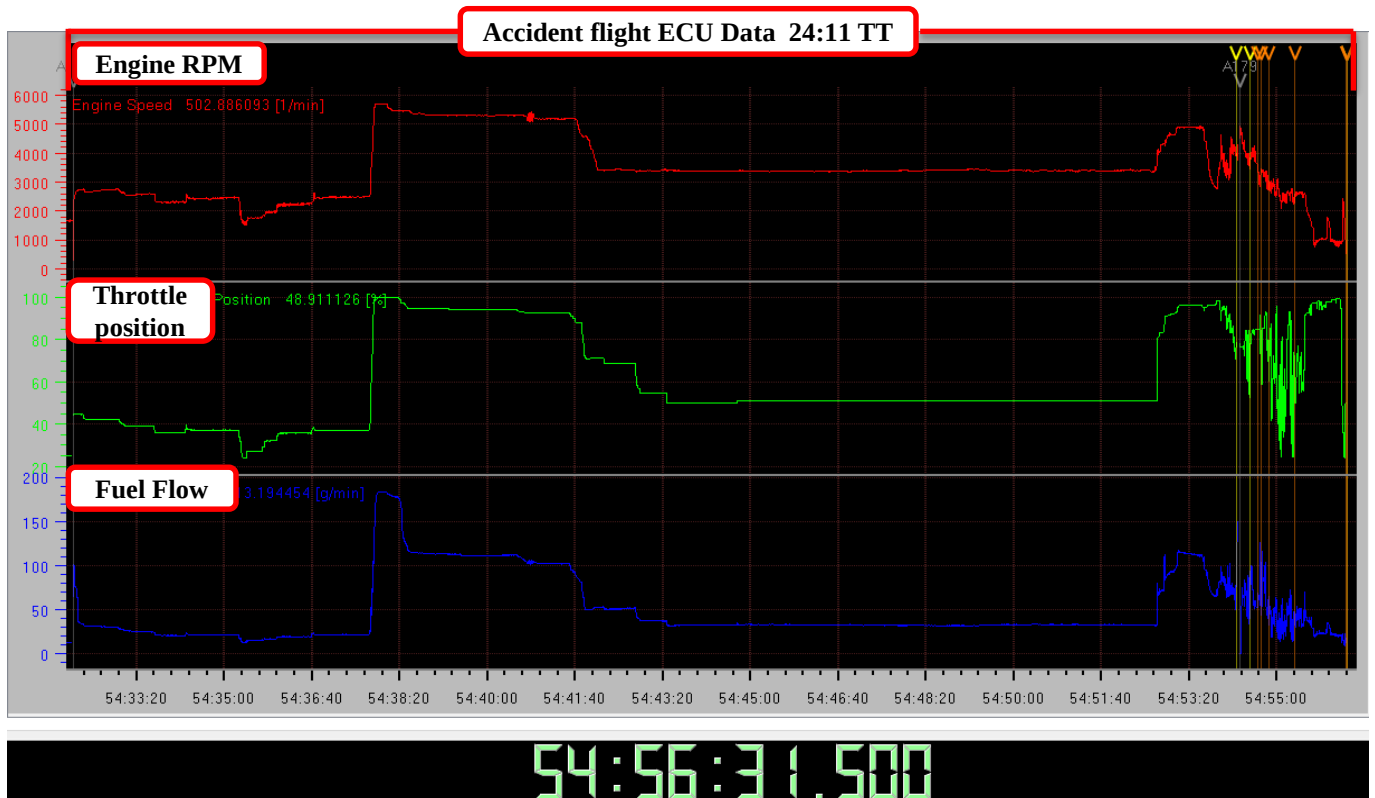
Based off the accident ECU data, it was determined the Rotax 912iS engine ran for approximately 24 min and 11 seconds during the accident flight.

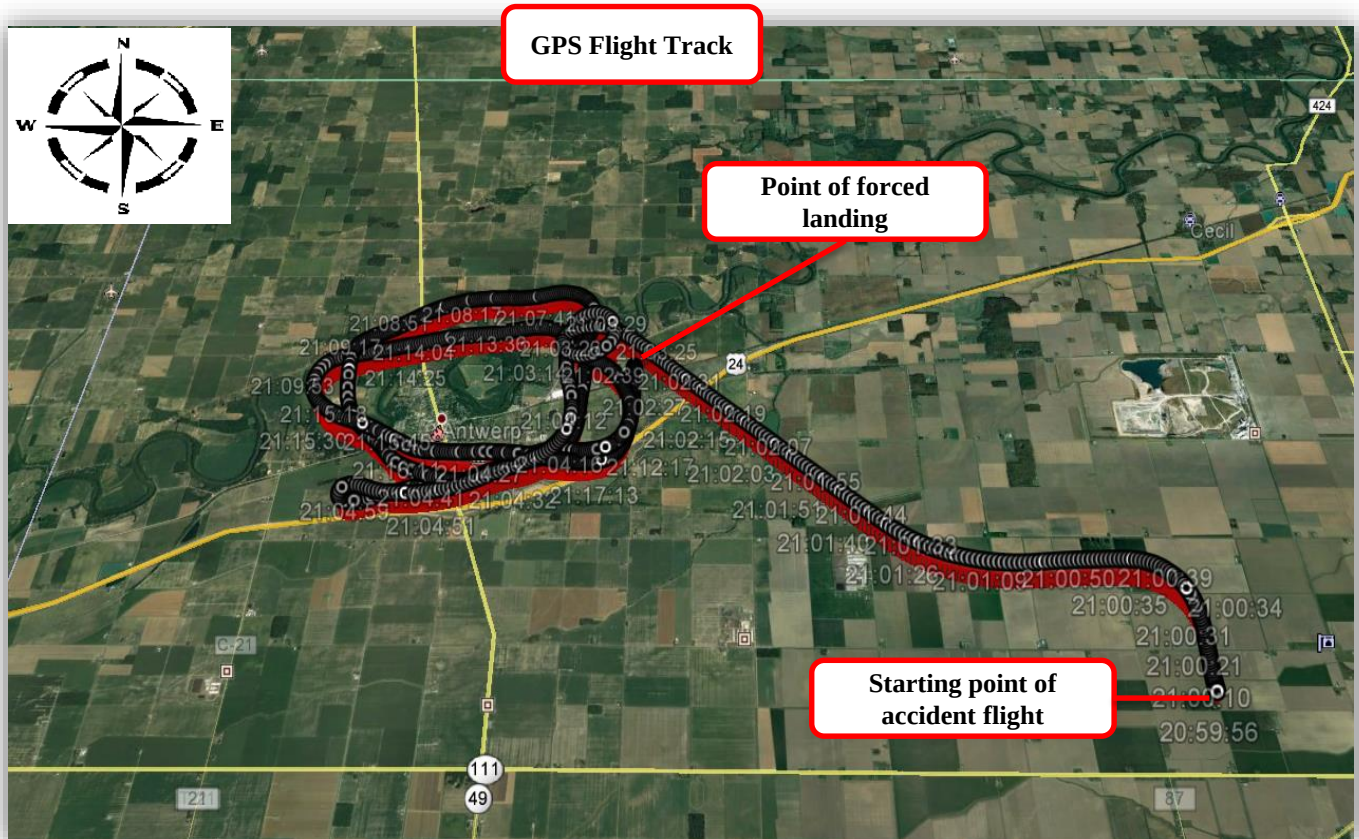
The aircraft's GPS was able to track the accident flight from the point of take-off to the point of the forced landing. This GPS data was used in conjunction with the engine ECU data to determine the point of fluctuating engine RPM (Engine roughness) and loss of engine RPM/power.

Following the point of take-off the aircraft ascended and made multiple left hand turns with multiple altitude changes. From the point of take-off to the forced landing was approximately 19 minutes.

The aircraft was heading South East in a left hand climbing turn when the engine began to loose power following fluctuations in engine RPM (Engine running rough).
