# Continental Motors

## ENGINE EXAMINATION REPORT

| ENGINE MODEL | IO-470-C |
| FILE NUMBER | 17-377 |

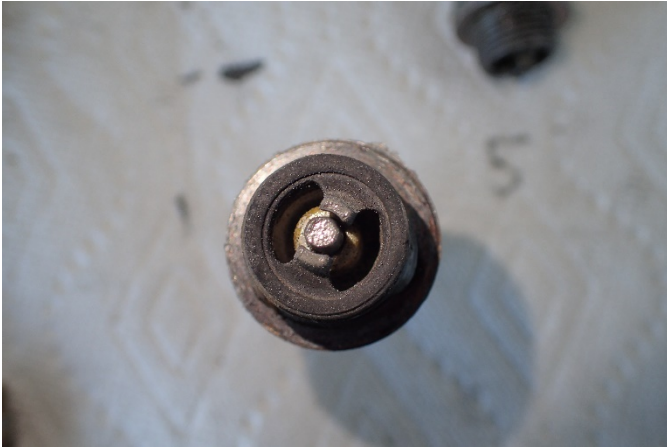
#3 Top Spark Plug

All of the spark plugs remained installed in their cylinders and were undamaged. The top spark plugs were removed from their cylinders and visually inspected. The top spark plugs displayed normal operating and wear signatures when compared with Champion Aviation Service Manual AV6-R. The bottom spark plugs were inspected using a lighted borescope; the #5 bottom spark plug was not examined due to being submersed in engine oil which was consistent with post-accident accumulation. The visible spark plugs displayed normal operating and wear signatures.
