# Continental Motors

## ENGINE RUN REPORT

**N6860W**

| ENGINE MODEL | TSIO-520-UB (12B) |

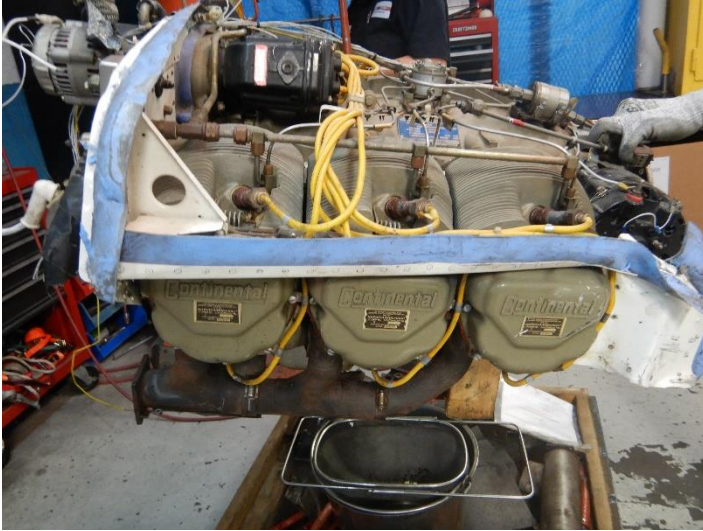
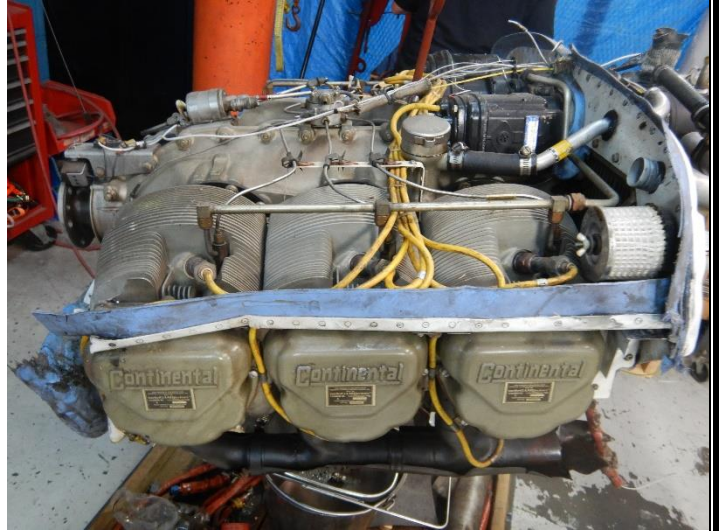
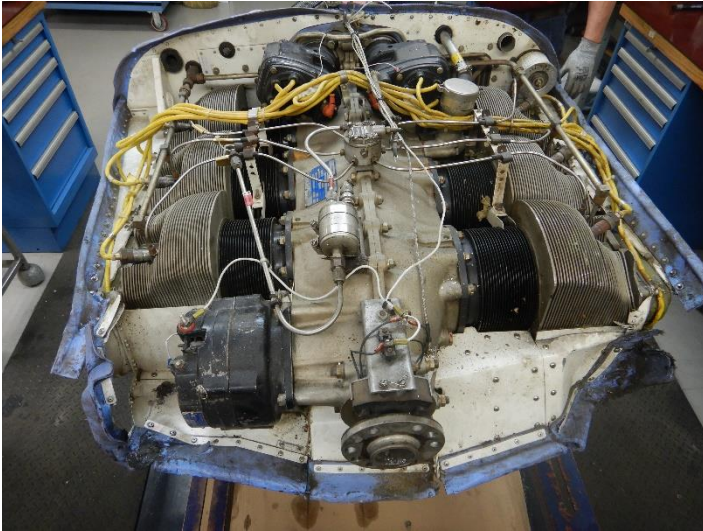
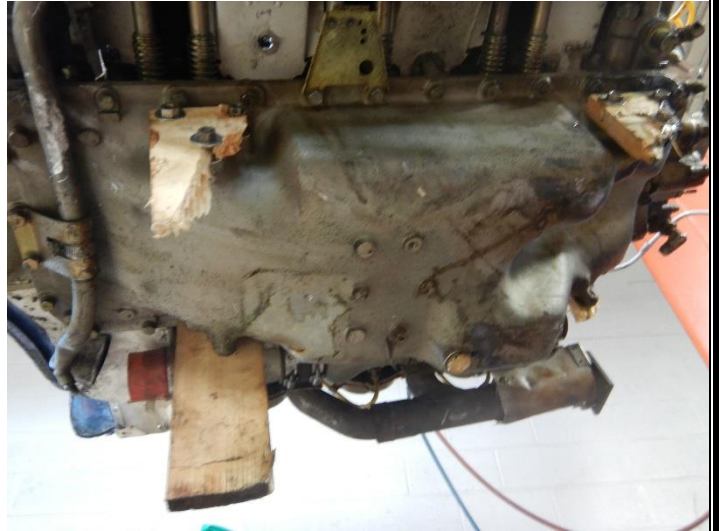
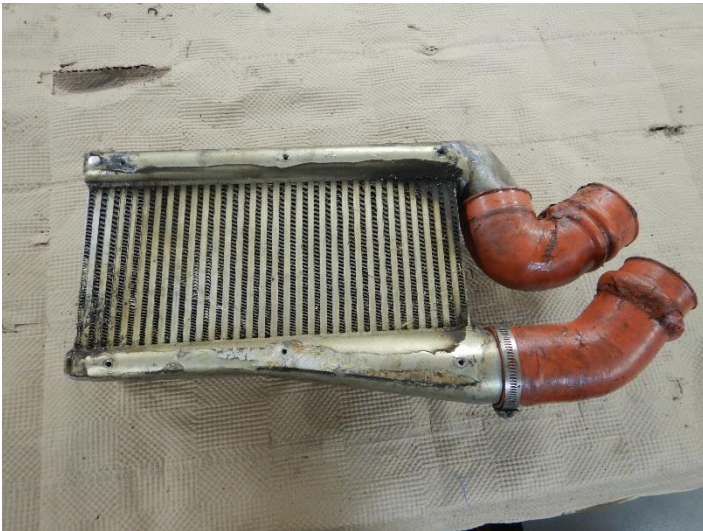
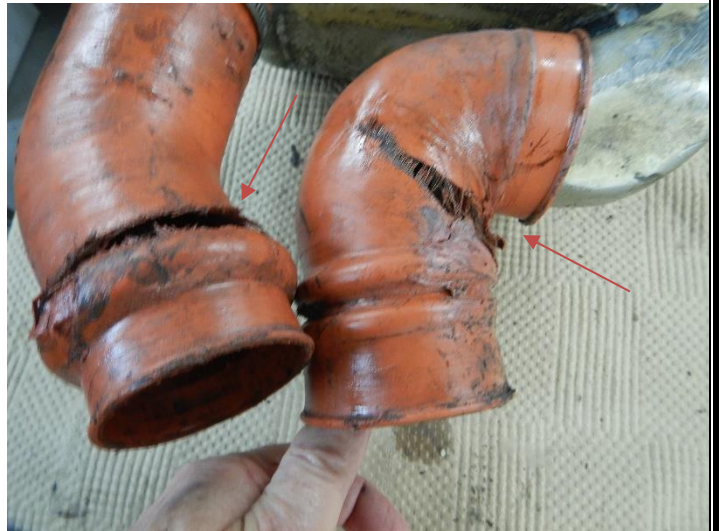
The engine was received in a shipping crate supplied by Continental Motors. The shipping crate was opened in the presence of the FAA Inspector who was acting as Governmental oversight approved by the NTSB IIC. All four engine mounts were broken as a result of impact damage. The exhaust system was crushed on the right and left side. The forward induction balance tube was impact damaged. The number 6 bottom ignition lead was damaged. The turbo discharge hose to the aftermarket intercooler was torn with oil saturation on the torn surface. The additional turbo discharge hose from the intercooler to the overboost valve was torn with evidence of red RTV repairs near the tear. The check-valve on the turbo oil feed was broken. The oil inlet fitting was damaged at the wastegate controller.

The turbocharger/tailpipe v-band clamp was damaged and consistent with side-overload caused by corresponding impact forces on the tailpipe.

Several exhaust flange nuts were missing:

Cylinder # 2- two exhaust nuts missing.

Cylinder # 4- three exhaust nuts missing.

Cylinder # 6- all four exhaust nuts missing.

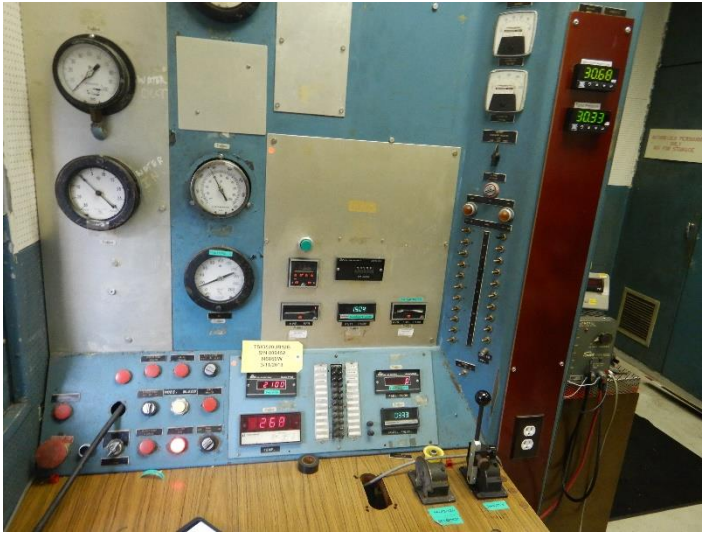
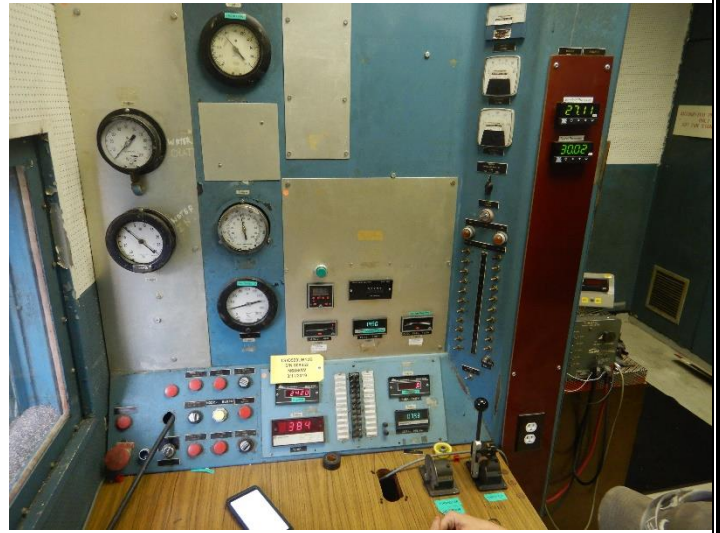
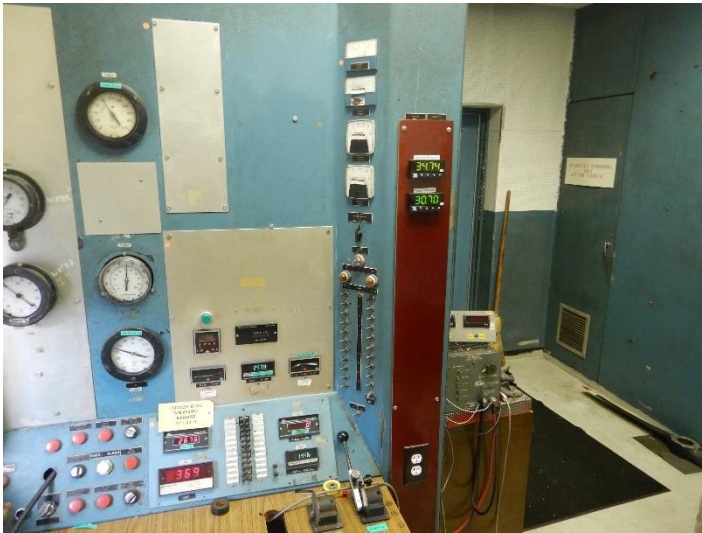
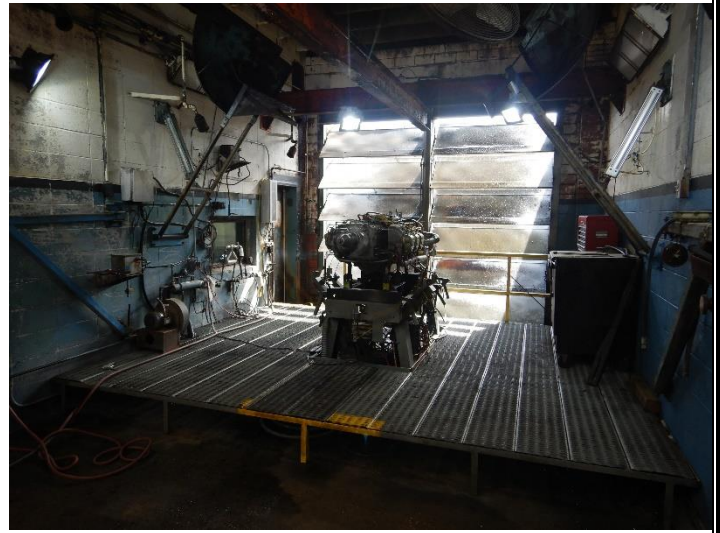
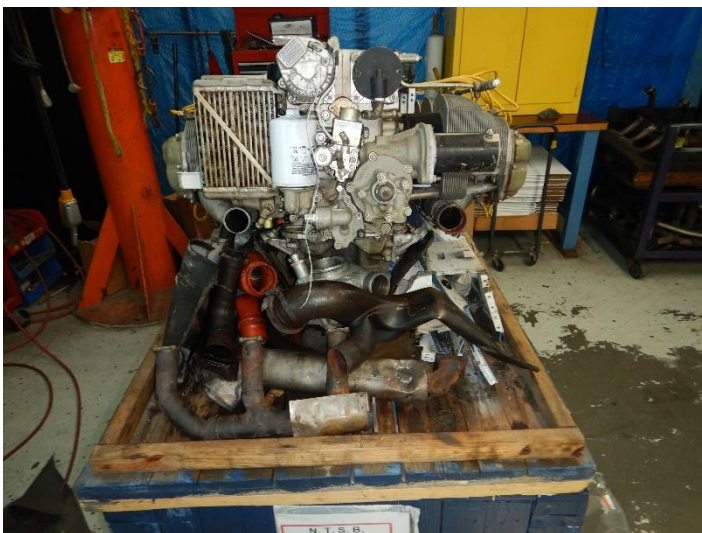
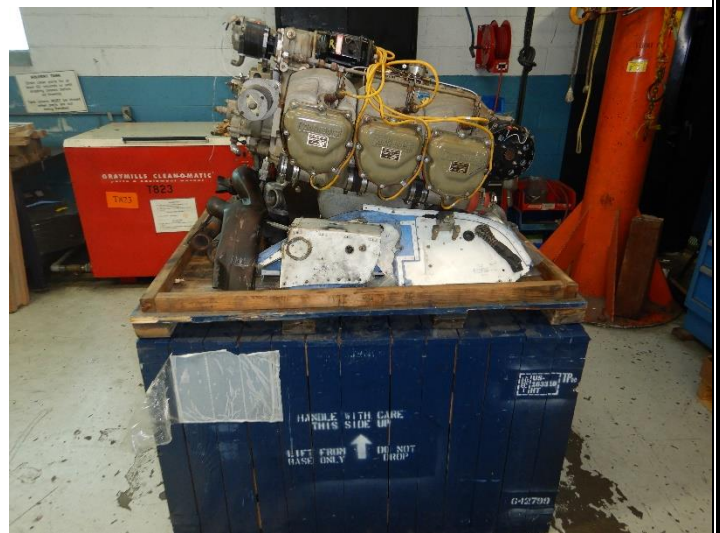
The engine experienced a normal start on the first attempt without hesitation or stumbling in observed RPM. The engine RPM was advanced in steps for warm-up in preparation for full power operation. The engine throttle was advanced to 1200 RPM and held for five (5) minutes to stabilize. The engine throttle was advanced to 1600 RPM and held for five (5) minutes to stabilize. The engine throttle was advanced to 2450 RPM and held for five (5) minutes to stabilize. The engine throttle was advanced to full open position and held for five (5) minutes to stabilize. The engine throttle was rapidly advanced from idle to full throttle five times where it performed normally without any hesitation, stumbling or interruption in power.
