Federal Aviation Administration (FAA)  
Flight Standard District Office (FSDO)  
Cincinnati, Ohio 4

NTSB accident # CEN18LA362 / FAA Accident # AGL0518010  
N2305K Accident at New Carlisle, OH August 31, 2018  
Report Written By Andrew Porter on September 26, 2018

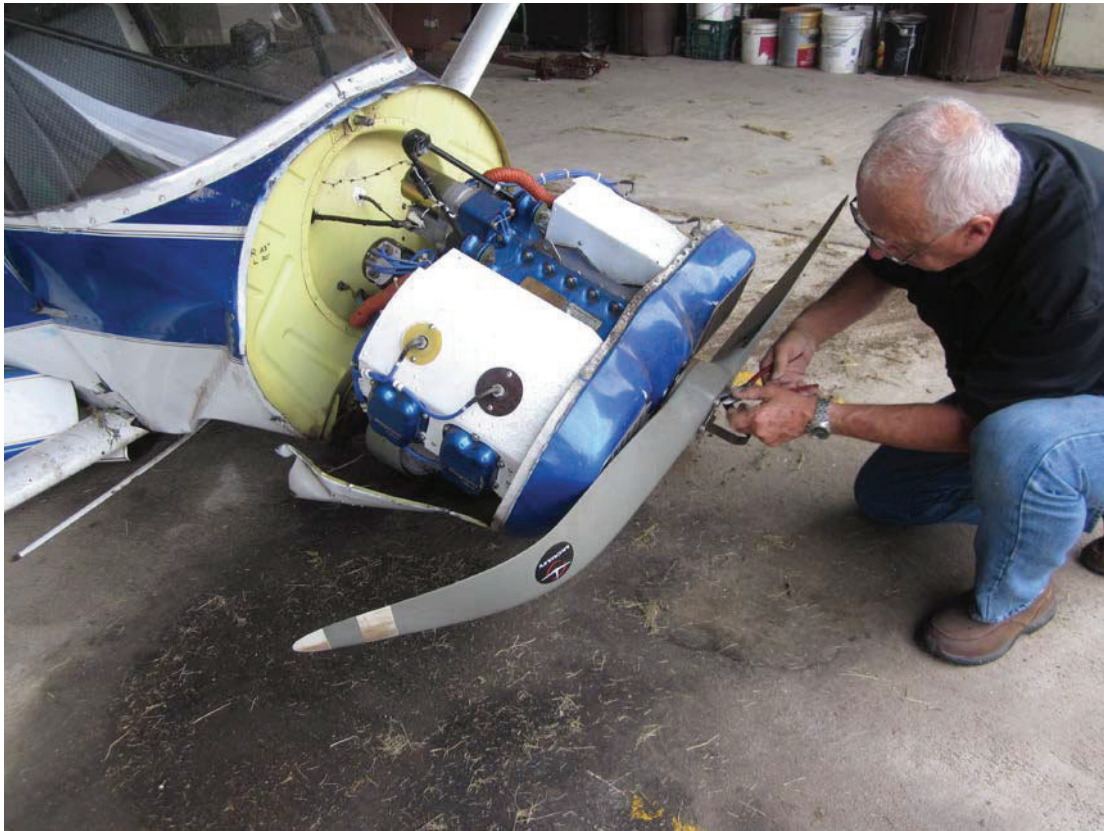
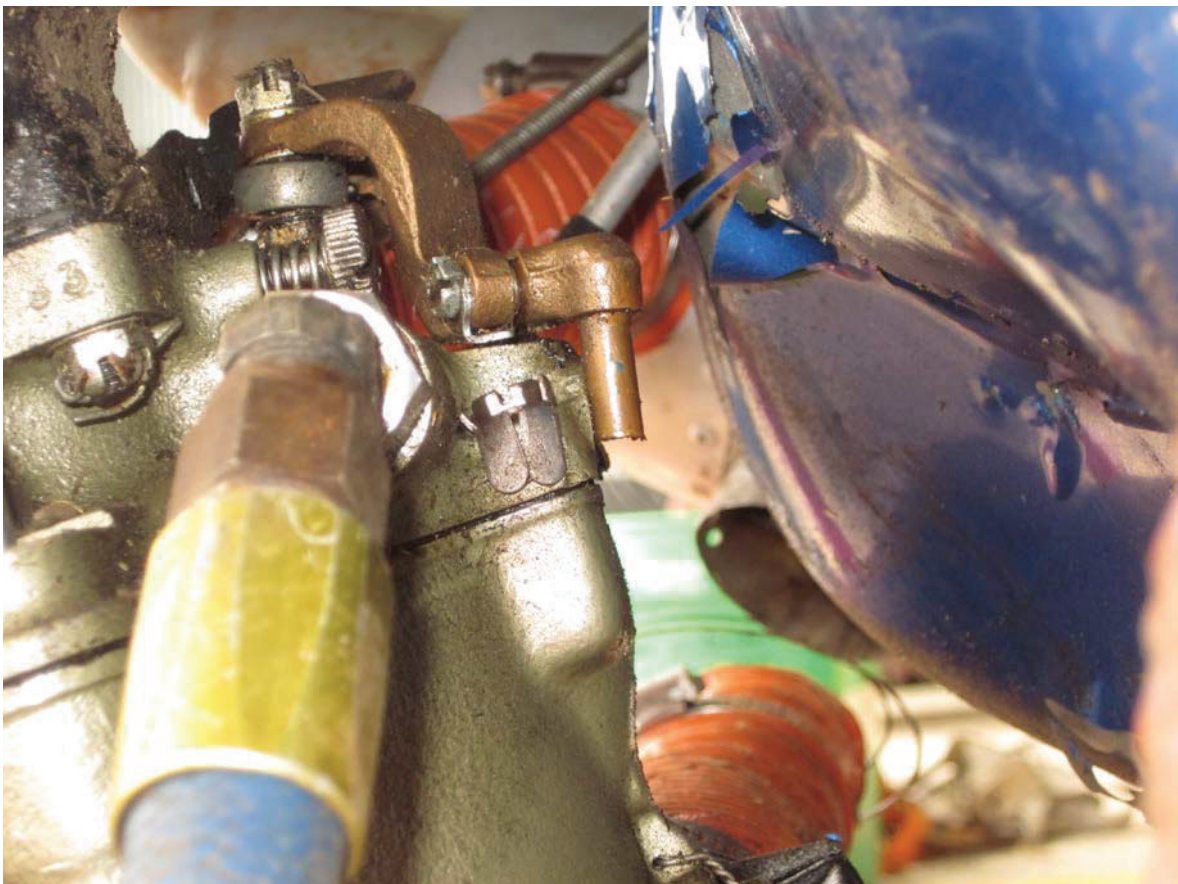
- #4 lower cylinder spark plug lead was found slightly loose (finger tight ). The lead could be move easily. There was no evidence of arcing on the lead or spark plug
- #4 lower cylinder spark plug was wet with oil, however no signs of burnt oil.
- #1 lower cylinder spark plug was wet with oil, however no signs of burnt oil.
- Both magnetos sparked normally.
- Each plug sparked to the case.
- Magneto timing checked good. Right mag 28 degrees BTDC, Left mag 30 degrees BTDC.
- Cylinder differential pressures were as follows:
  - #1: 74 psi.
  - #2: 72 psi.
  - #3: 74 psi.
  - #4 73 psi.
- Valve covers all removed, no issues found.
- the cylinders were boroscoped and some build up was seen was seen on the pistons and valves
