# Physical Analysis Report on CEN19FA018

Prepared by Binghamton University for the  
National Transportation Safety Board

December 10, 2018

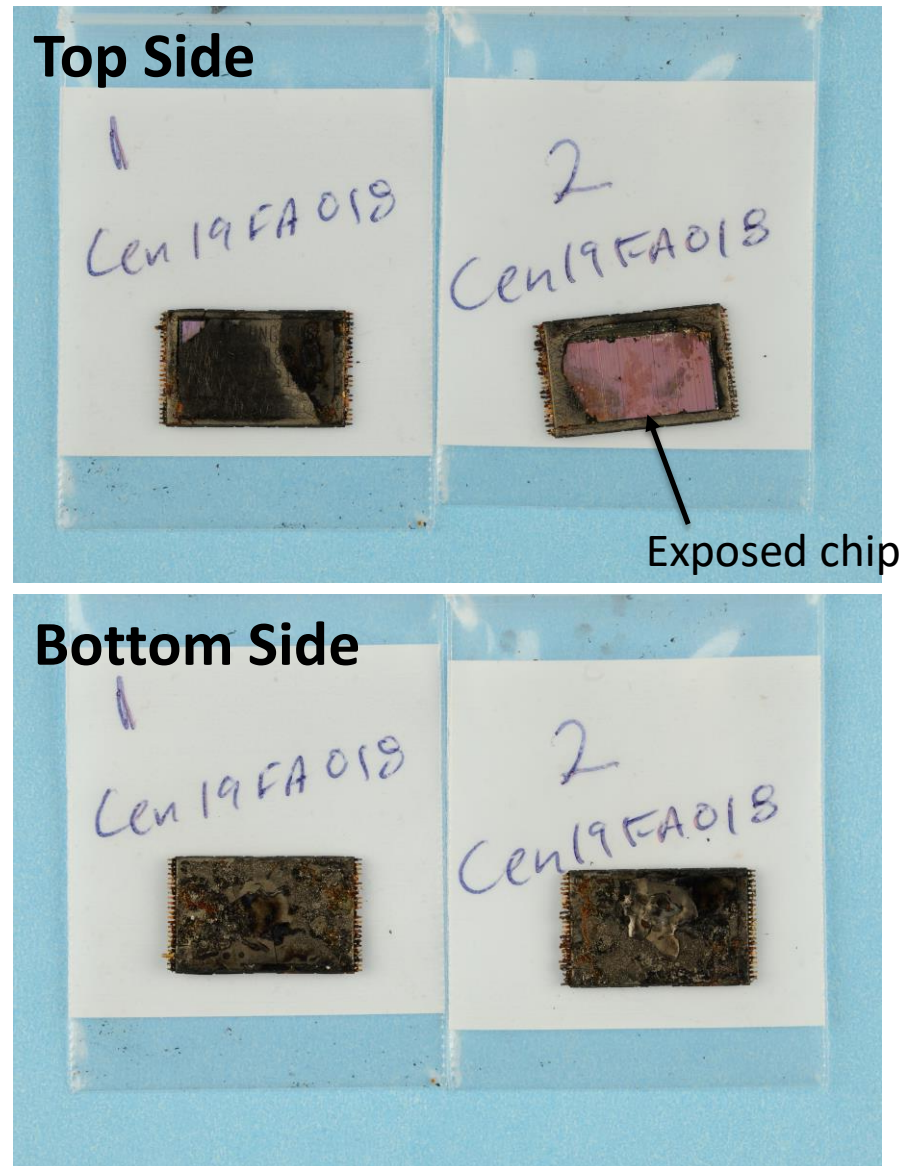
# Initial Images of the Two Modules

Modules were removed from their plastic bags and photographed from the top and from the bottom
