# Continental Motors

## ENGINE EXAMINATION REPORT

| ENGINE MODEL | GTSIO-520-L |
| AIRCRAFT REGISTRATION | N421NS |

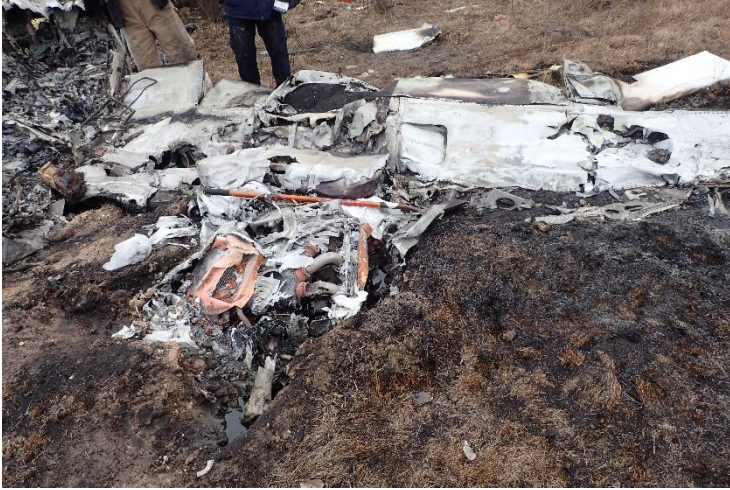
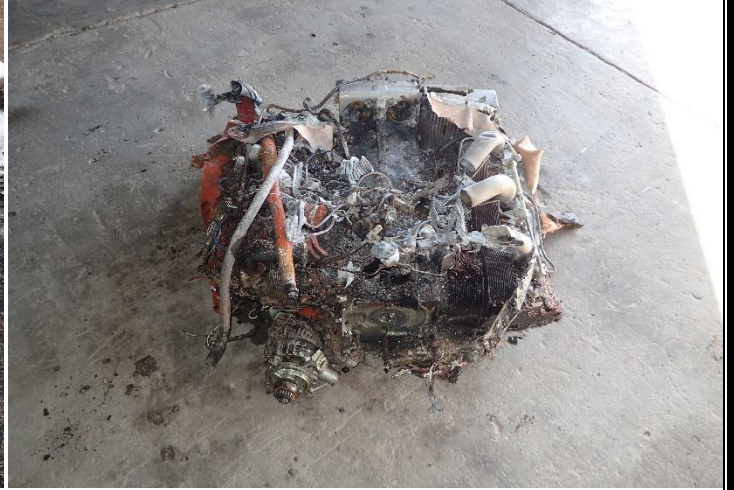
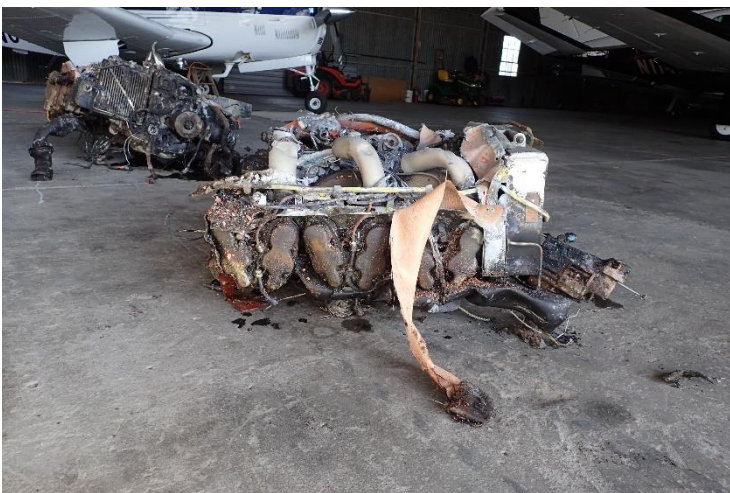
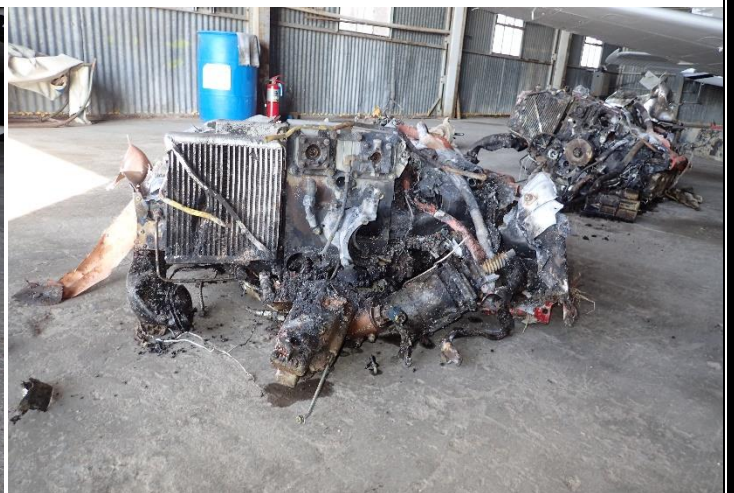
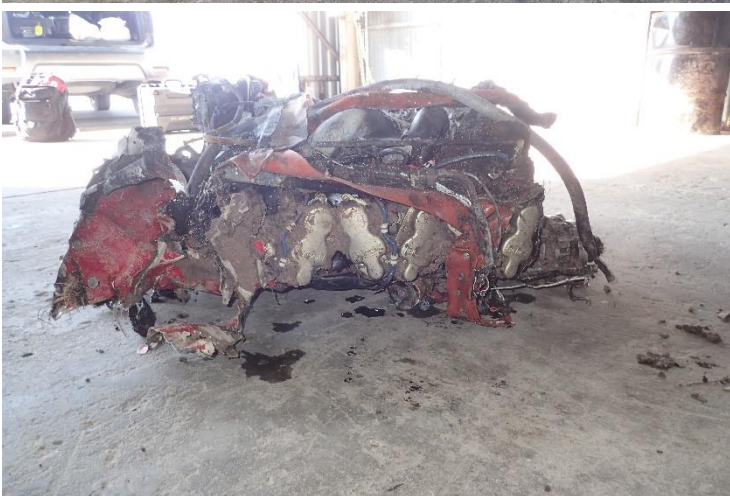
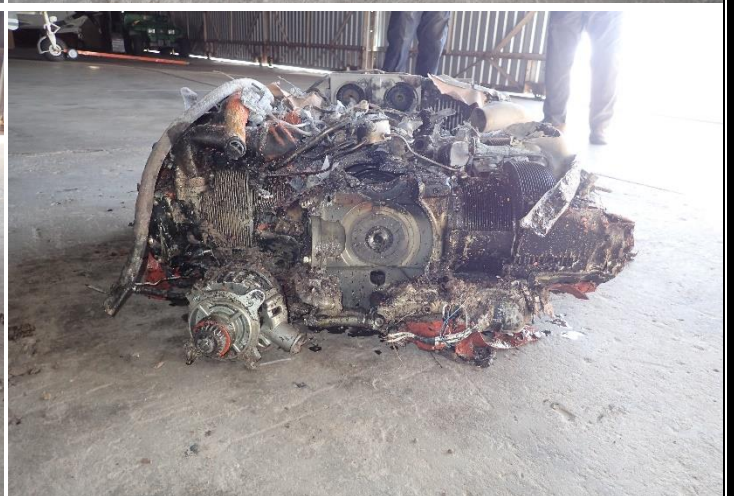
The engine sustained a significant amount of impact and thermal damage to the entire engine and its components. The forward portion of the crankcase that houses the propeller shaft and reduction gear had broken free from the rest of the crankcase; the damage was consistent with impact damage. The three blade, variable pitch propeller had broken free from the propeller shaft and all three propeller blades displayed varying amounts of impact damage. All six cylinders remained attached to the engine and displayed impact damage signatures with the most damage occurring to the bottom of the cylinders.

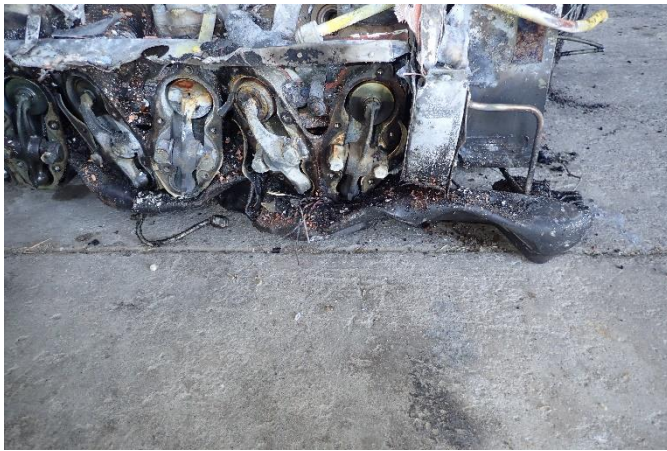
The exhaust system remained attached to the engine and displayed a significant amount of impact damage. The exhaust risers displayed the most impact damage and were crushed upwards against the engine; several of the risers were crushed almost completely flat. There were no signs of exhaust leaks noted.

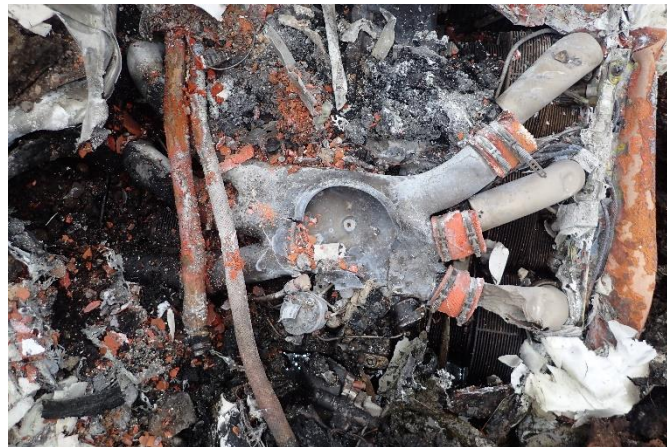
The induction system displayed a significant amount of impact and thermal damage signatures; several of the induction tubes had partially melted. There were no signs of induction leaks noted with the remaining induction tubes.

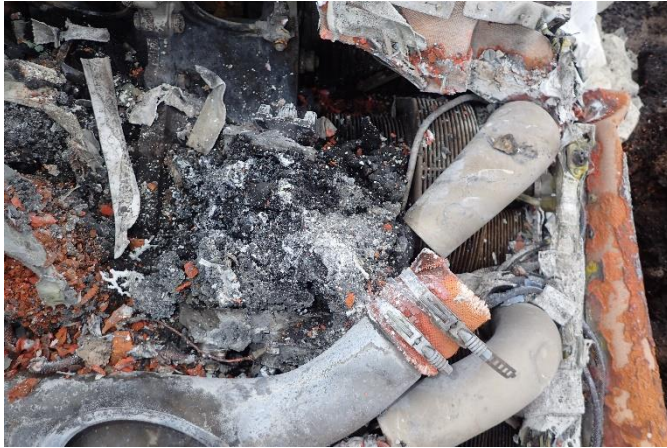
The magneto had broken free from its installation point and was almost destroyed by thermal forces; the housing had almost completely melted and all of the internal components displayed significant thermal damage.

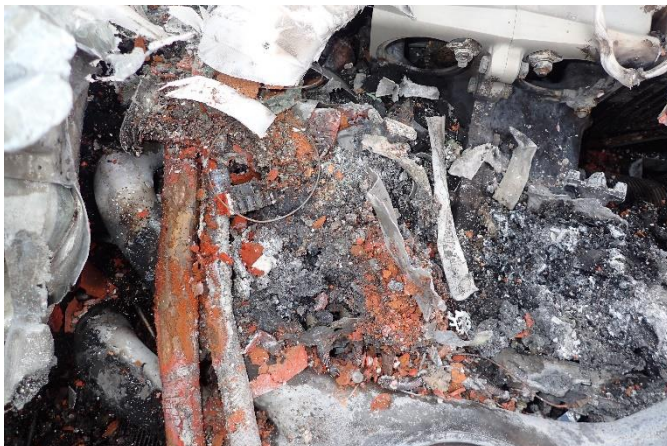
The magneto had broken free from its installation point and was almost destroyed by thermal forces; the housing had almost completely melted and all of the internal components displayed significant thermal damage.

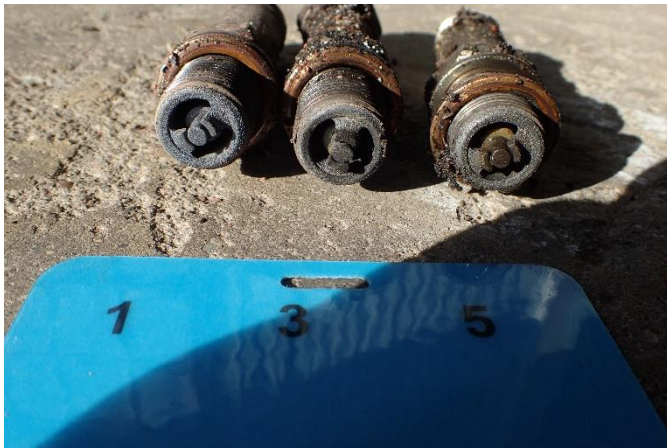
#1, #3, #5 Top Spark Plugs

Condition:

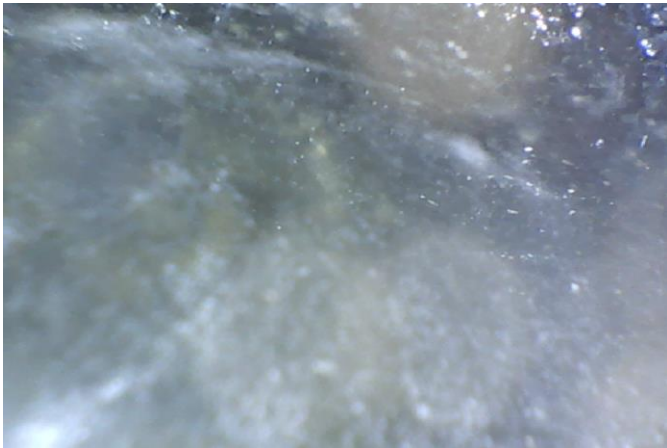
#3 Bottom Spark Plug (submersed)

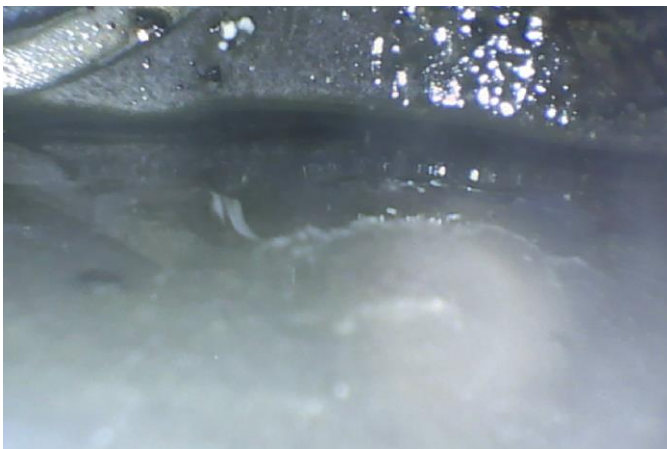
#5 Bottom Spark Plug (submersed)

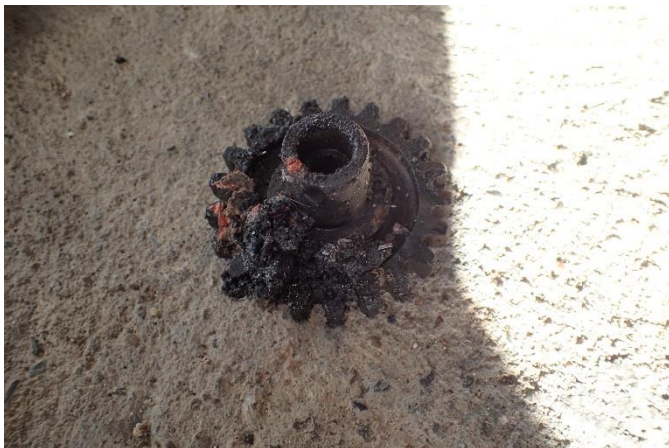
The fuel pump had broken free from its installation point and displayed a significant amount of impact damage signatures; several portions of the fuel pump were not located at the time of the examination. The fuel pump drive shaft and drive gear were located and were found to be intact. The fuel pump drive shaft and vanes were noted to have remained intact and displayed some impact damage signatures. There were no anomalies noted with the recovered portions of the fuel pump.

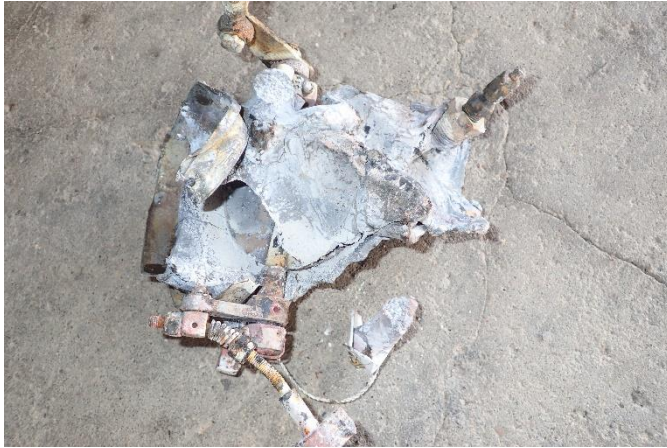
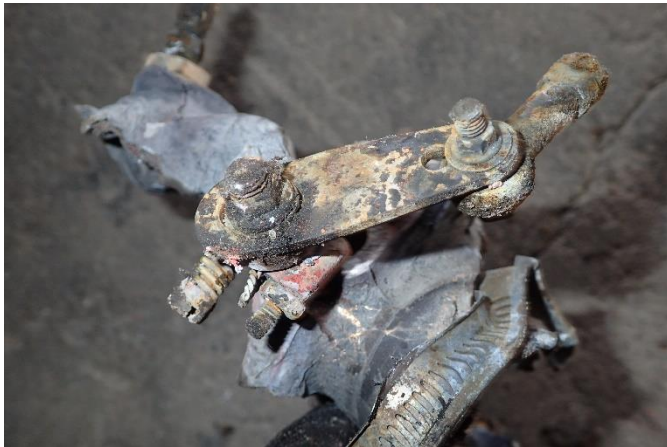
The throttle body and metering unit had broken free from its installation point and displayed a significant amount of impact and thermal damage signatures; the metering assembly had broken free from the throttle body and was not located at the time of the examination. There were no anomalies noted with the recovered portion of the throttle and metering assembly.

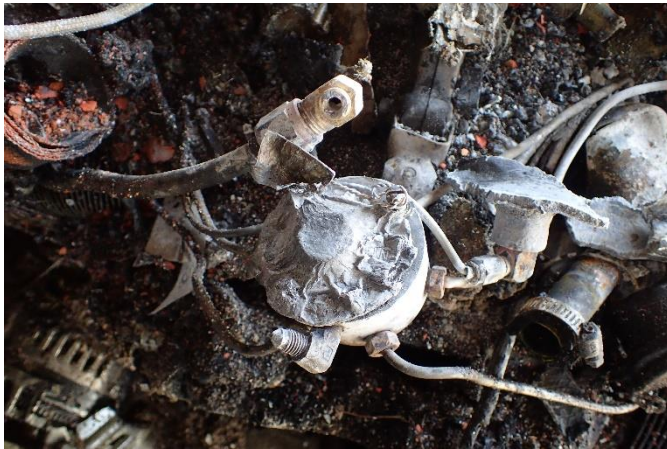
The fuel manifold valve remained partially attached to the engine and displayed some impact and a significant amount of thermal damage; the manifold valve cap had almost completely melted. The internal components displayed thermal damage signatures. There were no anomalies noted.

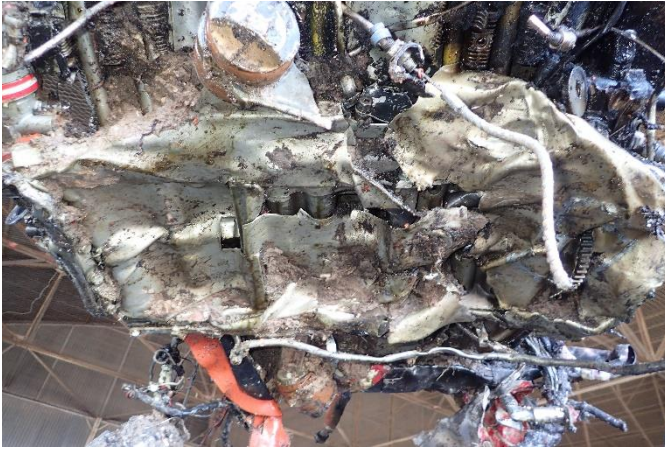
The oil sump displayed a significant amount of impact damage and was crushed upwards and was breached. There were no anomalies noted.

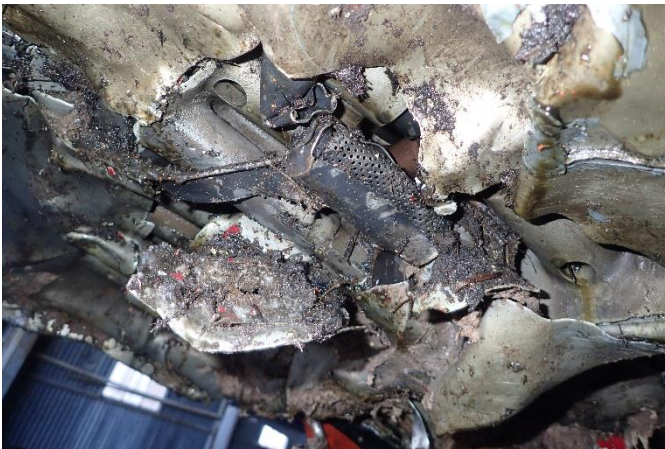
The oil pick-up tube and screen were visible through the broken oil sump. The pick-up tube and screen displayed significant impact damage signatures and the screen had material consistent with dirt/mud in the screen. There was no metallic material found in the oil pick-up screen. There were no anomalies noted.

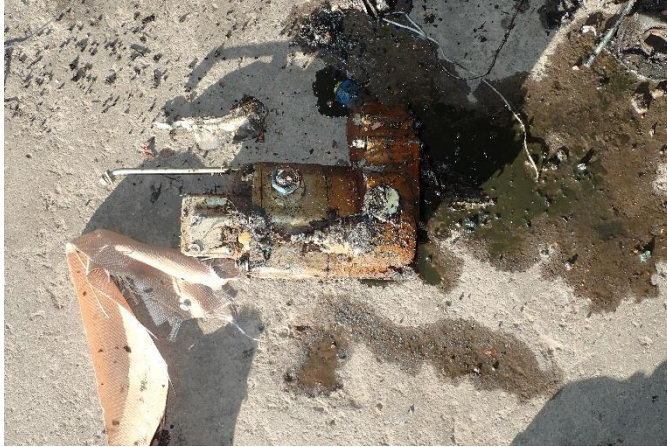
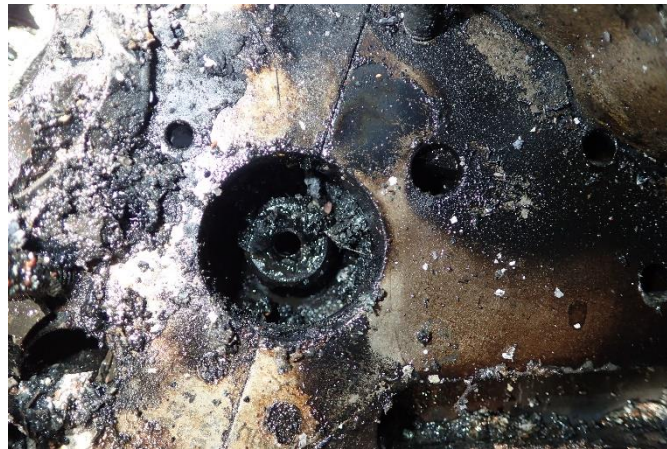
The oil pump had broken free from the engine and displayed a significant amount of impact damage signatures. It was noted that the oil pump drive shaft had broken, and a portion of the shaft remained within the camshaft gear; the damage was consistent with impact damage. There were no anomalies noted with the oil pump.

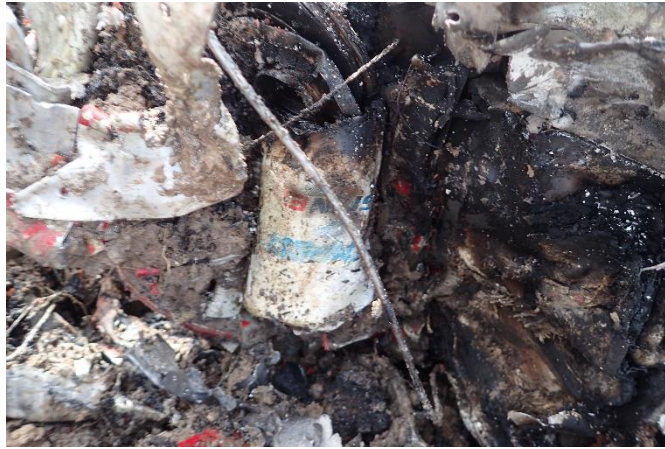
The oil filter remained partially attached to the oil filter adapter and displayed a significant amount of impact damage. Due to the impact damage the filter could not be removed.

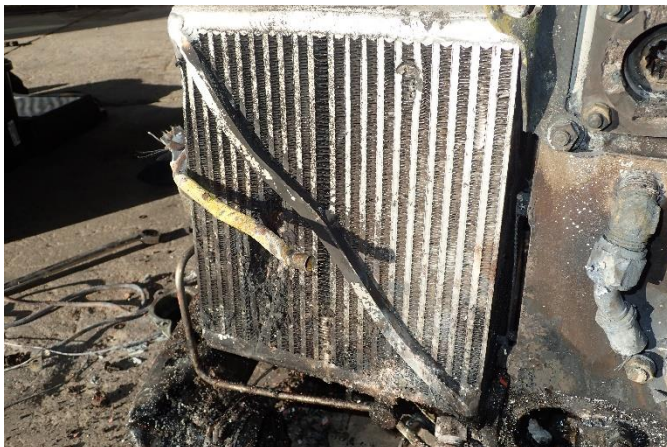
The oil cooler remained attached to the engine and displayed impact damage signatures. There were no anomalies noted with the oil cooler.

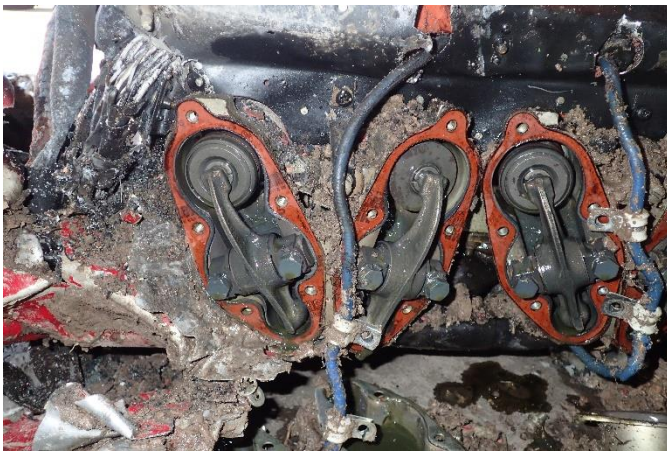
#1 Cylinder

The cylinders remained attached to their cylinder bays and displayed impact damage signatures with most of the damage occurring to the bottom of the cylinders. The cylinders were inspected using a lighted borescope. The cylinder bores, piston faces, and valve heads displayed normal operating and combustion signatures. The overhead components (springs, valves, and rocker arms) displayed thermal damage signatures to the left side cylinders; all of the overhead components also displayed normal operating signatures. All of the rocker arms and valve were capable of movement when actuating manually. There were no anomalies noted.

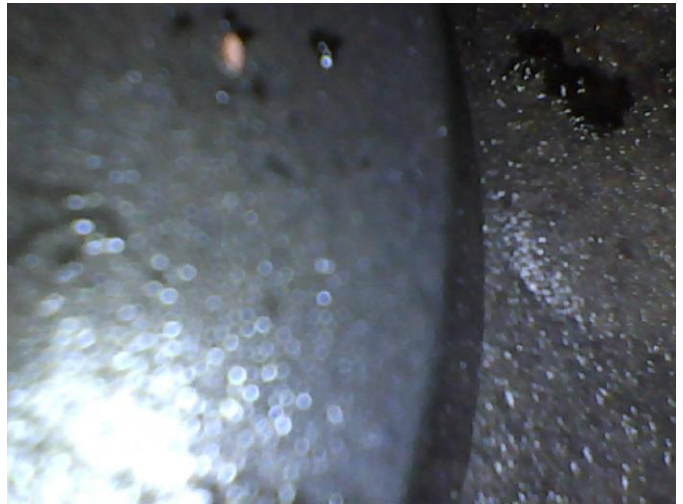
#1 Intake Valve

The valve heads were inspected using a lighted borescope; the valve heads displayed normal operating and combustion signatures. All of the valves were capable of movement when actuating the rocker arms manually; there were no anomalies noted.

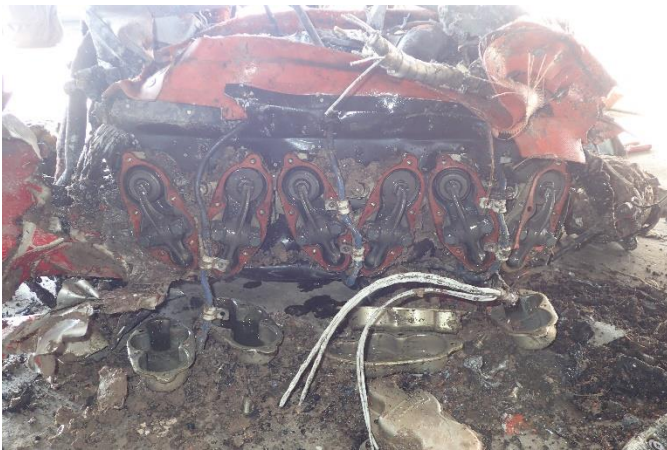
All of the rocker arms remained attached to their cylinders and displayed varying amounts of thermal damage signatures with the left side rocker arms showing the most thermal damage. The rocker arms also displayed normal operating signatures and were capable of movement when actuating the rocker arms manually.

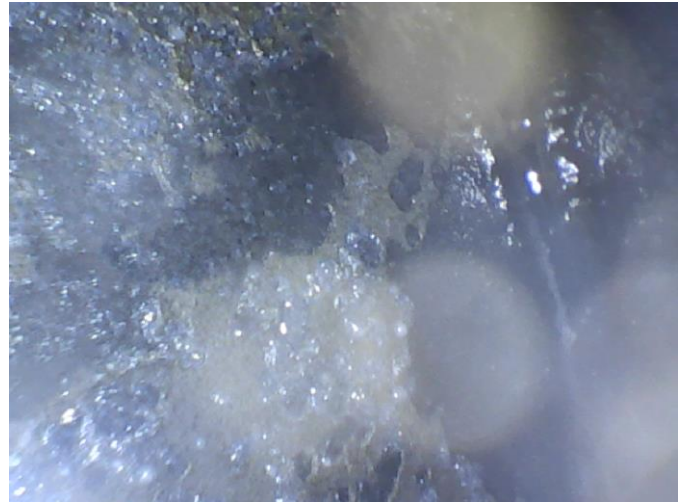
#3 Piston

All of the piston faces were inspected using a lighted borescope. The piston faces displayed normal operating and combustion signatures. There were no anomalies noted with the pistons.

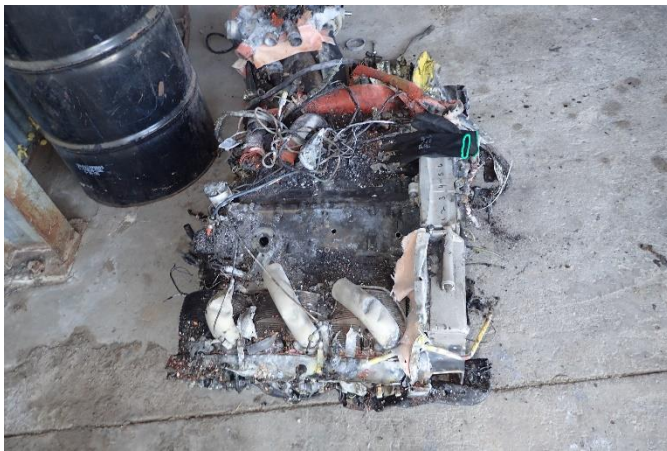
| CRANKCASE | Casting Number: | 1-3-5: Not observed | 2-4-6: Not observed | S/N: Not observed |
|---|---|---|---|---|
| Condition: | <p>The crankcase displayed a significant amount of impact damage with most of the damage occurring to the forward portion of the crankcase; the portion of the crankcase that houses the propeller shaft and reduction gear had broken free from the rest of the crankcase. There were no breaches in the crankcase that would indicate a catastrophic internal engine failure. Holes were drilled into the top of the crankcase to facilitate inserting a lighted borescope to inspect portions of the internal components; there were no anomalies noted with the visible internal portions of the crankcase.</p> | | | |

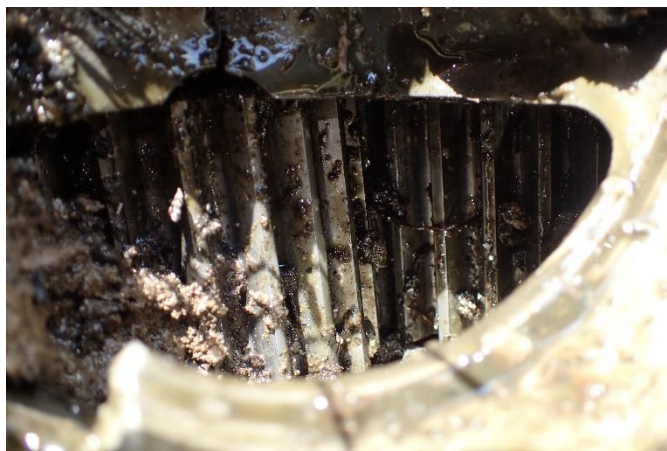
The reduction gear was partially visible through the broken crankcase; the visible portion of the reduction gear displayed normal operating signatures.

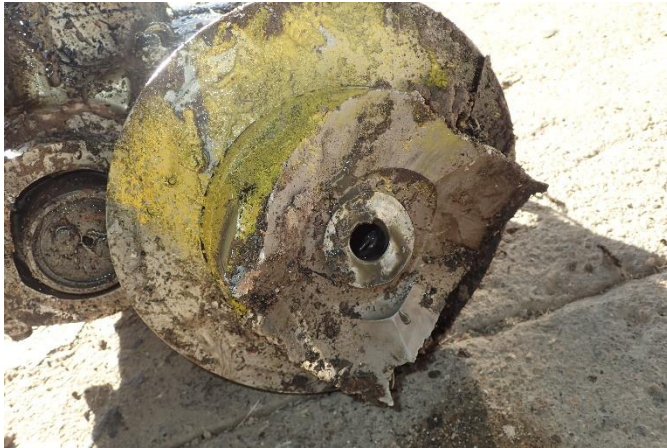
The propeller flange remained attached to the propeller shaft and displayed impact damage signatures. A portion of the rear part of the propeller shaft was visible and displayed impact damage and normal operating signatures.

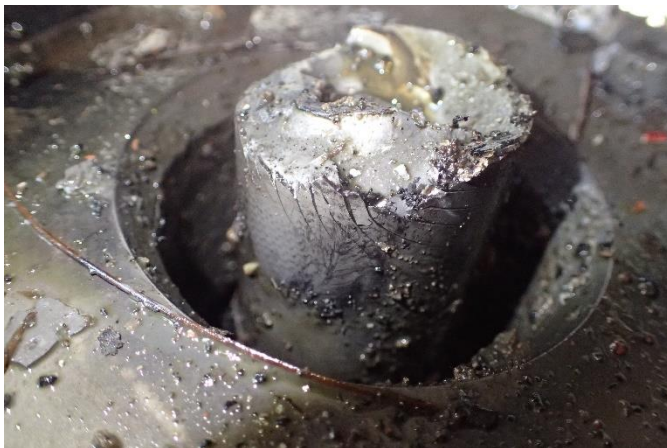
The quill shaft displayed impact damage signatures and was broken into two pieces. The fracture surface displayed some 45° cracks and ratcheting marks.

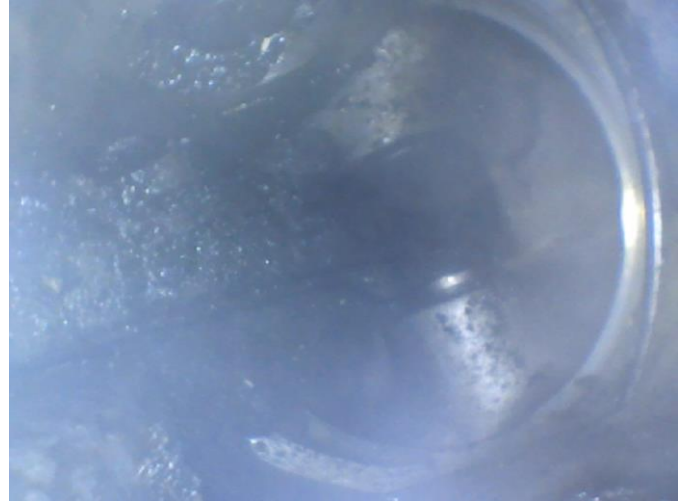
#3 Connecting Rod

The connecting rods were able to be partially inspected by drilling holes in the crankcase and inserting a lighted borescope. It was noted that all six connecting rods remained on their journal and there were no signs of lubrication distress to any of the rods.

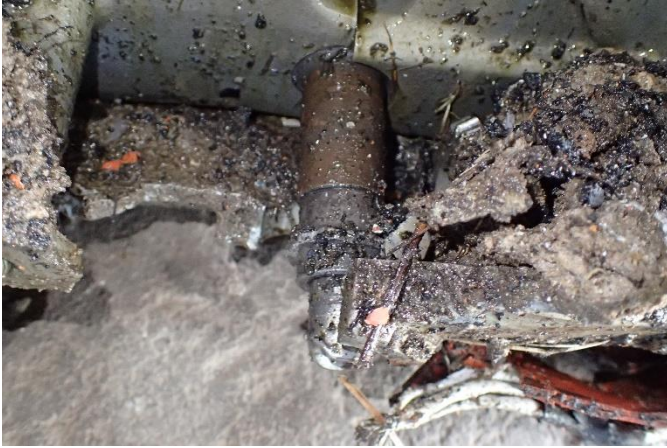
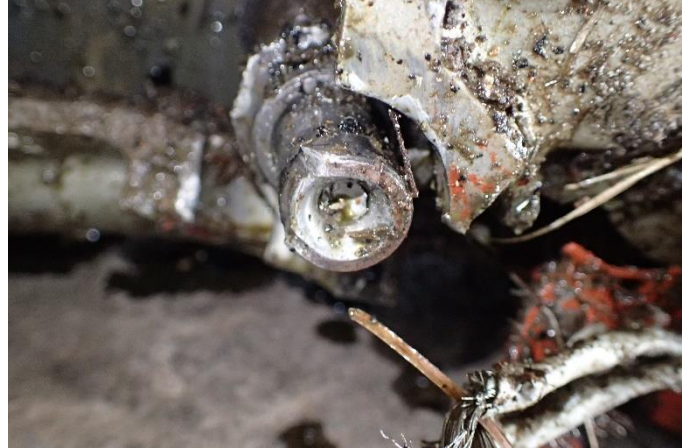
The forward portion of the camshaft was visible through the broken crankcase; the camshaft displayed impact damage signatures and a portion of the camshaft had broken free from the rest of the camshaft. The rest of the camshaft was partially visible by inserting a lighted borescope into drilled holes in the crankcase. The visible portions of the camshaft displayed normal operating and lubrication signatures.

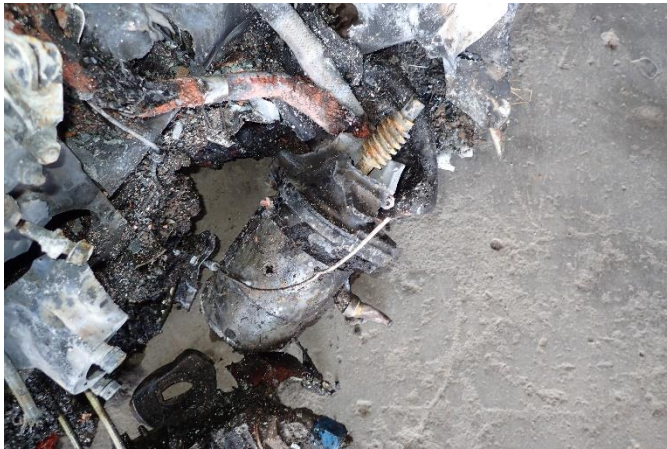
The starter remained attached to its mounting flange; however, the mounting flange had broken free from the rest of the starter adapter. The starter displayed impact and significant thermal damage signatures. There were no anomalies noted.

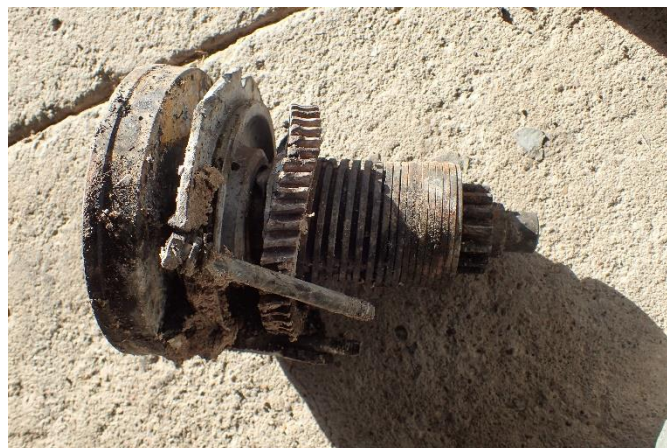
The starter adapter remained partially attached to its installation point and displayed a significant amount of impact damage and thermal damage. The adapter was removed, and it was noted that the gears displayed significant impact damage. There were no anomalies noted.

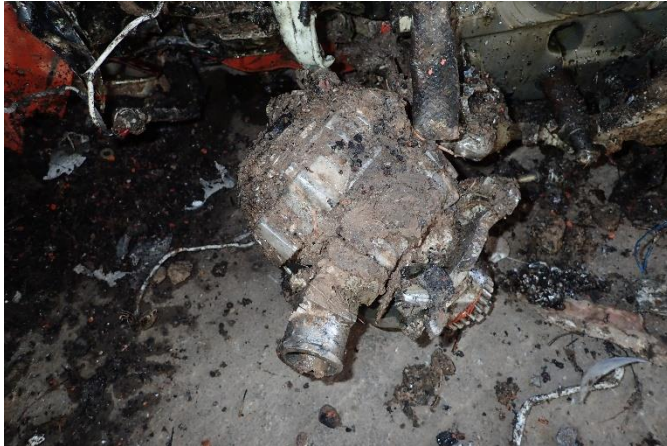
The alternator had broken free from its installation point and displayed significant impact damage signatures and the drive shaft was unable to be rotated. There were no anomalies noted.

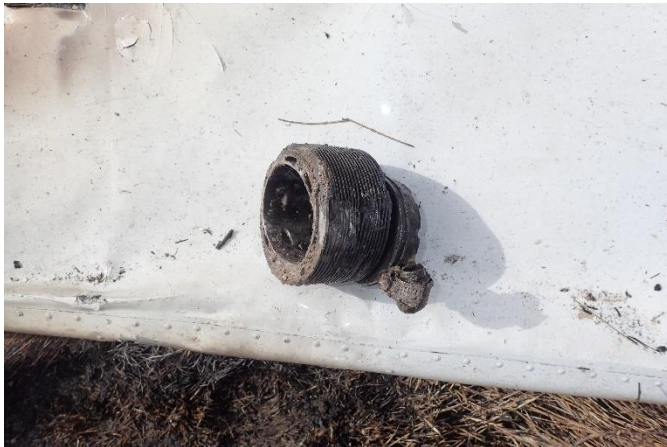
The vacuum pump had broken free from the engine and only the vacuum pump housing was located at the time of the examination. There were no anomalies noted with the recovered portion of the vacuum pump.

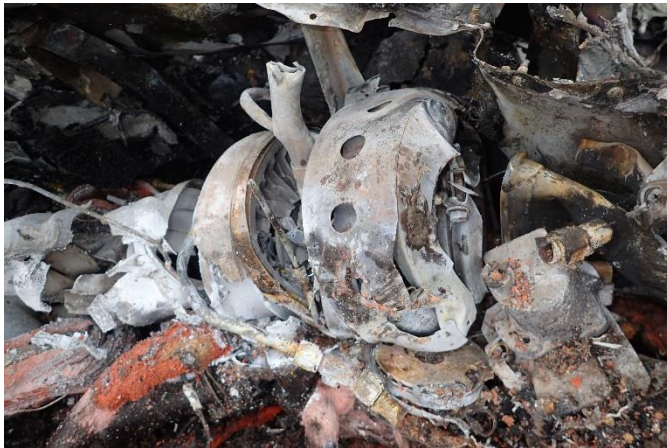
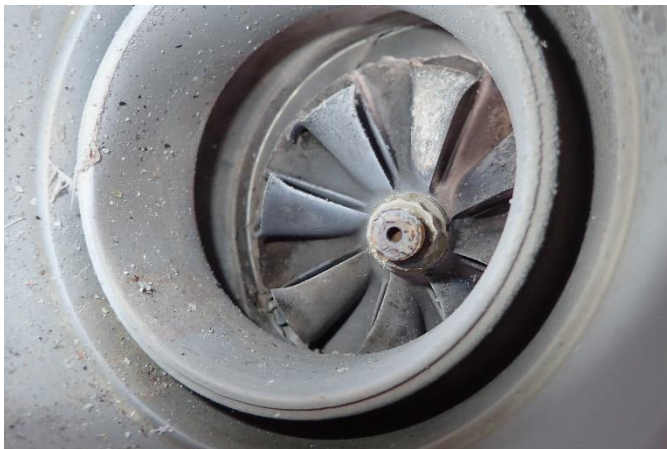
The turbocharger remained attached to its installation point and displayed impact and thermal damage signatures. It was noted that the V-band clamp remained attached to the turbocharger exhaust; however, the tailpipe had broken free from the turbocharger exhaust which was consistent with impact damage. It was noted that the turbine and compressor were unable to be rotated which was consistent with the impact and thermal damage. The compressor blades and turbine blades displayed normal operating signatures.

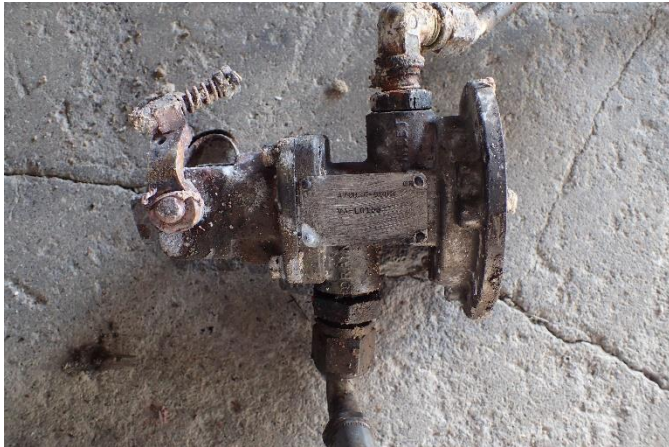
The turbocharger controller had broken free from its installation point and displayed a significant amount of impact damage signatures. There were no anomalies noted with the recovered portions of the controller.

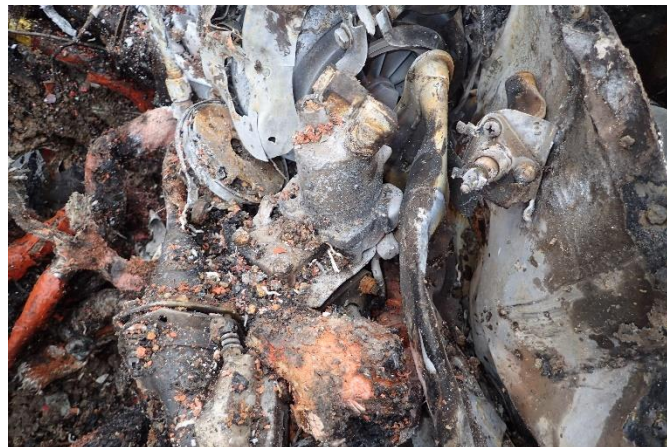
The wastegate remained attached to its installation point and displayed impact and thermal damage signatures. There were no anomalies noted with the wastegate.

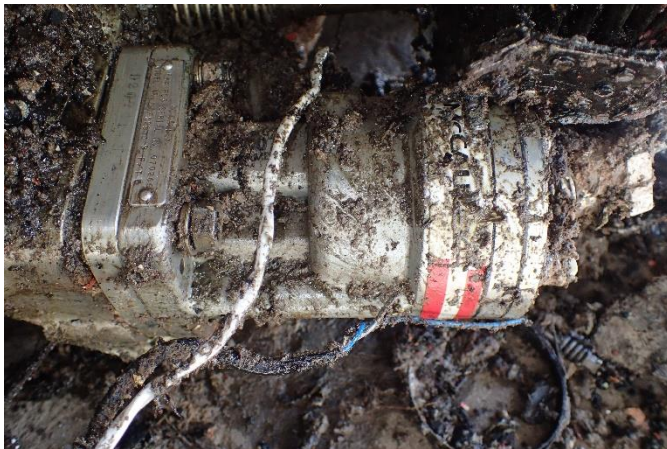
The propeller governor remained attached to its installation point and displayed impact damage signatures. There were no anomalies noted.

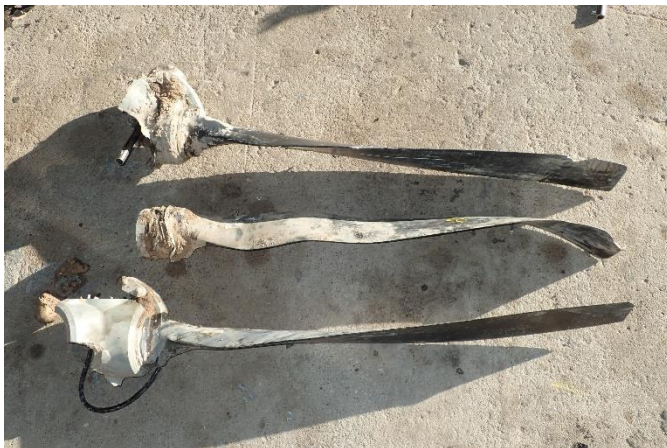
The three blade, constant speed propeller had broken free from the propeller shaft and the propeller hub was found to be fractured into multiple pieces. Two of the three propeller blades remained attached to portions of the propeller hub; the third propeller blade had completely separated from the propeller hub. The propeller blade marked "A" displayed a large gouge in the trailing edge, twisting deformation, leading edge polishing and chordwise scratches. The propeller blade marked "B" displayed S-bending deformation, significant polishing of the cambered side, and chordwise scratches. The propeller blade marked "C" displayed chordwise scratches and minor forward bending deformation.

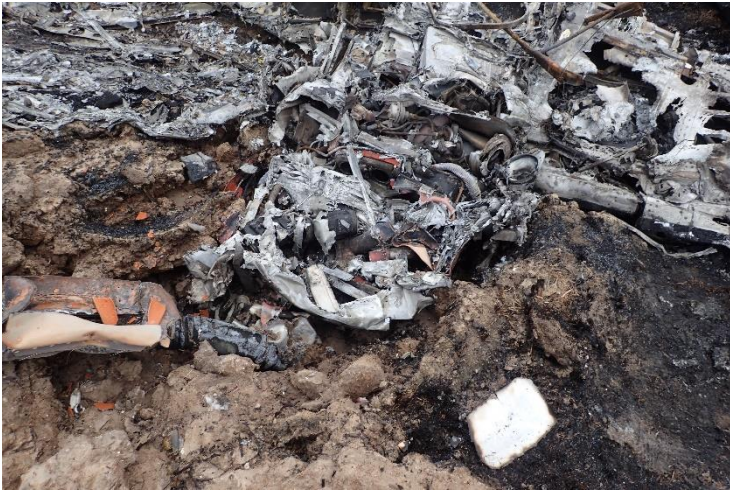
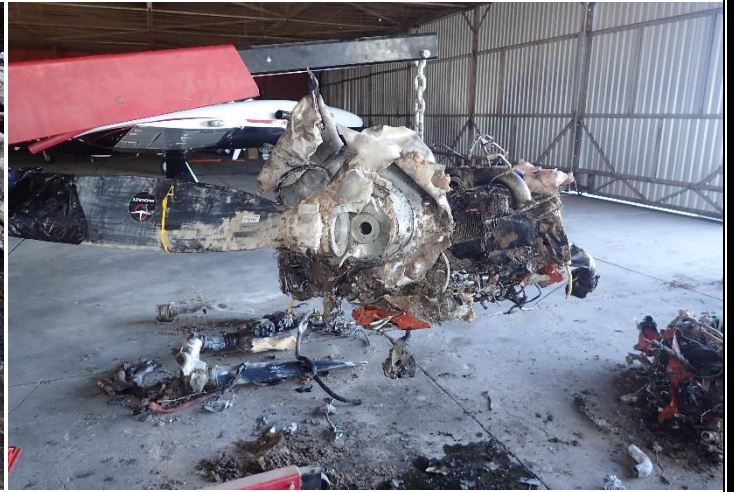
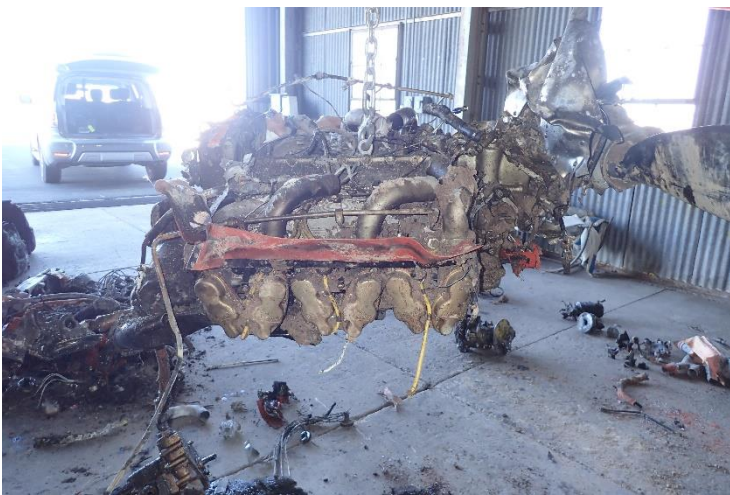
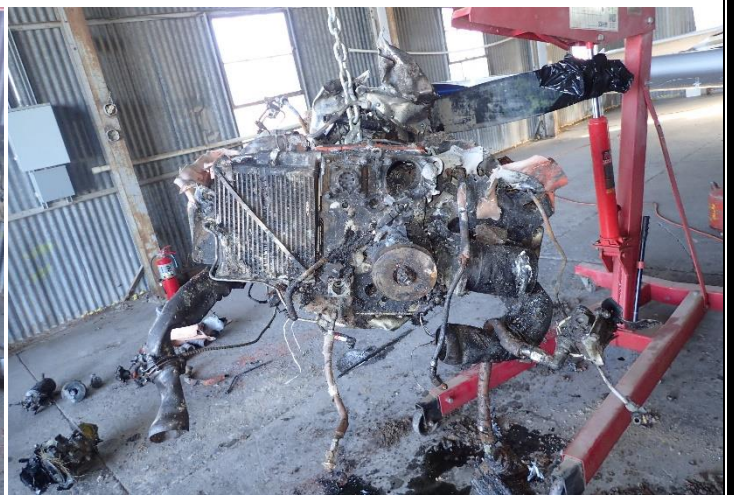
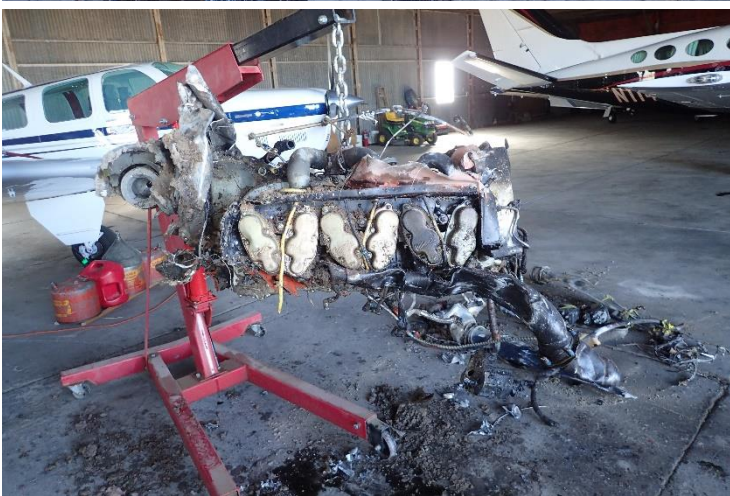
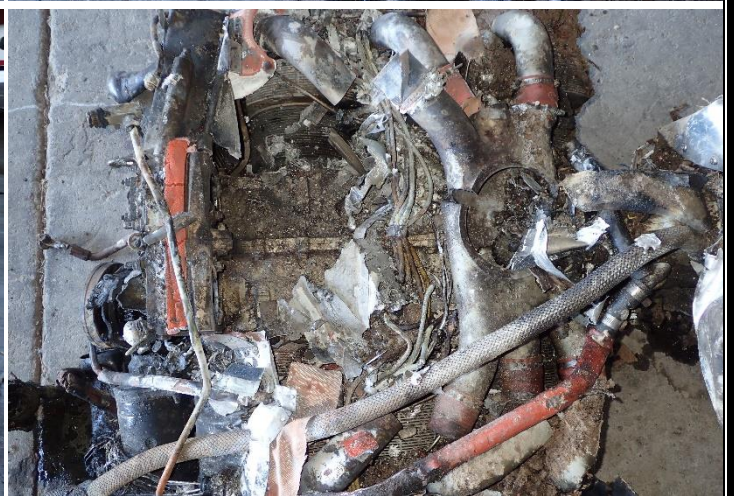
The engine remained partially attached to the airframe through hoses, cables, and wires; all four engine mounts had broken. The engine displayed a significant amount of impact damage signatures throughout the entire engine; the engine also displayed thermal damage signatures concentrated to the rear mounted accessories. The three blade, constant speed propeller remained partially attached to the propeller shaft; two of the three blades and portions of the hub had broken free. All three propeller blades displayed impact damage signatures. The crankcase displayed impact damage signatures and there were no breaches in the crankcase that would indicate a catastrophic internal engine failure. The forward portion of the crankcase that houses the propeller shaft and reduction gear assembly was noted to be cracked and slightly displaced consistent with impact damage. All six cylinders remained attached to their cylinder bays and displayed varying amounts of impact damage; the most damage occurred to the bottom of the cylinders.

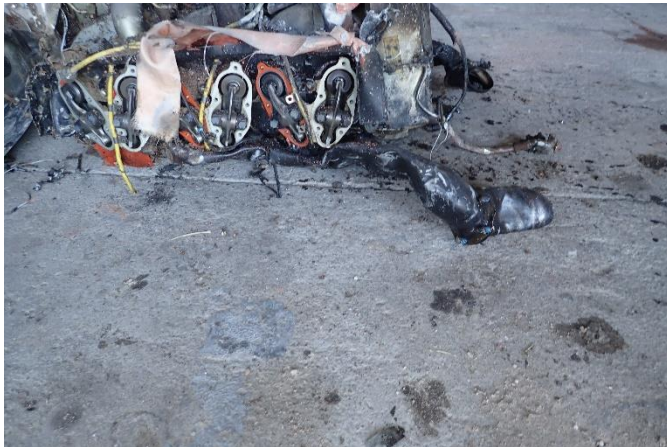
The exhaust system displayed a significant amount of impact damage signatures; the risers had crushed upwards and several of the risers were crushed almost completely flat in areas. The turbocharger V-band clamp was noted to have remained attached to the tailpipe; however, it had broken free from the turbocharger which was consistent with impact damage.

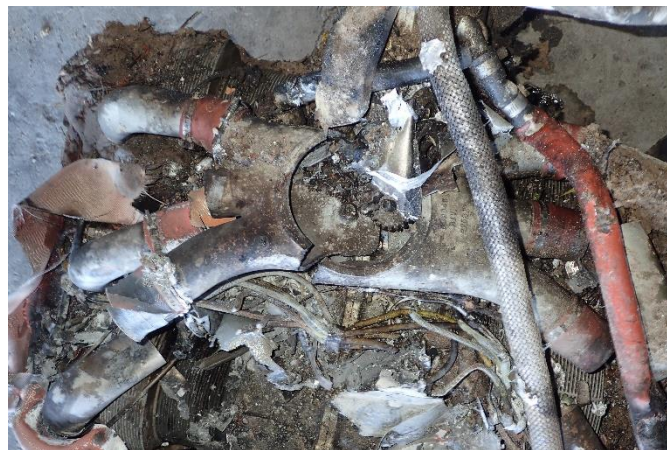
The induction system displayed a significant amount of impact damage signatures throughout the system. There were no signs of an induction leak or blockage noted.

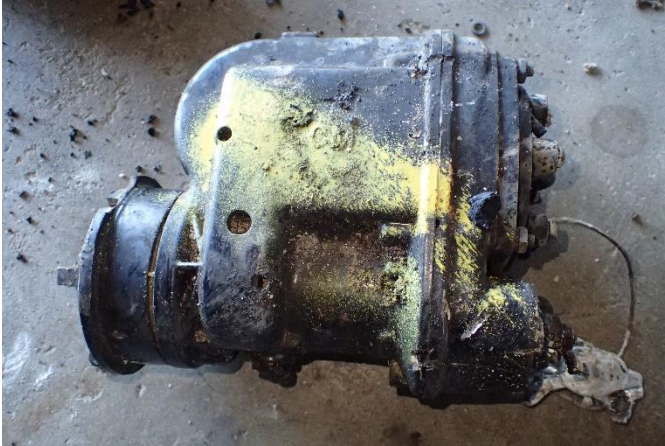
The magneto had broken free from its installation point and displayed impact and thermal damage signatures. The drive shaft was noted to be capable of rotation; however, it was noted that magneto was unable to produce a spark. The magneto was partially disassembled, and it was noted that all of the internal components displayed significant thermal damage signatures.

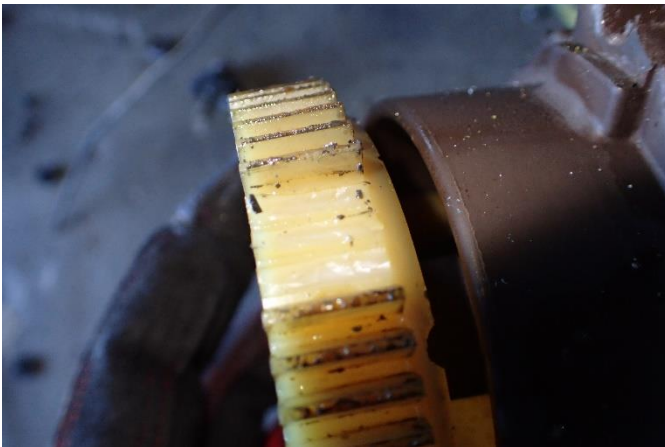
The magneto had broken free from its installation point and displayed impact and thermal damage signatures. The magneto drive was rotated, and it was noted that the driven gear was not rotating, and the magneto was unable to produce a spark. The magneto was disassembled, and it was noted that several gear teeth were broken that were in contact with the drive gear; there were no signs that the engine operated with the broken gear teeth and the damage was consistent with impact damage. The rest of the internal components displayed impact and thermal damage signatures.

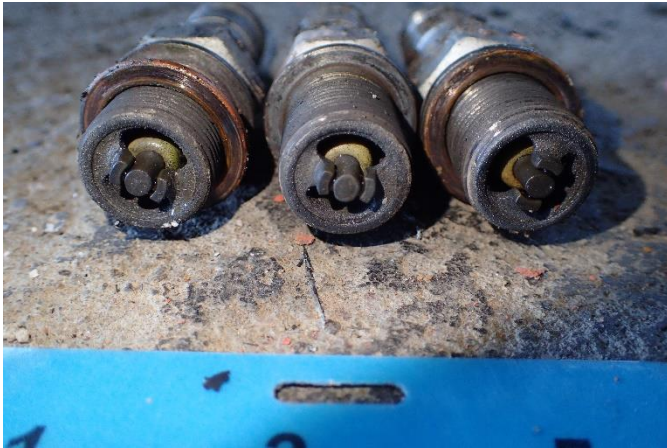
#1, #3, #5 Top Spark Plugs

All of the spark plugs remained installed in their cylinders and displayed varying degrees of impact damage with the bottom spark plugs showing the most impact damage. The top spark plugs were removed and their electrodes were visually inspected; the electrodes displayed normal operating and wear signatures. The bottom spark plugs were inspected using a lighted borescope; it was note that the #1, #5, and the #4 bottom spark plugs were completely submersed in oil and were not visible, the #3 and the #2 bottom spark plugs were submersed in water and were partially visible. The visible electrodes displayed normal operating and wear signatures.

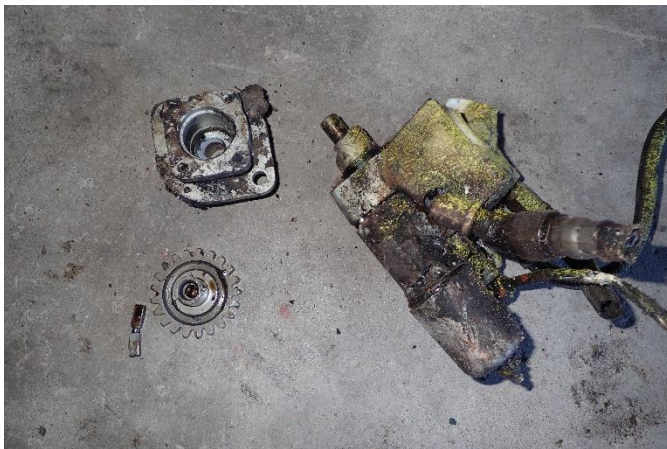
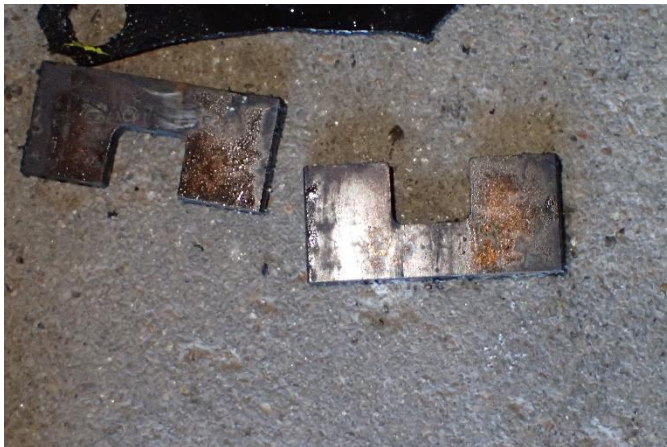
The fuel pump had broken free from its installation point and displayed impact and thermal damage signatures. It was noted that the fuel pump drive coupling remained with the drive gear and was bent; the damage was consistent with impact damage. It was noted that the fuel pump drive shaft was capable of rotation. The fuel pump was disassembled, and the internal components were visually inspected; the components displayed impact damage, some thermal damage, and normal operating signatures. There were no anomalies noted.

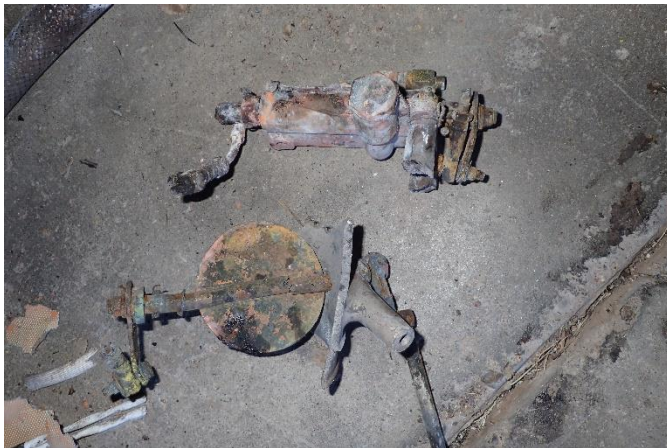
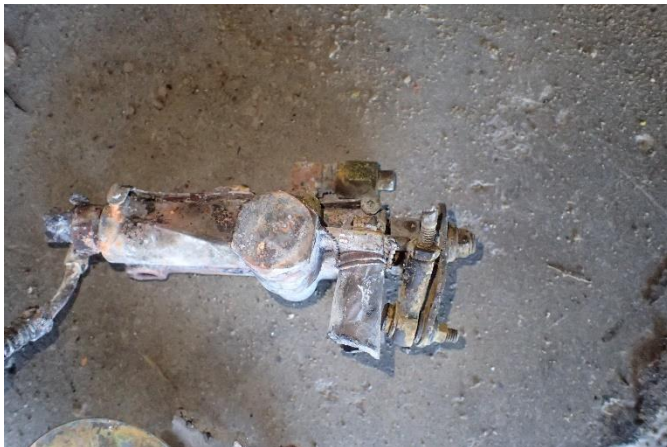
The throttle and fuel metering assembly had broken free from its installation point and displayed significant impact and thermal damage signatures. The metering assembly had broken free from the throttle body and most of the throttle body had broken free from the throttle valve. It was noted that the mixture and throttle control cable rod ends remained secured to their control arms. The fuel inlet screen was removed and was noted to contain a small amount of burnt debris but was not blocked. There were no anomalies noted.

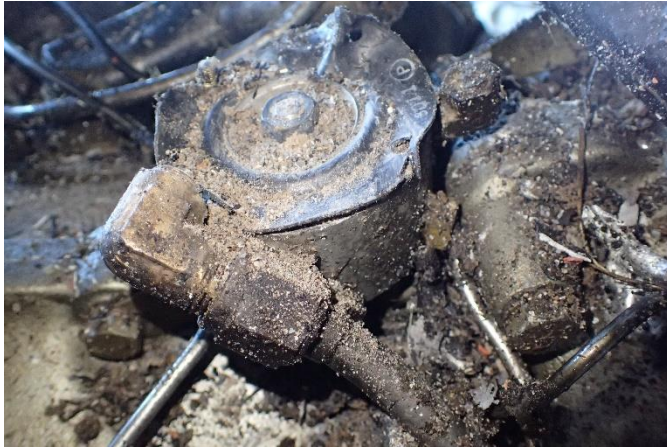
The fuel manifold valve remained partially attached to the engine through the fuel lines. The valve displayed a significant amount of impact damage; the fuel manifold valve cap had broken free from the rest of the valve and the diaphragm was torn. The internal components displayed impact damage and were covered in material consistent with dirt. There were no anomalies noted.
