# Continental Motors

## ENGINE EXAMINATION REPORT

| ENGINE MODEL | GTSIO-520-L |
| AIRCRAFT REGISTRATION | N421NS |

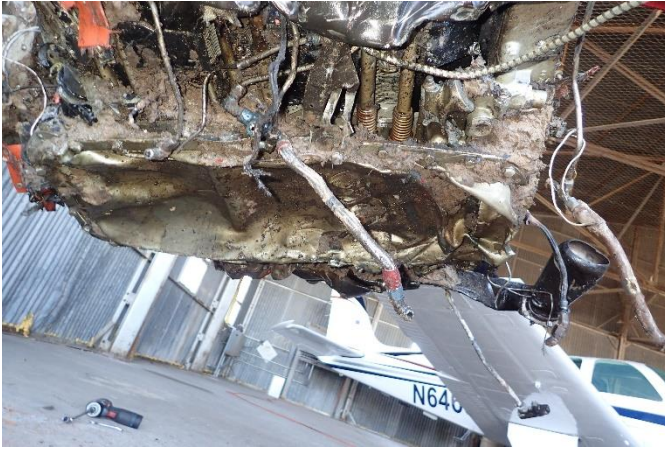
The oil sump displayed a significant amount of impact damage and was crushed upwards and breached. There were no anomalies noted.

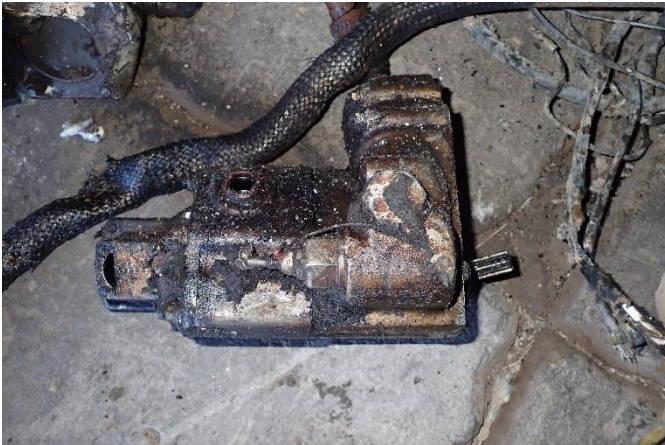
The oil pump had broken free from its installation point and displayed a significant amount of impact damage and some thermal damage signatures. The oil pump drive shaft was noted to be partially broken which was consistent with impact damage.

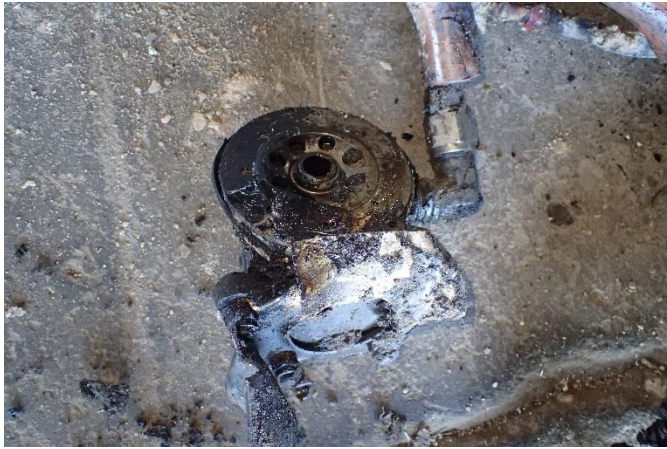
The oil filter had broken free from the oil filter adapter and was not located at the time of the examination.

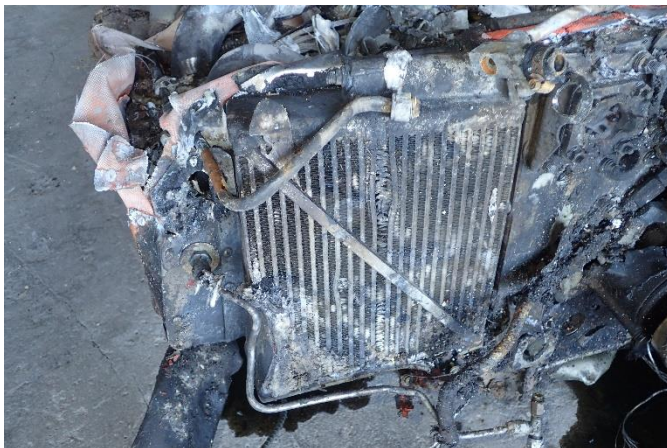
The oil cooler remained attached to the engine and displayed a significant amount of impact damage and some thermal damage signatures. There were no anomalies noted with the oil cooler.

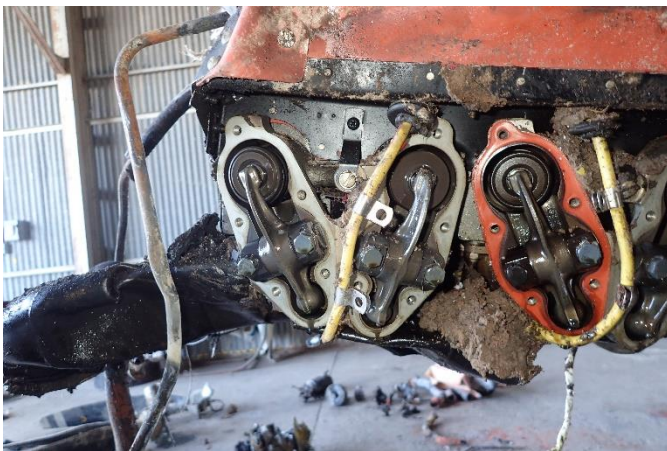
#1 Cylinder

All six cylinders remained attached to their cylinder bays and displayed impact damage signatures with the bottoms of the cylinders showing the most damage. All of the cylinders were inspected using a lighted borescope; the valve heads, cylinder bores, and piston faces displayed normal operating and combustion signatures. The overhead components (valves, springs, and rocker arms) displayed normal operating and lubrication signatures. All of the rocker arms and valves were capable of movement when actuating the rocker arms manually.

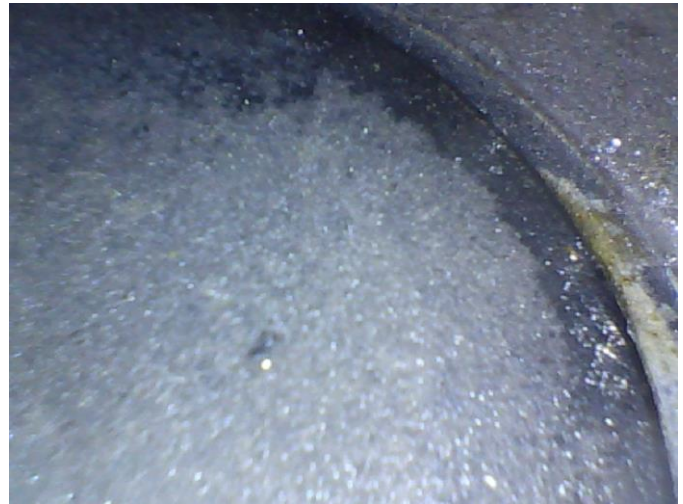
#1 Intake Valve

The valve heads were inspected using a lighted borescope. The valve heads displayed normal operating and combustion signatures. It was noted that the valves were capable of movement when the rocker arms were actuated manually.

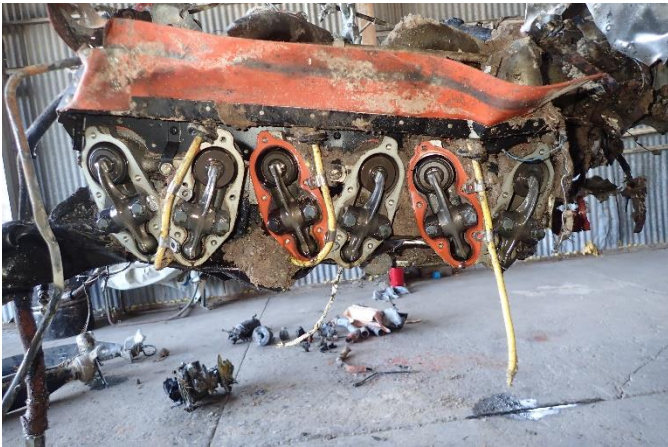
The rocker arms remained attached to their installation points and displayed normal operating and lubrication signatures. The rocker arms were operated manually, and it was noted that all of the rocker arms were capable of movement.

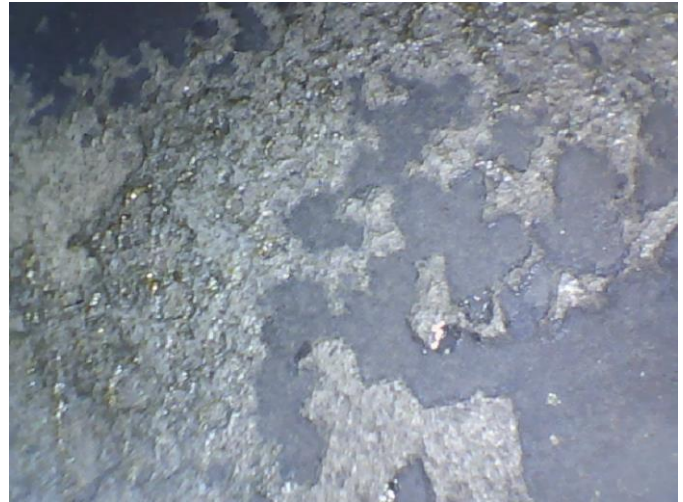
#3 Piston

The piston faces were inspected using a lighted borescope. The piston faces displayed normal operating and combustion signatures. There were no anomalies noted with the pistons.

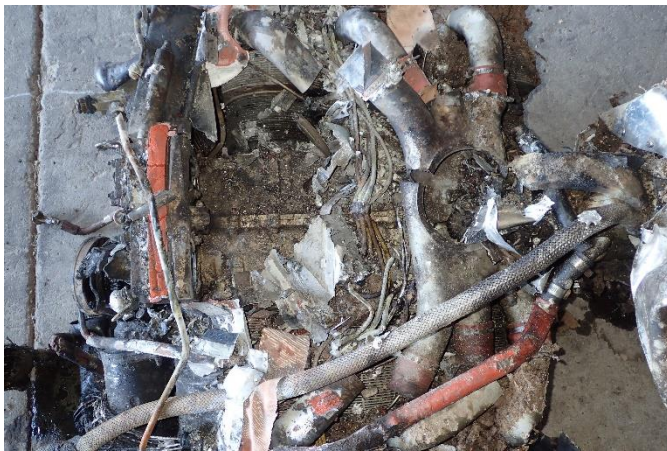
| CRANKCASE | Casting Number: | 1-3-5: Not observed | 2-4-6: Not observed | S/N: Not observed |
|---|---|---|---|---|
| Condition: | The crankcase displayed impact damage signatures with the most damage occurring to the bottom and front of the crankcase; the portion of the crankcase that houses the propeller shaft and reduction gear assembly was cracked and had partially separated. There were no breaches in the crankcase that would indicate a catastrophic internal engine failure. Holes were drilled in the top of the crankcase to facilitate inspection of the internal components; there were no anomalies noted with any of the internal portions of the crankcase. | | | |

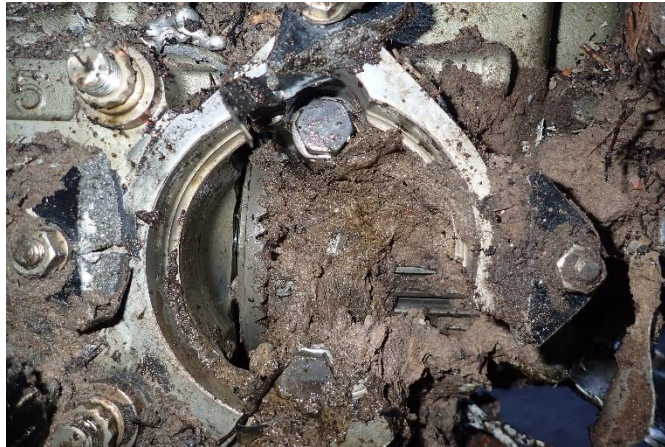
| Condition: | The reduction gear was partially visible through the alternator installation hole. The visible portion of the gear was impacted with mud and displayed normal operating signatures. | | |

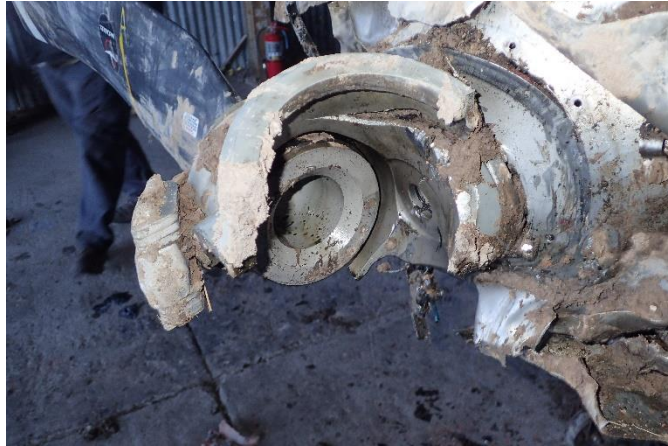
The propeller flange remained attached to the rest of the shaft; the propeller shaft displayed impact damage signatures.

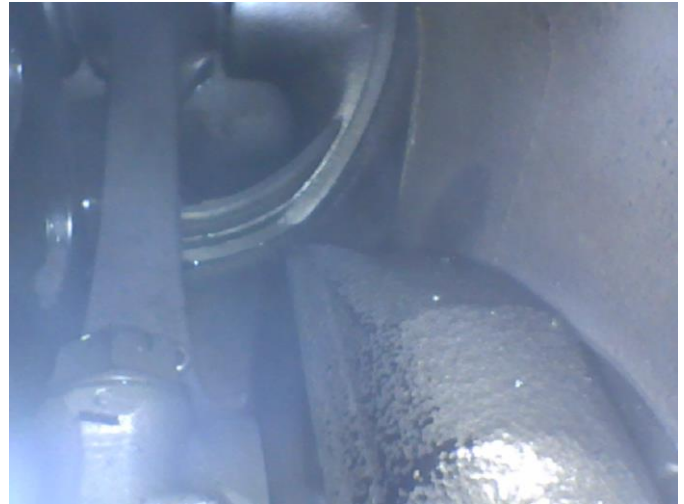
#3 Connecting Rod

The connecting rods were inspected using a lighted borescope that was inserted into holes that were drilled into the crankcase. All of the connecting rods remained attached to their journals and displayed normal operating and lubrication signatures. There were no anomalies noted.

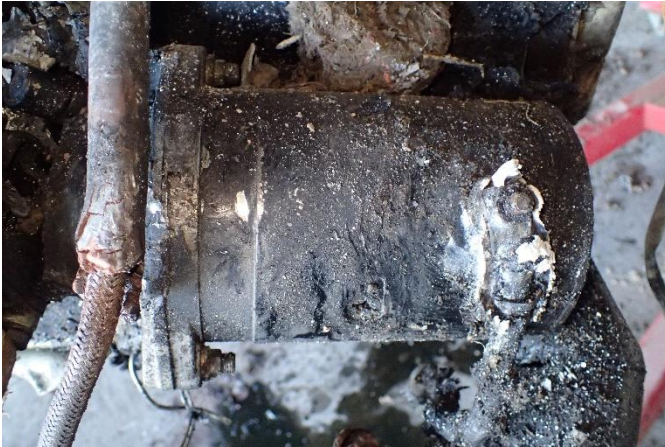
The starter remained attached to the starter adapter attach flange; however, the attach flange had broken free from the rest of the adapter. The starter displayed impact and thermal damage signatures. There were no anomalies noted.

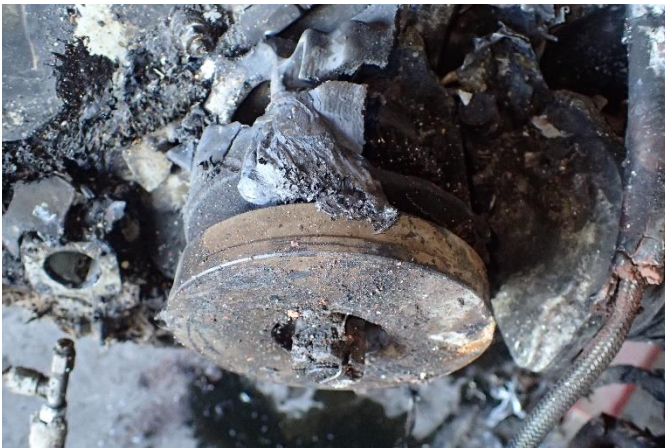
STARTER  
ADAPTER

The starter adapter remained partially attached to its installation point and displayed a significant amount of impact damage and some thermal damage signatures. There were no anomalies noted.

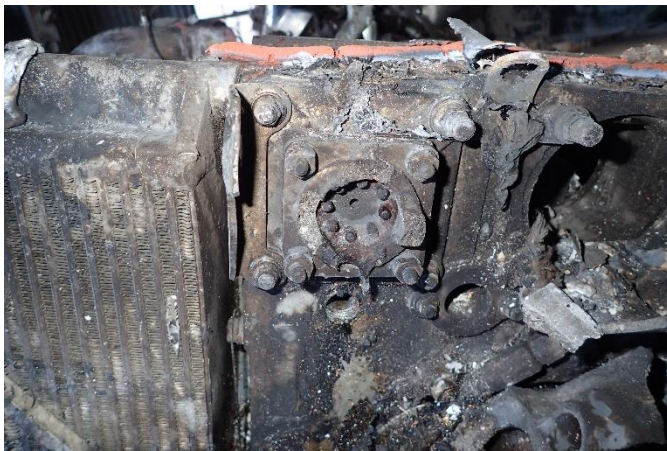
The vacuum pump had broken free from its installation point and displayed a significant amount of impact and thermal damage signatures. The drive coupling was not located at the time of the examination. The internal components were visible due to impact damage; the vanes and rotor displayed significant impact damage.

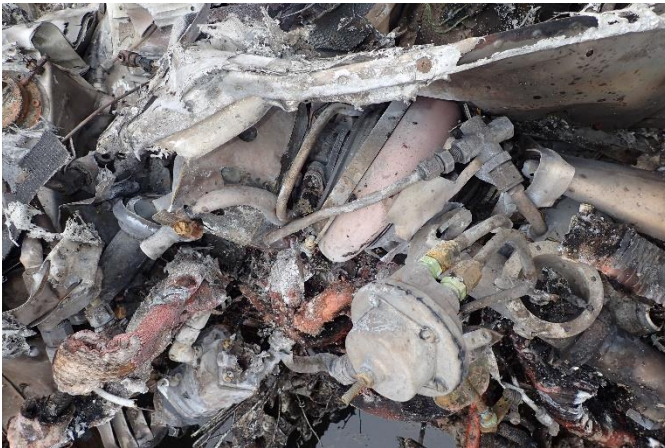
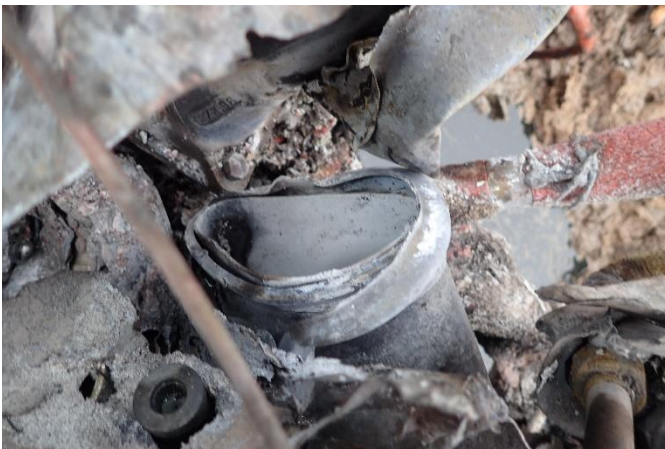
The turbocharger remained attached to its installation point and displayed impact and thermal damage signatures. It was noted that the V-band clamp remained attached to the tailpipe; however, it had disconnected from the turbocharger, the damage was consistent with impact damage. The turbine was visible and displayed normal operating signatures; it was noted that it was unable to be rotated which is consistent with the impact damage. The compressor was also visible and displayed impact and thermal damage signatures, the blades were bent and appeared to have partially melted.

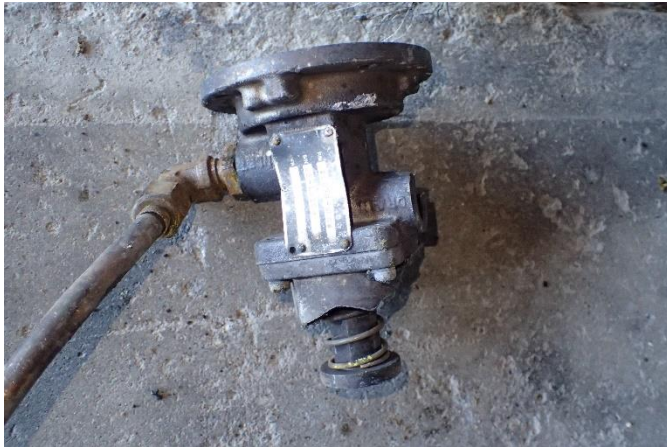
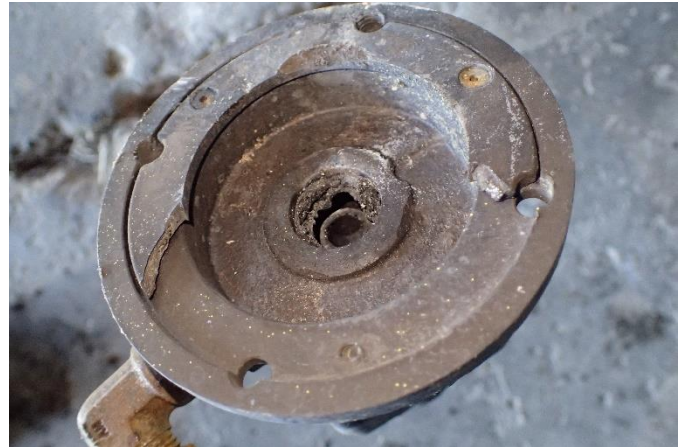
The turbocharger controller had broken free from its installation point and displayed significant impact damage signatures. Several portions of the controller had broken free and were not located at the time of the examination. There were no anomalies noted.

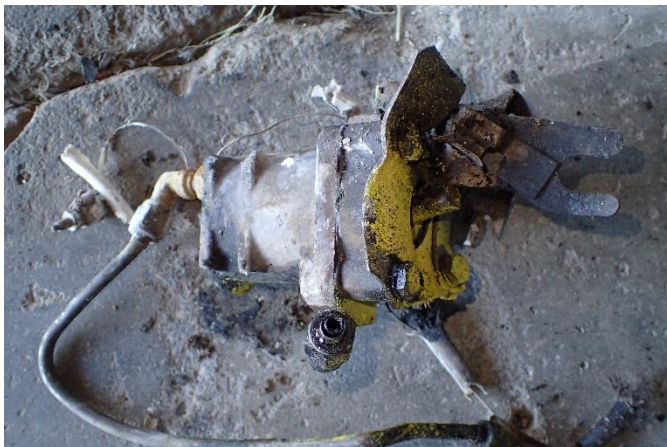
The wastegate had broken free from its installation point and displayed impact and thermal damage signatures. There were no anomalies noted.

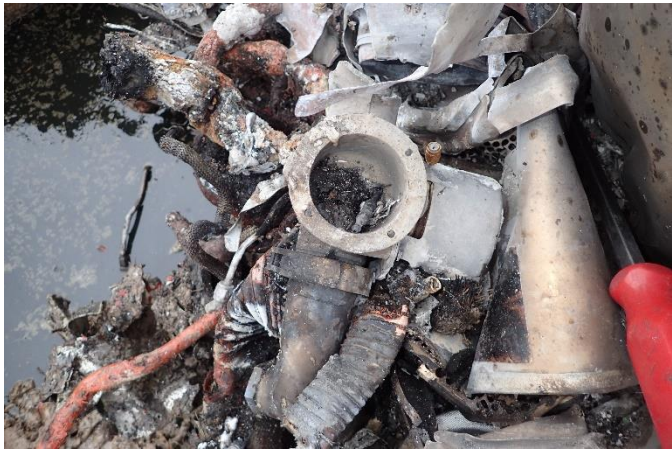
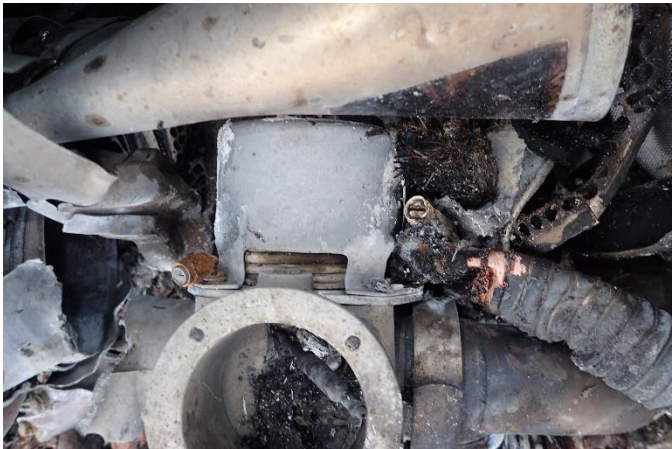
| Condition: | The overboost valve remained attached to its installation point and displayed thermal damage signatures. There were no anomalies noted. | | |

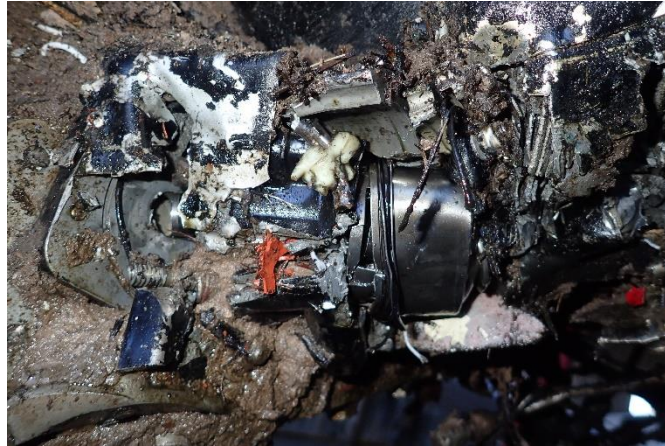
The governor remained partially attached to the engine and displayed a significant amount of impact damage; the housing had fractured, and the internal components were exposed and also displayed significant impact damage.

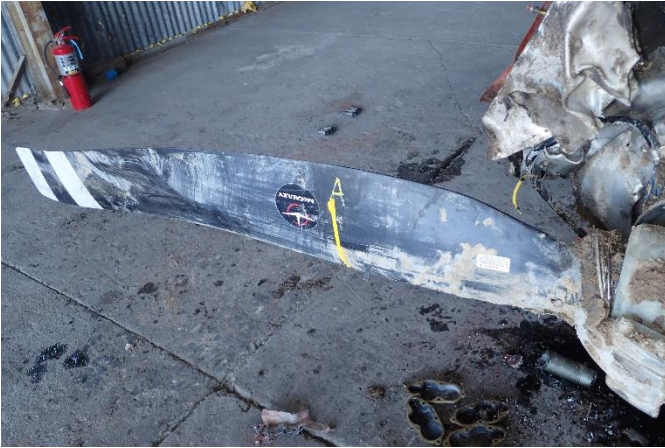
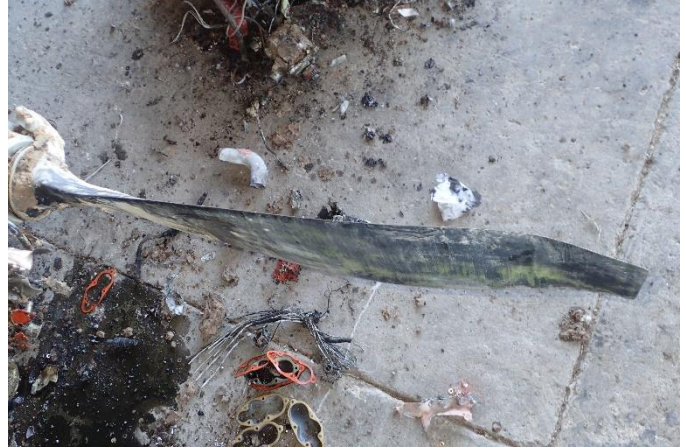
Propeller Blade "A"

The three blade, constant speed propeller remained partially attached to the propeller shaft; only one propeller blade and a portion of the propeller hub remained attached. The other two propeller blades and the rest of the hub had broken free. The propeller blade marked "A" displayed forward bending deformation and chordwise scratches. The propeller blade marked "B" displayed leading edge polishing, minor twisting deformation, and a small portion of the blade tip trailing edge was curled. The propeller blade marked "C" displayed significant leading edge and cambered side polishing, and aft bending deformation.
