## Honeywell

Re: NTSB ID: CEN19FA088, N428CD, Piper PA-46-350P JetProp Conversion; Honeywell examination

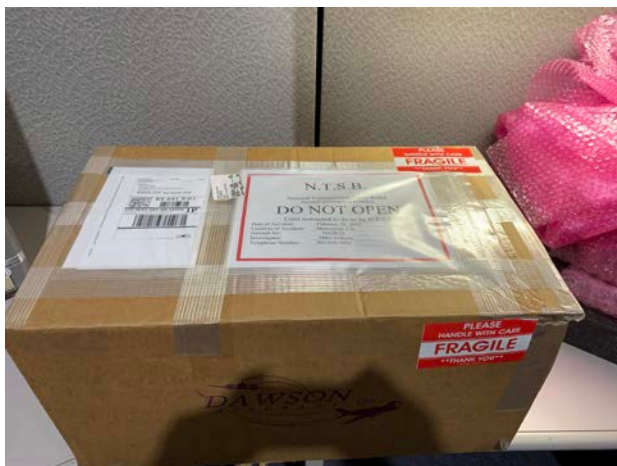
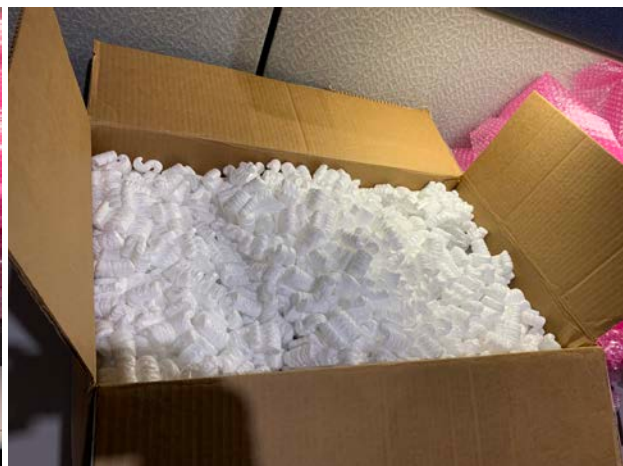
As received – sealed box and contents well packed

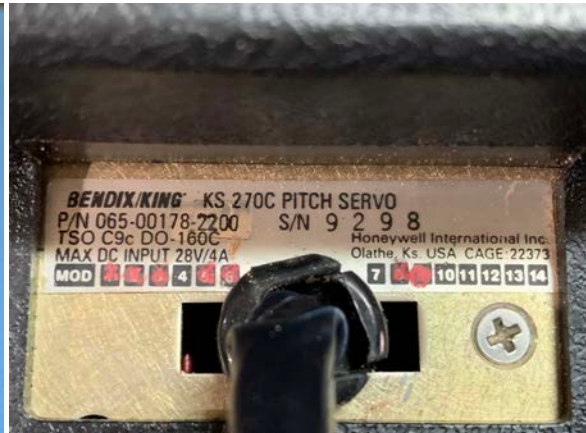
KS 270C Pitch Servo dataplate

- The plastic servo cover attach plate is bent and not allowing the cover to fit properly.
- The cover was removed to allow visual inspection. Traces of dried dirt/mud present on electrical and mechanical assemblies – removed the debris as necessary to allow electrical testing.
- The servo was subjected to acceptance testing per maintenance manual, 006-15618-000. The unit failed two tests with minor out of tolerance measurements as noted below. Neither failure would adversely affect proper servo function. A copy of the test data sheet can be found in appendix A of this report.
  - o Test Step S: Strain Gauge sensing CCW Trim Sense, failed with reading of 1.21V (limit =  $1 \pm .2V$ ).
  - o Test Step S: Null, failed with a reading of .089V (limit =  $-.05V$  to  $+.05V$ ).

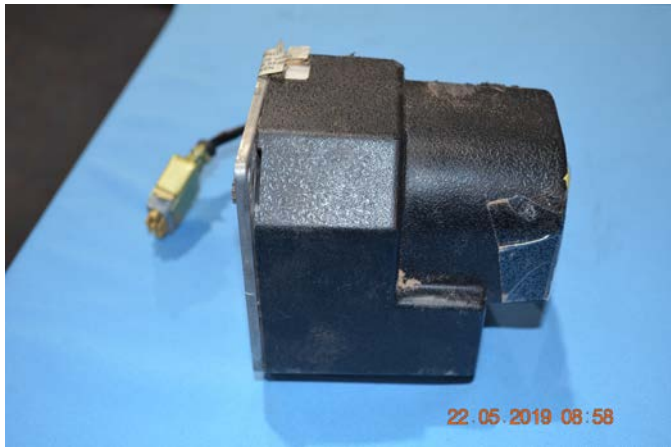
KS 271C Roll Servo – side view

- The cover was removed to allow visual inspection. Traces of dried dirt/mud present on electrical and mechanical assemblies – removed the debris as necessary to allow electrical testing.
- The servo was subjected to acceptance testing per procedure 924-01337-0000, rev 25. The unit failed two tests with minor out of tolerance measurements as noted below. Neither failure would adversely affect proper servo function. A copy of the test data sheet can be found in appendix A of this report.
  - Proc step 5.3: Solenoid engage pulling against gravity – solenoid engages/disengages at 27.3 volts (limit = 20.6 volts max). Note: dirt/sand present in solenoid assembly.
  - Proc step 5.7: Torque characteristics – solenoid disengages in the CW direction in 3 seconds (limit = 2 seconds max).

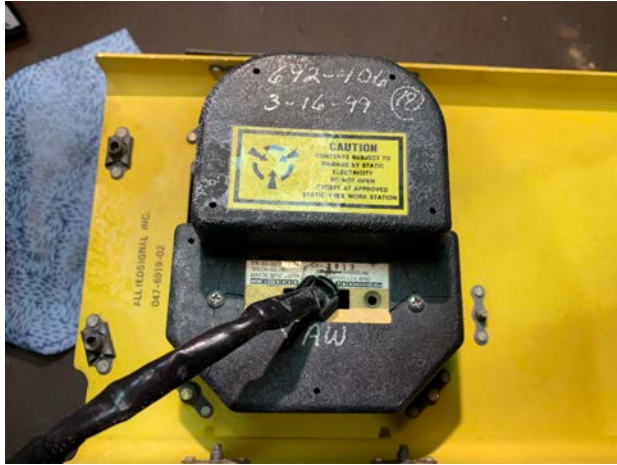
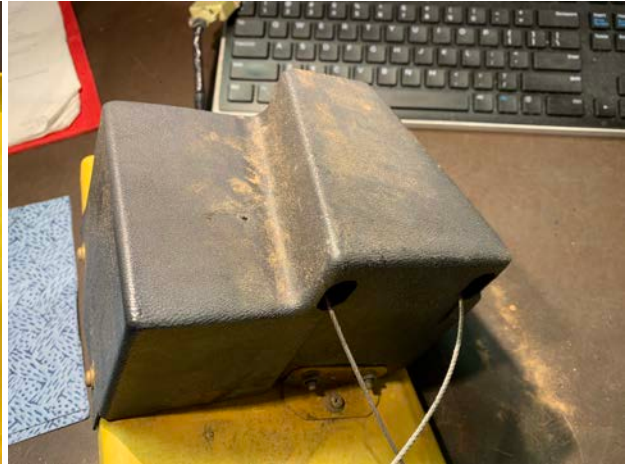
- The KS 271C Yaw Servo was received attached to servo mount and aircraft bracket. They were separated to facilitate testing.
- The cover was removed to allow visual inspection. Traces of dried dirt/mud present on electrical and mechanical assemblies – removed the debris as necessary to allow electrical testing.
- The servo was subjected to acceptance testing per procedure 924-01337-0000, rev 25. The unit failed two tests with minor out of tolerance measurements as noted below. Neither failure would adversely affect proper servo function. A copy of the test data sheet can be found in appendix A of this report.
  - o Proc step 5.4: Motor breakout CW input – measured 1.0 volts (limit = 0.3 volts max).
  - o Proc step 5.4: Motor breakout CCW input – measured -0.7 volts (limit = -0.3 volts max).

KS 271C Yaw Servo with associated aircraft bracket and cover

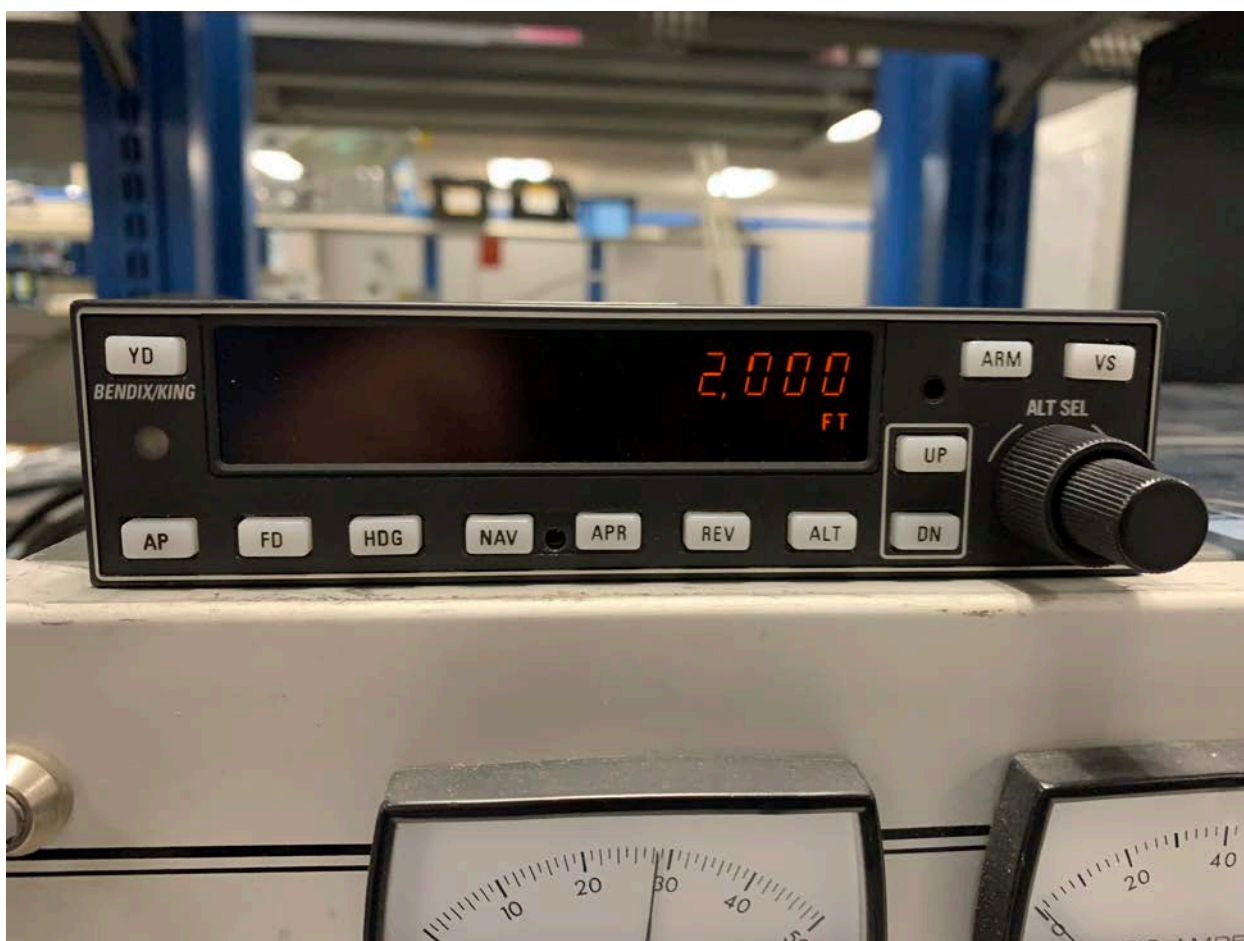
Last preselected altitude by the flight crew was 2000 feet

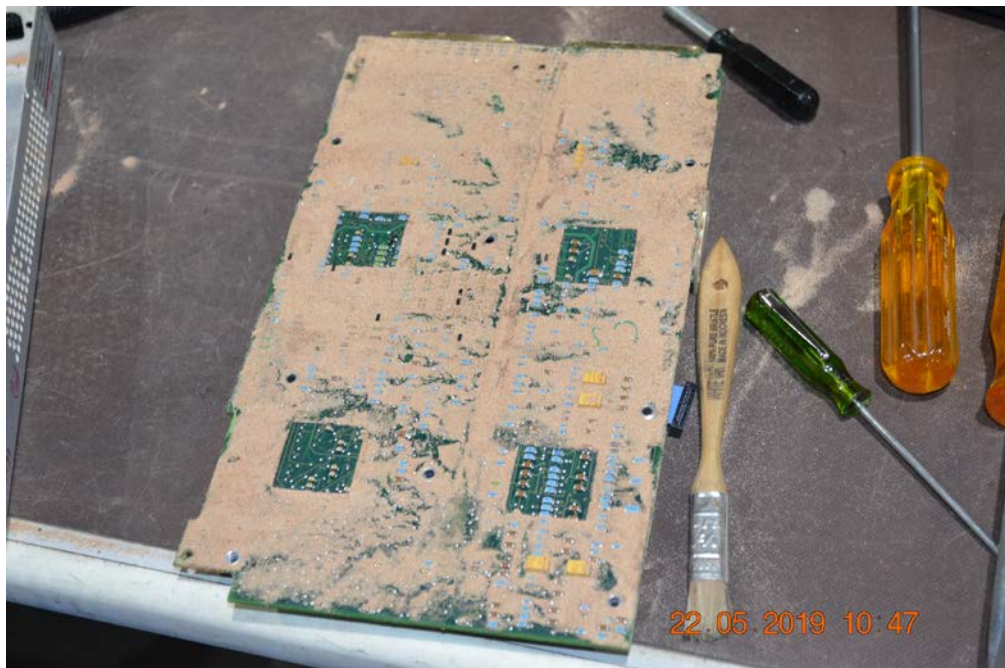
The KC 225 Flight Computer was received installed into its associated rack. The outside of the unit was contaminated with dried dirt/mud/sand, consistent with being recovered from a river bottom. The unit was removed from the rack and opened to inspect for internal damage. The circuit boards were found covered/caked with dried dirt/mud/sand – see photos below. The boards were removed, cleaned, and re-installed. The unit was then connected to a KC 225 test panel and power was applied. No abnormal current draw was observed and the unit started preflight testing. The unit failed preflight test with a trim fault illuminated on the front of the test panel and error codes 78 (*MET trim runaway*) and 172 (*MET fail*) were produced. Error 172 was logged during the accident flight, but error 178 was not.

KC 225 – boards were removed for cleaning

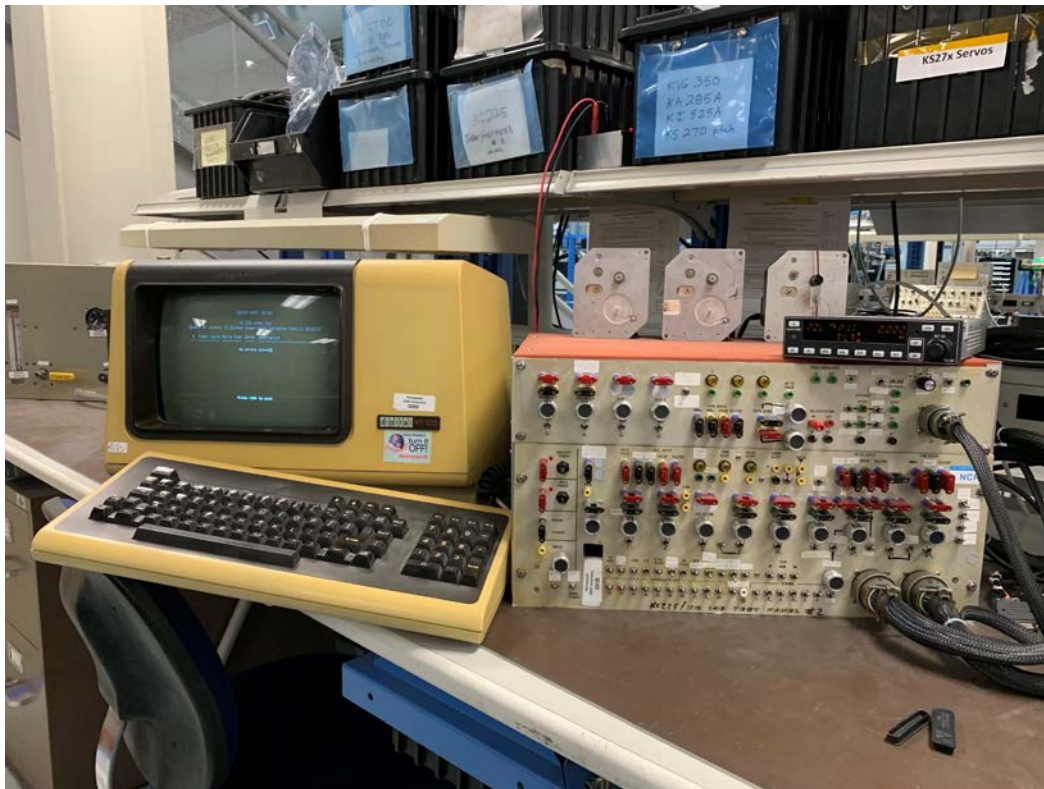
KC 225 Demonstration of the Manual Electric Trim Switch (Arm Switch) regarding error 172, *MET fail*.

Exemplar KC 225 Flight Computer and KC 225 engineering test panel. Here, the KC 225 passed preflight test and no errors were recorded.

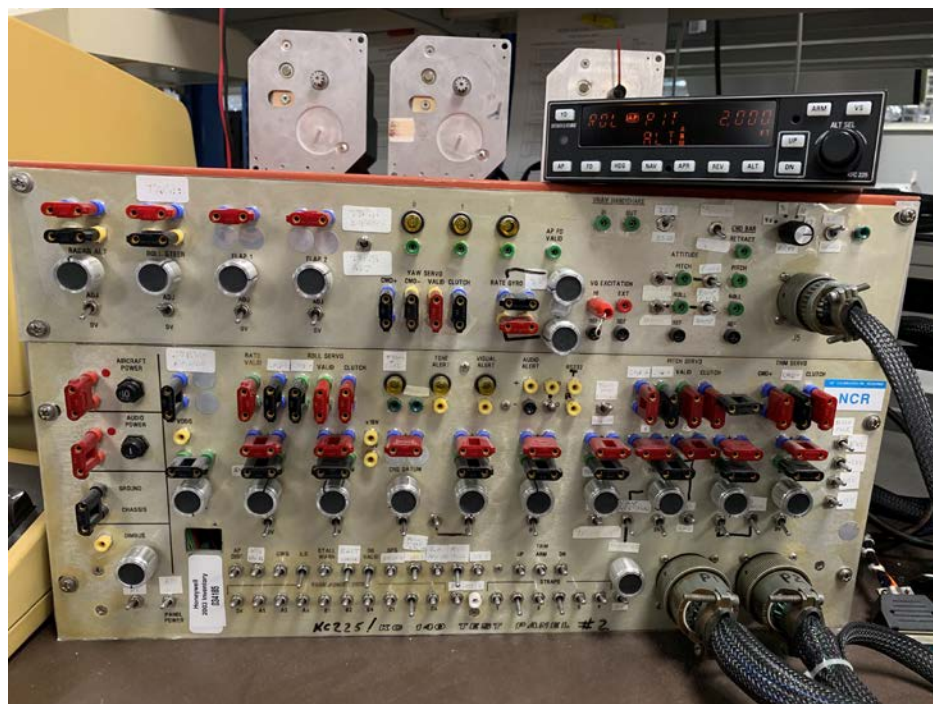
KC 225 Flight Computer and engineering test panel – Autopilot is engaged

When the “Arm” switch is activated or moved to the down position, the autopilot automatically disengages and error 172 *MET fail* is logged. All FD that were active before disengagement remain active. Notice the absence of the “AP” notation where circled above.
