## CASE NOTES

During the course of the investigation, the following observation and facts were collected:

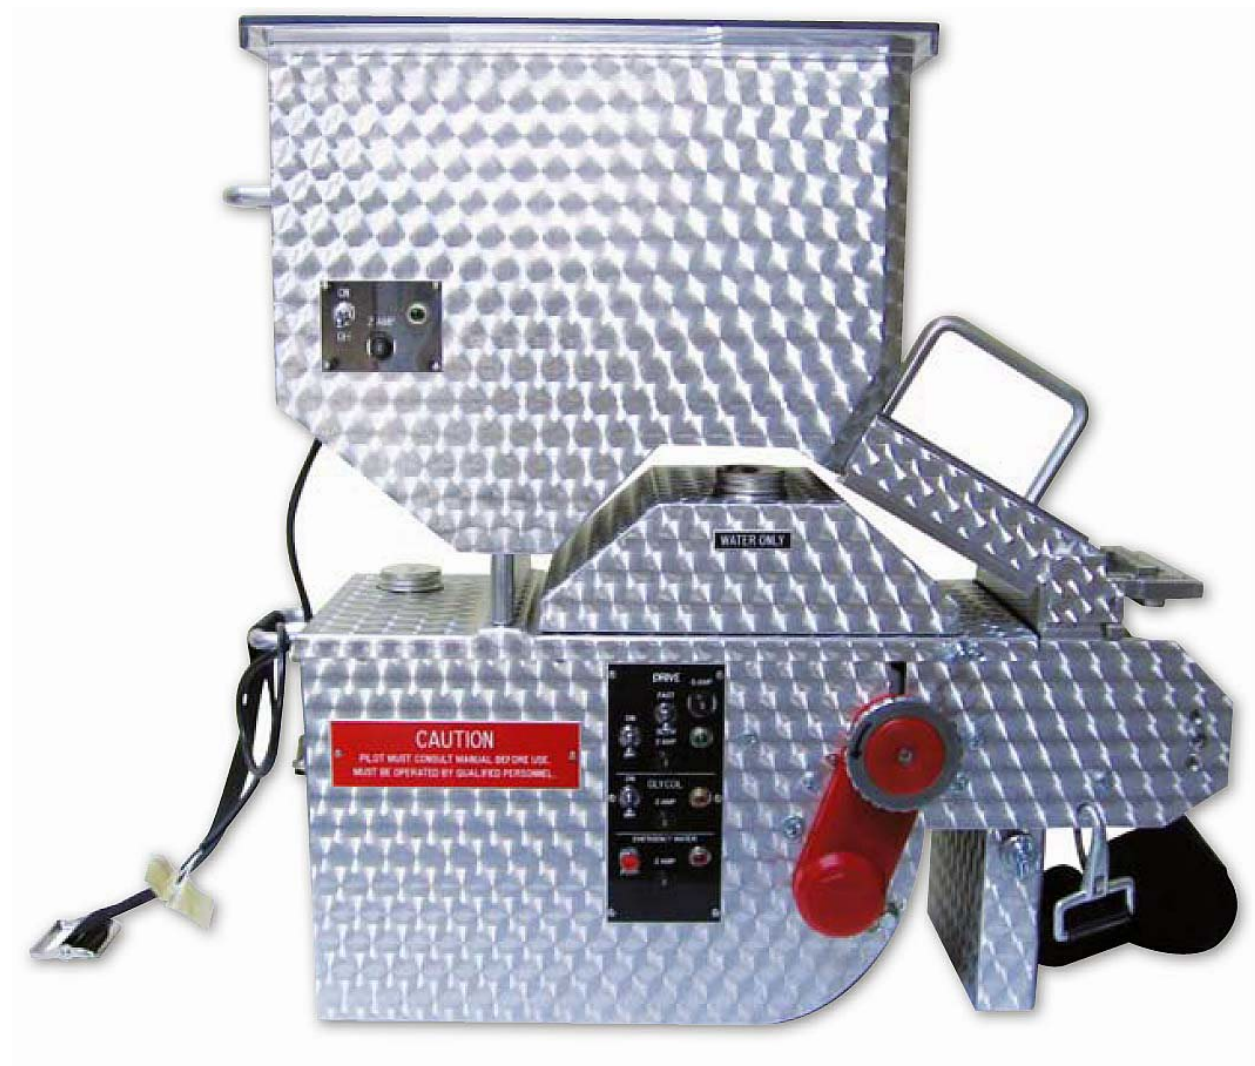
*Figure 2 Exemplar Premo MKIII PSD*

The Premo MK III PSD was examined and did not appear to contribute to the accident.
