# Survivability Notes CEN19FA109

### I. ACCIDENT INFORMATION:

NTSB ID: CEN19FA109  
Location: Montgomery, TX  
Aircraft: Eurocopter AS350 B3  
Tail number: N818MC  
Accident date: March 27, 2019 1435 CDT  
Injuries: 1 fatal (Passenger), 2 serious (pilot/ passenger)

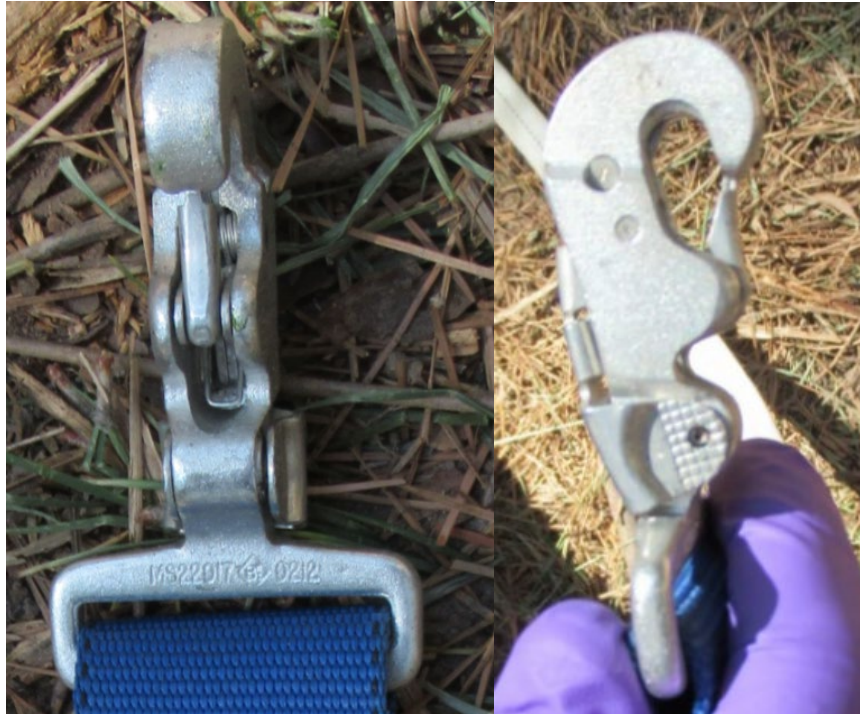
**Photograph 9 – Hook of Rear Supplemental Passenger Restraint System**

The silver hook was labeled:  
MS22017 ◇ 0212

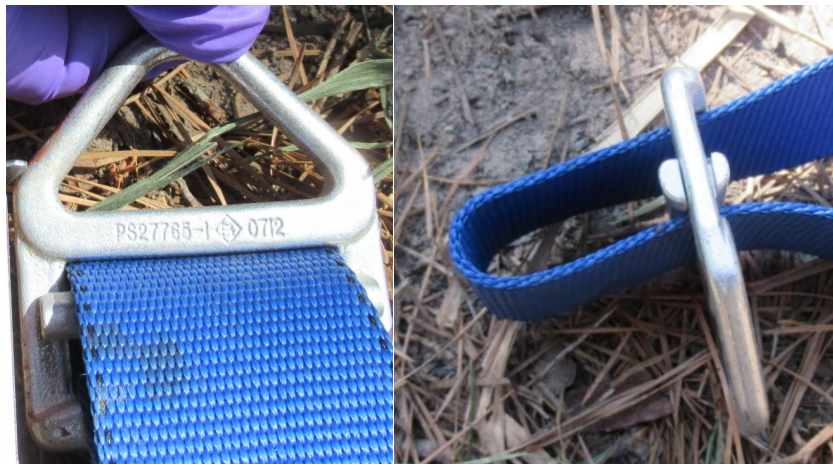
**Photograph 10 – Adjuster of Rear Supplemental Passenger Restraint System**

The silver adjuster was labeled:  
PS27765-1 ◇ 0712
