## ENGINE RUN REPORT

| ENGINE MODEL | IO-520-D30B |
| AIRCRAFT MAKE & MODEL | Cessna A185F |
| FILE NUMBER | 19-100 |

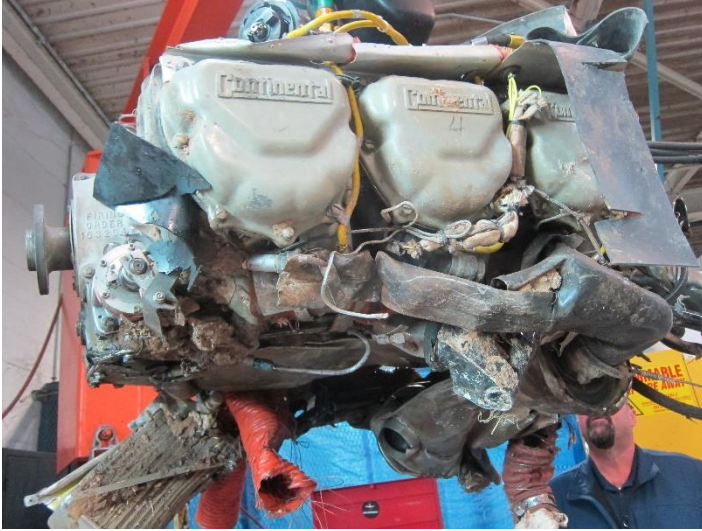
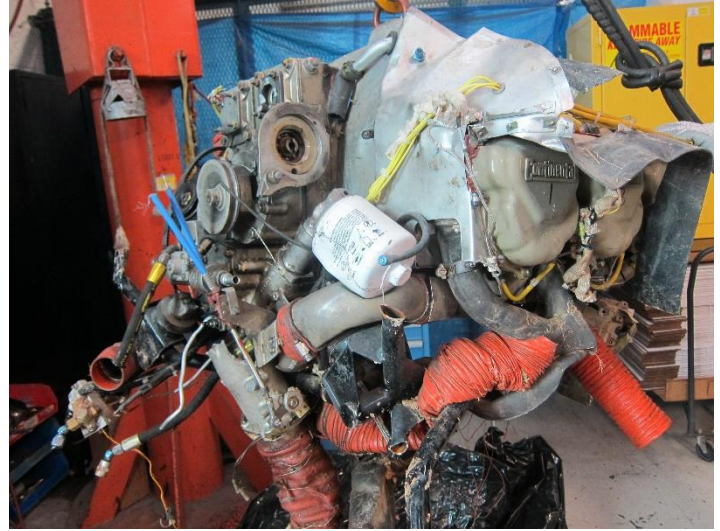
The engine was received in a Continental engine shipping crate. Damage was noted to the oil sump, induction and exhaust systems, the forward left crankcase half and the magnetos were impact separated from their mounts. The oil cooler and adaptor exhibited impact damage as well as some of the cylinder heads.
