## Stinson 108 aircraft accident, aircraft evaluation.

On January 24, 2019 I traveled with inspector Joe Saunders to Shawano WI to perform an evaluation of a Stinson 108 aircraft after it was involved in an accident where it was reported that the engine lost power and stopped running prior to the crash. As a result of the crash the aircraft ended up inverted in a ditch alongside a road. The aircraft was moved from the accident site to a hangar at the Shawano airport prior to our arrival and was left in the inverted position.

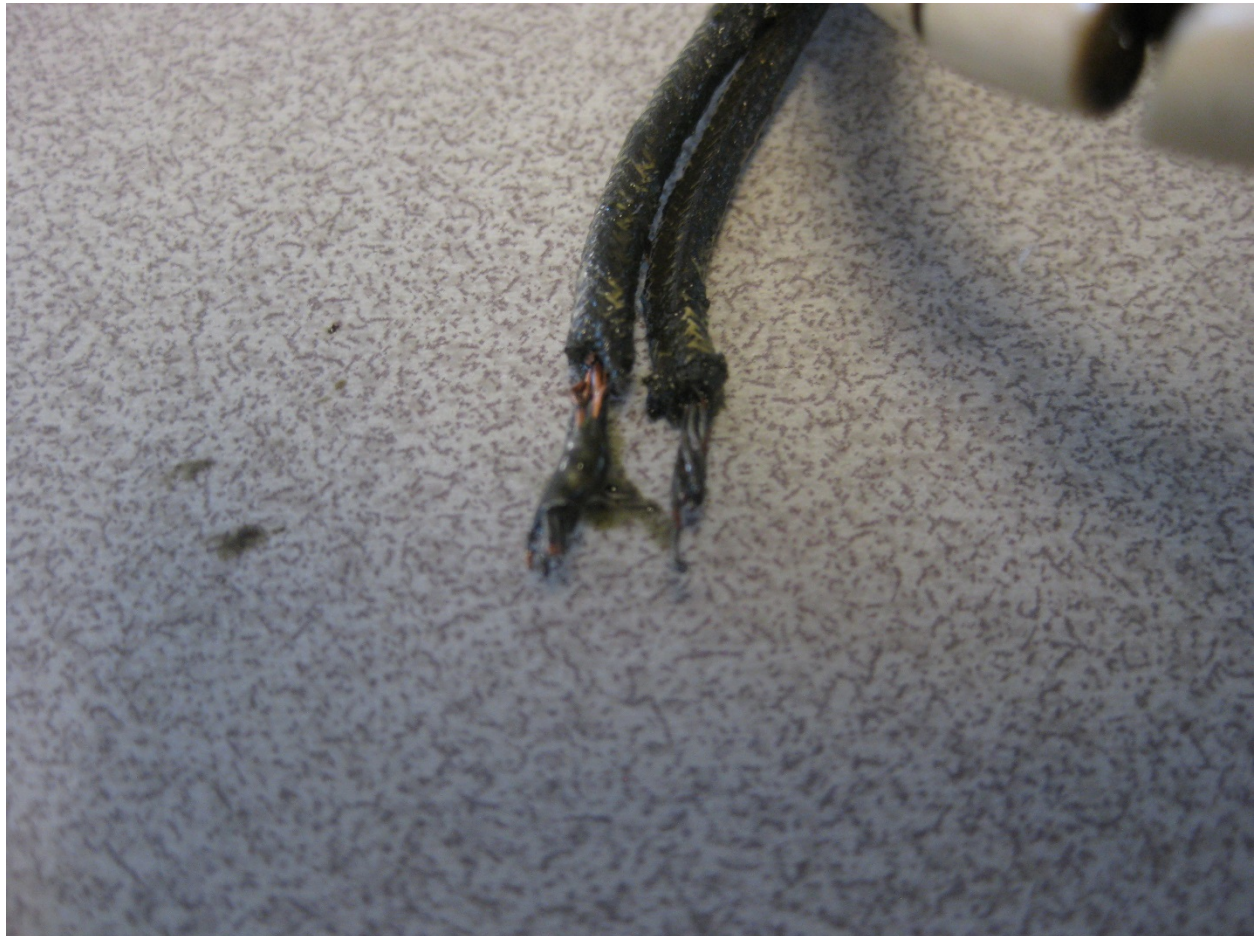
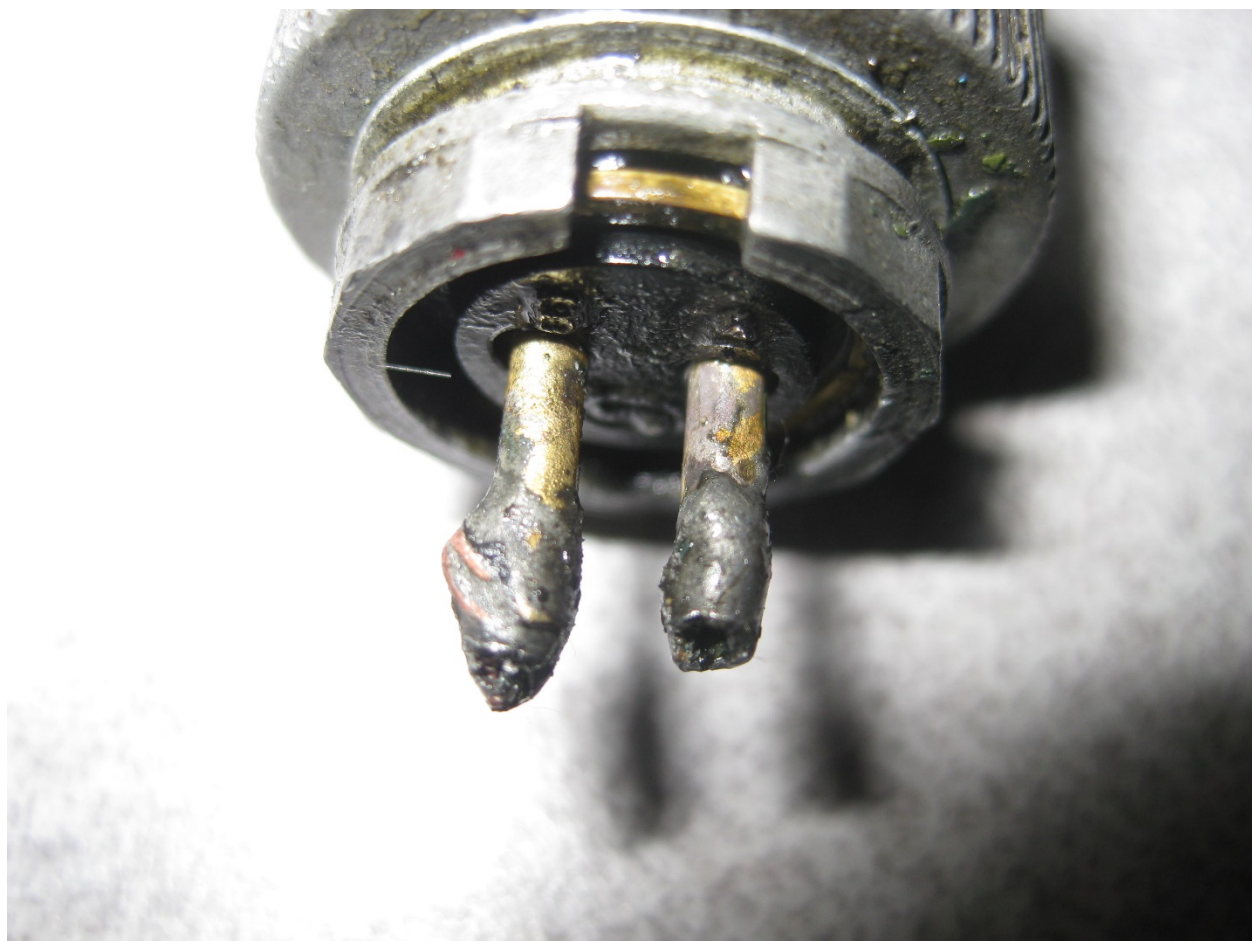
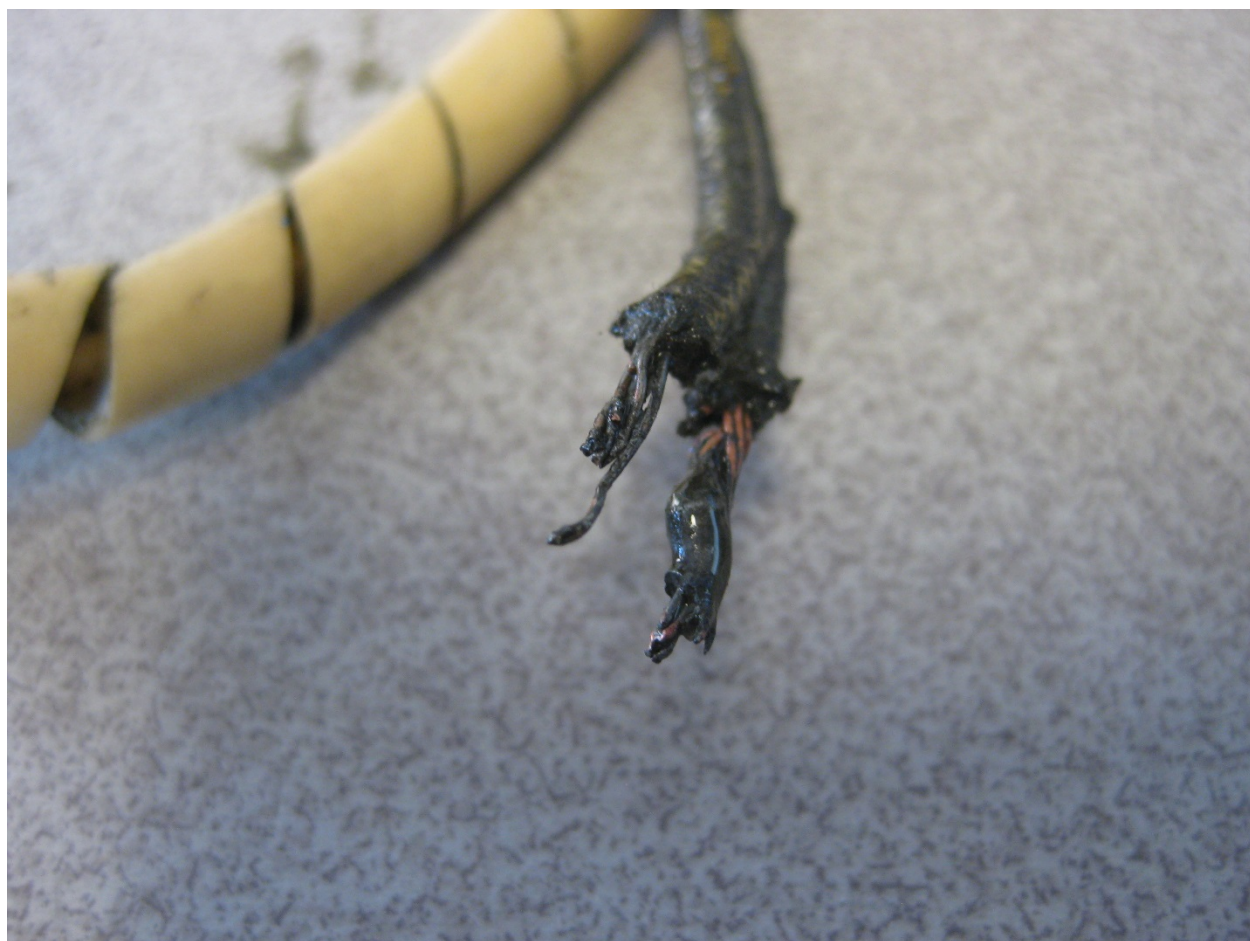
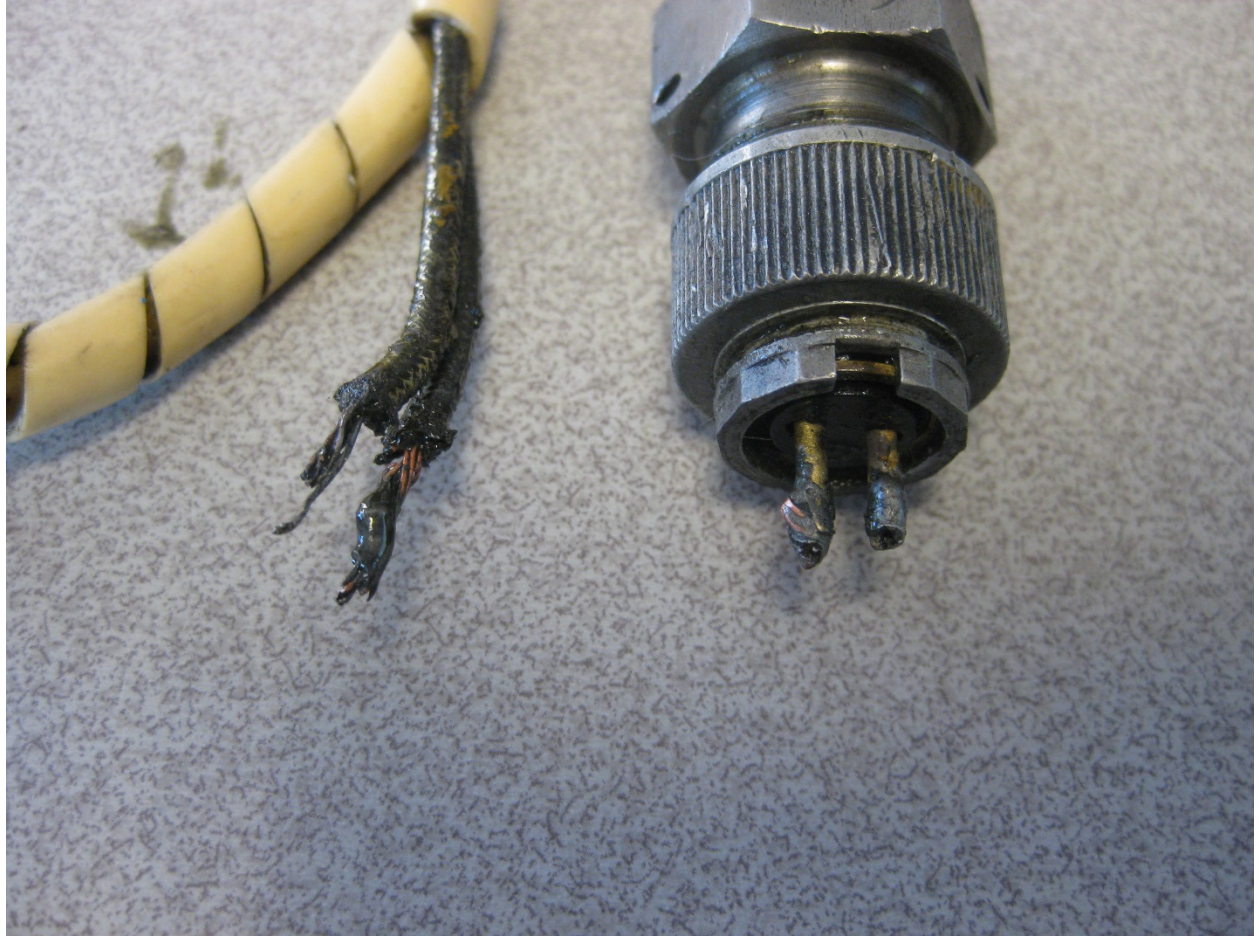
Prior to leaving the hangar we removed temperature bulb from the carburetor air box as well about 10 inches of the wires that were broken off the cannon plug connector. Examination of those items is not conclusive that they were broken off before the crash but their general condition would lead us to believe they were not operational.
