# NATIONAL TRANSPORTATION SAFETY BOARD

## MATERIALS LABORATORY FACTUAL REPORT

Report No. 19-040

Place : Sheldon, Missouri  
Date : April 26, 2019  
Vehicle : Beech E50  
NTSB No. : CEN19LA127  
Investigator : Mike Hodges, AS--CEN

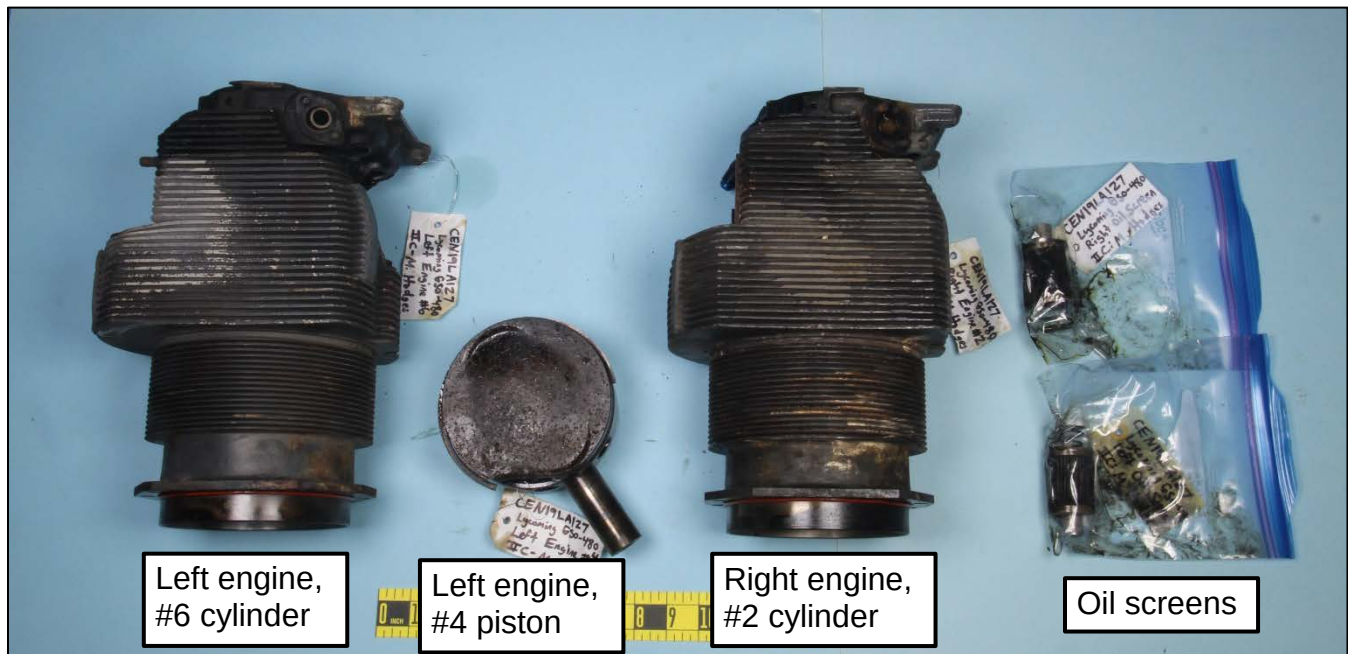
An overall view of the submitted components is shown in figure 1. The components were from each of the two Lycoming GSO-480 engines installed on the accident airplane. The cylinder head on each of the submitted cylinder assemblies had similar damage with material fractured and missing from the head between the exhaust valve and one of the spark plug ports. Photographs of the interior of the cylinders are shown in figures 2 and 3, and the damaged area is outlined with a dashed line. Material was also fractured and missing from the side of the number 4 piston assembly from the left engine as shown in figure 4, and a dashed line in figure 4 outlines the area of damage. The piston compression rings and oil rings were also fractured, and pieces were missing. The damage to the piston and cylinder assemblies was consistent with detonation damage.

Figure 1. Overall view of the submitted components.
