**NATIONAL TRANSPORTATION SAFETY BOARD  
OFFICE OF AVIATION SAFETY  
WASHINGTON, D.C. 20594**

**POWERPLANTS GROUP CHAIRMAN'S FACTUAL REPORT**

**NTSB ID No.: CEN19LA231**

Location: Breckenridge, Michigan  
Date: July 21, 2019  
Time: 0705 Eastern Daylight Time  
Aircraft: Ayres S2R-G10, Registration: N766BF

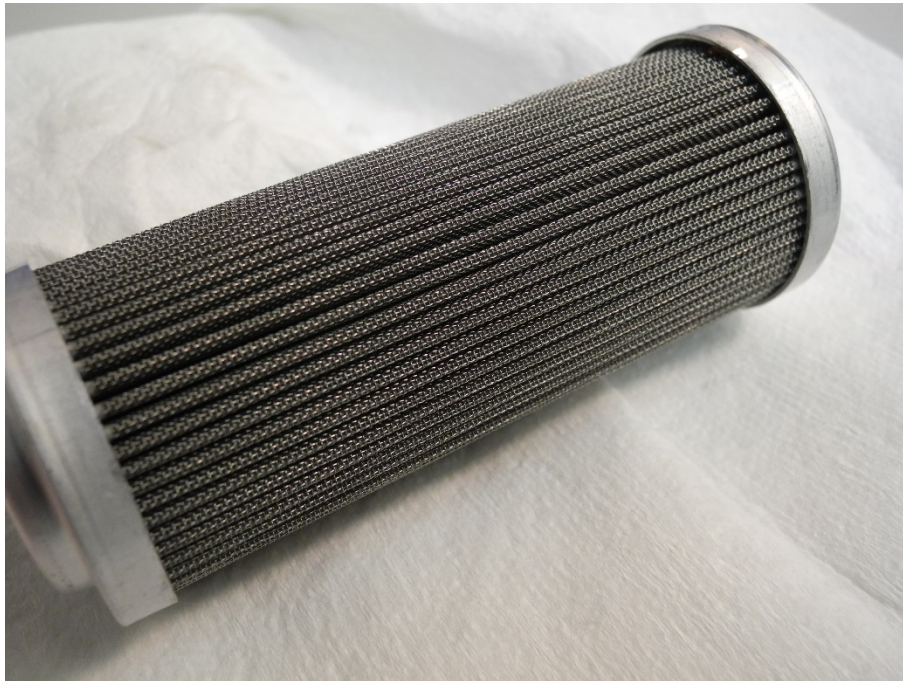
The nose cone, gearbox housing and the compressor housing were intact and undamaged ([Photo 5](#)). The nose cone chip detector ([Photo 6](#)) and the oil filter ([Photo 7](#)) were removed, and both were clean and oil wetted. The oil tank was intact; however, it was dented and scratched in several locations, consistent with impact damage ([Photo 8 & Photo 9](#)). The oil tank appeared to be empty; however, as the engine was tilted aft-wards while it moved to the engine stand via overhead crane, approximately 0.5 liter of clean oil was captured as it drained from the oil tank and lines. The tank normally contains 6 liters.

Photo 8 – Oil Tank – Still Installed on Engine

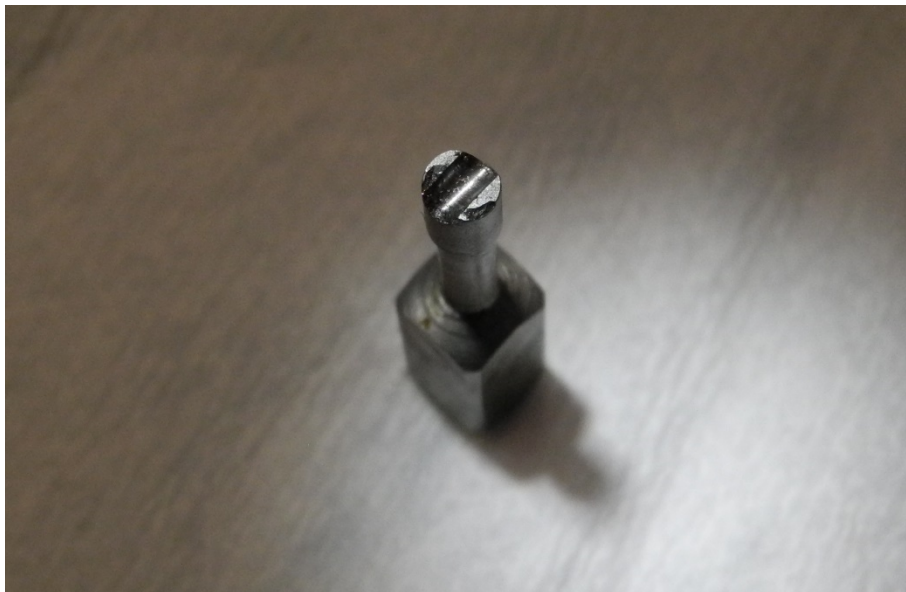
The Nose Cone (Photo 14 & Photo 15) and Gearbox Housing (Photo 16) were removed, and the internal mechanism examined. All the parts were oil wetted. All the gears, shafts and bearings were undamaged. The torque sensor was intact (Photo 17) and the direct drive fuel control (DDFC) gears turned freely. The scavenge oil screen was free of debris. There was an impact mark on the forward face of the torque sensor, consistent with contact against the sun gear nut during impact. The spur gear and cam assembly (Figure 5) could not be separated from the helical gearshaft, consistent with the spur gear and cam assembly moving aft and over-traveling the engagement with the helical gearshaft (circled in red), causing the helical gearshaft to become stuck in the cavity of the spur gear and preventing the spur gear from returning to the forward position (Photo 18), consistent with a propeller sudden stoppage. No further disassembly was done.

Photo 14 – Nose Cone & Propeller Shaft – Undamaged, Oil Wetted

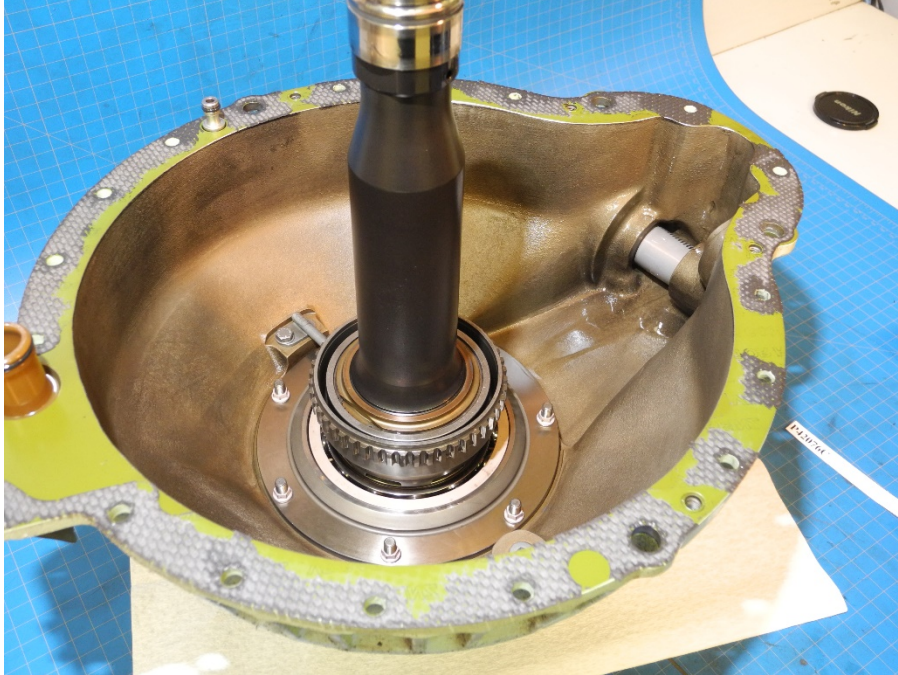
Photo 15 – Nose Cone Gearing – Undamaged & Oil Wetted

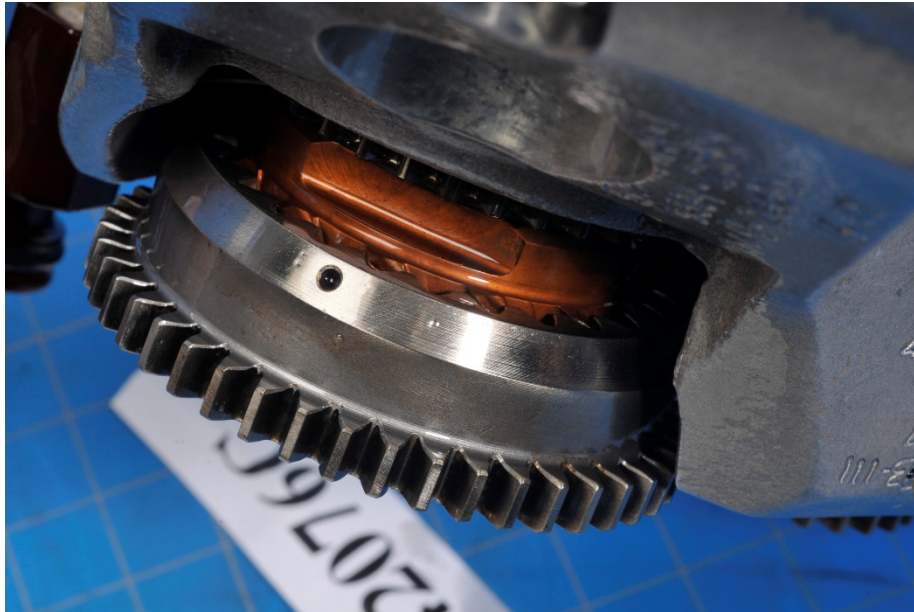
If the compressor bearing carbon seal is damaged, then oil could leak into the engine flow path, so therefore the compressor bearing, and carbon seal were removed and both parts were found undamaged ([Photo 19](#) & [Photo 20](#)). The compressor section contains no oil system related components and was therefore not further disassembled.

**Photo 19** – Compressor Bearing - Undamaged

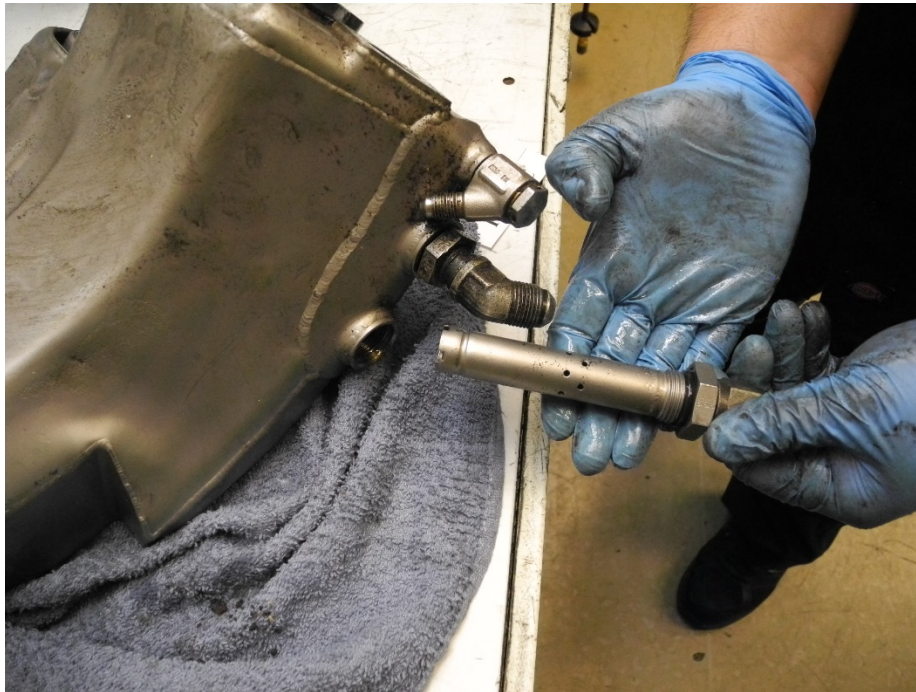
The oil tank was dented and scratched in several locations, consistent with impact damage; however, it was intact and not breached (Photo 9). The oil tank was removed from the engine and the air/oil separator and the fuel heater were withdrawn from the oil tank. The air/oil separator was intact and undamaged (Photo 21); however, an airframe supplied B-nut and short section of tubing was attached to the fitting. Routing of the vent line in the Ayres installation is unknown. The internal surface of the short section of tubing was coated with a thick layer of black debris. The external face of the Teflon ribbon cylinder was coated with black debris; however, the cylinder and aft face of the Teflon ribbon cylinder were clean. Additionally, the Teflon ribbon cylinder was observed to slide in the metallic sleeve when tapped on a hard surface. The air oil separator cavity in the oil tank contained loose black debris. In this Ayres airframe installation, the fuel heater function is not used; however, the fuel heater is still mounted in the oil tank and the fuel fittings are blanked off. The fuel heater (Photo 22) was undamaged, and all O-rings were in location and undamaged.

Photo 22 – Fuel/oil Heater - Undamaged

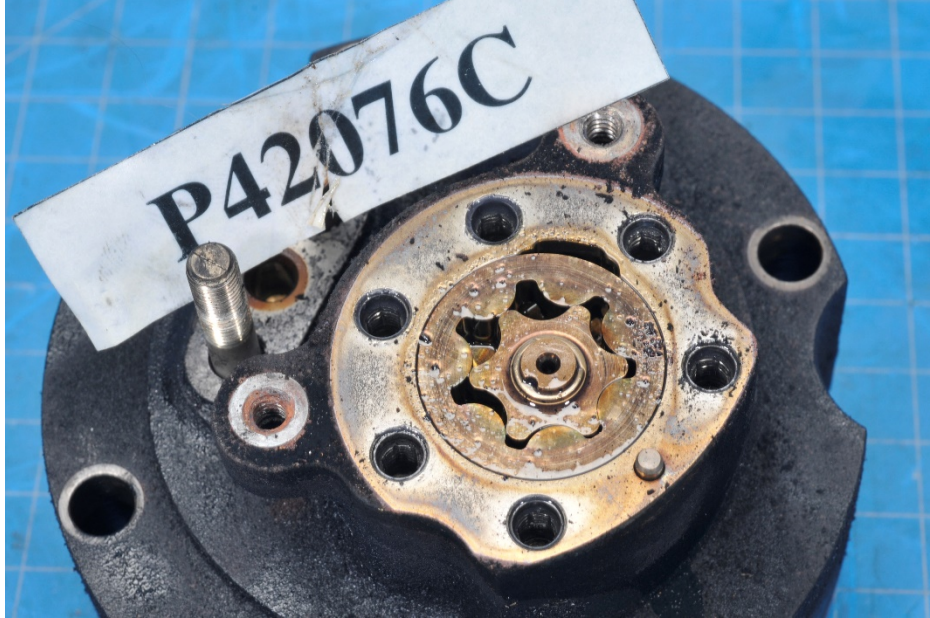
The oil vent valve ([Photo 27](#)) operates during the cold engine start sequence and temporarily allows air to enter the pressure and scavenge pumps, so that they do not offer resistance during a cold start sequence. If the valve fails, then it could allow air to enter the oil system and cause aeration and foaming.

Photo 27 – Oil Vent Valve

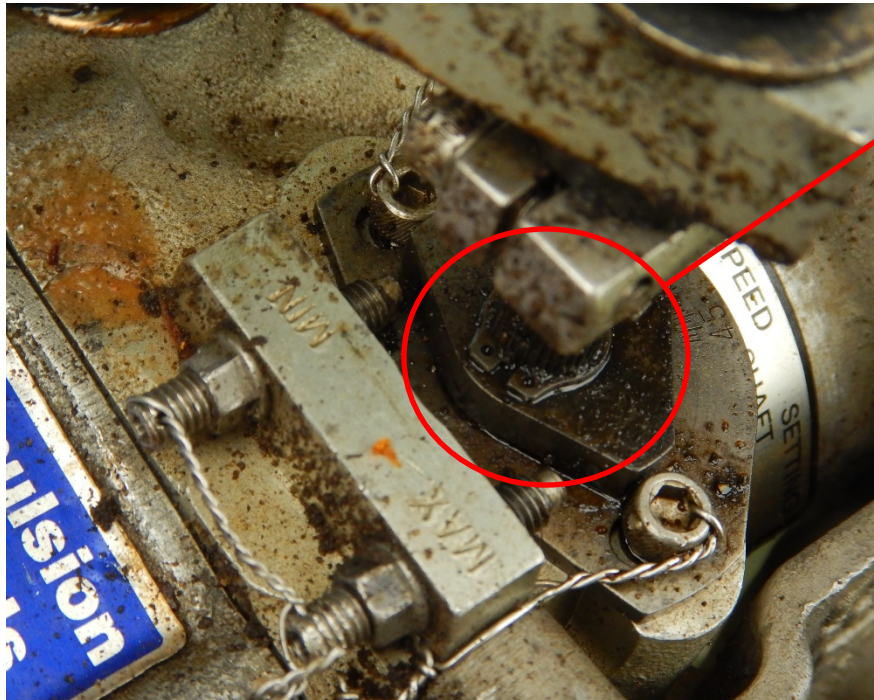
Circlip is Oil  
Soaked
