## **Engine Investigation Report**

**Model 250-C20J  
Engine CAE 271024**

**Accident Date: 16 August 2019  
Engine Exam Date: 5 November 2019**

**Omaha Police Department  
Omaha, Nebraska  
N106PD**

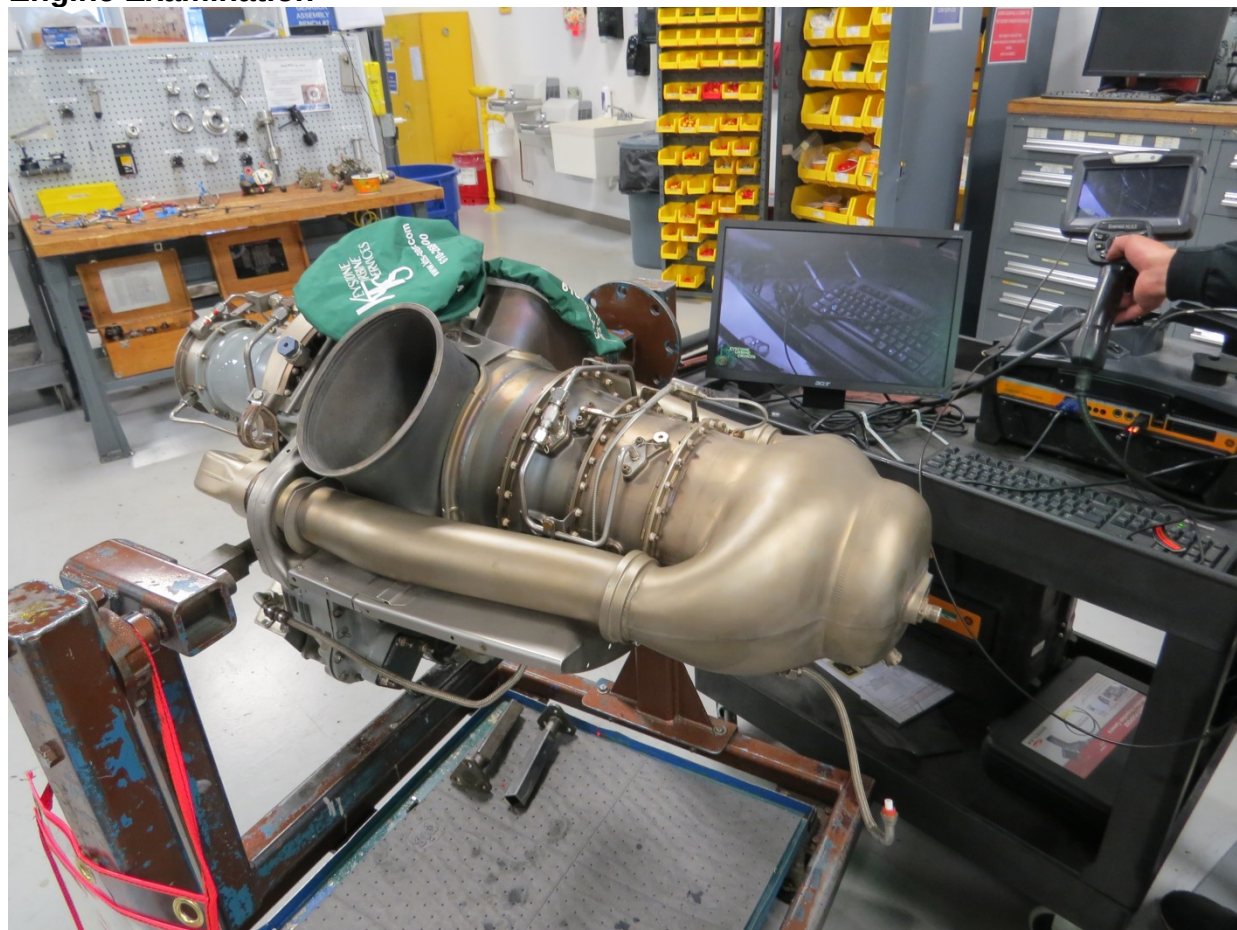
Impact damage was noted on the bottom side of the compressor housing. The damage was consistent with damage typically seen when the engine drive shaft fails while the engine is still running. As the shaft continues to rotate, the liberated end of the drive shaft will flail and strike the underside of the engine's compressor, causing impact damage like that noted on the subject engine.
