# NATIONAL TRANSPORTATION SAFETY BOARD

## MATERIALS LABORATORY FACTUAL REPORT

Report No. 20-030

Place : Monroe, WI  
Date : August 27, 2019  
Vehicle : Beech V35 Bonanza, N6245V  
NTSB No. : CEN19LA290  
Investigator : Joshua Lindberg (AS-CEN)

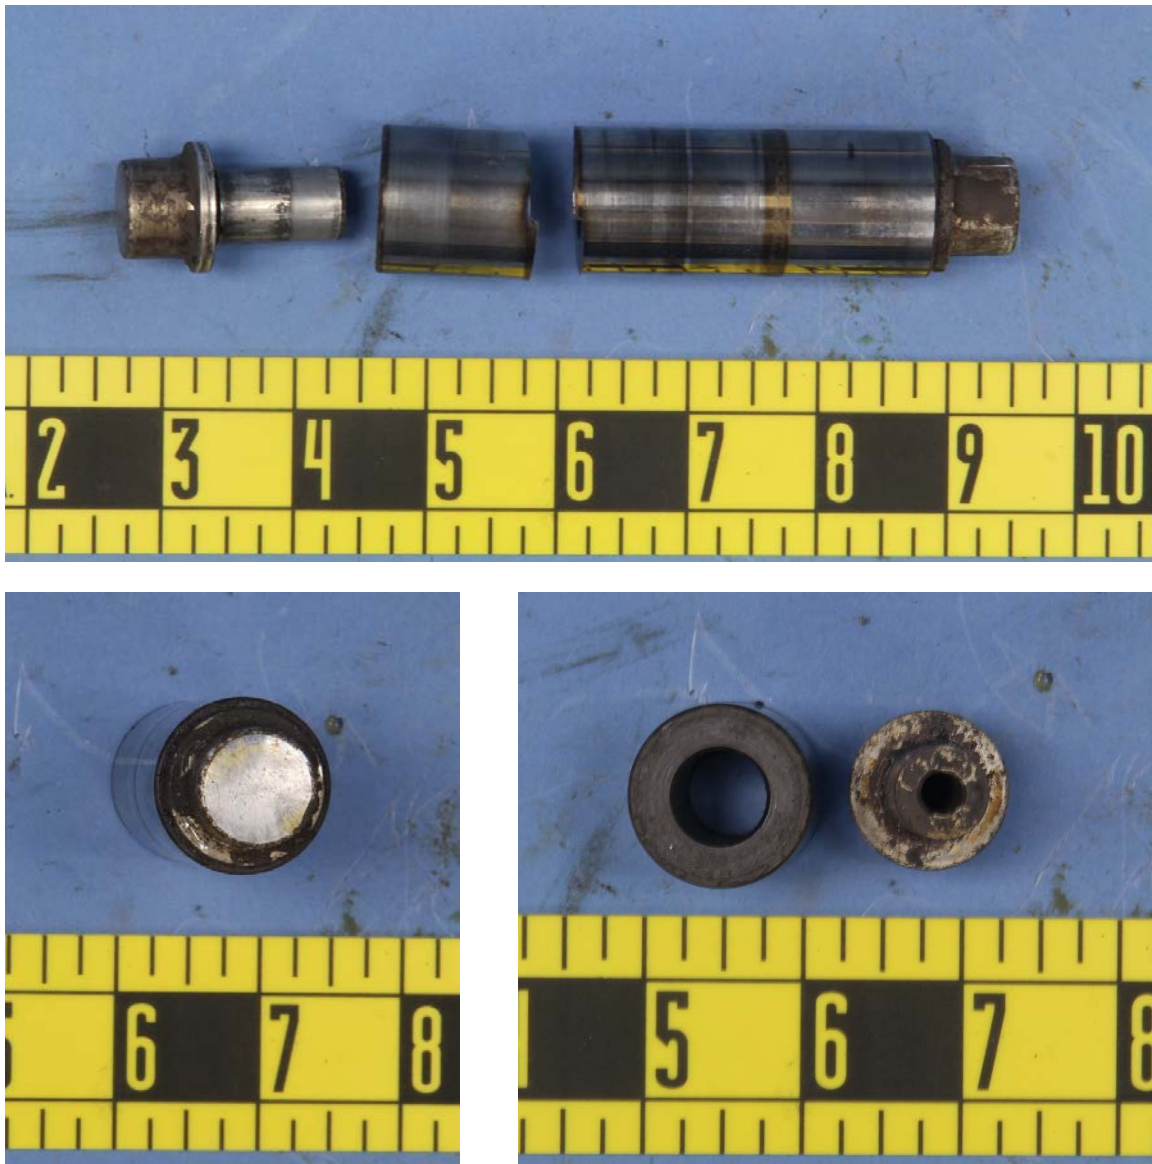
Two piston wrist pins were submitted for examination, an exemplar one that was sectioned and provided for comparison purposes, and one that had fractured. The exemplar wrist pin is shown in Figure 1. The fractured wrist pin is shown in Figure 2.

Figure 1: Overall photos of the exemplar sectioned wrist pin.
