**NATIONAL TRANSPORTATION SAFETY BOARD  
OFFICE OF AVIATION SAFETY  
WASHINGTON, D.C. 20594**

**POWERPLANTS GROUP CHAIRMAN'S FACTUAL REPORT**

**NTSB ID No.: CEN19LA295**

Location: Olney, Texas  
Date: August 29, 2019  
Time: 1100 central daylight time  
Aircraft: Air Tractor AT-502A, Registration: N8517Q

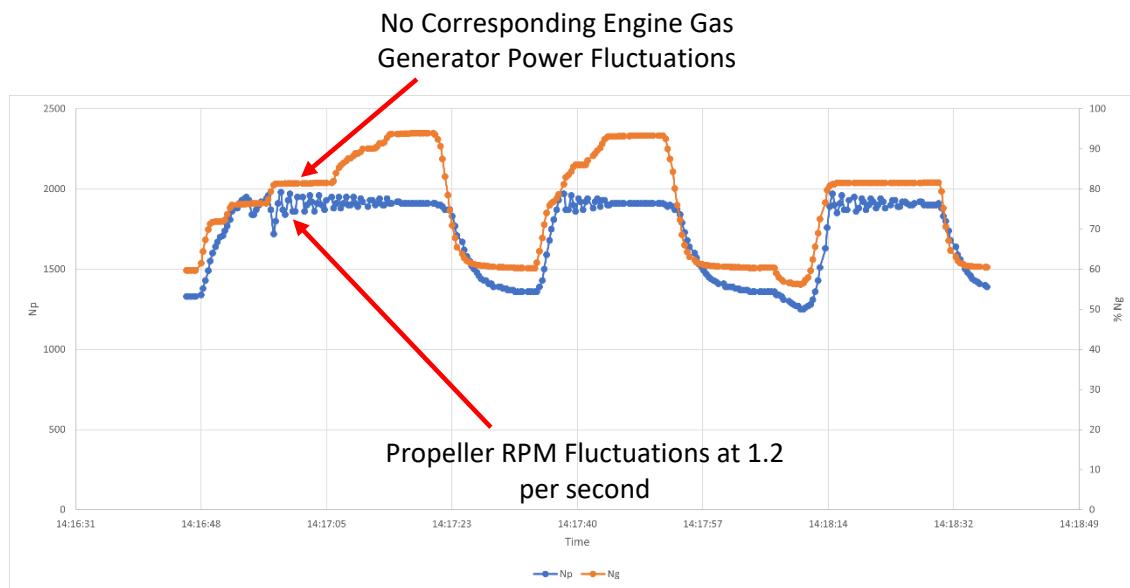
**Figure 4** – Graph of Propeller rotational speed (revolutions per minute (RPM)) vs. Time on Test Airplane (Figure Courtesy of Hartzell)

The pilot described the surge event as a violent occurrence. He stated that he was pitched forward, so that his seat belt restrained him, and then about a second later, he was thrown to the back of his seat. The cycle continued despite him retarding the power lever in an unsuccessful effort to modulate the power on-off surge.

Although the behavior appears to suggest that the engine power (gas generator section) is cycling between maximum and minimum power, this is not the case because the engine acceleration and deceleration respond in a much slower manner. The maximum acceleration of the gas generator from idle to maximum power is approximately 4-5 seconds. The deceleration is faster but is still about 2-3 seconds. Thus, a full engine output cycle is approximately 7 seconds, which is much slower than what the pilot reportedly experienced. The quick behavior could be explained by a propeller in which the blades change pitch quickly. A recent artificially induced surge test performed on a similar airplane at Air Tractor revealed a cycling time of about 1.2 seconds, similar to what the event pilot encountered (See [Figure 4](#)).

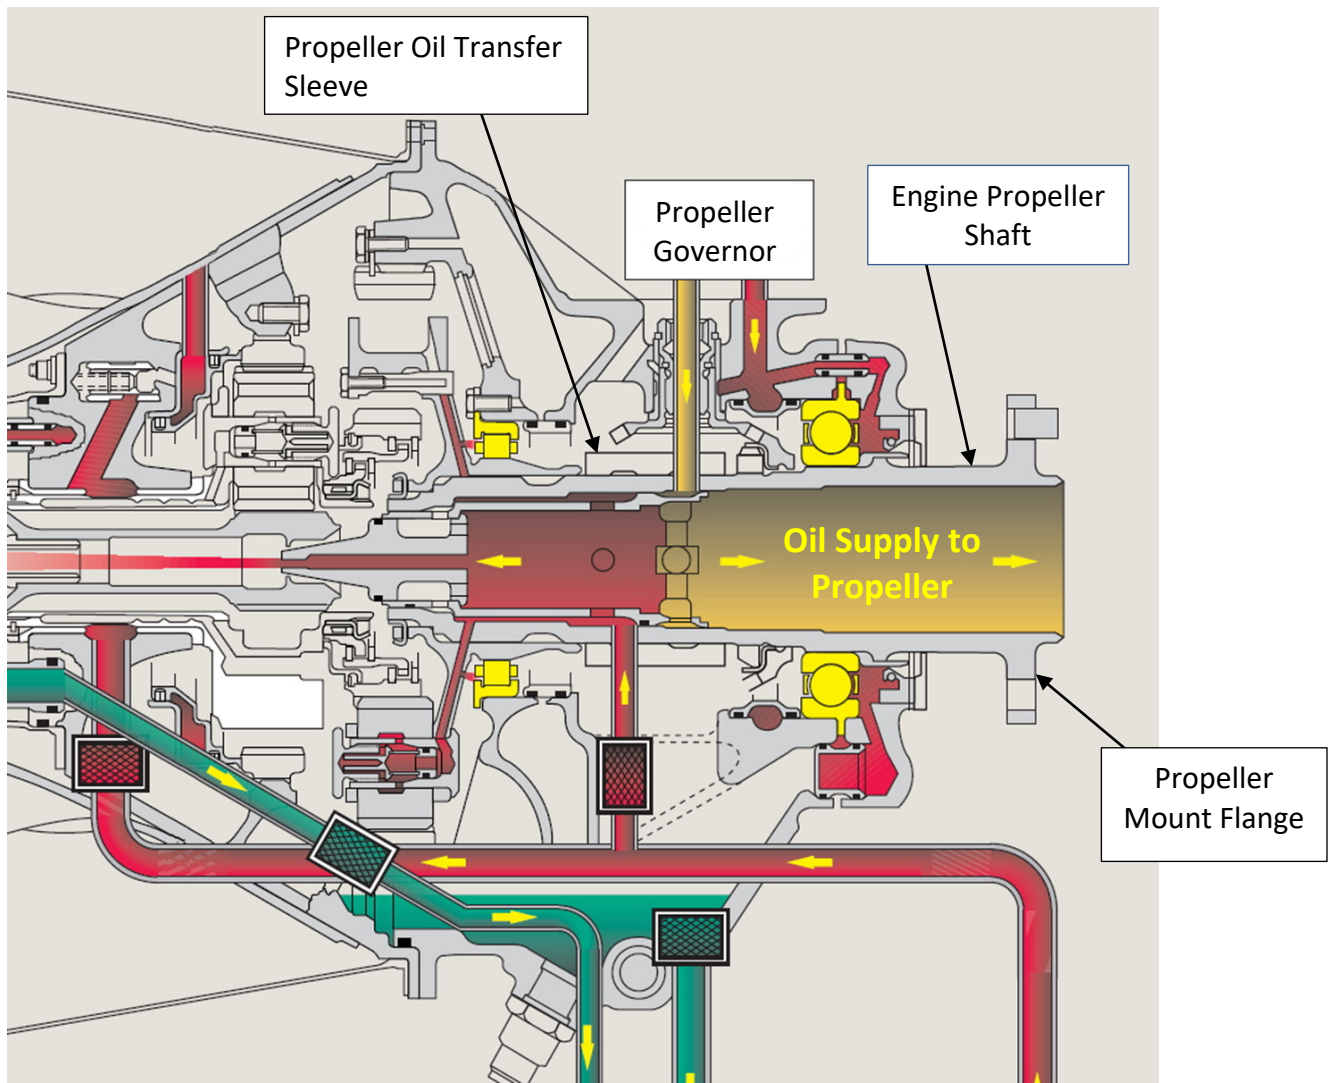
Figure 5 - PT6A Reduction Gearbox Propeller Oil Transfer Schematic (Courtesy of Pratt & Whitney Canada)

When newly assembled, the engine propeller shaft (Figure 5) and the propeller cavity (Figure 6 - depicted in blue) contain only air. Once the engine is started, oil is transferred from the prop governor via the propeller oil transfer sleeve in the RGB, through the oil transfer holes in the propeller shaft and into the propeller shaft hollow center. Oil flows forward, into the propeller cavity, filling the inner cavity of the cylinder and then passes through the transfer oil holes, filling the external piston cavity. The piston cavity is a closed dome with no bleed fitting, and any air and oil trapped in the piston must leave back through the oil transfer holes in the cylinder. The propeller begins spinning as soon as the engine started and the oil entering the piston is centrifuged outward, causing any trapped air (Figure 7 – depicted in pink) to be captured at the center of the external piston. Once shut down, it is possible that the remaining air may be captured in the forward upper portion of the external piston (Figure 7 - depicted in yellow). The chance that all the air will exit the transfer holes is low if the cycles are all made with the airplane at the nose-high ground angle.

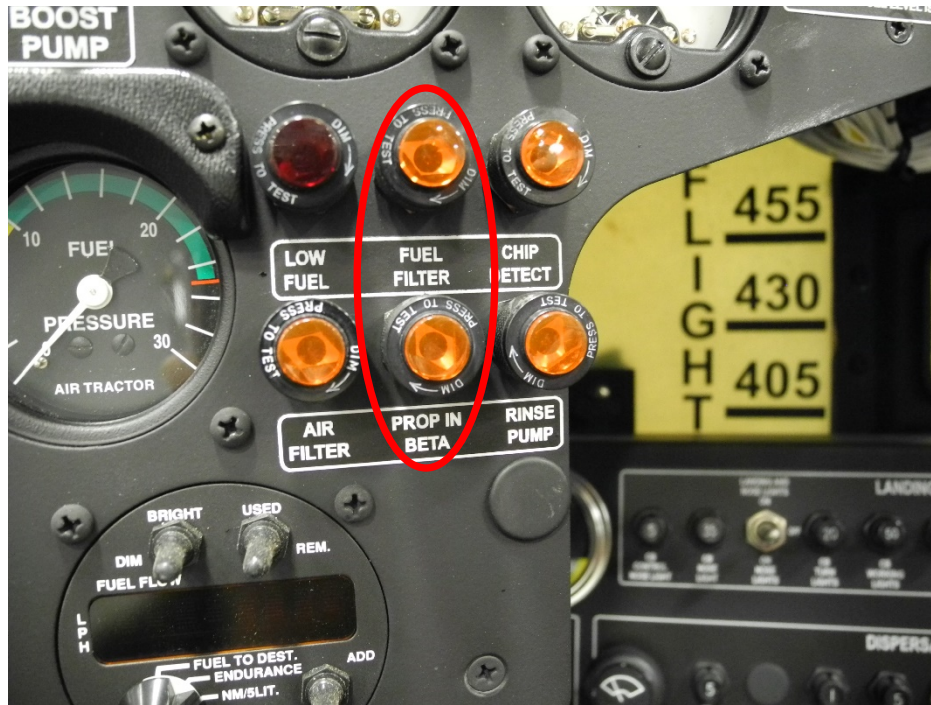
Photo 17 – Cockpit Gauges Depicting Proximity of Amber Warning Lights

The event pilot reported that he saw an illuminated amber light that he believed was a clogged fuel filter light; however, examination of the fuel system could find no fuel system anomalies. An examination of the cockpit amber warning lights revealed that the fuel filter and the prop-in-beta lights are adjacent ([Photo 17](#)). It is possible that he saw the 'prop-in-beta' warning light. A 'prop-in-beta' warning lamp is triggered if the pilot pulls the throttle lever below the ground idle detent into the beta range.

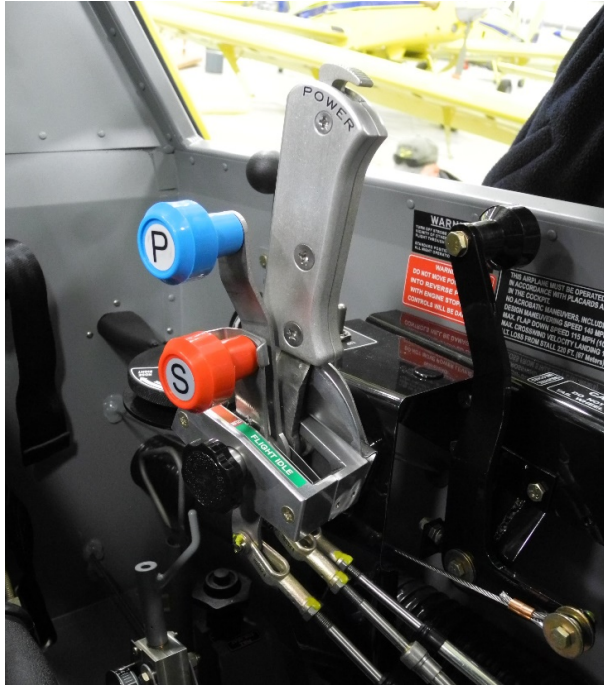
Photo 18 – Kawak Quadrant – Integrated Detent Handles Close to Control Knob

A review of the throttle lever quadrant revealed that it is not a standard Air Tractor part but rather a Kawak quadrant which can be factory installed at the request of customers. The Kawak quadrant ([Photo 18](#)) features small, compact levers (when compared to the Air Tractor quadrant) and a collar type of detent-defeat mechanism with a relatively low spring tension. It was noted that the collar can be grabbed and lifted quite easily and inadvertently compared to the Air Tractor ([Photo 19](#)) thumb operated button that requires a deliberate opposite-direction thumb motion to defeat the beta range detent. It is conceivable that the pilot, during a stressful situation, will grab the entire handle, thereby inadvertently raising the beta-detent collar, so that he would encounter no resistance at the idle detent location while retarding the power lever, allowing the lever to enter the beta range in flight.

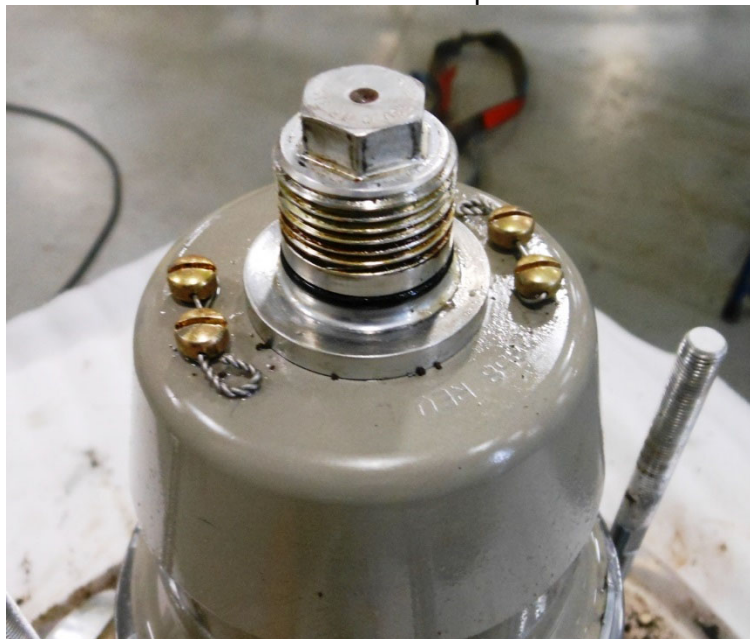
Photo #4 – Feather stop screws

**Feather Stop Screws:** The feather stop screws appeared intact and undamaged (see Photo #4).

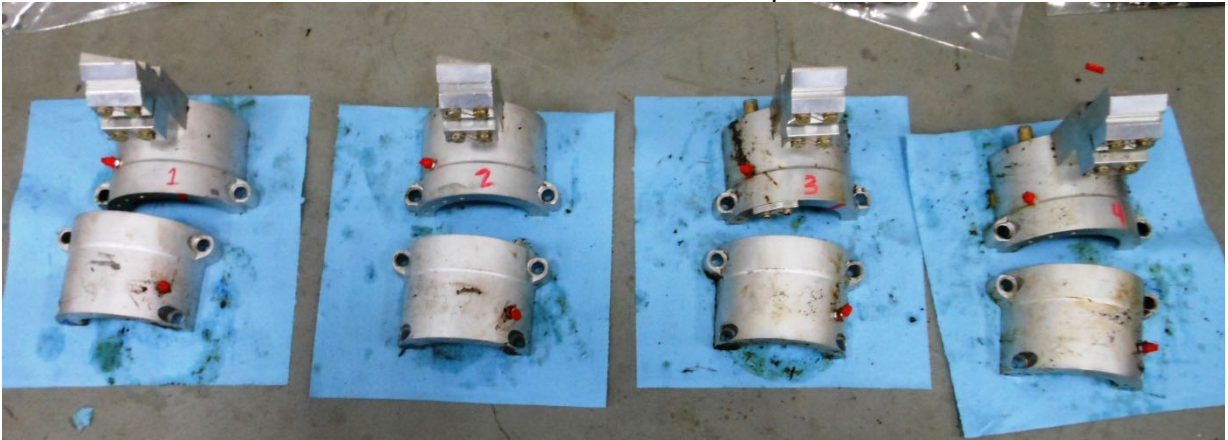
Photo #7 – Blade retention clamps

**Clamps and Counterweights:** (see Photo #7) All clamp bolts were present and secure.

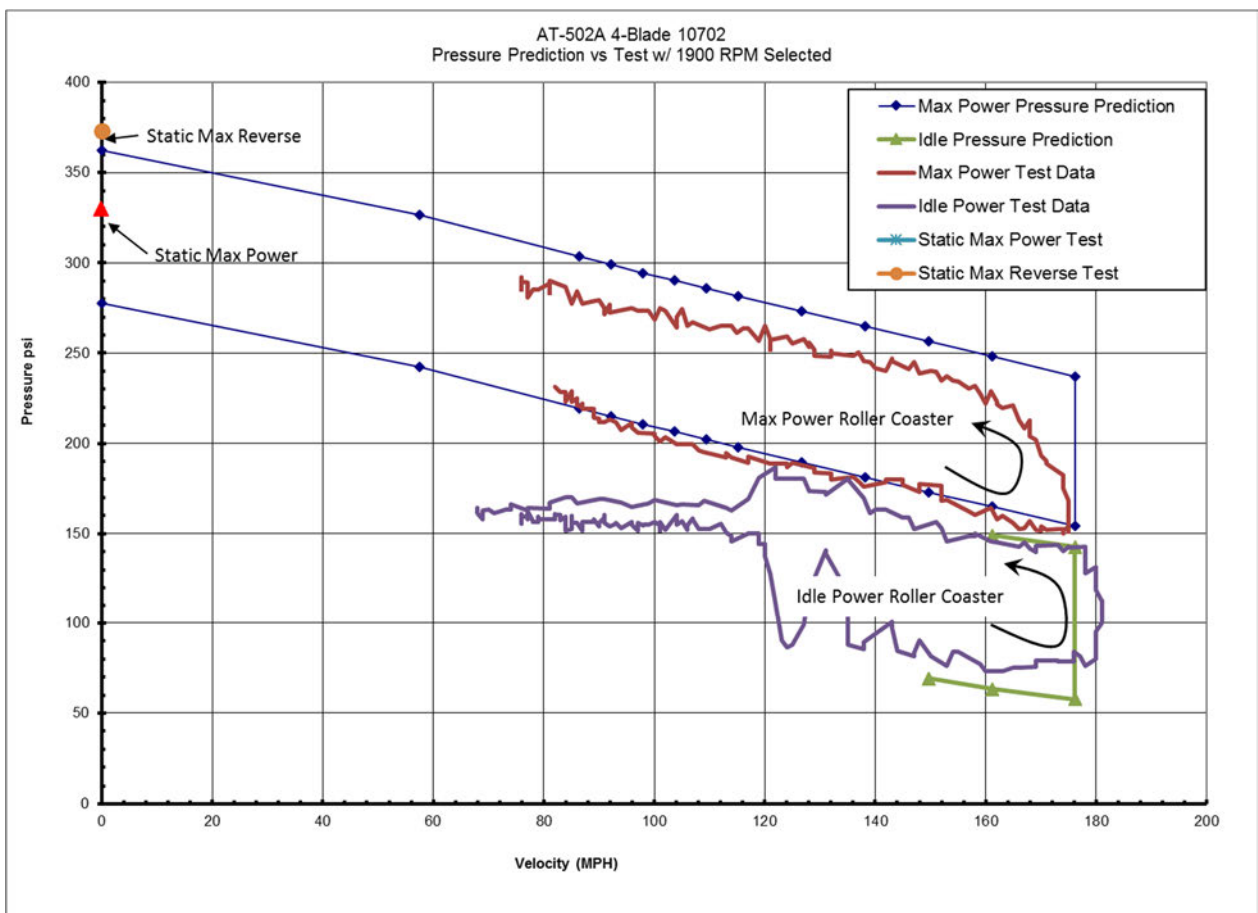
Figure 2 – Propeller Servo Pressure Survey

A propeller servo pressure survey was conducted by Air Tractor on an exemplar AT-502A with the PT6A-140AG engine on 4/29/2020 and 4/30/2020. A plot of the recorded pressures compared to the predicted pressures is shown in Figure 2. As shown in Figure 2, all governing servo pressures were adequately below the maximum relief setting of the governor (385+/-15). A margin of 50 psi or greater was maintained at  $V_{NE}$  with idle power.

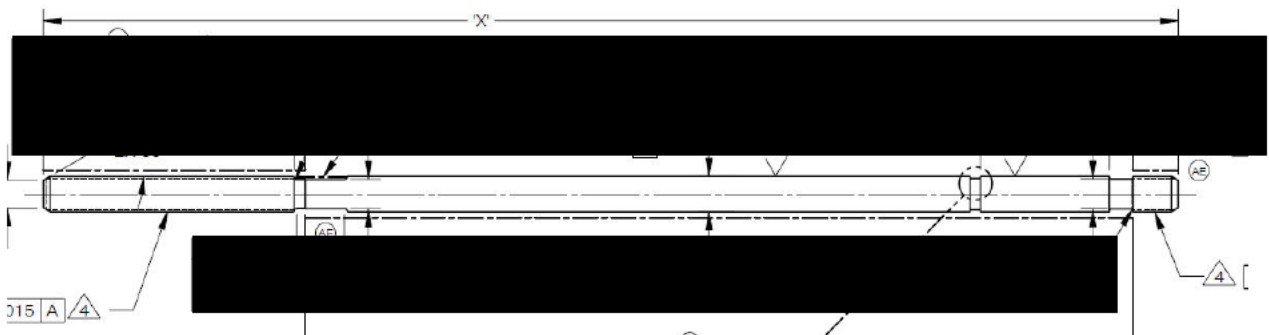
As you can see from the drawing below, all the rods were within spec.
