## ENGINE EXAMINATION REPORT

| ENGINE MODEL | TSIO-360-FB |
| AIRCRAFT REGISTRATION | N2890T |
| FILE NUMBER | 19-095 |

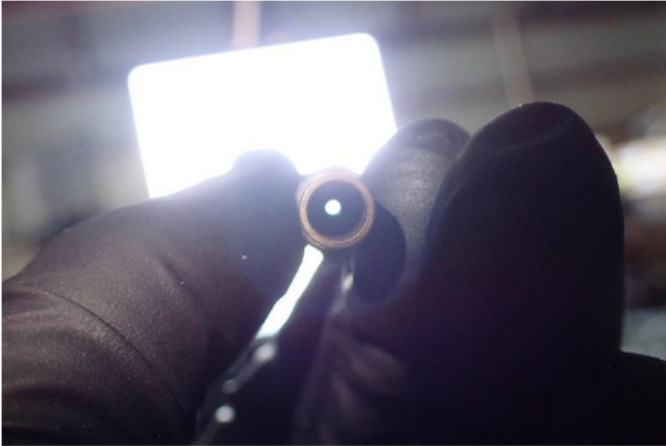
#1 Nozzle (after air was blown through the inlet)
