**NATIONAL TRANSPORTATION SAFETY BOARD**  
**Office of Aviation Safety**  
**Washington, D.C. 20594**

**POWERPLANT GROUP CHAIRMAN'S FACTUAL REPORT**  
**NTSB No: CEN19MA312**

Location: Monclova, Ohio

Aircraft: Convair 440, Registration Number N24DR

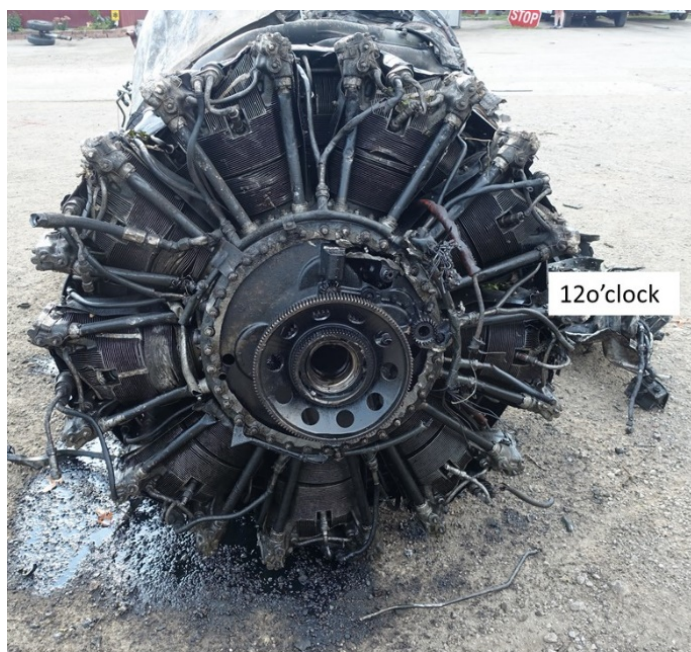
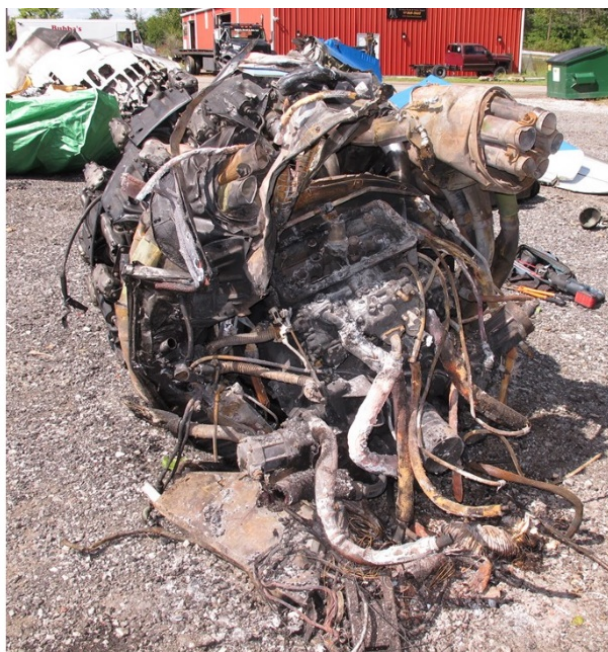
**Photo 11- (L) Engine Front, (R) Engine Rear (After Removal of Cowling and Bulkhead Material)**

The No. 2 engine was separated from the wing and thrown clear of the wreckage, further along the intended direction of flight, and came to rest in a parking area. The right propeller was separated from the engine during impact and was recovered in the main debris field. The engine came to rest on its left side (9 o'clock position) and was facing approximately 180° relative to the flight path (**Photos 11 and 12**). The GPS positions and location within the debris field were documented with an UAS and are available in the UAS Aerial Imagery report in the investigation docket.

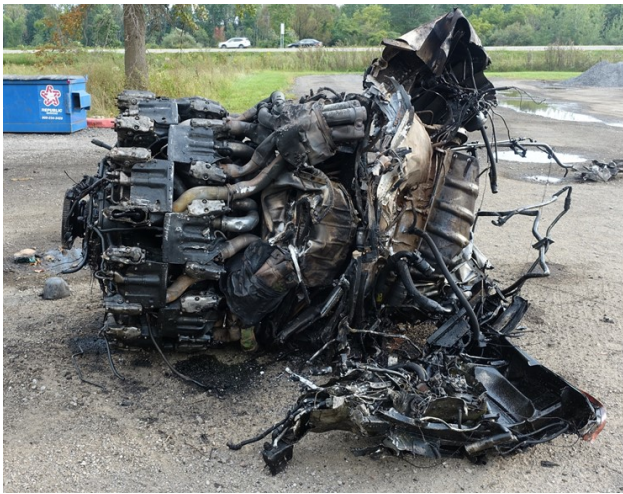
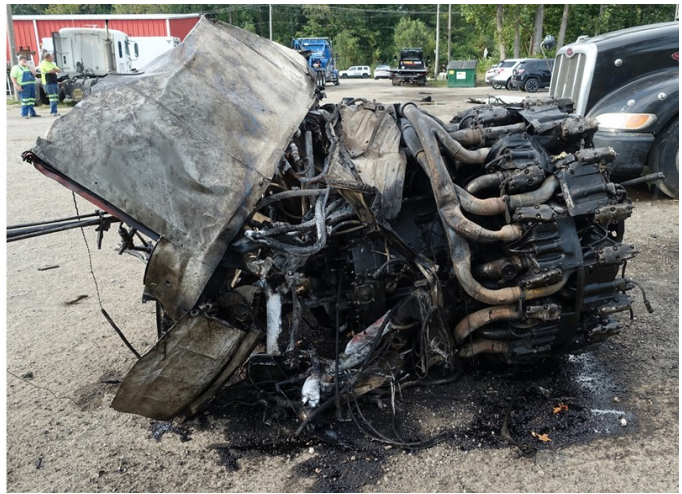
**Photo 12- (L) No. 2 Engine, 12 o'clock Position, (R) No. 2 Engine, 6 o'clock Position**

All 18 cylinders were present and complete. Branches, leaves, and dirt debris were collected in the front cylinder head cooling fins between the 12 and 5 o'clock positions (**Photo 14**). The exhaust rocker cover on cylinder 2 and the intake rocker cover on cylinder 18, both located near the 12 o'clock position were separated and the surfaces around the separated covers had impact/rub damage in the axial direction. The exhaust manifold plumbing was all present, but some crushing deformation was observed at about the 1 o'clock position. There was a small area of localized thermal damage at approximately the 12 o'clock position (left side as the engine was resting), immediately aft of the cylinder

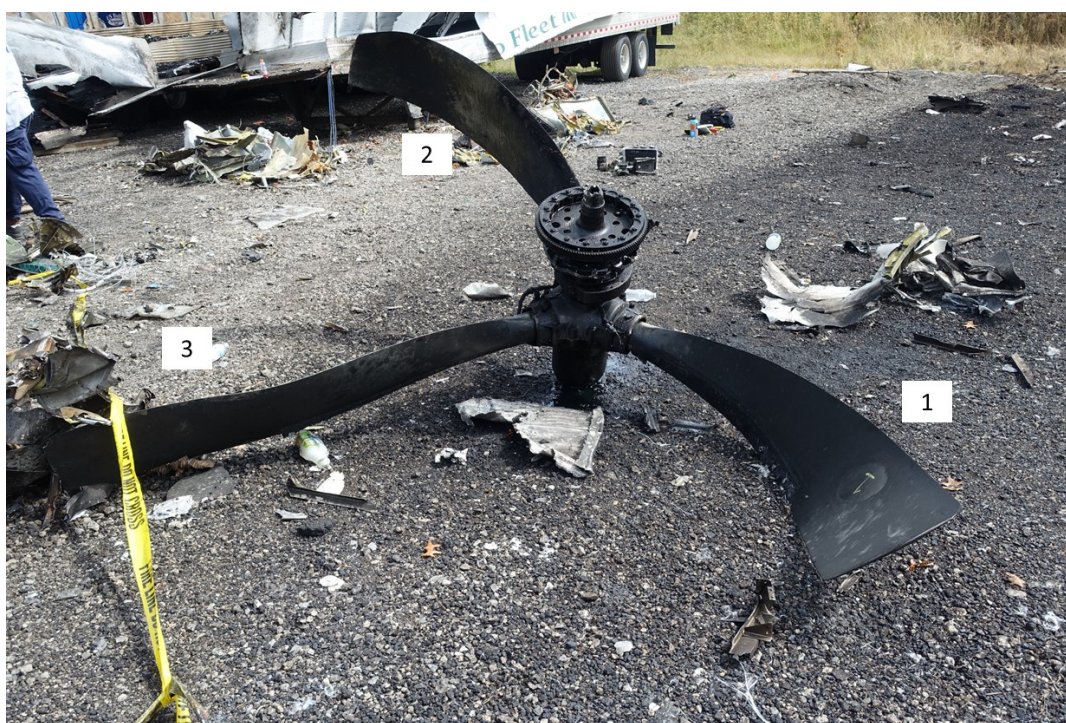
**Photo 17- Right Propeller Assembly**

The aft end of the propeller shaft was separated during the impact sequence. The separated section of the shaft was recovered near the propeller (**Photo 16**). On both sides of the shaft fracture there was circumferential scoring. The scoring was coincident with the scoring documented in the engine propeller shaft journal. The propeller came to rest with the propeller dome and two of the blades against the ground (**Photo 17**). All three propeller blades were full span, approximately 71 inches from blade collar to tip. One propeller blade (blade 2) was rotated 180° relative to the other two. The blades labeled 1 and 2 both exhibited bending in the clockwise direction. The anti-icing boot on all three blades was thermally damaged. The as-recovered blade angles did not appear consistent with the deformation on the blade collars.

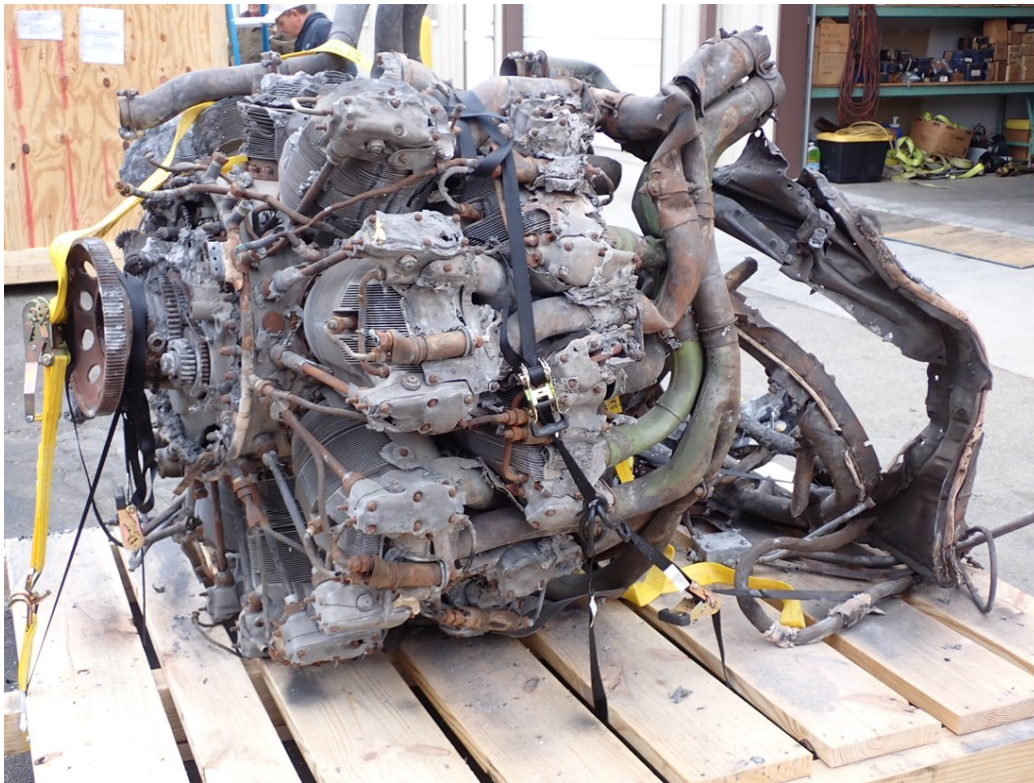
**Photo 19- No. 1 Engine, Left Side, as Received**

The No. 1 engine was uncrated and left on the shipping pallet for examination and partial disassembly (**Photos 19 and 20**). The intake and exhaust duct manifolds were cut with a reciprocating saw to access the engine cylinders (**Photo 21**). The remaining spark plugs that were not consumed by the fire were removed and inspected<sup>3</sup>. The removed spark plugs did not appear uniform. Several spark plug electrodes appeared ashy/white<sup>4</sup> and others appeared to be corroded (**Photos 22 and 23**). Cylinders 16, 17, and 18 were partially seized in the crank case and pry bars and a dead blow hammer were required for removal. The interior surface of each of the cylinders were rusted, but the walls of the cylinder and the valve heads were unremarkable. The exposed piston heads were rusted but there was no evidence of detonation<sup>5</sup> or material deformation (**Photo 24**). The mechanics were unable to remove the piston head cylinder pin from cylinder 18, so a reciprocating saw was used to cut the piston connecting rod. The rear and aft sides of the crankcase were inspected visually and with a handheld borescope. The internal surfaces were rusted but there was no evidence of internal failure or loose debris.

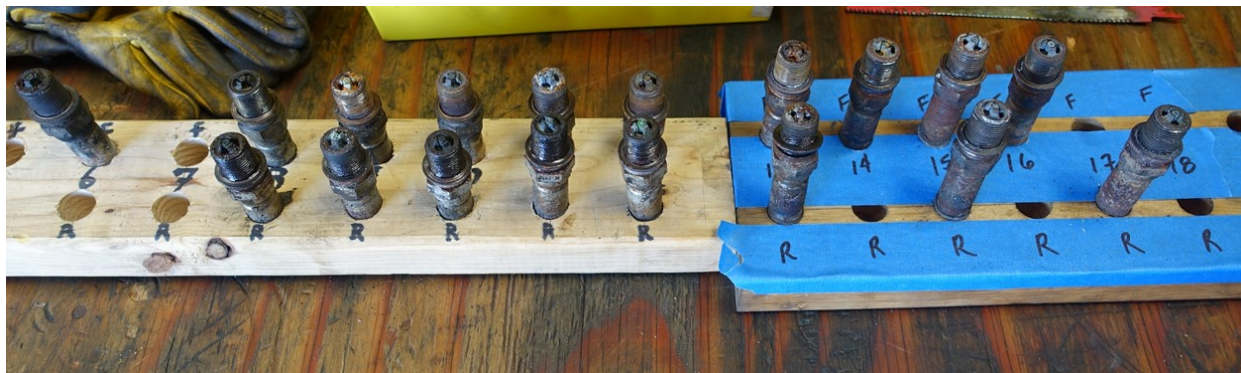
**Photo 22- No. 1 Engine Spark Plugs**

<sup>4</sup> According to Vintage Radials, ashy or light colored spark plug electrodes are commonly seen when the engine is operated with a lean fuel mixture.

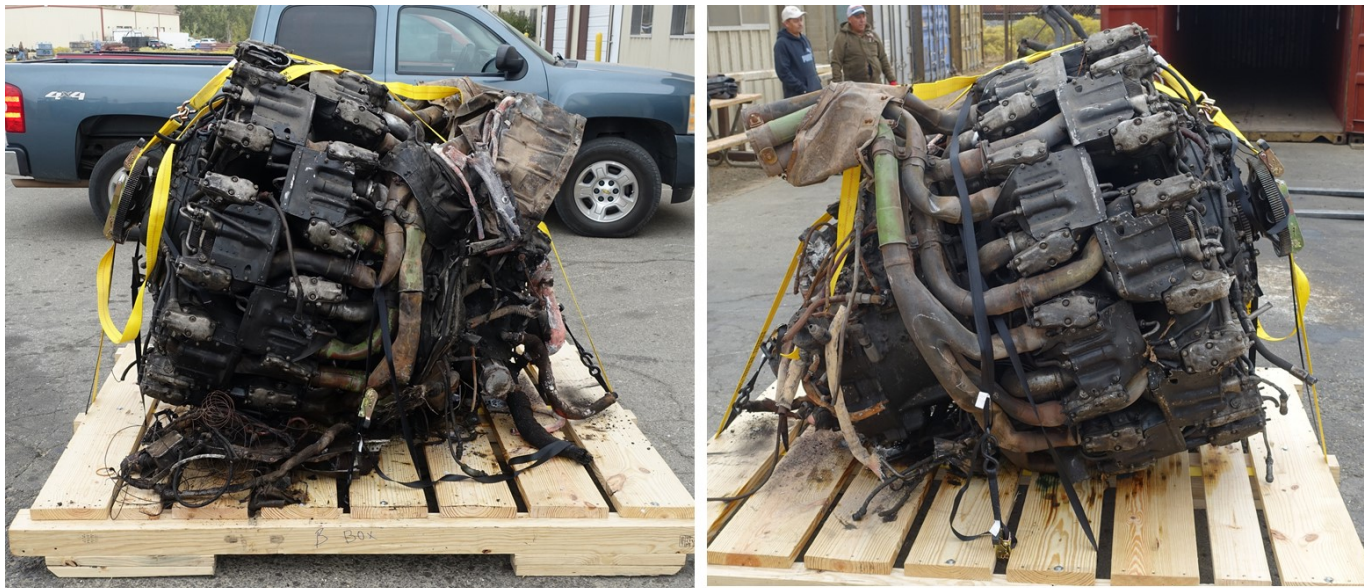
**Photo 25- No. 2 (Right) Engine, (L) Left Side, (R) Right Side, as Received**

The No. 2 engine was uncrated and left on the shipping pallet for examination and partial disassembly (**Photo 25**). As noted in Section 4.1 of this report, the propeller reduction case was separated from the engine during the accident sequence and the fracture surface of the gearbox that remained attached to the engine appeared rough and jagged (**Photo 26**). According to Vintage Radials, it is common for the propeller assembly to separate from an R2800 engine when the propeller impacts a hard surface while operating a high power. A random sample of spark plugs were removed, and all spark plugs electrodes were in good condition (**Photos 27 and 28**). Intake and exhaust manifold ducting was cut with a reciprocating saw to allow for removal of cylinders 5, 6, and 16 for inspection. The inside of the

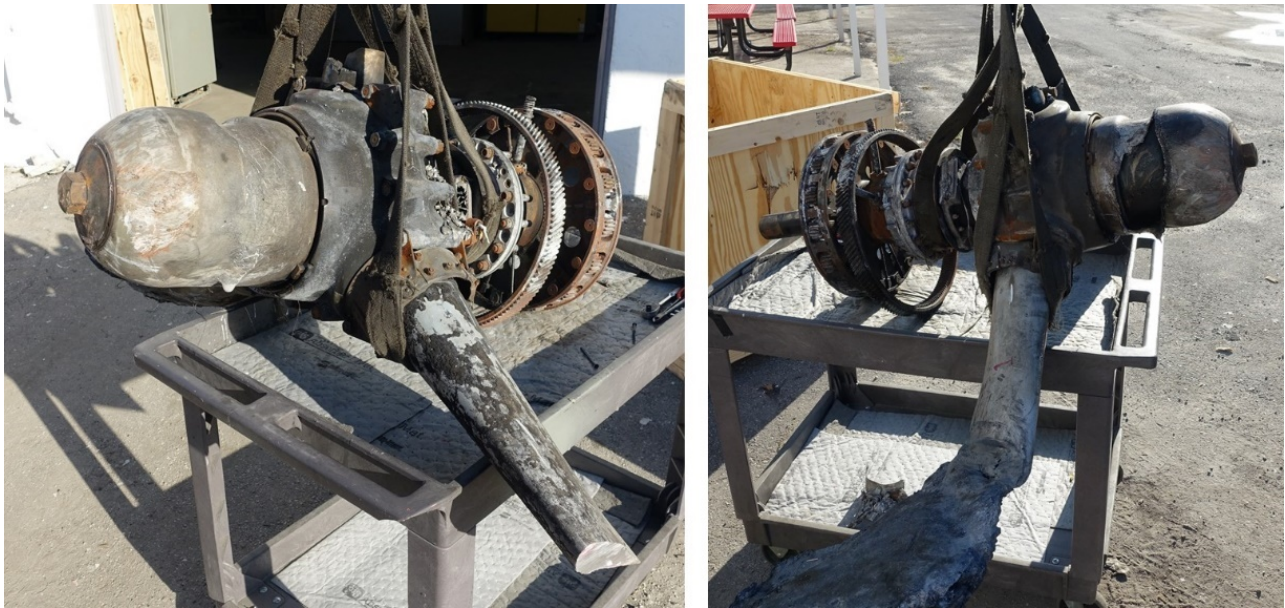
**Photo 32- Left Propeller, As-Received**

The left propeller was removed from the shipping crate and visually examined. There was no additional damage noted when compared to the photographs that were taken during the on-scene portion of the investigation (**Photo 32**).

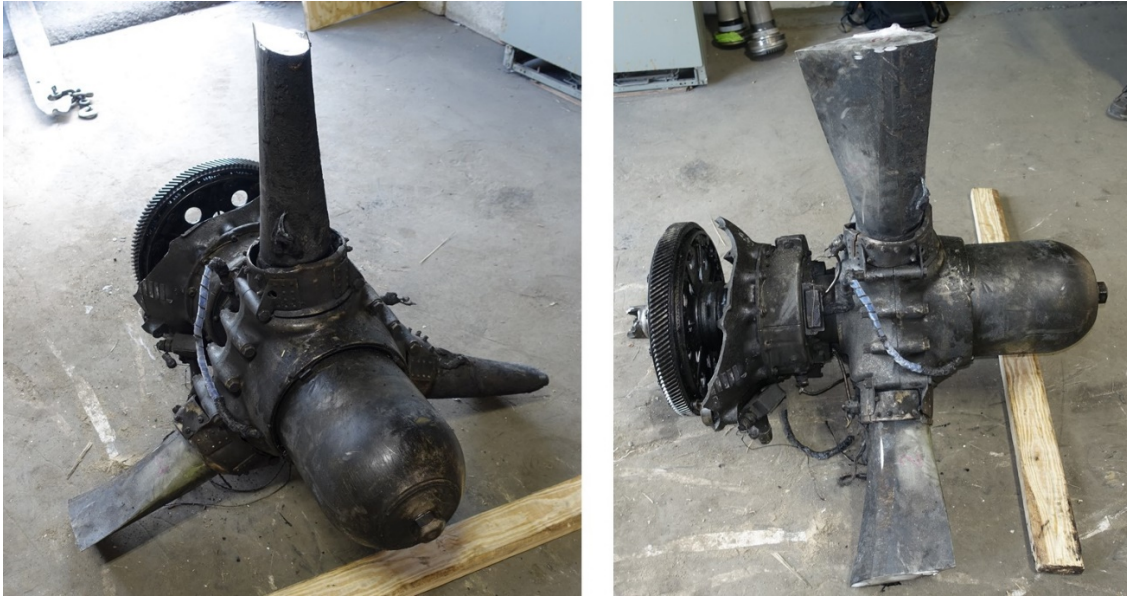
**Photo 40- Right Propeller Assembly, As-Received**

The right propeller assembly was removed from the shipping crate and visually examined. There was no additional damage to the assembly when compared to the photographs that were taken during the on-scene portion of the investigation (**Photo 40**).
