| <b>Rolls-Royce</b> | Rolls-Royce Corporation<br>450 S. Meridian Street<br>Indianapolis, Indiana<br>46225-1103, USA | <b>REPORT NO.</b><br>20FAE-014-PR | <b>REV.</b><br>Initial | <b>PAGES</b><br>1 of 135 |
| <b>TITLE</b><br><br><b>METALLURGICAL INVESTIGATION OF A HELICAL POWER TURBINE PINION GEAR, P/N 6893672, INSTALLED IN AN M250-C47B ENGINE, S/N CAE847031, OPERATED BY PANTHER HELICOPTERS</b> | | <b>PREPARED</b><br><br>Signatures on file | | |

| Engine Model: | M250-C47B |
| Evaluations: | Failure Analysis |

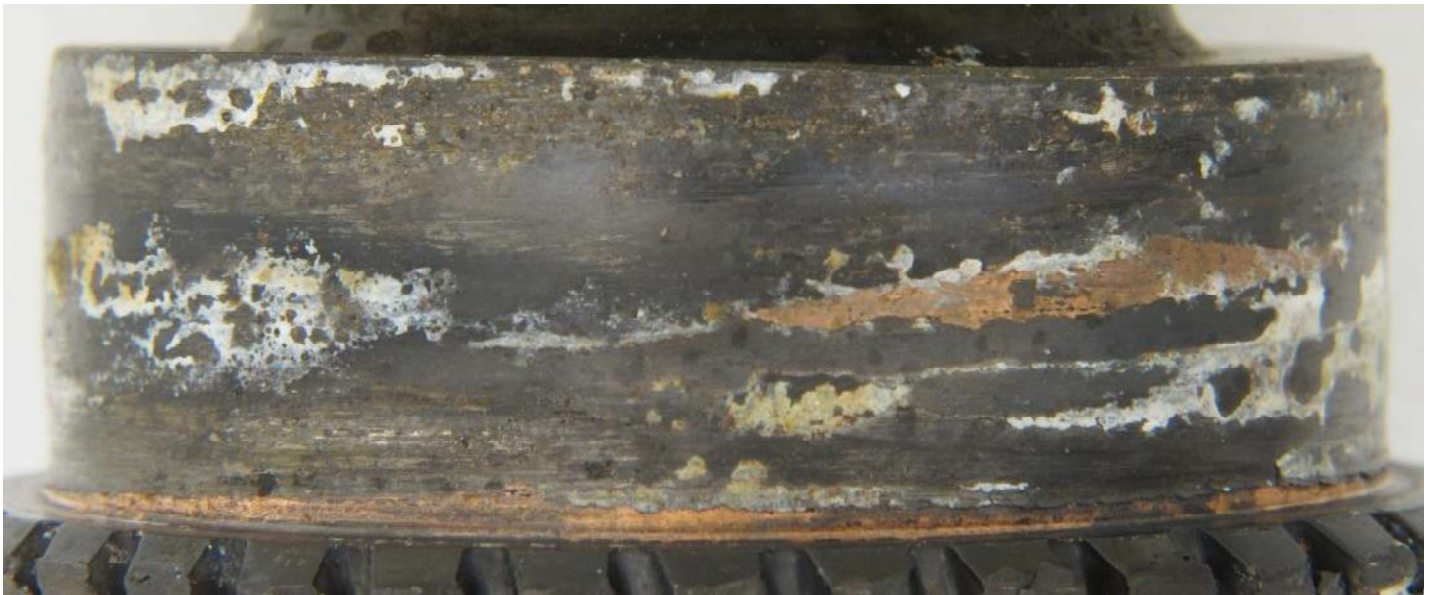
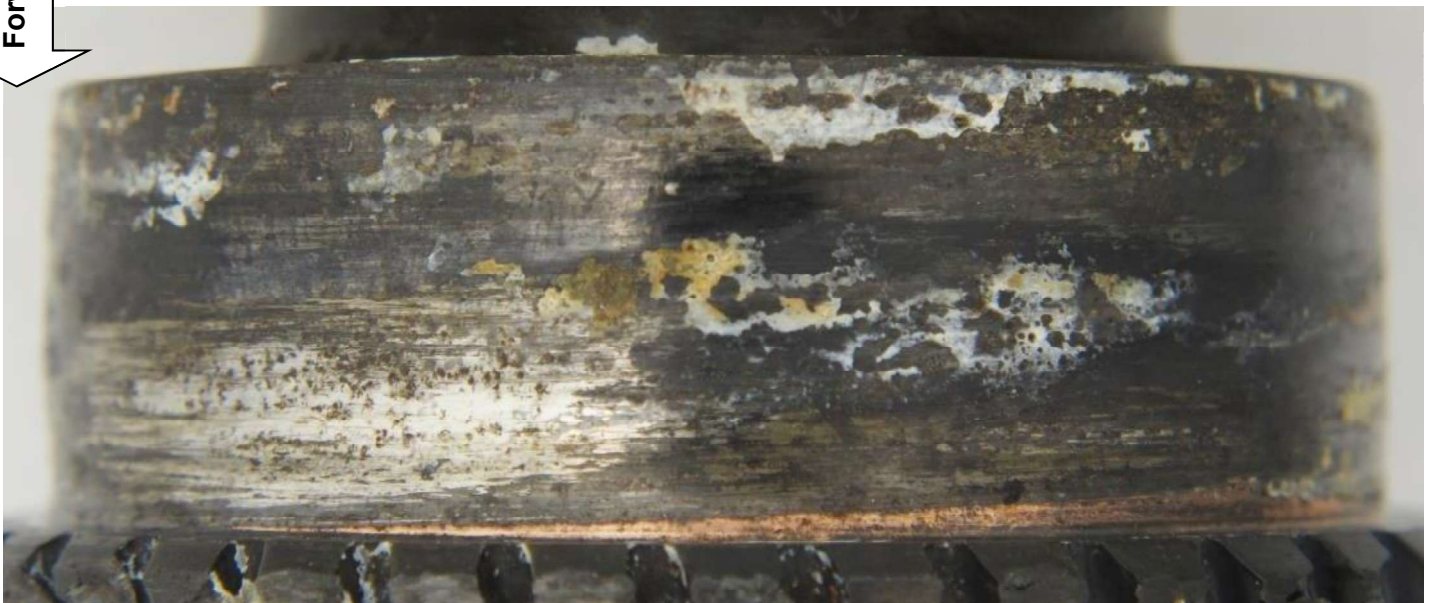
**Figure 6.** Detailed views of No. 4 bearing journal, which exhibited circumferential rub. Each image shows the part rotated ~90° from the previous.

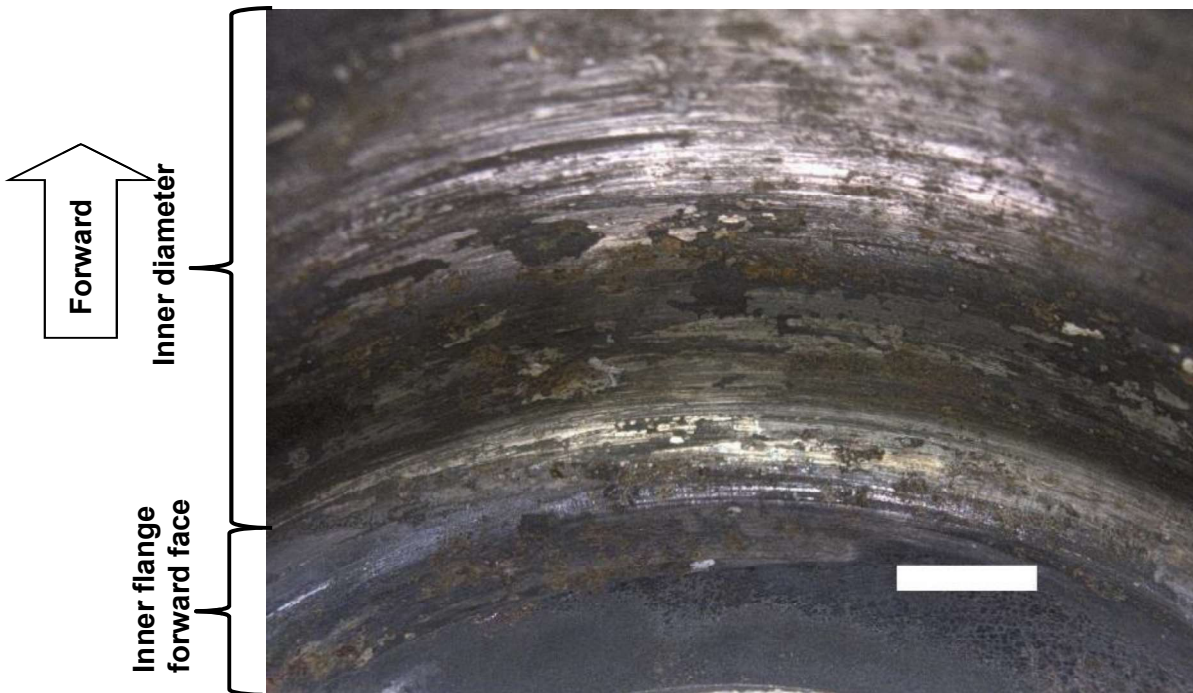
Figure 9. Detailed view of the inner diameter and inner flange forward face, which exhibited circumferential rub.

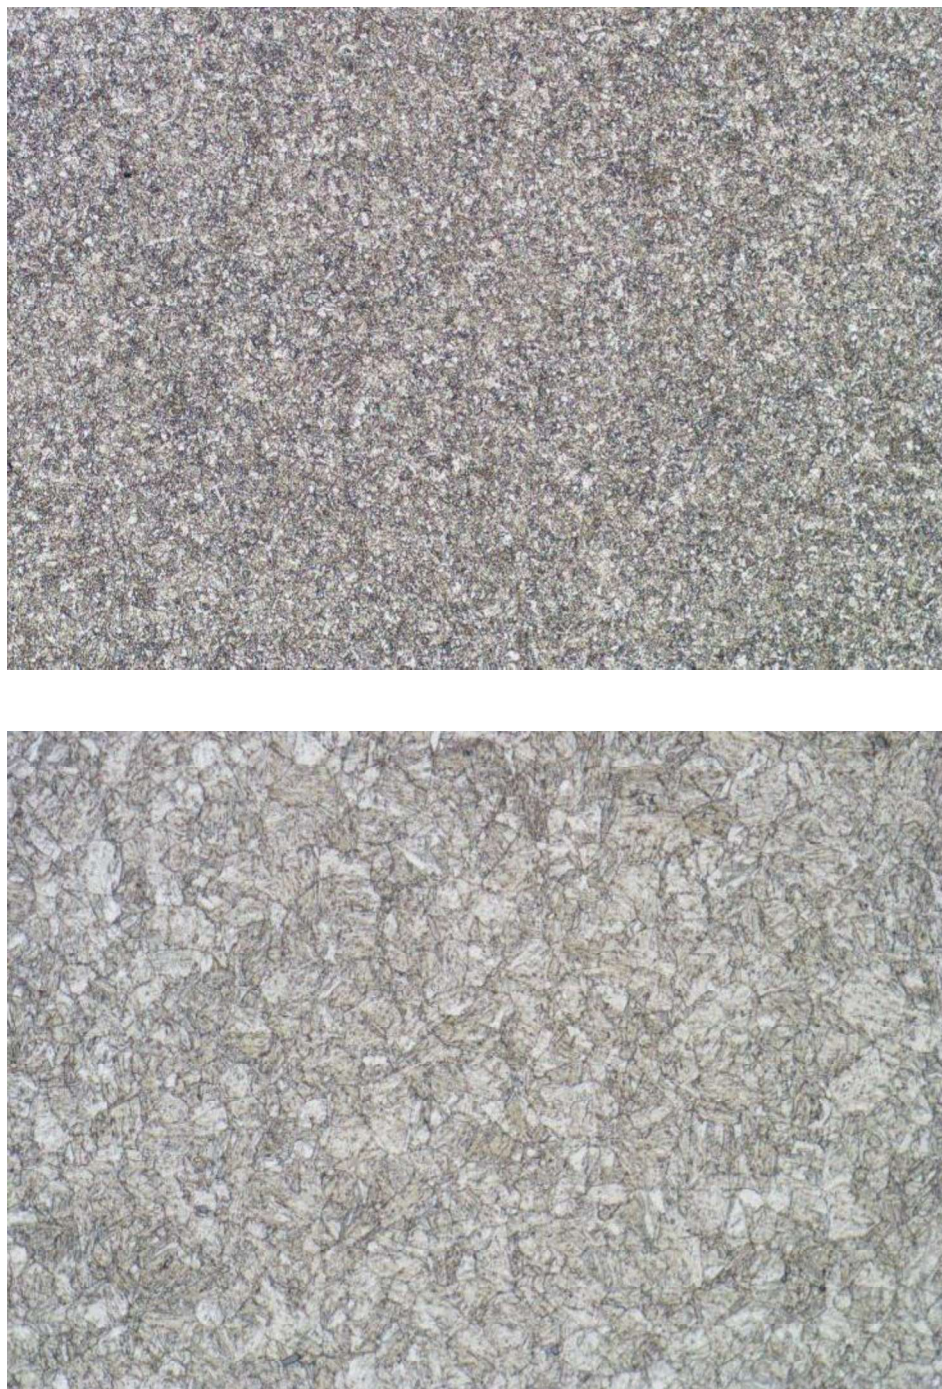
**Figure 23. Representative images of the core microstructure of the pinion gear. Etchant: 5% Nital**

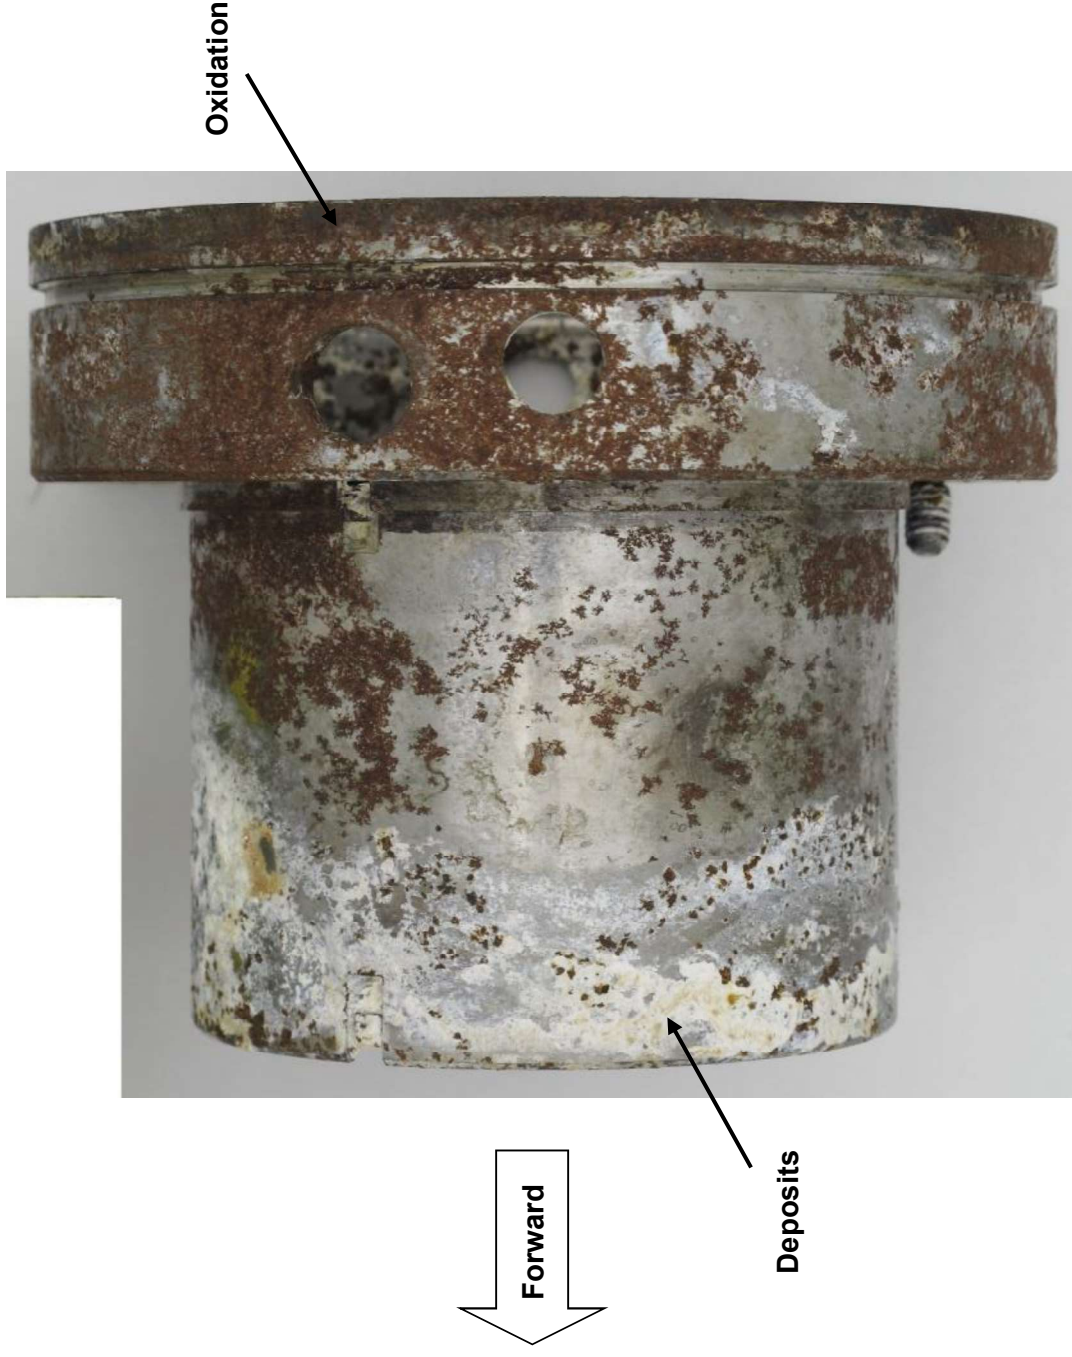
Figure 24. General condition of the bearing-stepped pinion cage after cleaning.

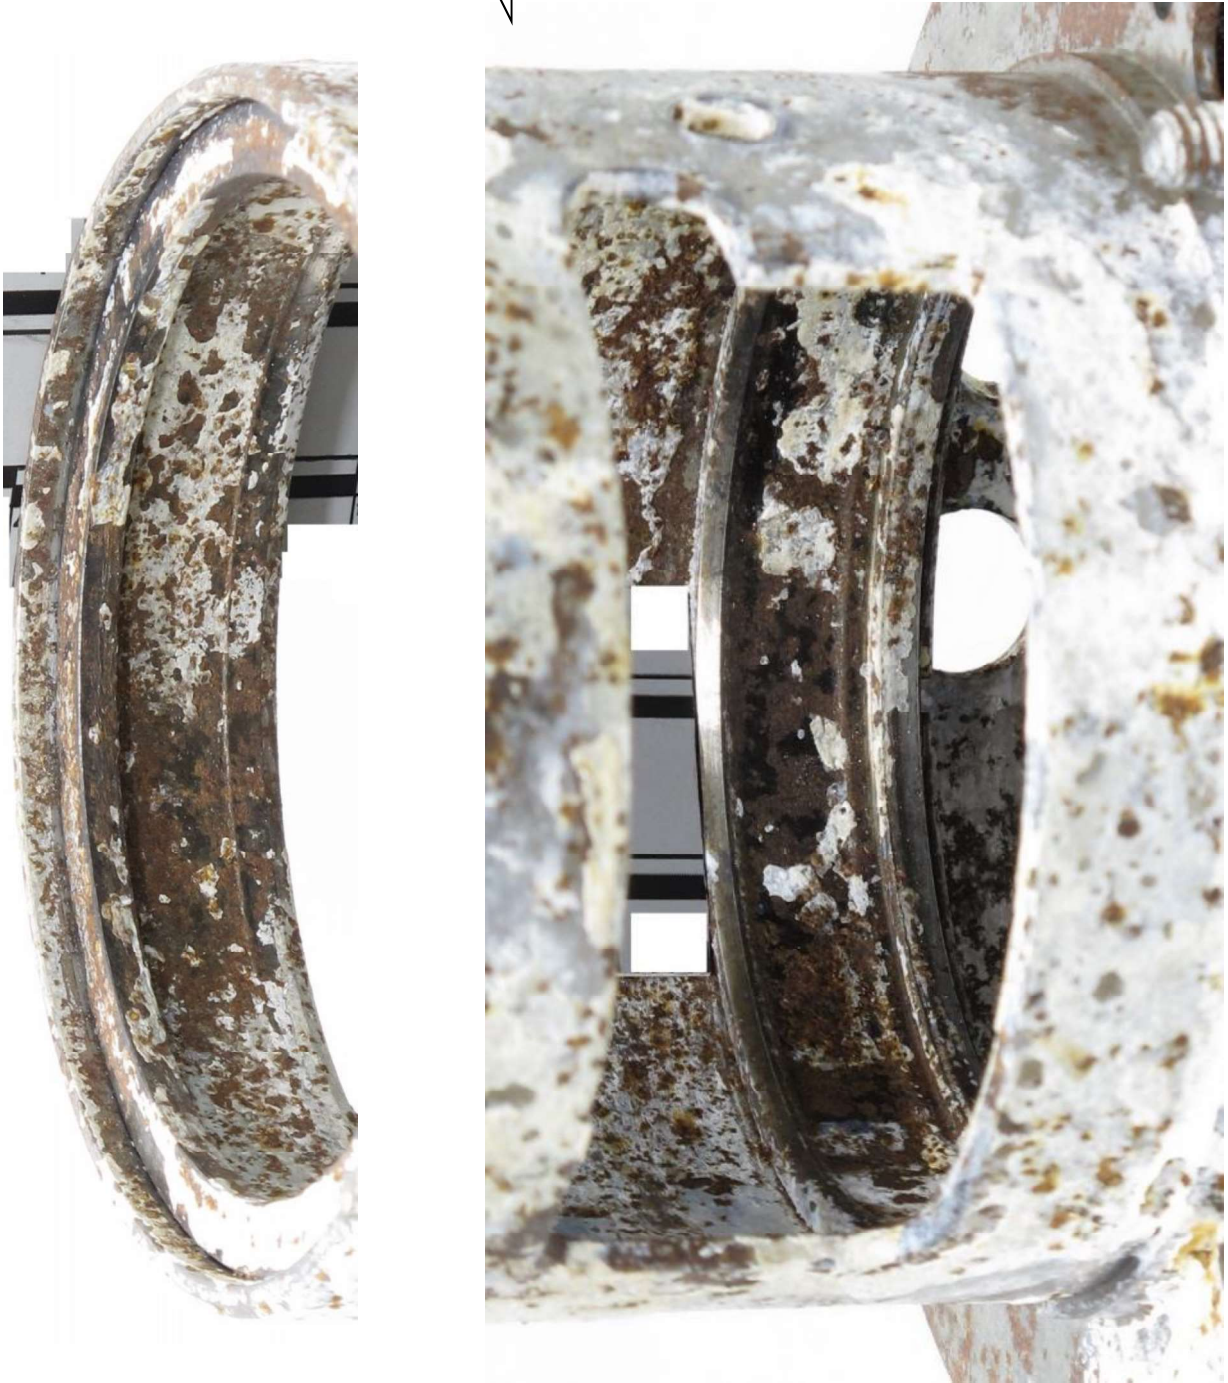
**Figure 25. Detailed views of the No. 3 bearing (left) and No. 4 bearing (right) outer rings assembled in the bearing-stepped pinion cage.**

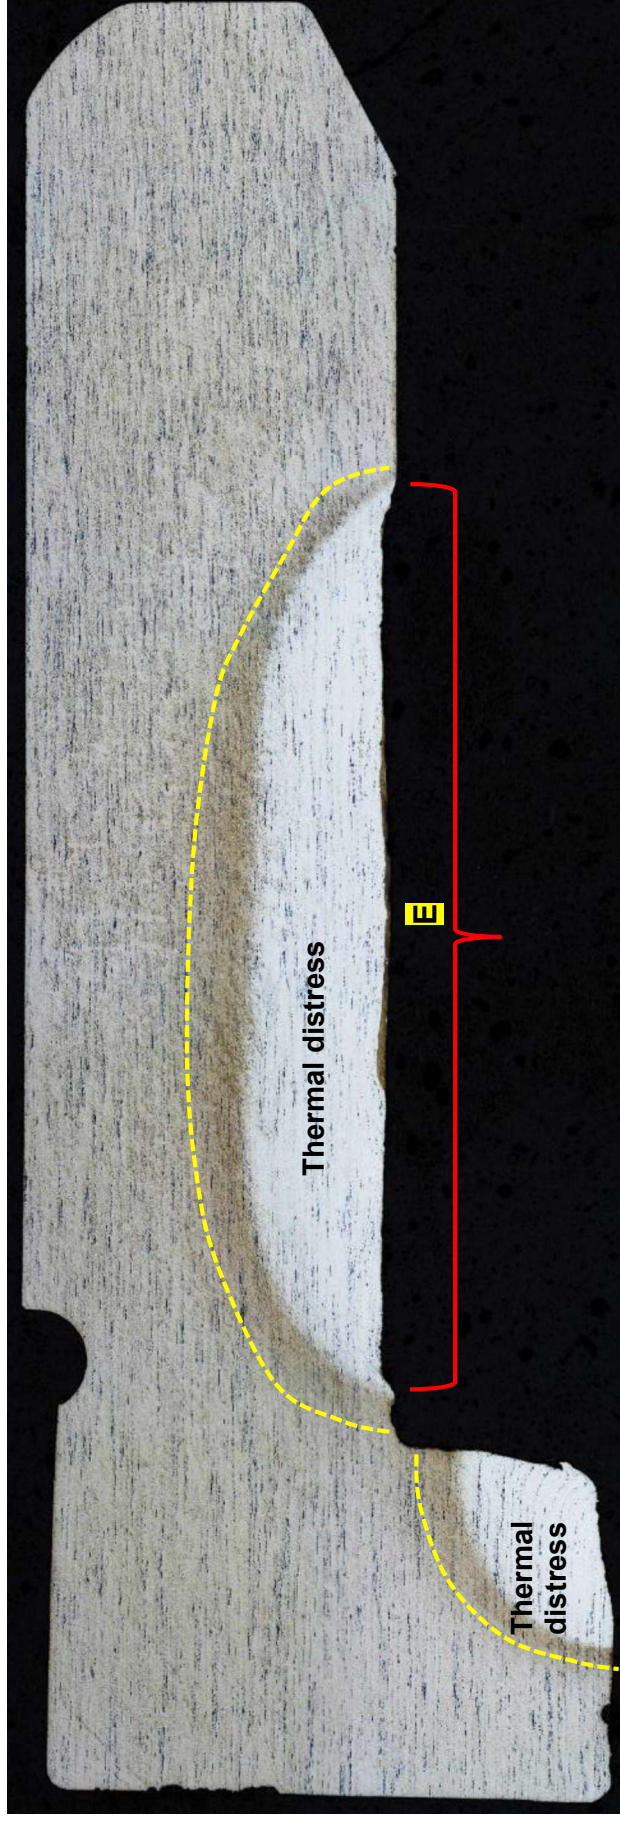
Figure 29. Metallographic cross-section through the outer ring (see yellow dashed line in Figure 26). Yellow outlines mark the boundaries of thermal distress on the raceway and forward shoulder corner, and the red brace marks material removal at the roller path. Location E is shown in more detail in the following figure. Etchant: Vilella's

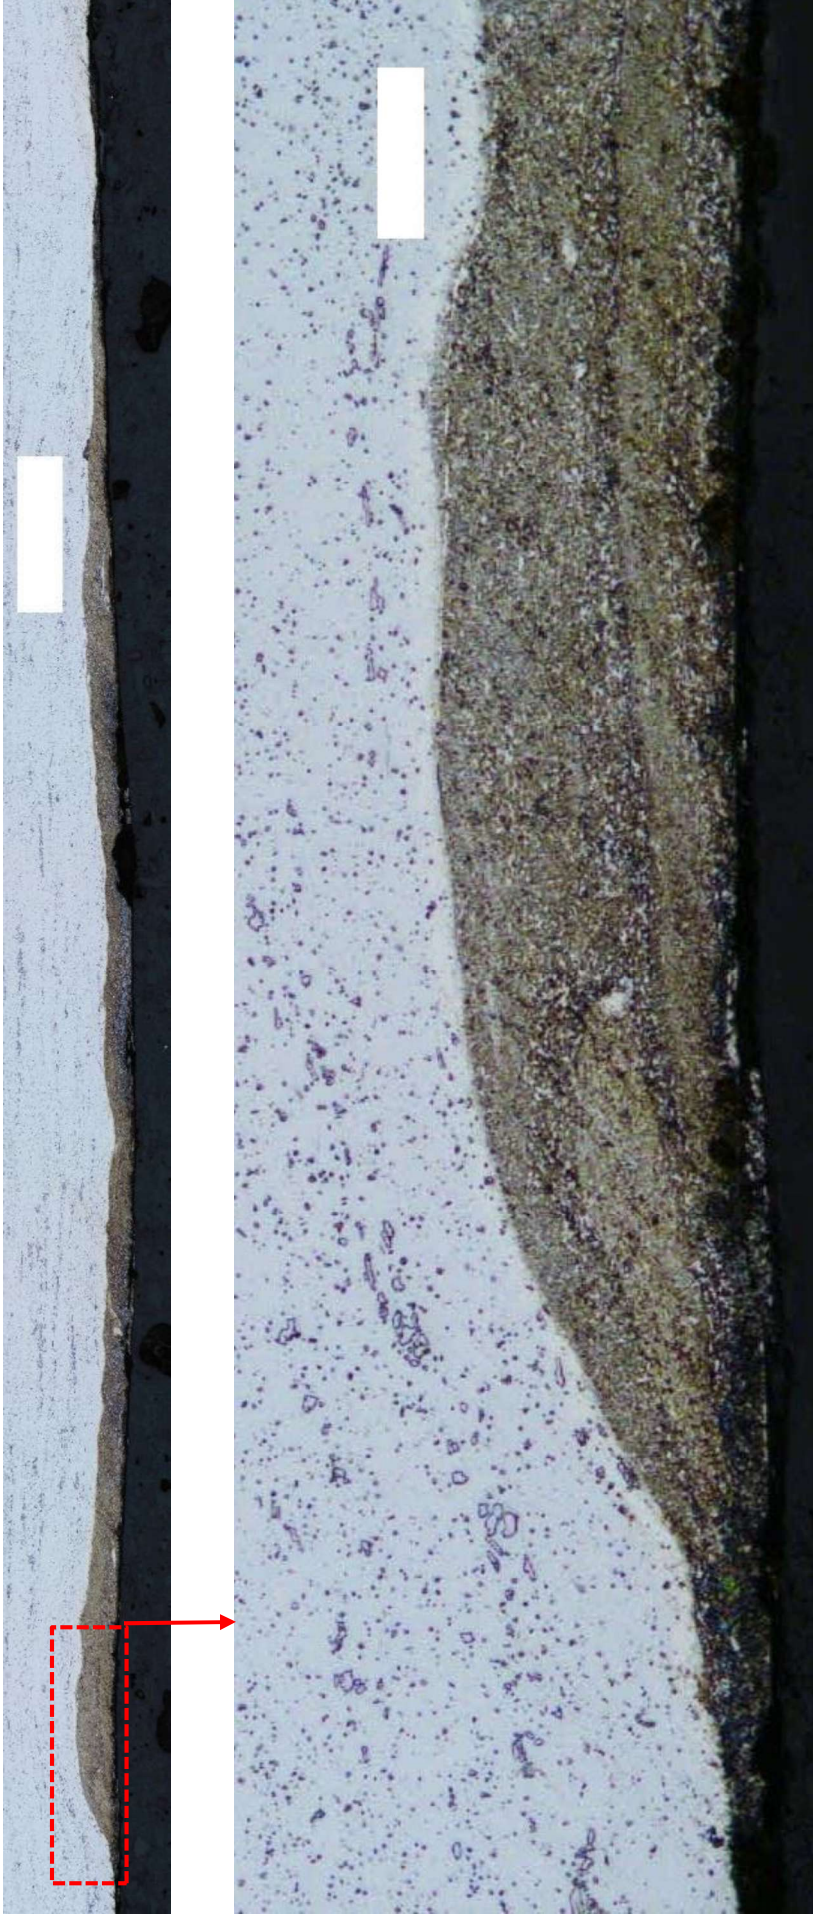
**Figure 30. Metallographic cross-section through the outer ring raceway, which exhibited transferred material. Etchant: Vilella's**

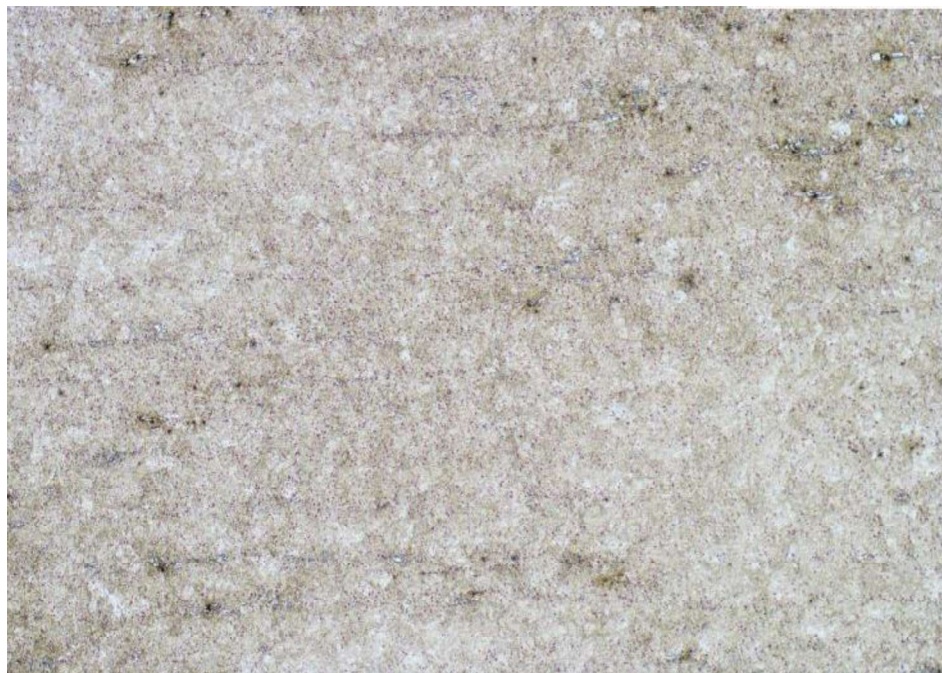
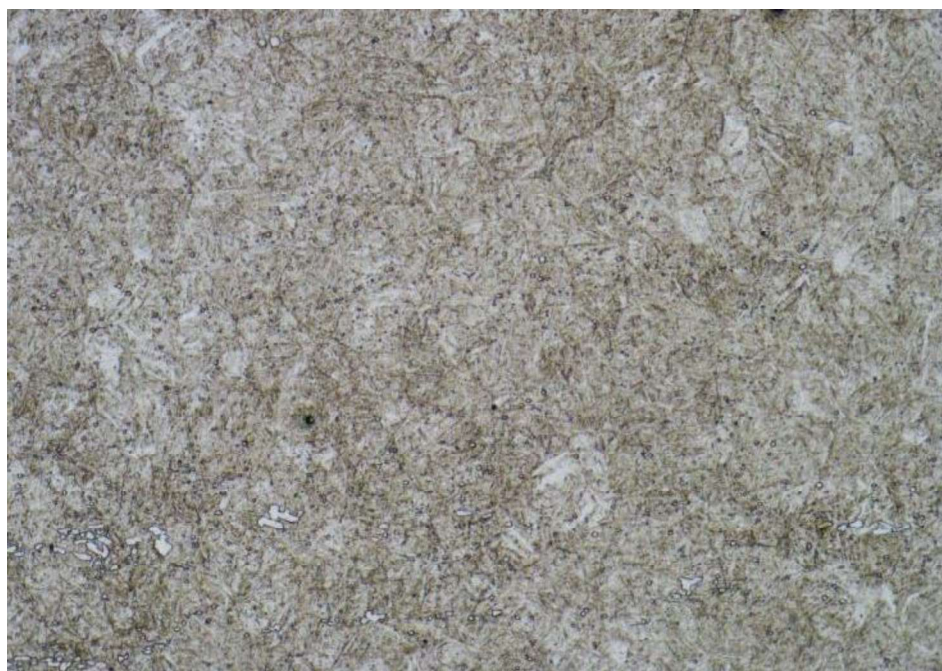
- 2.5 The composition and microstructure away from the thermal distress for the No. 3 bearing outer ring were consistent with the material type required by the component definition.

**Figure 31. Representative outer ring microstructure away from the thermally distressed region. Etchant: Vilella's**

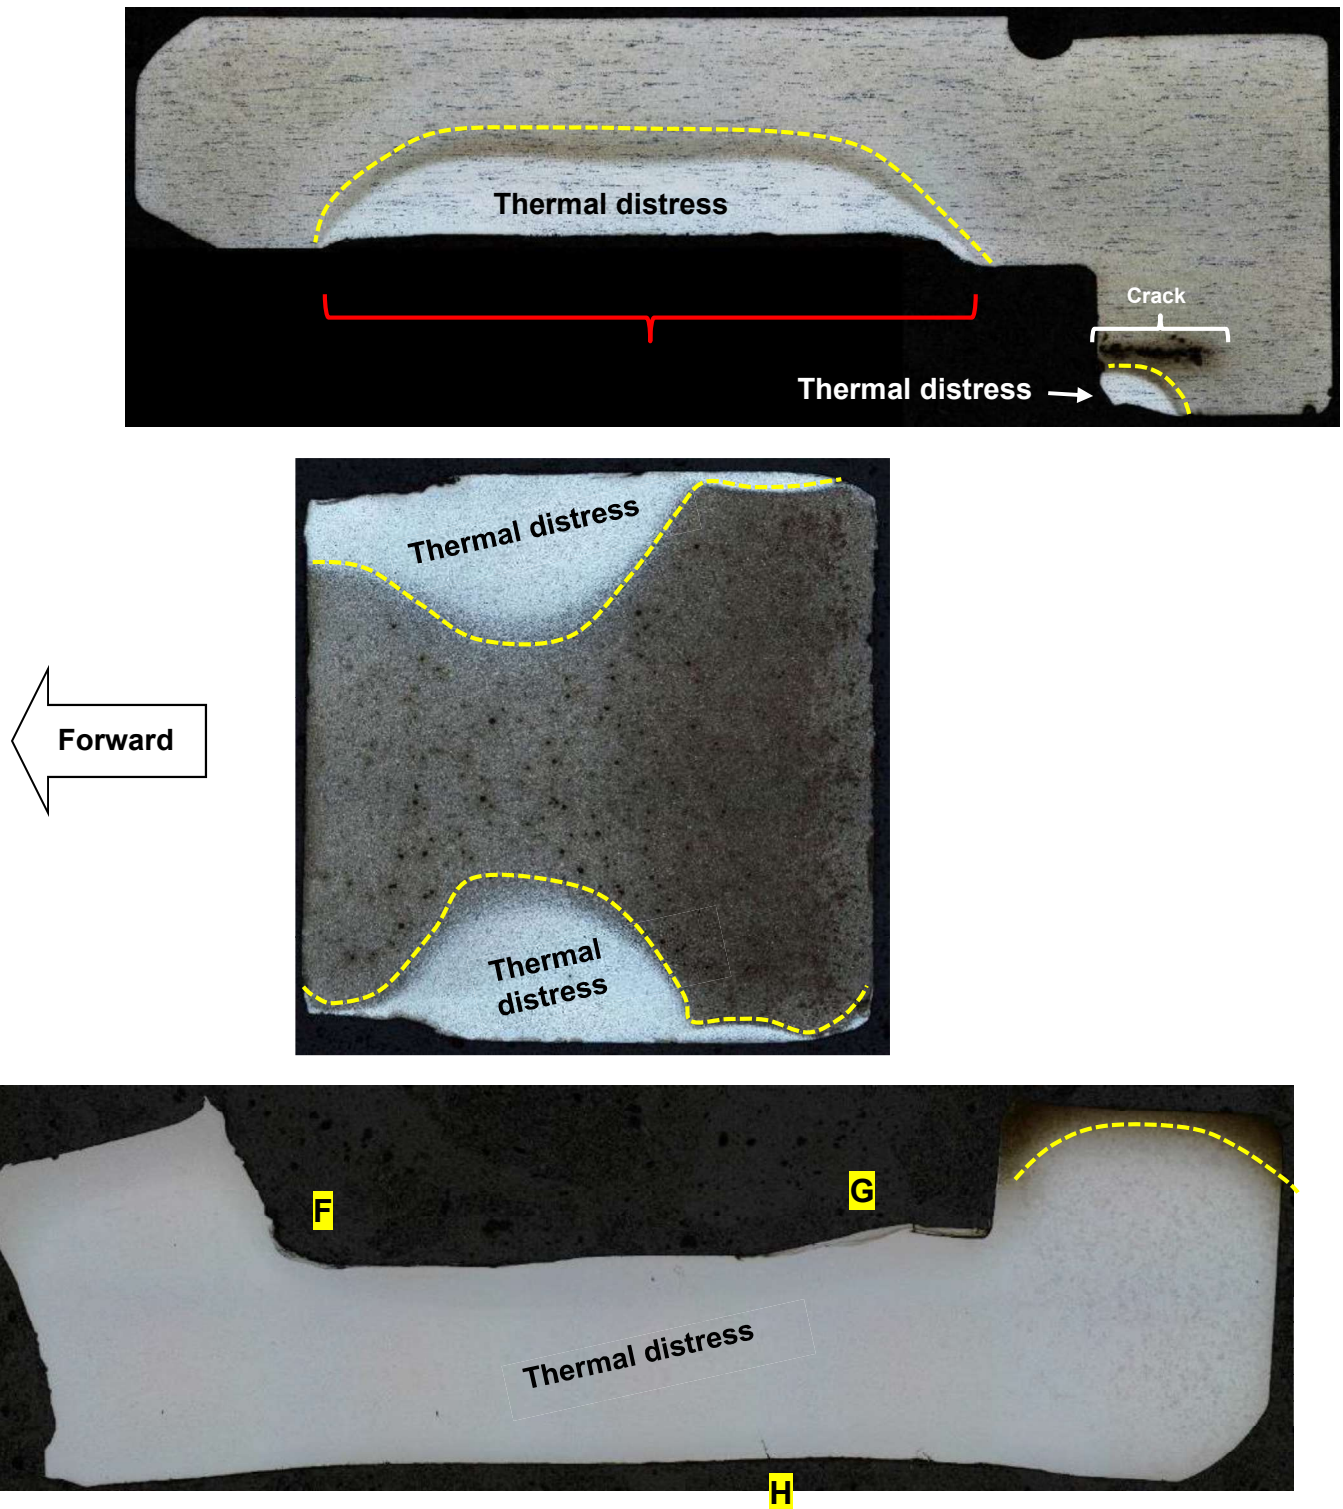
**Figure 41.** Metallographic cross-sections through the outer ring, a representative roller, and the inner ring (see yellow dashed lines in Figure 32, Figure 35, and Figure 40). Yellow outlines mark the locations of thermal distress on the outer ring raceway and aft shoulder corner, and the red brace marks material removal at the roller path. Locations F through H are shown in more detail in the following figures. Etchant: Vilella's

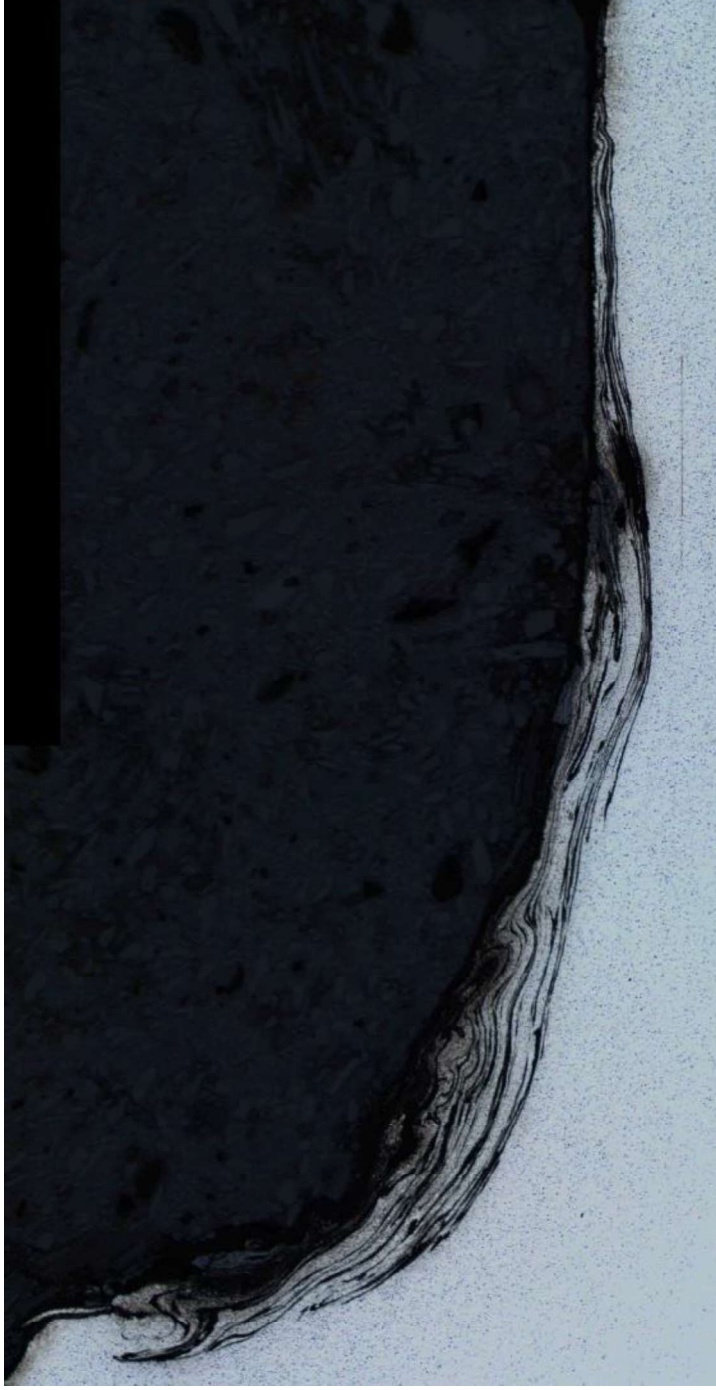
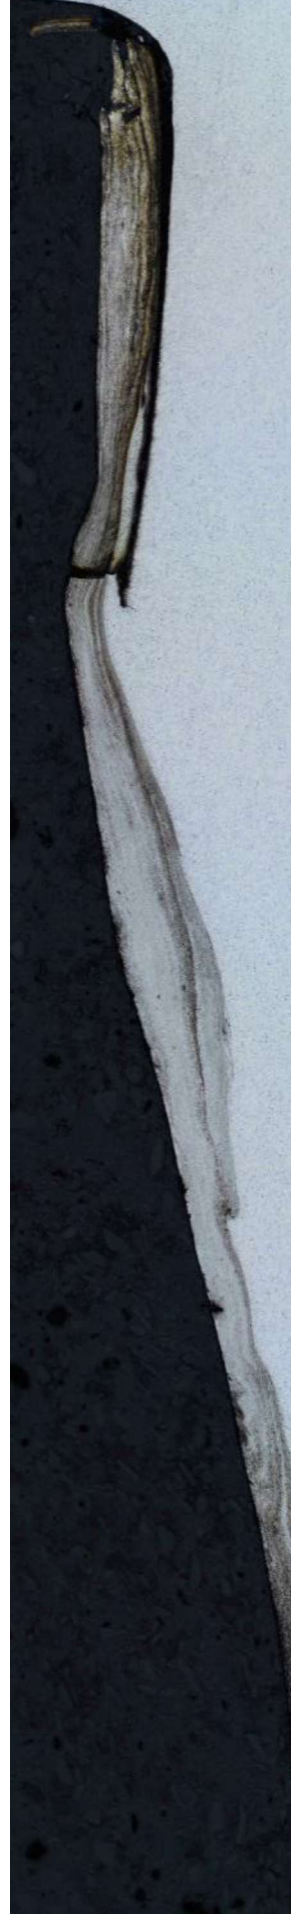
**Figure 42.** Metallographic cross-section through the forward (top) and aft (bottom) ends of the inner ring raceway (locations F and G in the previous figure, respectively), which exhibited transferred material. Etchant: Vilella's

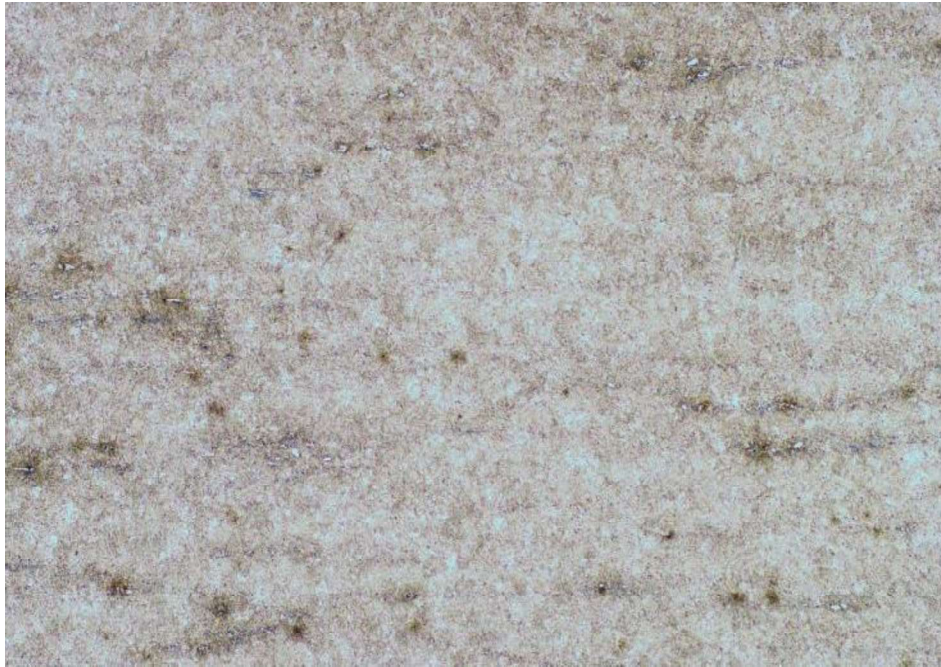
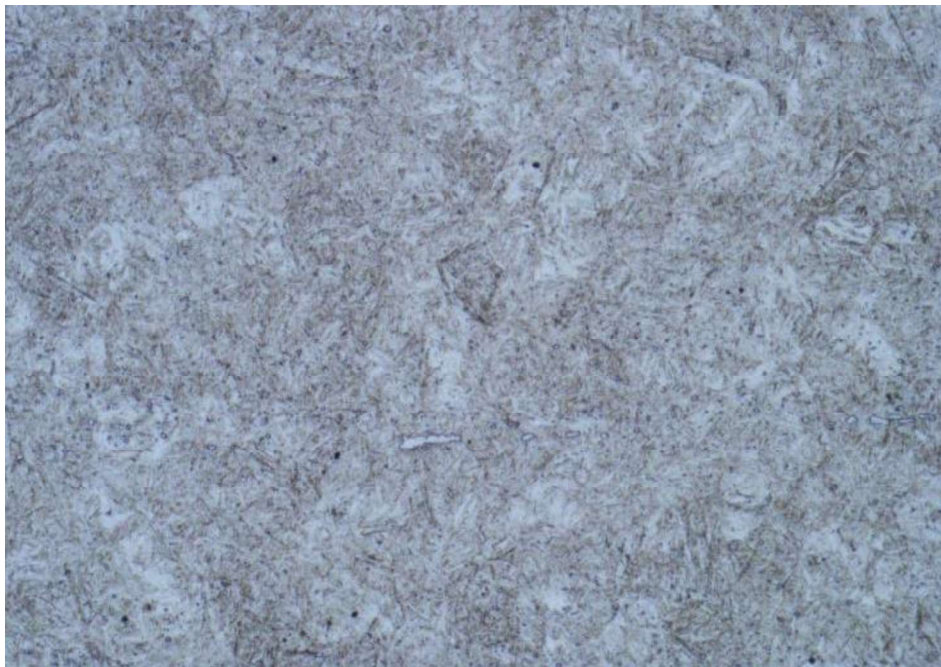
**Figure 44. Representative outer ring microstructure away from the thermally distressed region. Etchant: Vilella's**

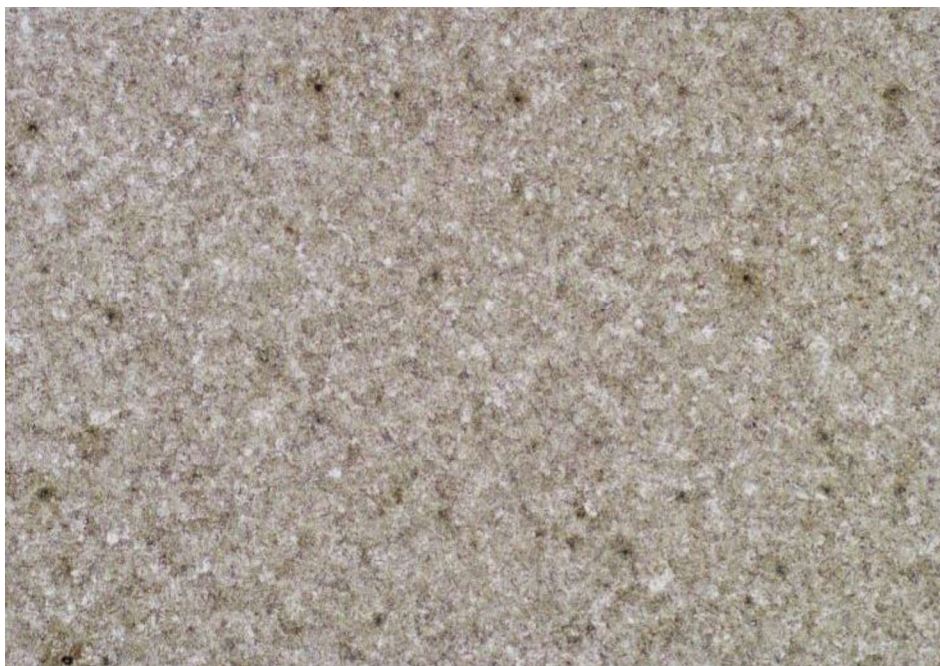
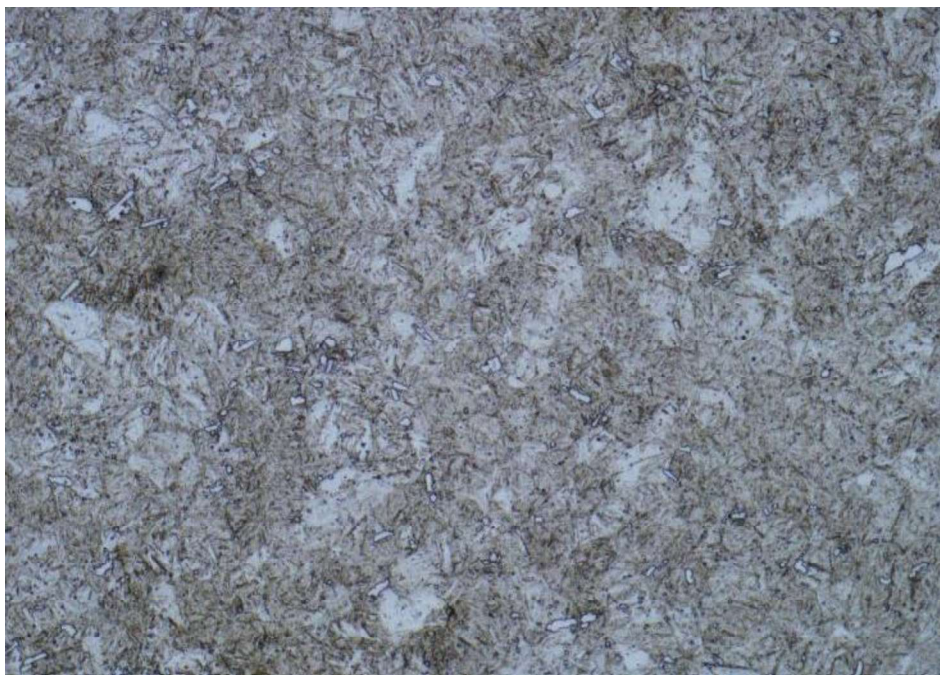
**Figure 45. Representative roller microstructure away from the thermally distressed region. Etchant: Vilella's**

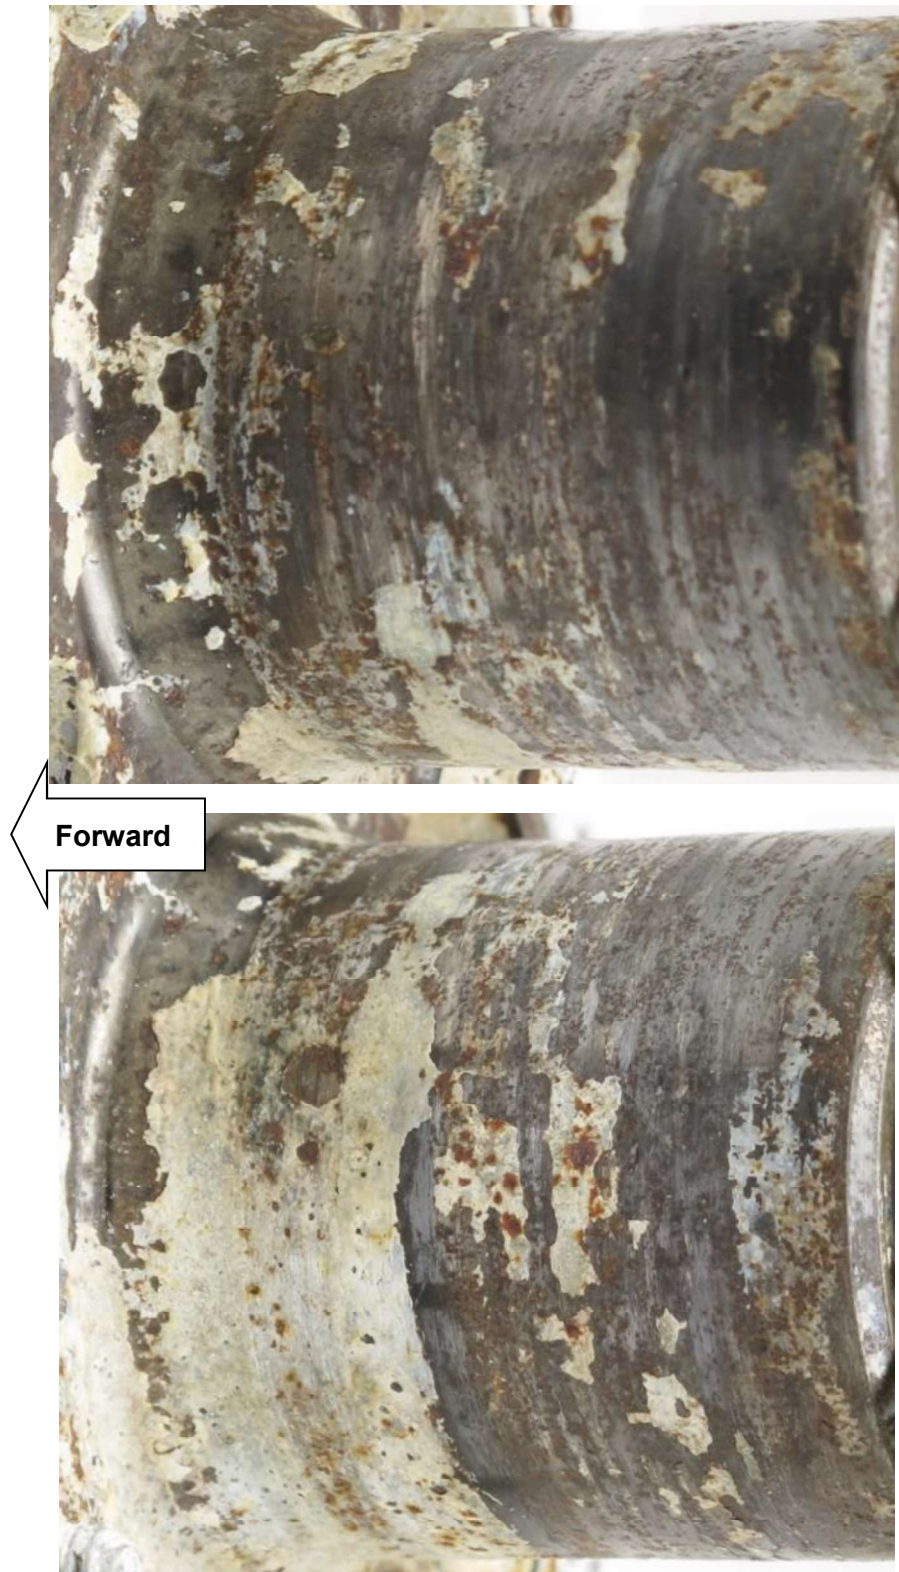
**Figure 48. Detailed views of outer diameter of the flanged No. 2.5 bearing support cage, which exhibited circumferential rub. Each image shows the part rotated  $\sim 90^\circ$  from the previous.**

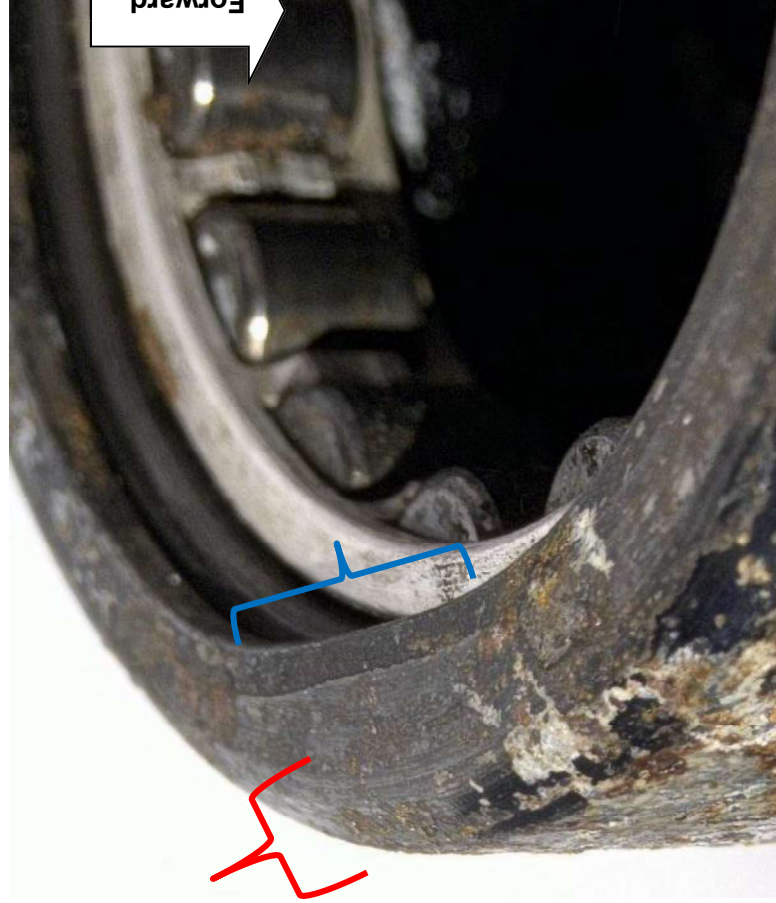
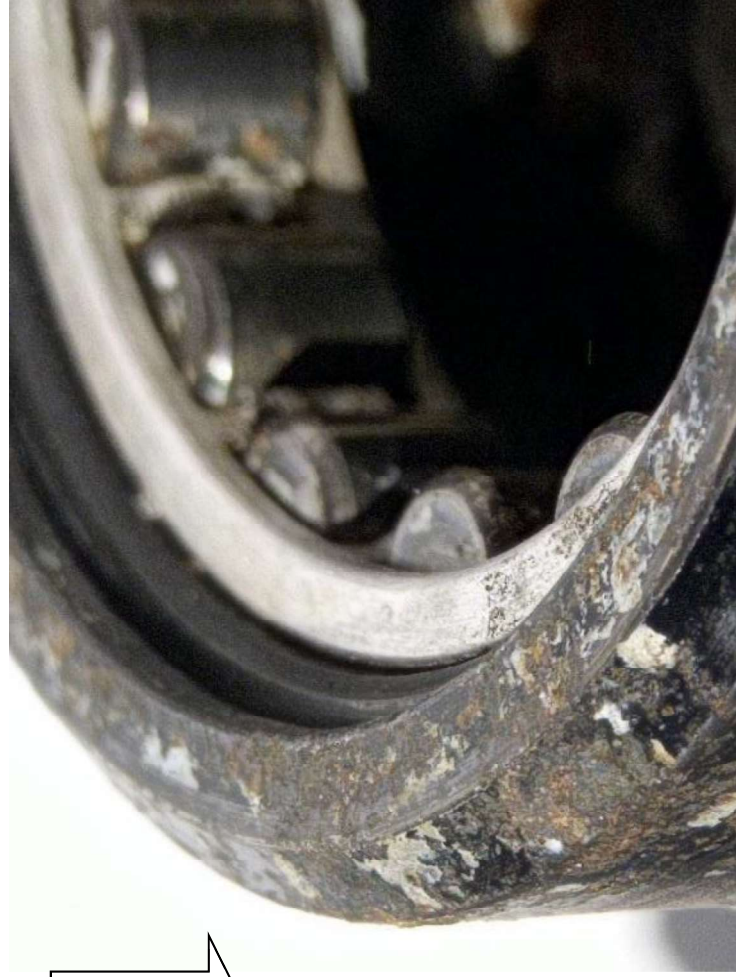
Figure 49. Detailed views of the aft face to outer diameter chamfer of the flanged No. 2.5 bearing support cage at two locations 180° apart. Circumferential rub (left, red brace) was observed at the same circumferential location at aft face deformation (blue brace, see following figure).

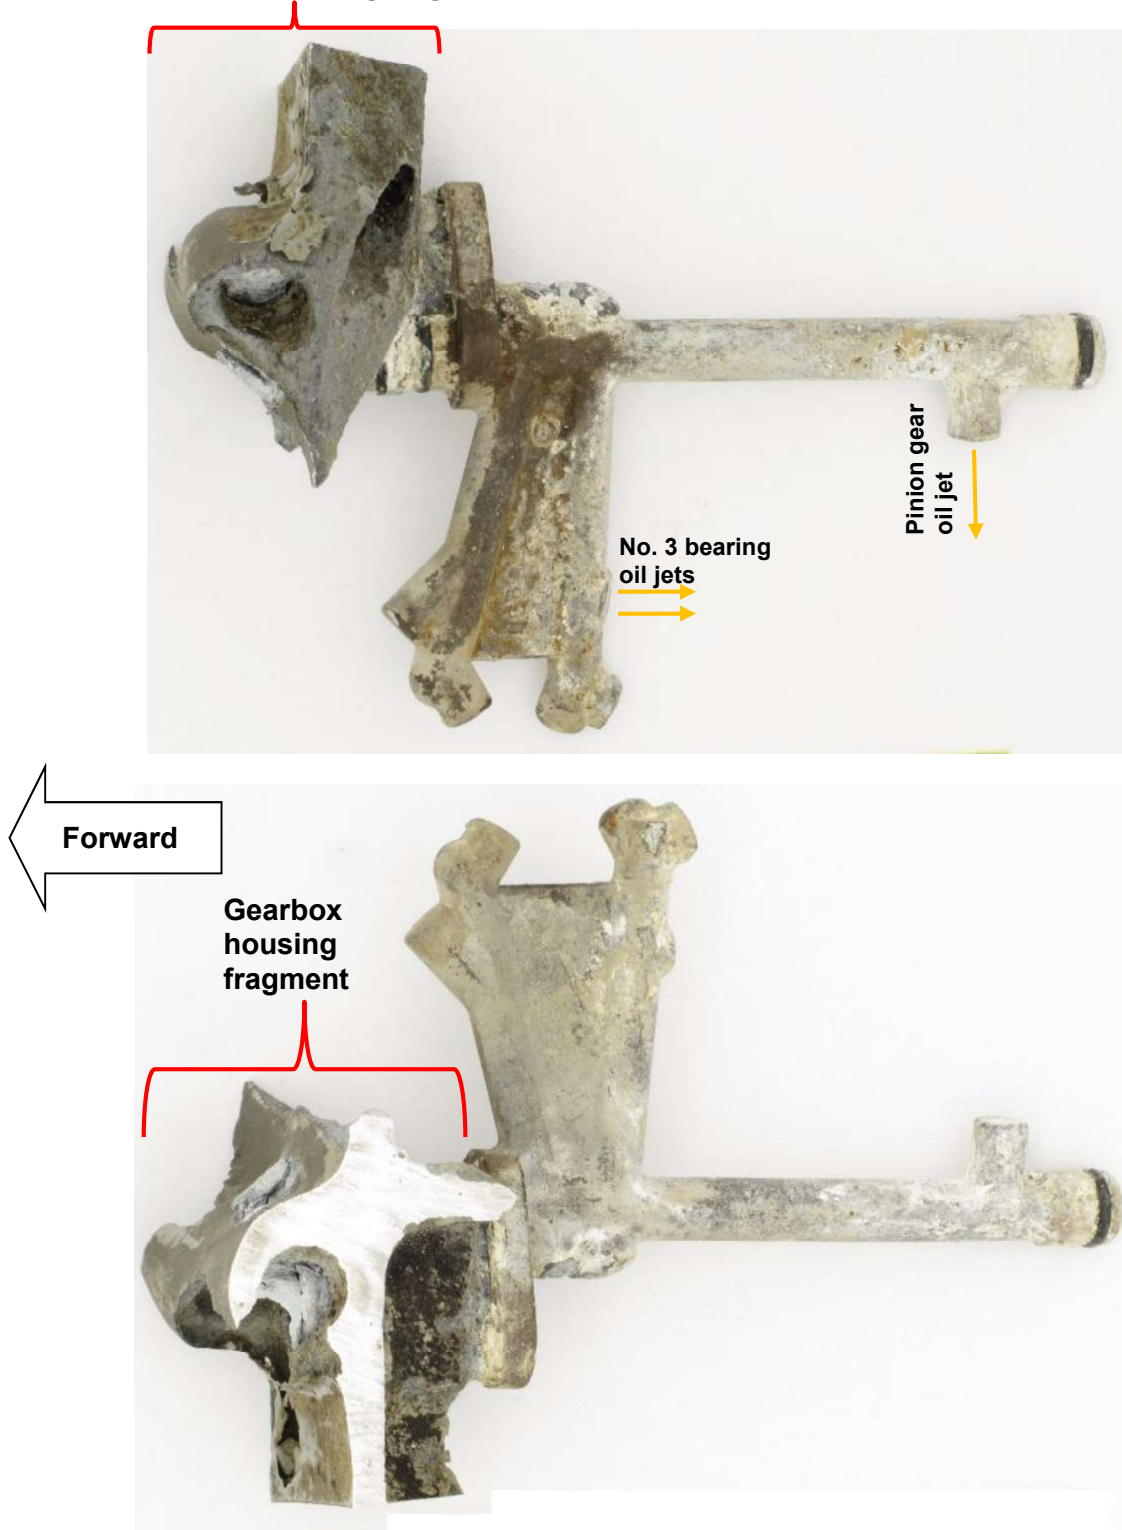
**Figure 53. General condition of the left (top) and right (bottom) hand sides of the oil delivery tube.**
