| <b>Rolls-Royce</b> | Rolls-Royce Corporation<br>450 S. Meridian Street<br>Indianapolis, Indiana<br>46225-1103, USA | <b>REPORT NO.</b><br>20FAE-014-PR | <b>REV.</b><br>Initial | <b>PAGES</b><br>1 of 135 |
| <b>TITLE</b><br><br><b>METALLURGICAL INVESTIGATION OF A HELICAL POWER TURBINE PINION GEAR, P/N 6893672, INSTALLED IN AN M250-C47B ENGINE, S/N CAE847031, OPERATED BY PANTHER HELICOPTERS</b> | | <b>PREPARED</b><br><br>Signatures on file | | |

| Engine Model: | M250-C47B |
| Evaluations: | Failure Analysis |

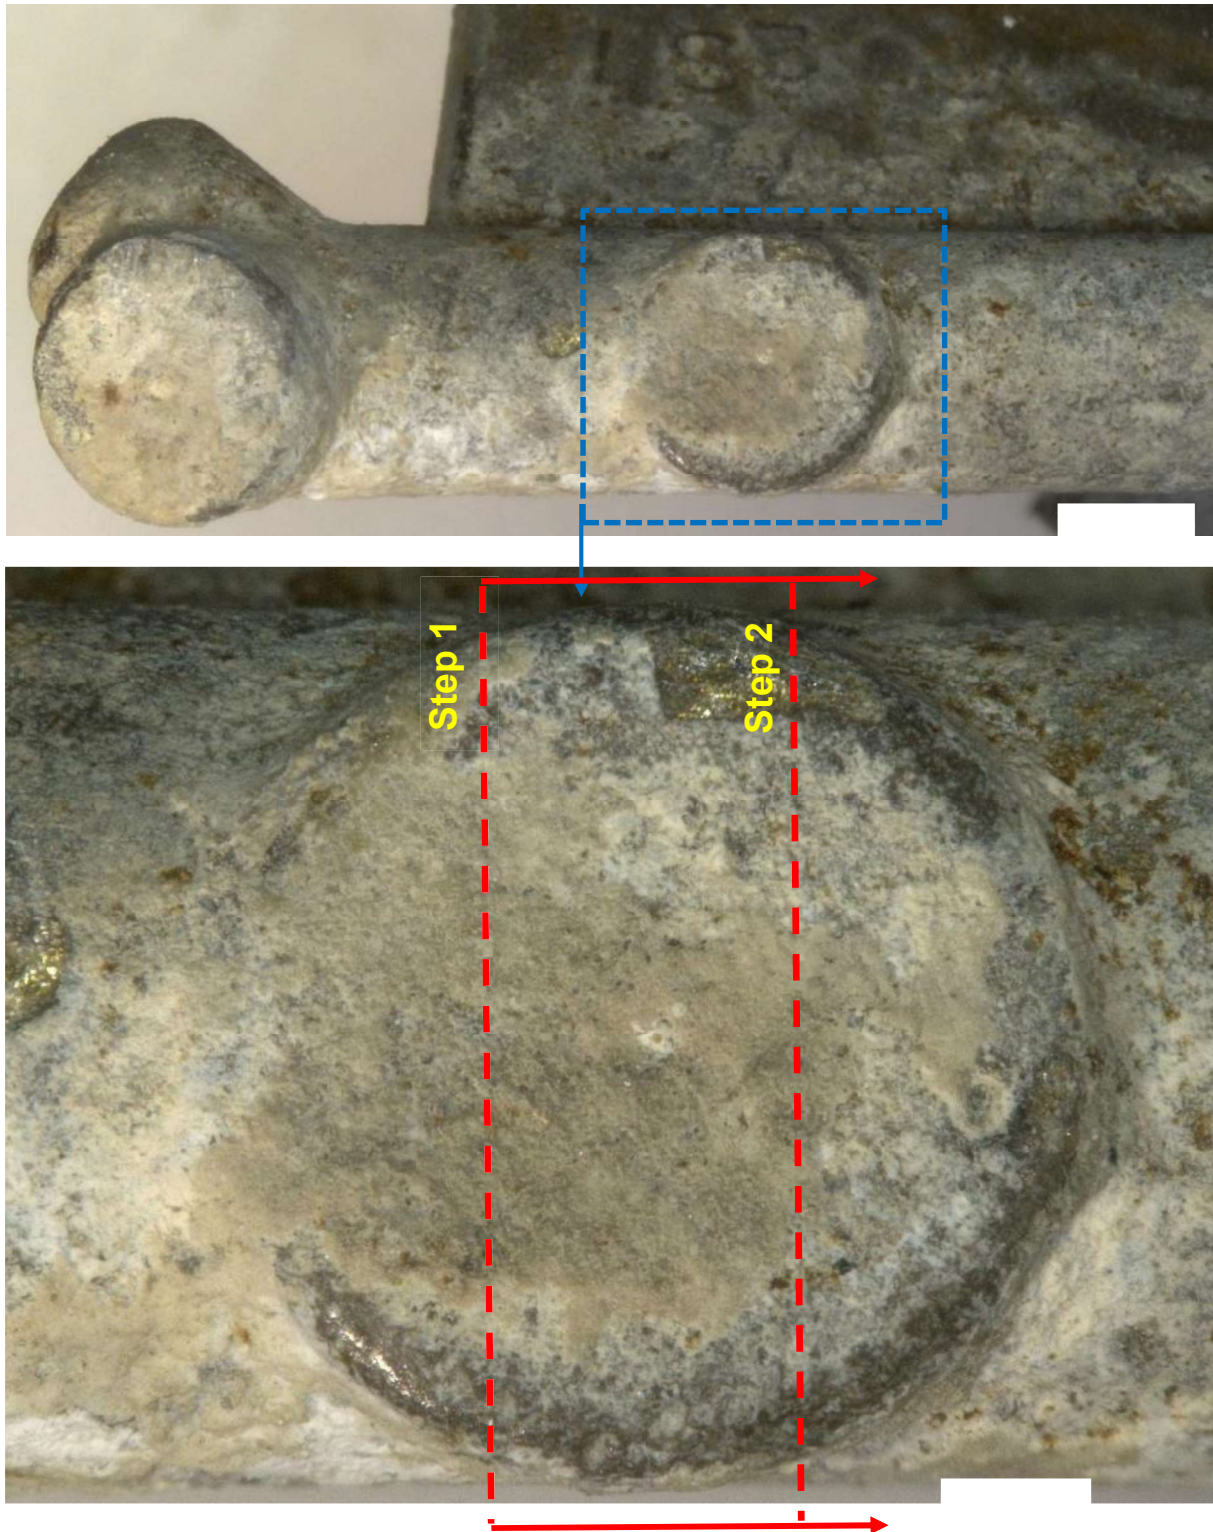
Figure 92 and Figure 93 show optical and backscattered electron SEM images of the metallographic section through No. 3 bearing oil jet A of the oil delivery tube (see step 1 in Figure 56), which also exhibited blockage material. Figure 94 through Figure 96 show the semi-quantitative EDS results for the blockage material. Finer, brighter particles (see locations AB in Figure 93) exhibited higher concentrations of iron and chromium. The specific iron-based alloy could not be identified. Blockage material at locations AC and AD in Figure 93 exhibited higher concentrations of oxygen, aluminum, and silicon (listed in order of concentration), which is consistent with corrosion product of the oil delivery tube. Blockage material at locations AE and AF in Figure 93 exhibited higher concentrations of oxygen, silicon, aluminum, calcium, and magnesium (listed in order of concentration), which is consistent with terrestrial material (dirt). The brighter particles on the outer end of the hole (see AG in Figure 93) exhibited higher concentrations of calcium and oxygen, which is consistent with calcium deposits that covered the No. 3 bearing oil jets (see Figure 56).

**Figure 56. Detailed views of No. 3 bearing oil jets on the oil delivery tube, which were coated in deposits. The red dashed lines mark the planes of metallographic evaluation (see Figure 63 and Figure 64).**

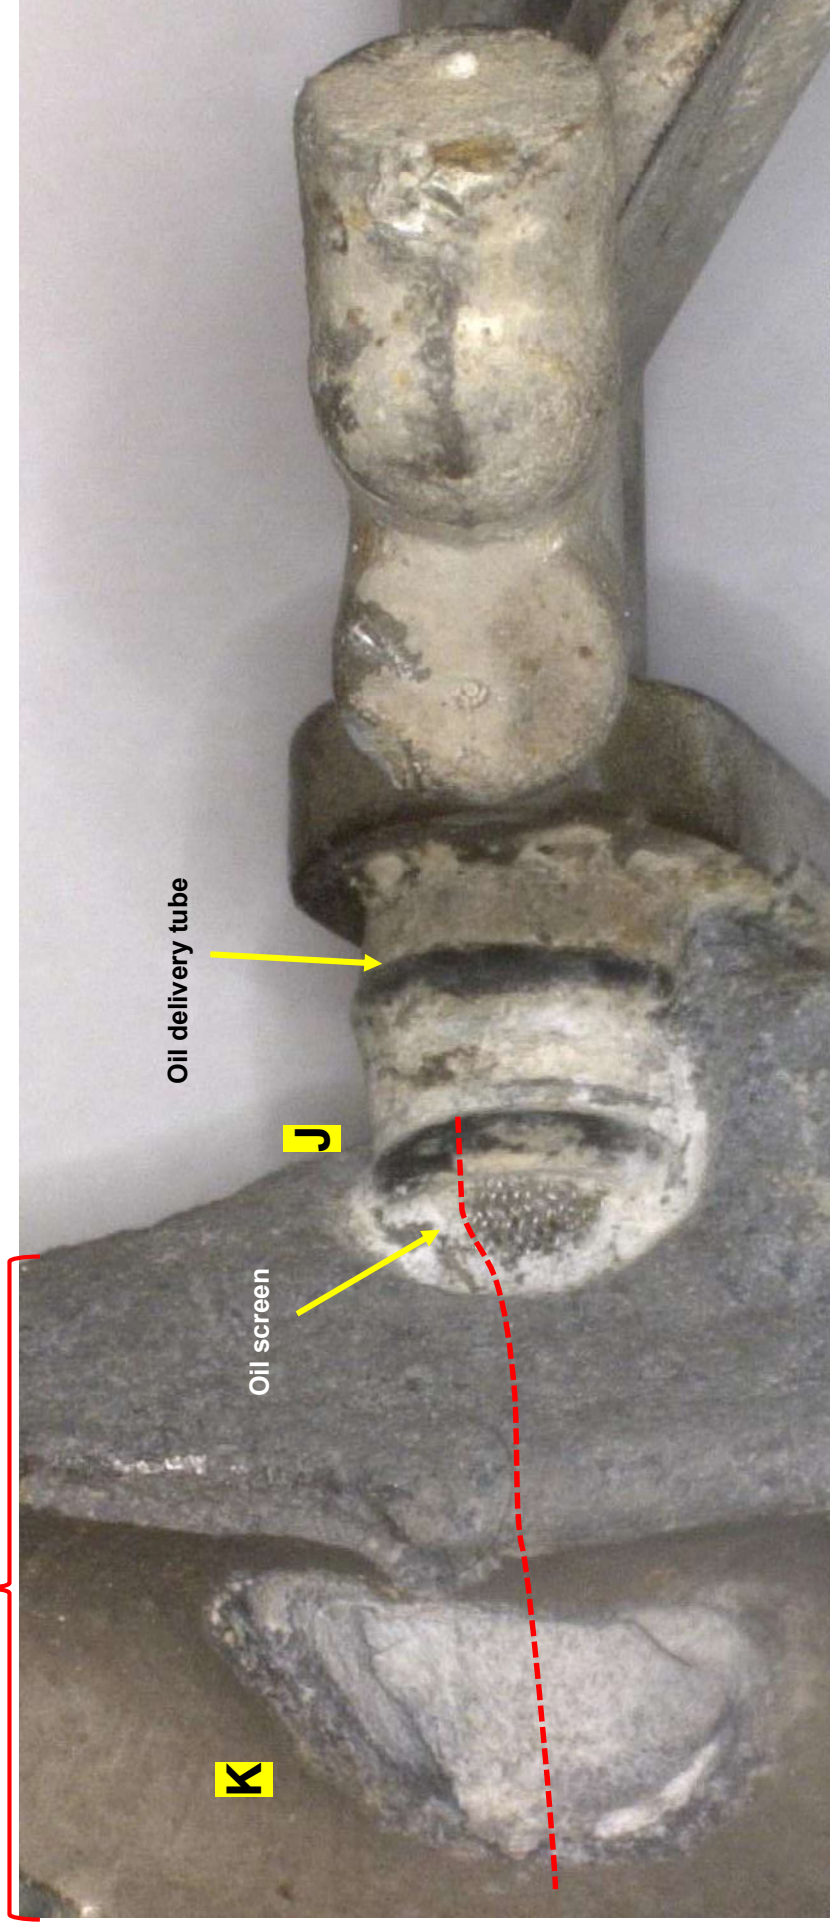
Figure 58. Detailed view of the oil delivery tube and oil screen assembled in a gearbox fragment. Locations J and K are shown in more detail in the following figure. The red dashed line marks the plane of metallographic evaluation (see Figure 65).

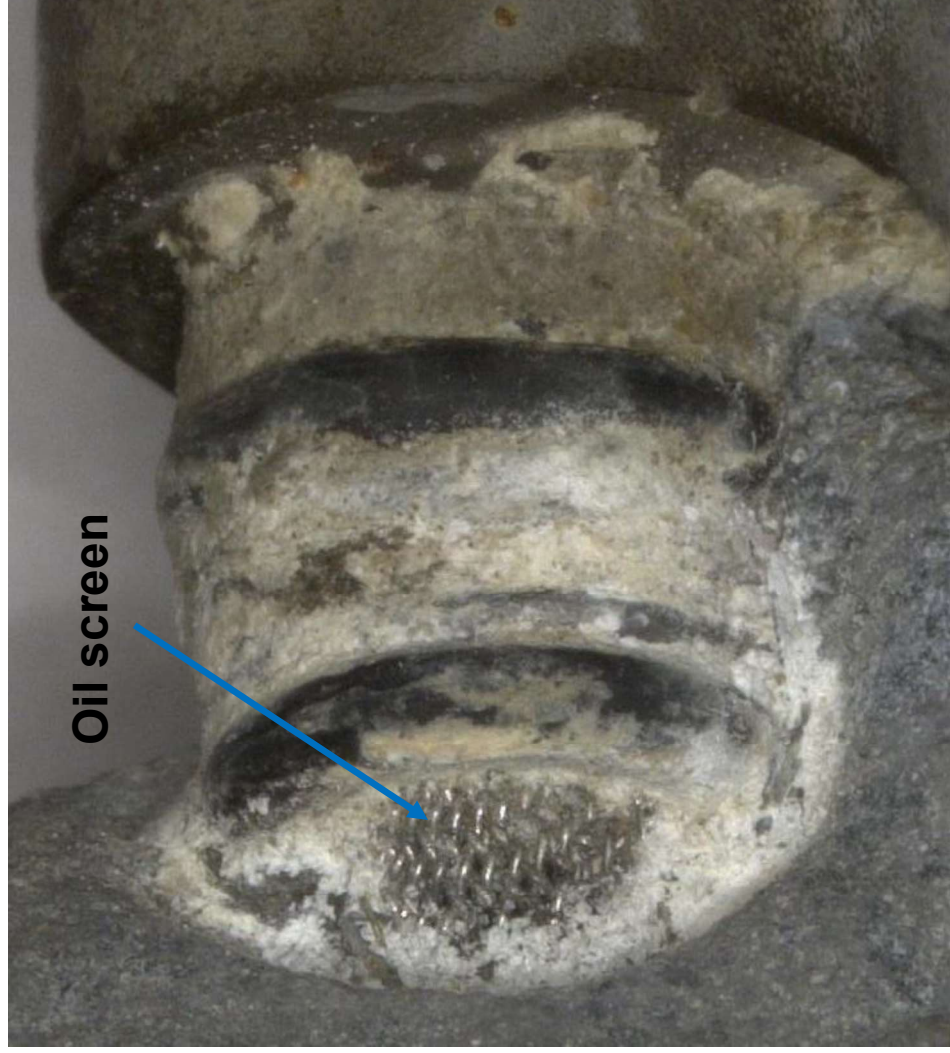
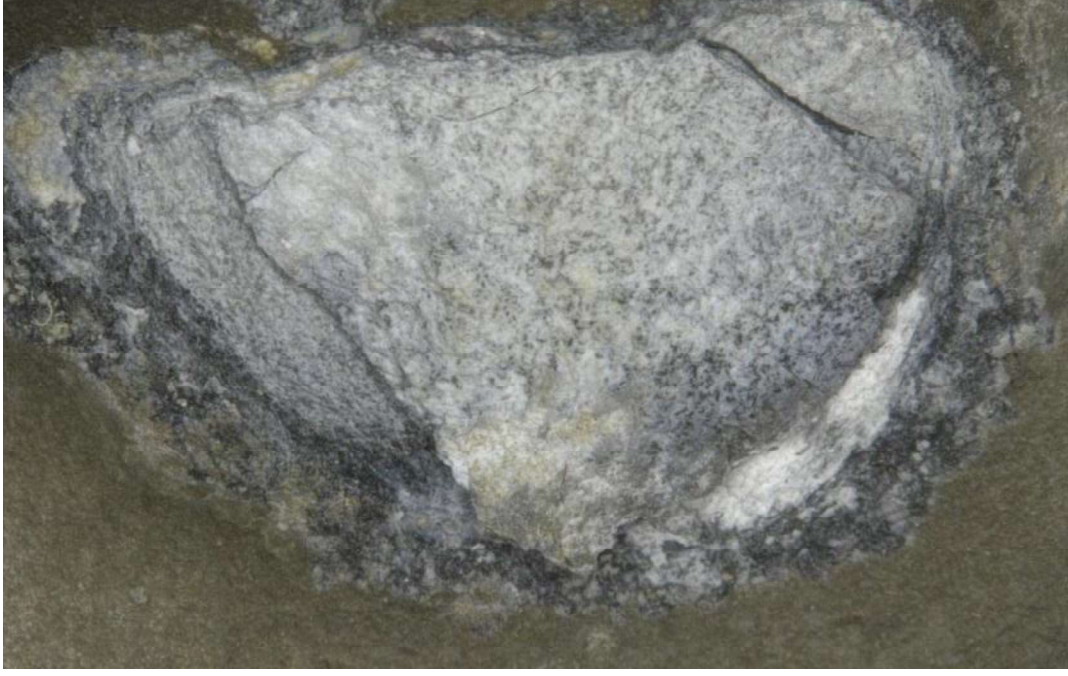
Figure 59. Detailed views of the oil screen and a blocked passage of the gearbox housing (see locations J and K in the previous figure, respectively).

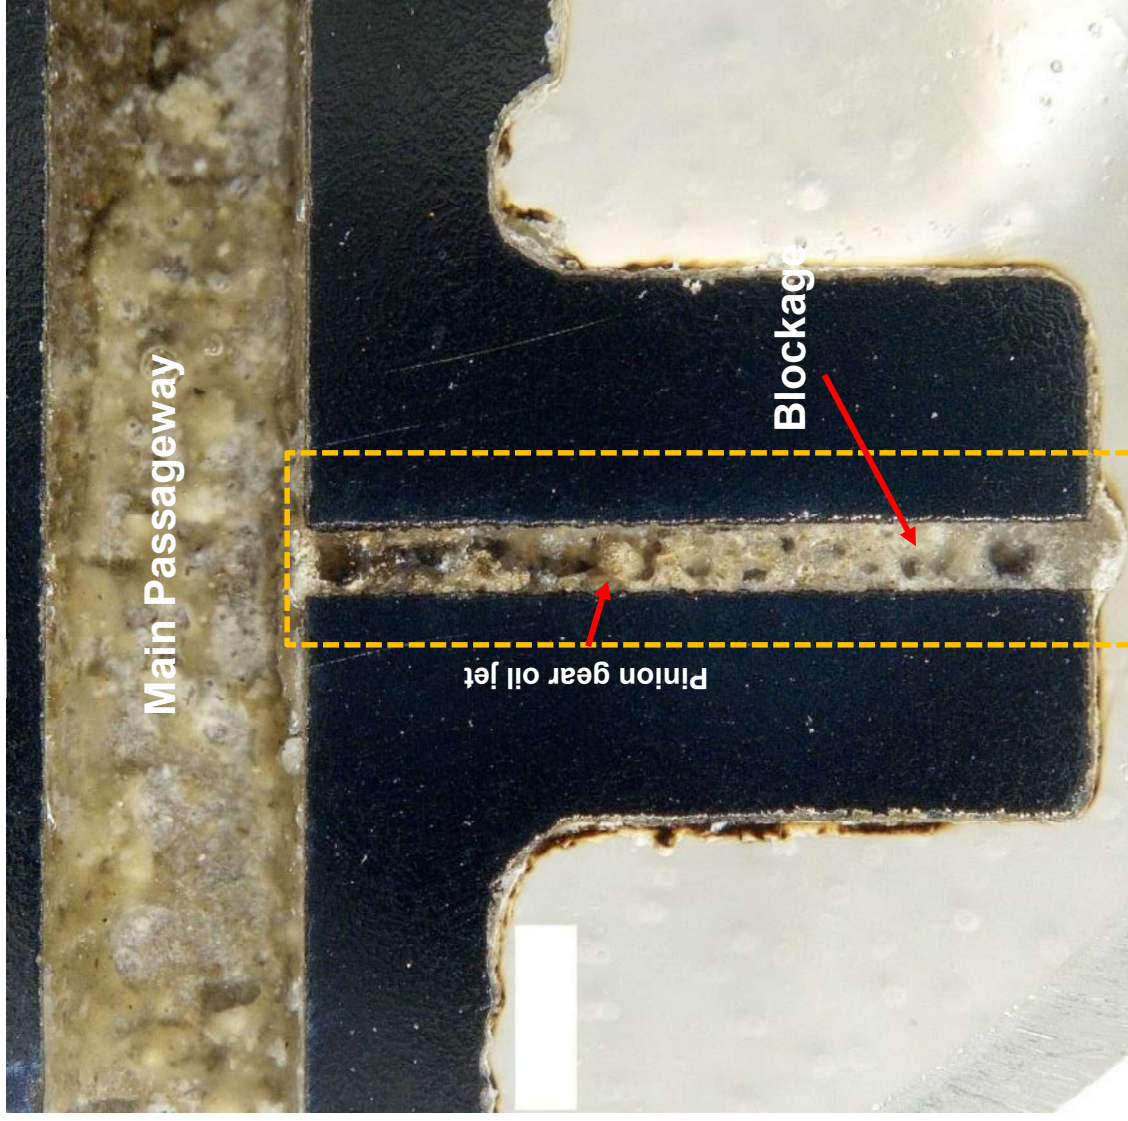
Figure 61 through Figure 64 show detailed views of the metallographic sections through the pinion gear oil jet, the main passageway adjacent to the pinion oil jet, and the No. 3 bearing oil jets of the oil delivery tube, which all exhibited blockage material. Figure 65 shows a detailed view of the metallographic section through the gearbox housing and oil screen.

Figure 61. Metallographic section through the oil delivery tube (see the red dashed line in Figure 54). Orange boxed area is shown in more detail in the Figure 84.

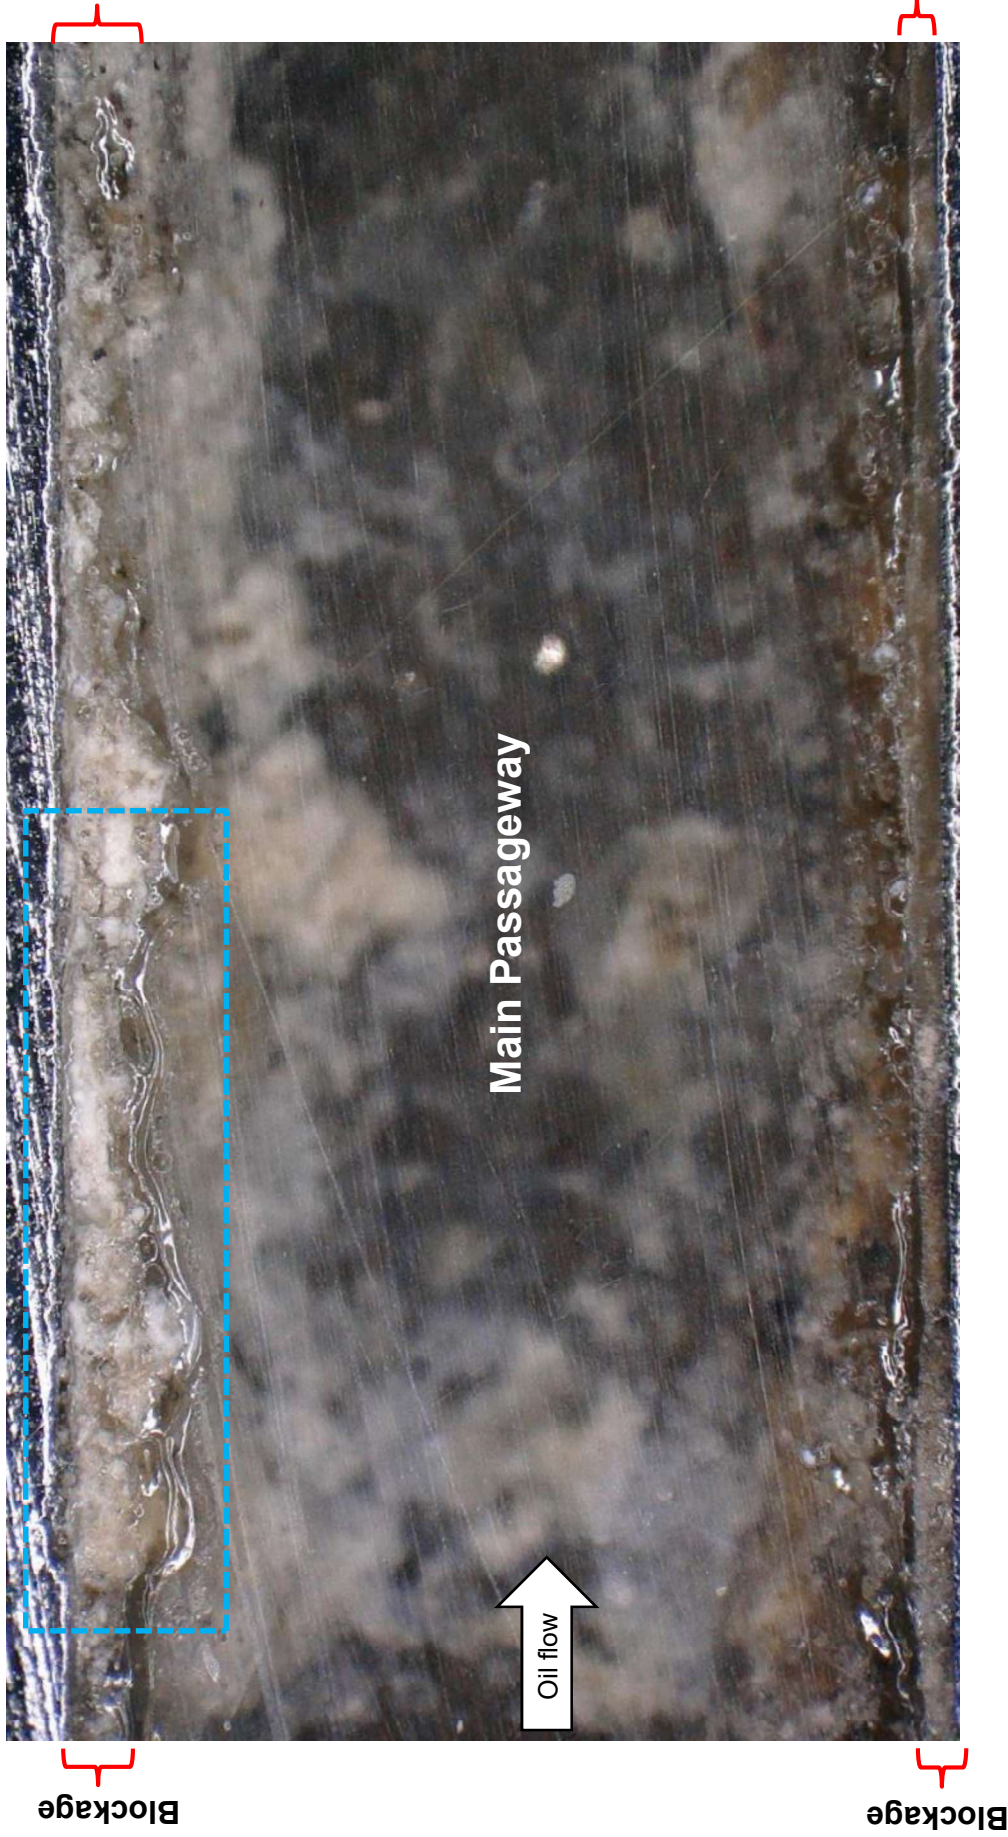
Figure 62. Metallographic section through the oil delivery tube (see the orange dashed line in Figure 54). Blue boxed area is shown in more detail in the Figure 89.

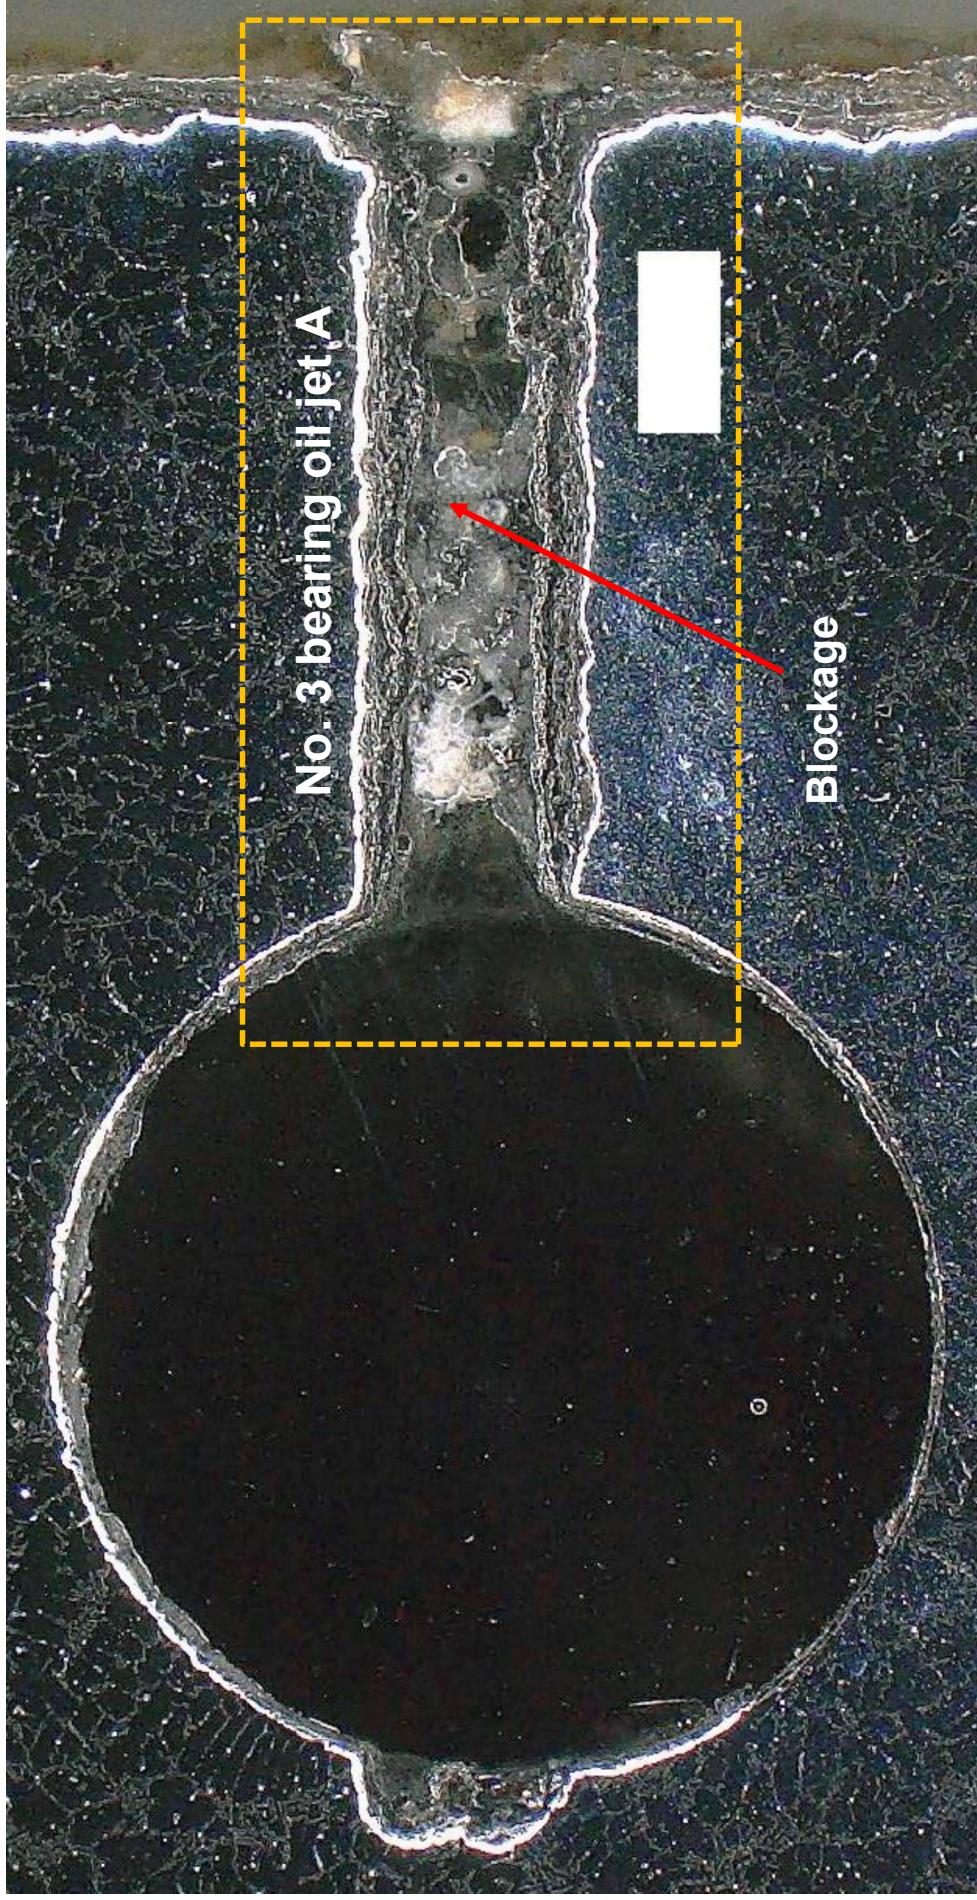
Figure 63. Metallographic section through the oil delivery tube (see the red dashed line at step 1 in Figure 56). Orange boxed area is shown in more detail in Figure 92.

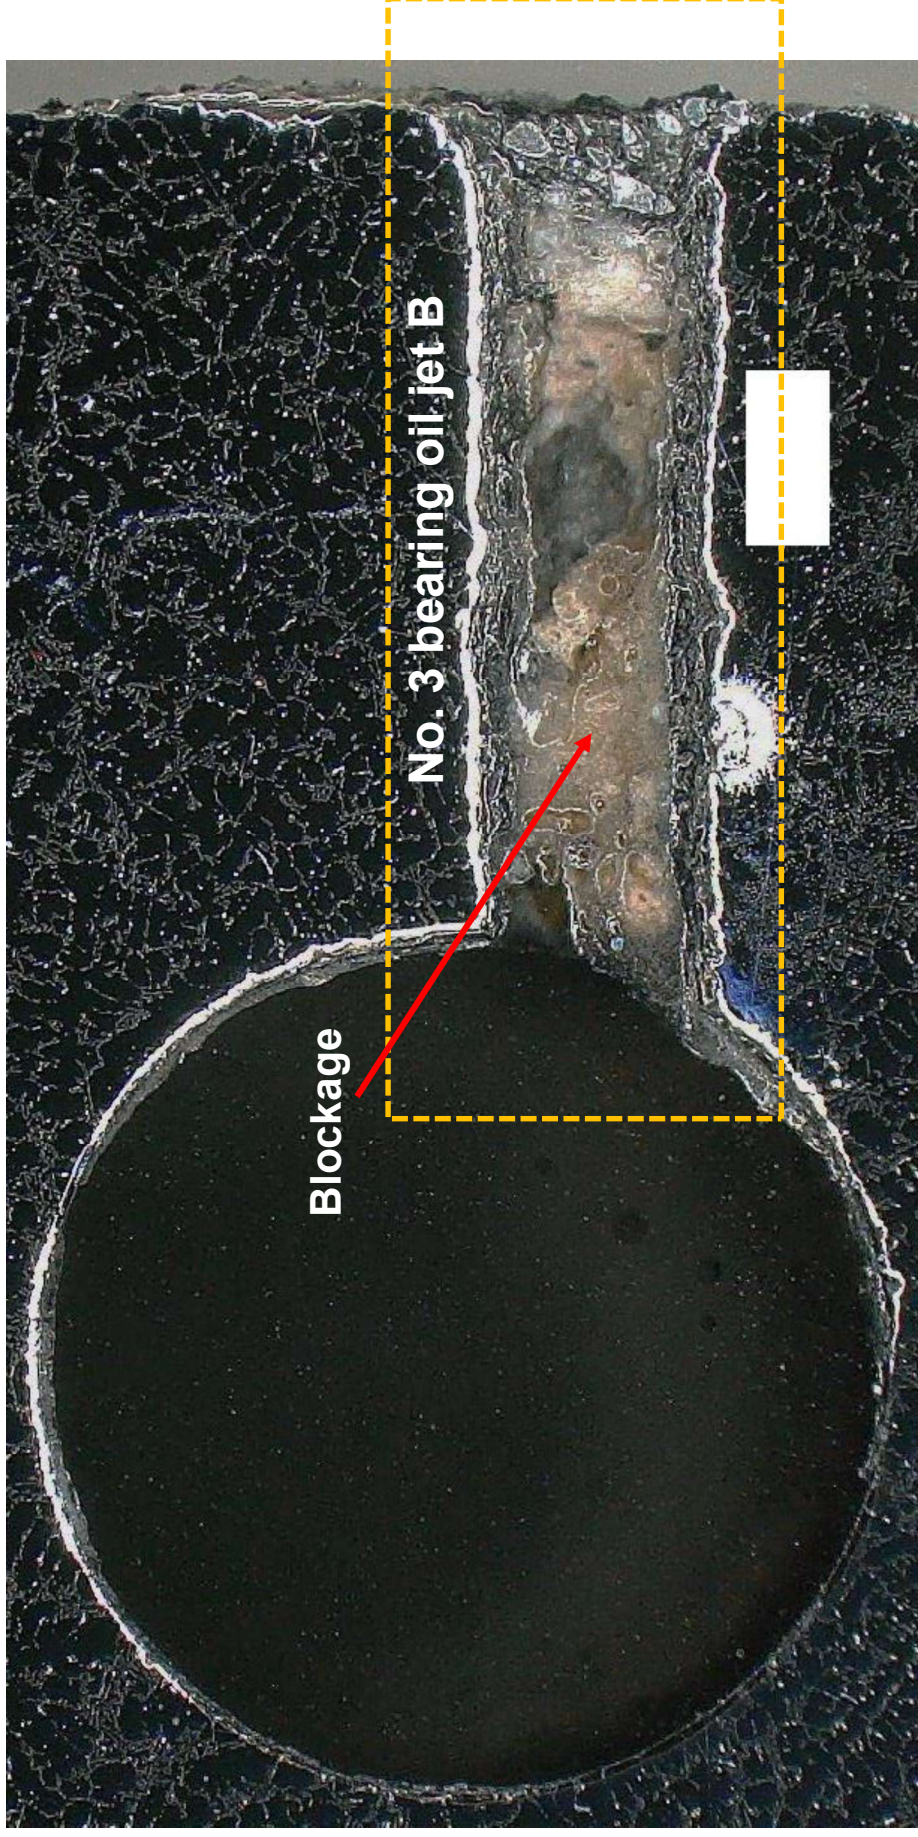
Figure 64. Metallographic section through the oil delivery tube (see the red dashed line at step 2 in Figure 56). Orange boxed area is shown in more detail in Figure 97.

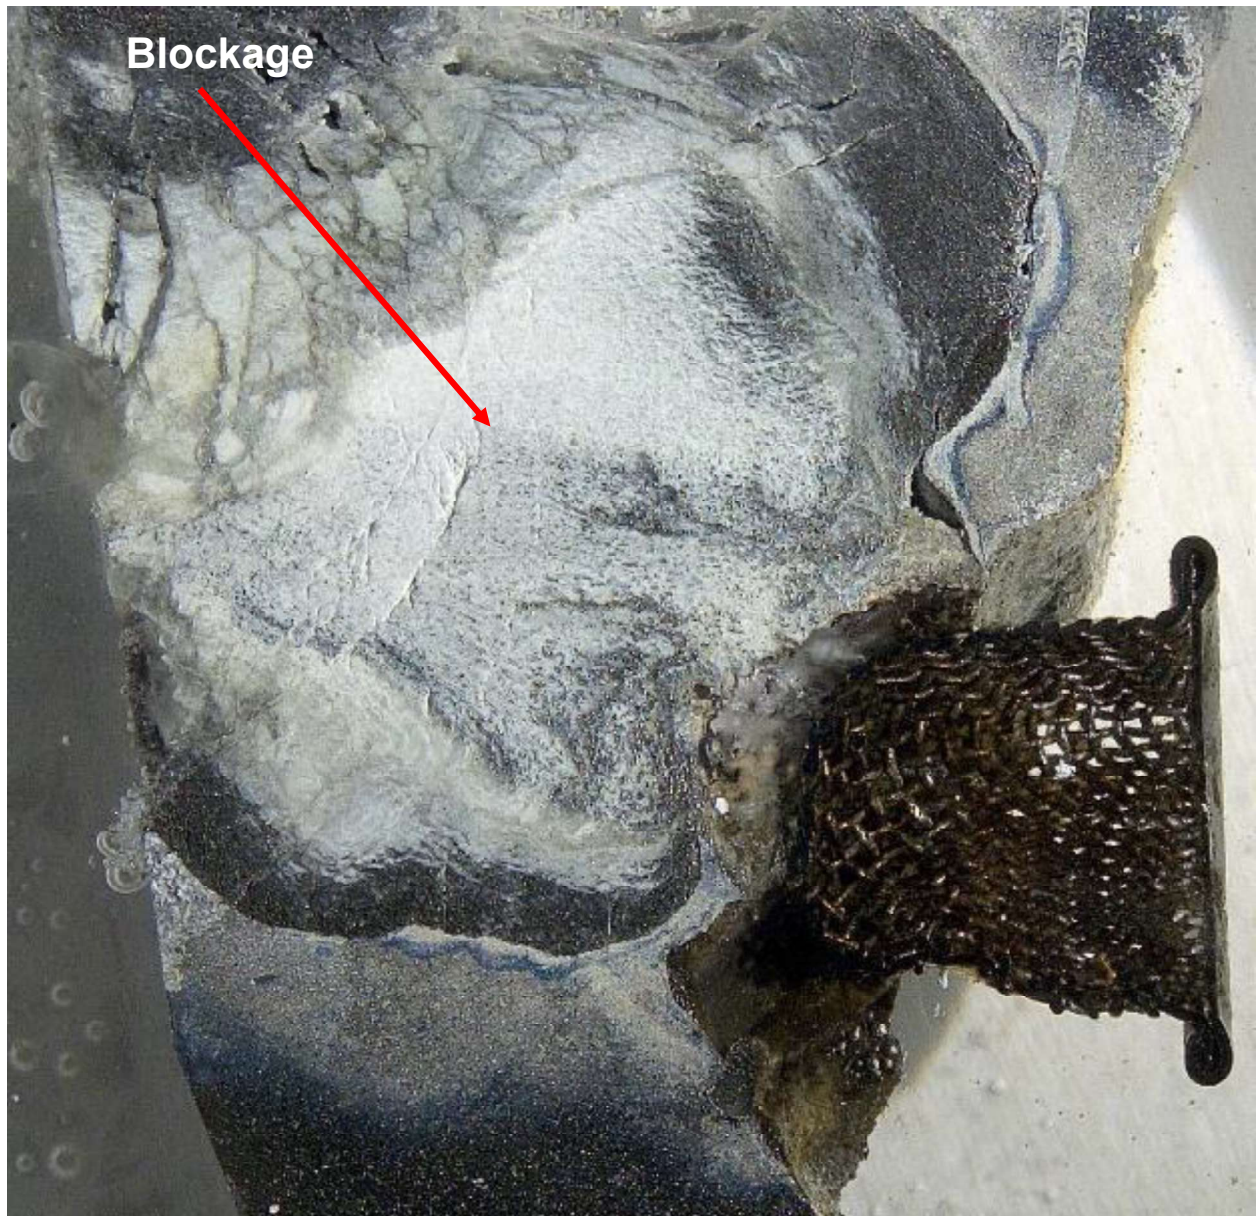
Figure 103 and Figure 104 show optical and backscattered electron SEM images of the metallographic section through blockage in the gearbox housing fragment and oil screen (see Figure 58). Figure 105 through Figure 106 show the semi-quantitative EDS results for the blockage material. Blockage material at locations AU and AW in the gearbox housing fragment (Figure 104) exhibited higher concentrations of oxygen, magnesium, and zinc (listed in order of concentration), which is consistent with corrosion product of the gearbox housing. Blockage material at locations AY in the gearbox housing fragment (Figure 104) exhibited higher concentrations of oxygen magnesium, calcium, sodium, chlorine, and silicon (listed in order of concentration), which is consistent with corrosion product of the gearbox housing and terrestrial material (dirt). Blockage material on the oil screen (locations AZ in Figure 104) exhibited higher concentrations of oxygen, magnesium, iron, and chromium (listed in order of concentration), which is consistent with corrosion product of the gearbox housing and oil screen.

**Figure 65. Metallographic section through the gearbox housing and oil screen (see the red dashed line in Figure 58).**

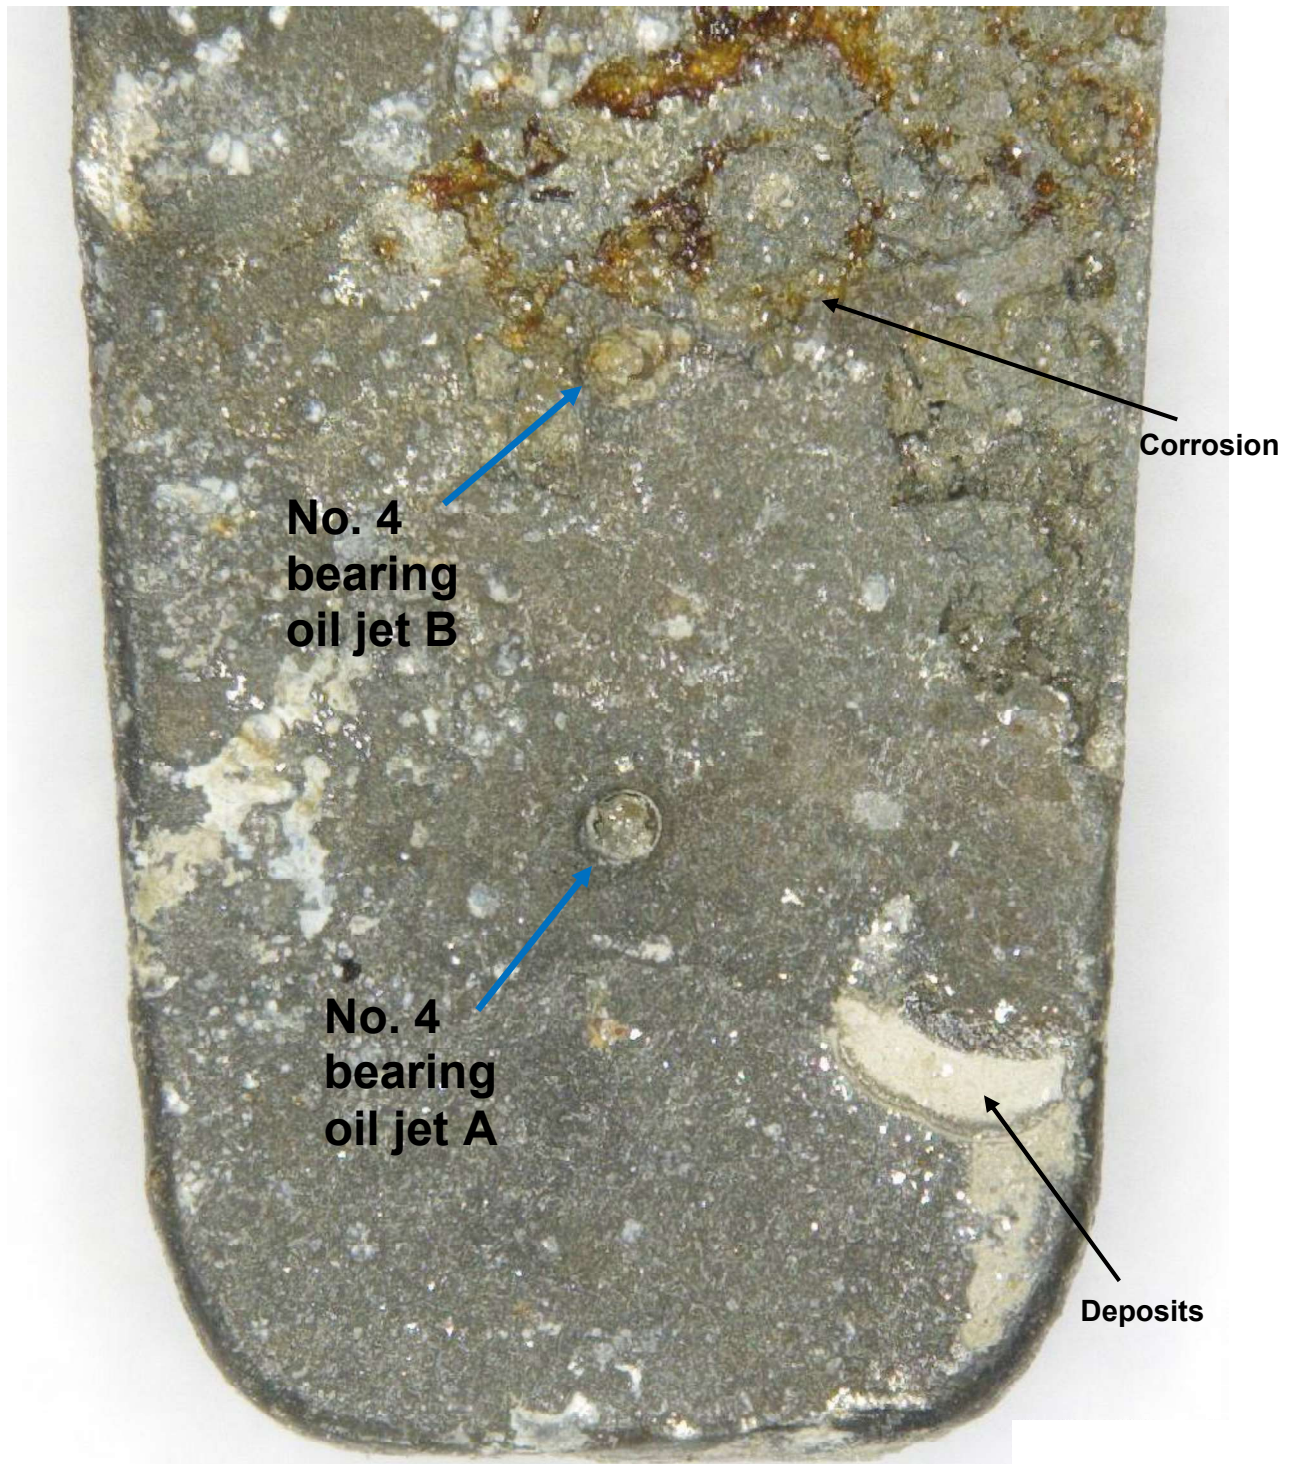
**Figure 67. Detailed forward looking aft view (red boxed area in previous figure) of the pinion gear oil nozzle.**

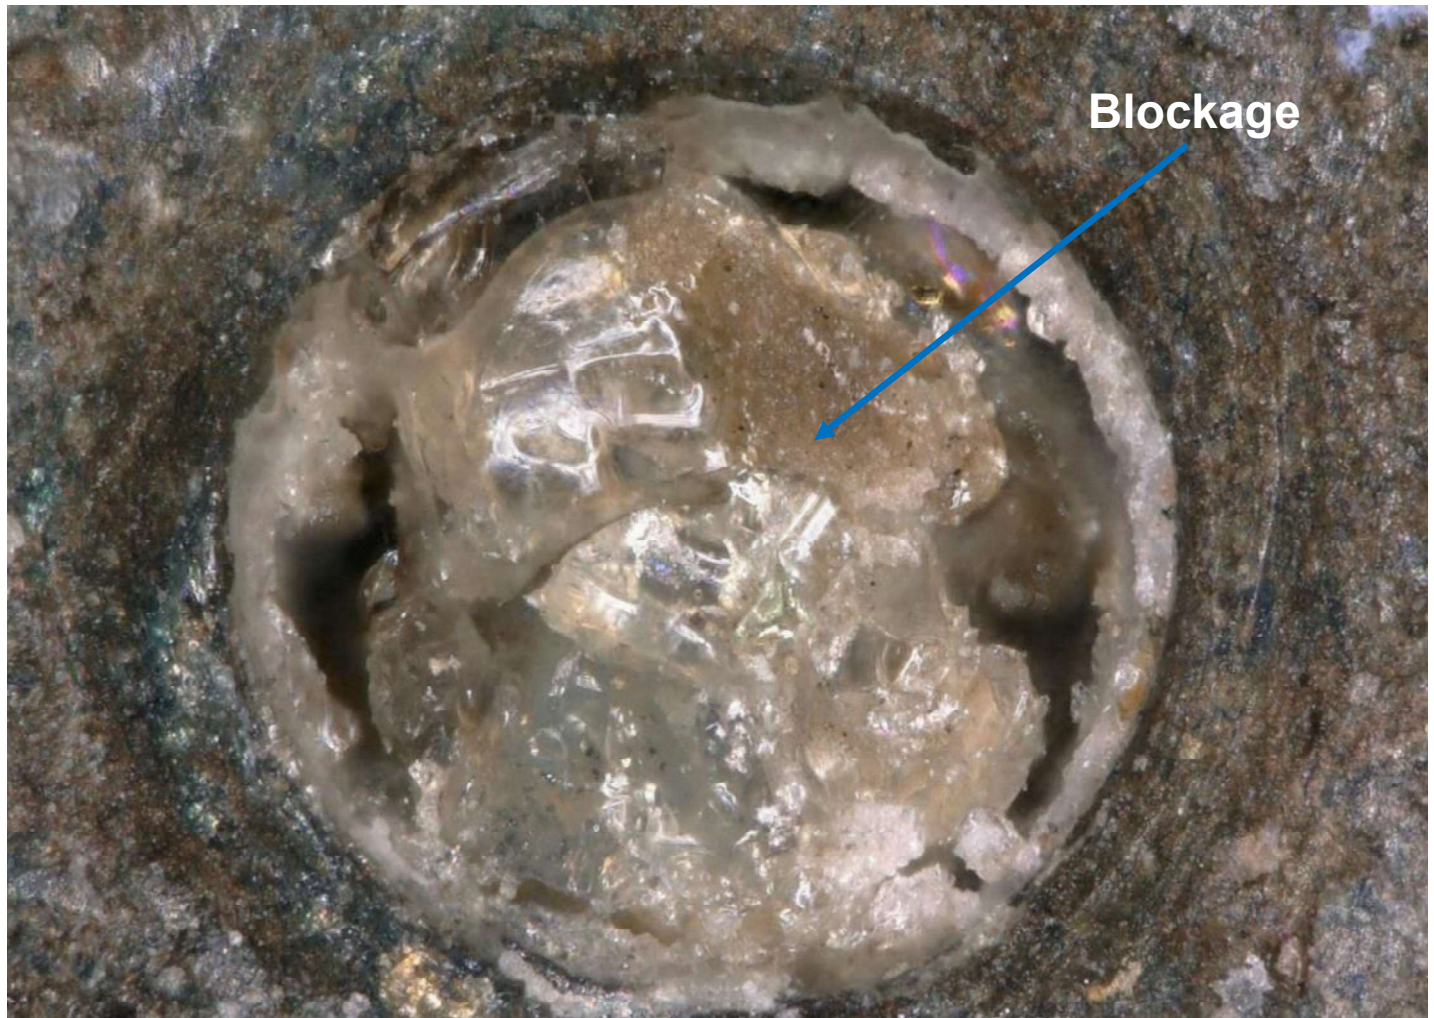
**Figure 68. Detailed view of No. 4 bearing oil jet A on the pinion gear oil nozzle, which exhibited blockage.**

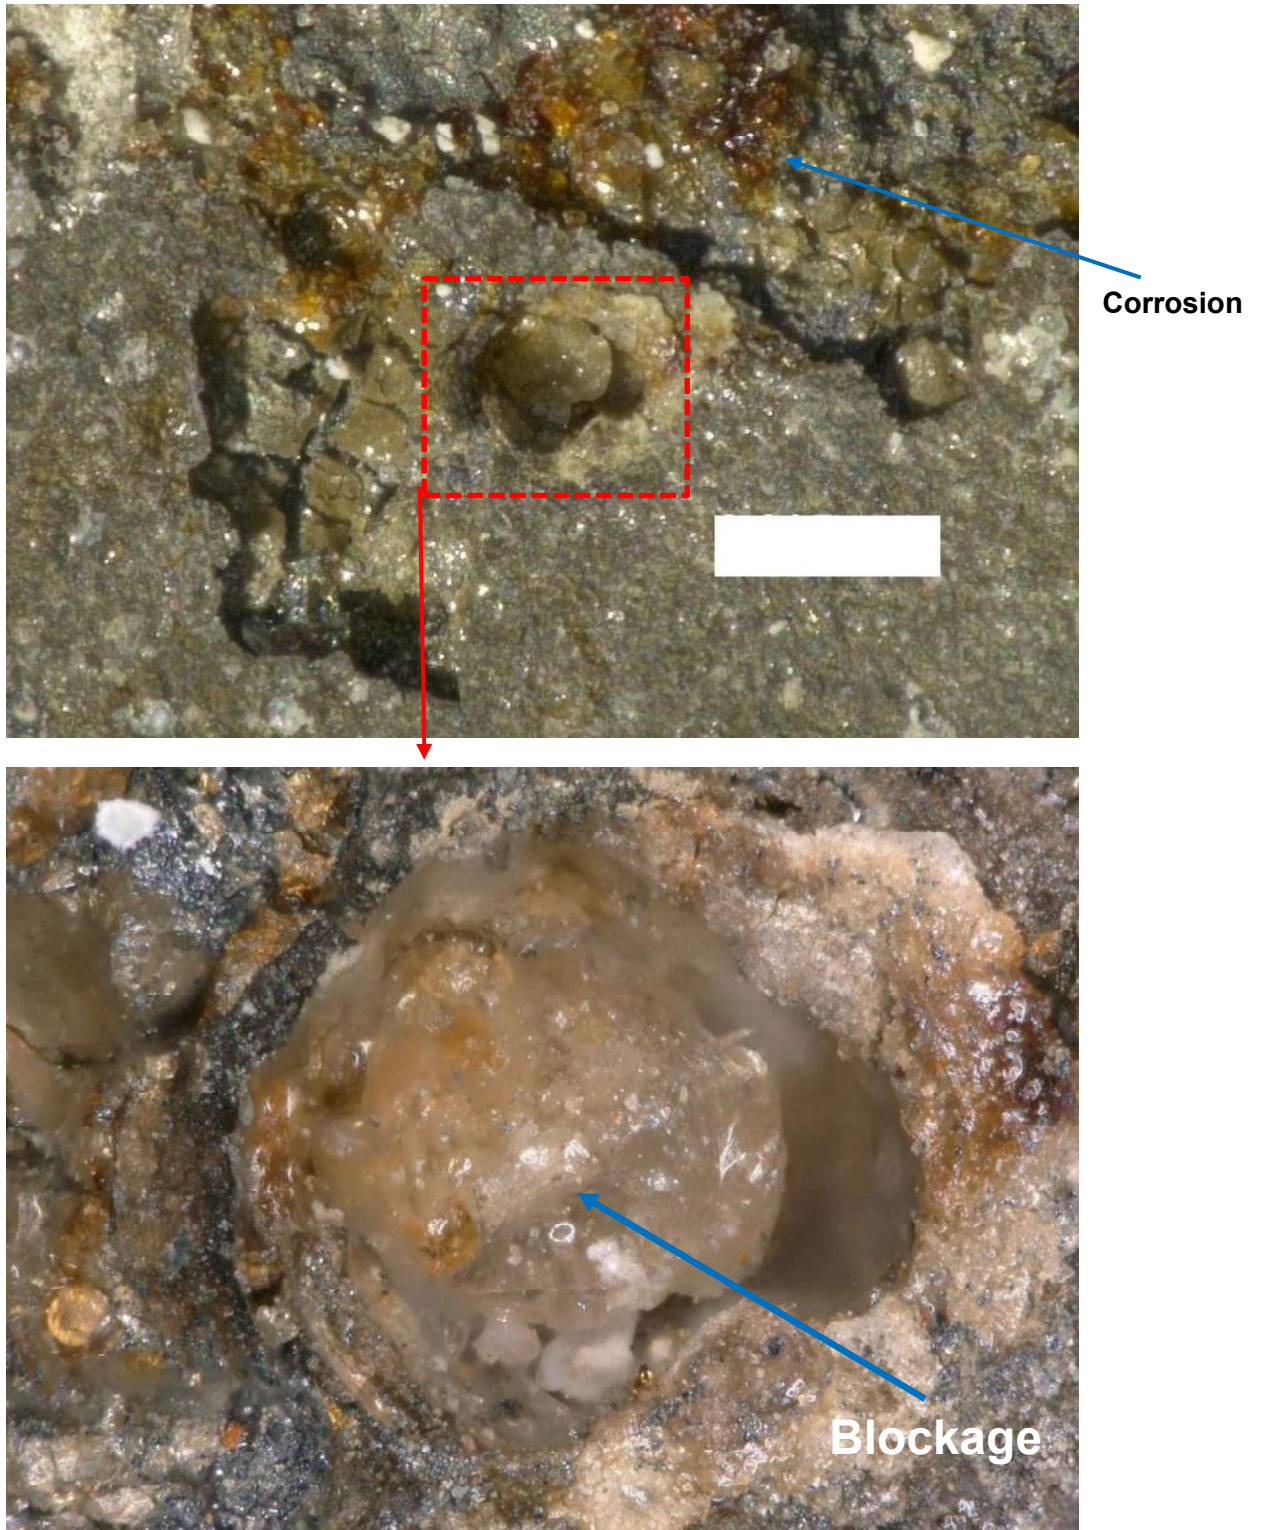
**Figure 69. Detailed views of No. 4 bearing oil jet B on the pinion gear oil nozzle, which exhibited blockage.**

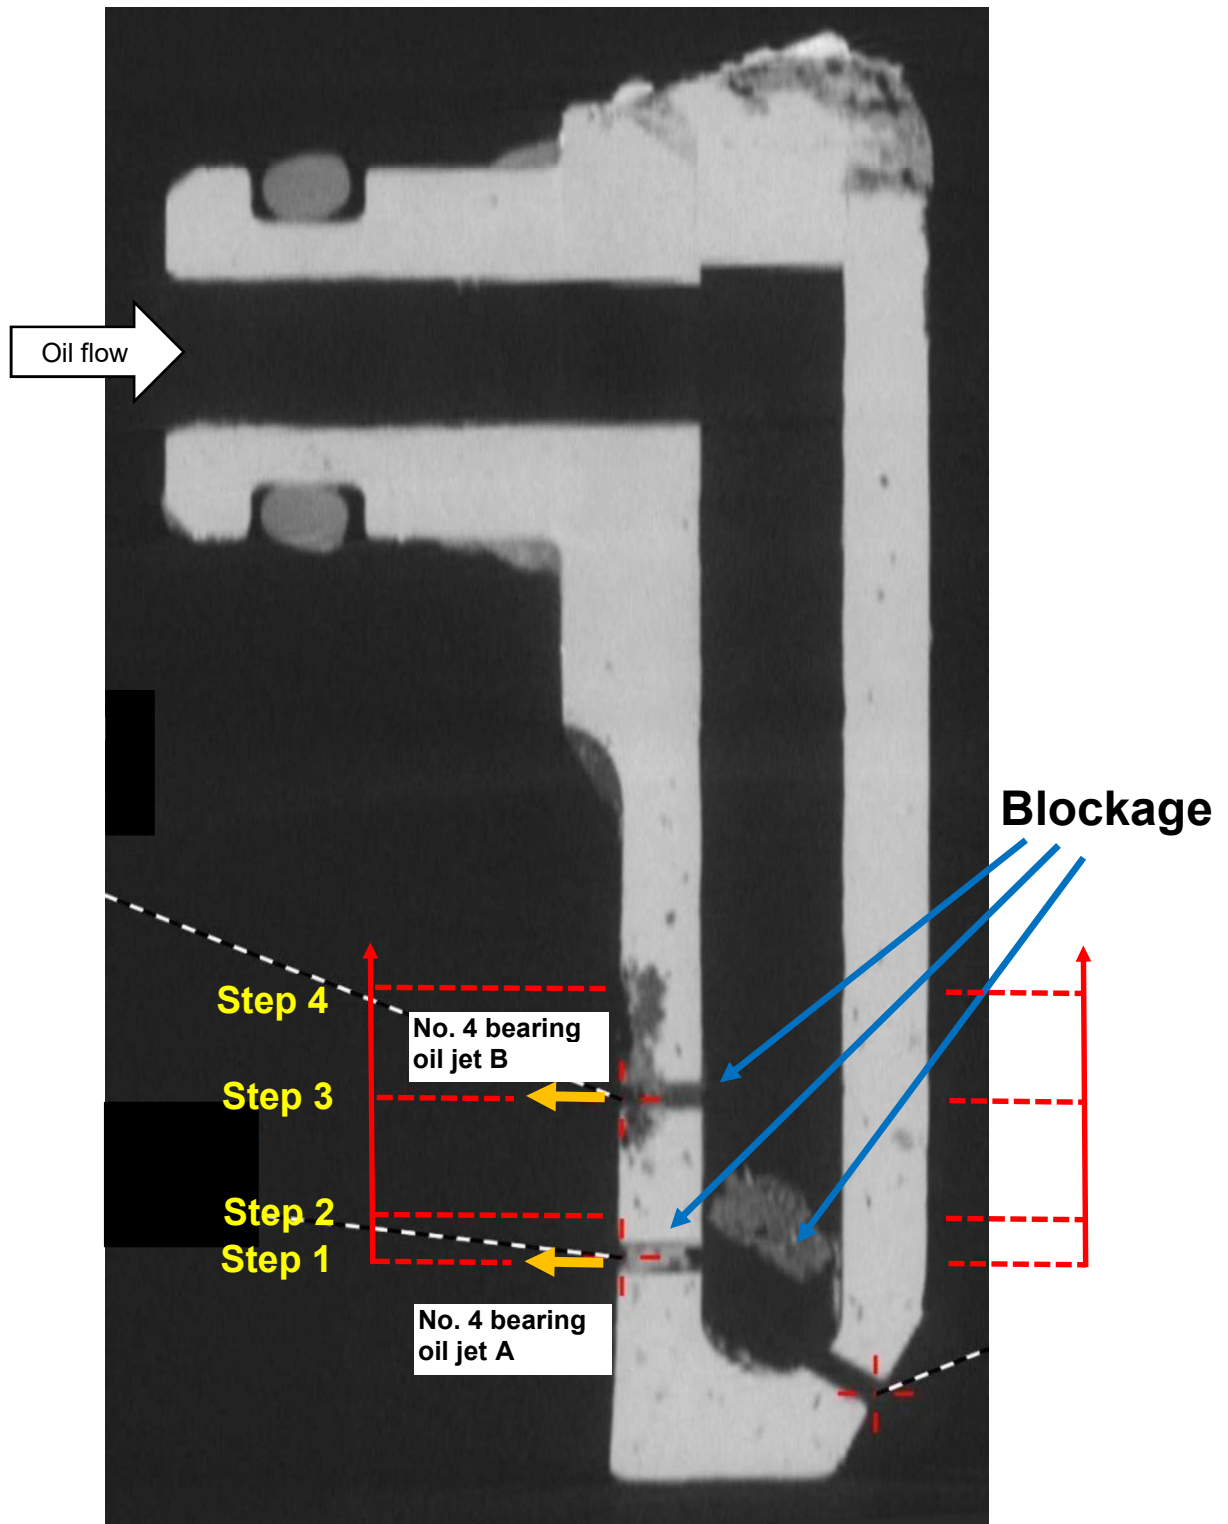
**Figure 70.** Detailed image of a CT cross section through the pinion bearing oil nozzle. The red dashed lines mark the planes of metallographic evaluation (see Figure 71, Figure 72, and Figure 73). Image was provided by an outside test facility.
