| <b>Rolls-Royce</b> | Rolls-Royce Corporation<br>450 S. Meridian Street<br>Indianapolis, Indiana<br>46225-1103, USA | <b>REPORT NO.</b><br>20FAE-014-PR | <b>REV.</b><br>Initial | <b>PAGES</b><br>1 of 135 |
| <b>TITLE</b><br><br><b>METALLURGICAL INVESTIGATION OF A HELICAL POWER TURBINE PINION GEAR, P/N 6893672, INSTALLED IN AN M250-C47B ENGINE, S/N CAE847031, OPERATED BY PANTHER HELICOPTERS</b> | | <b>PREPARED</b><br><br>Signatures on file | | |

| Engine Model: | M250-C47B |
| Evaluations: | Failure Analysis |

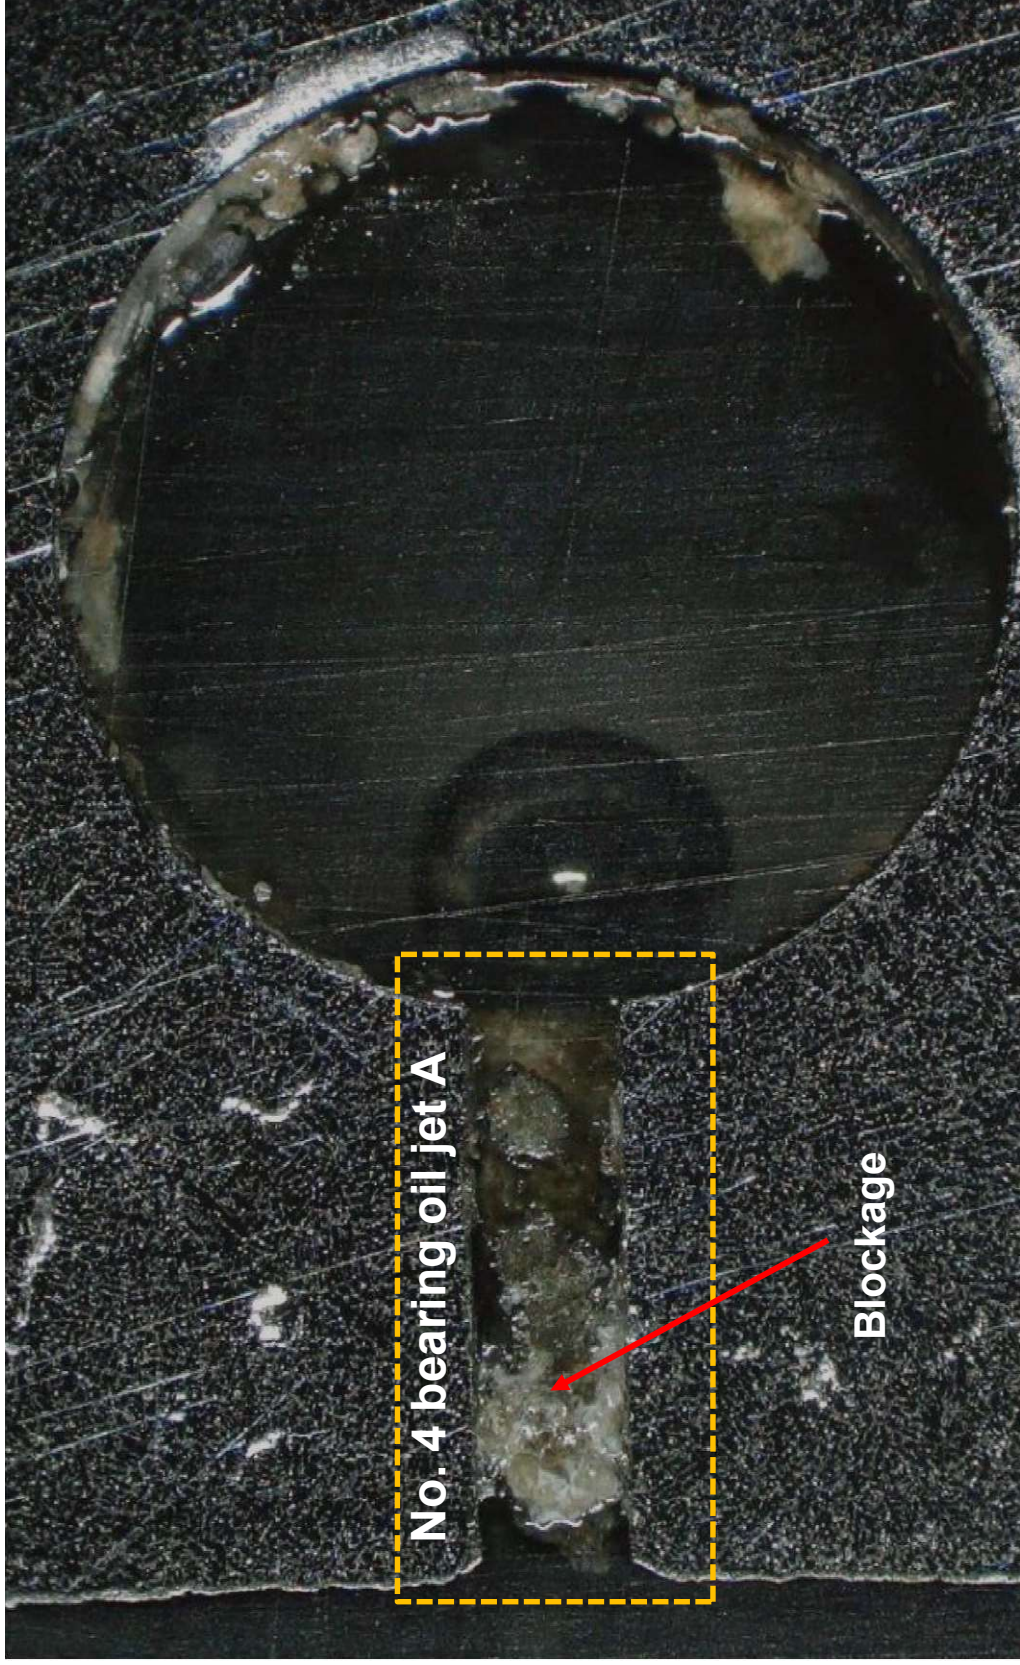
Figure 71. Metallographic section through the oil nozzle (see the red dashed line at step 1 in Figure 70). Orange boxed area is shown in more detail in Figure 108.

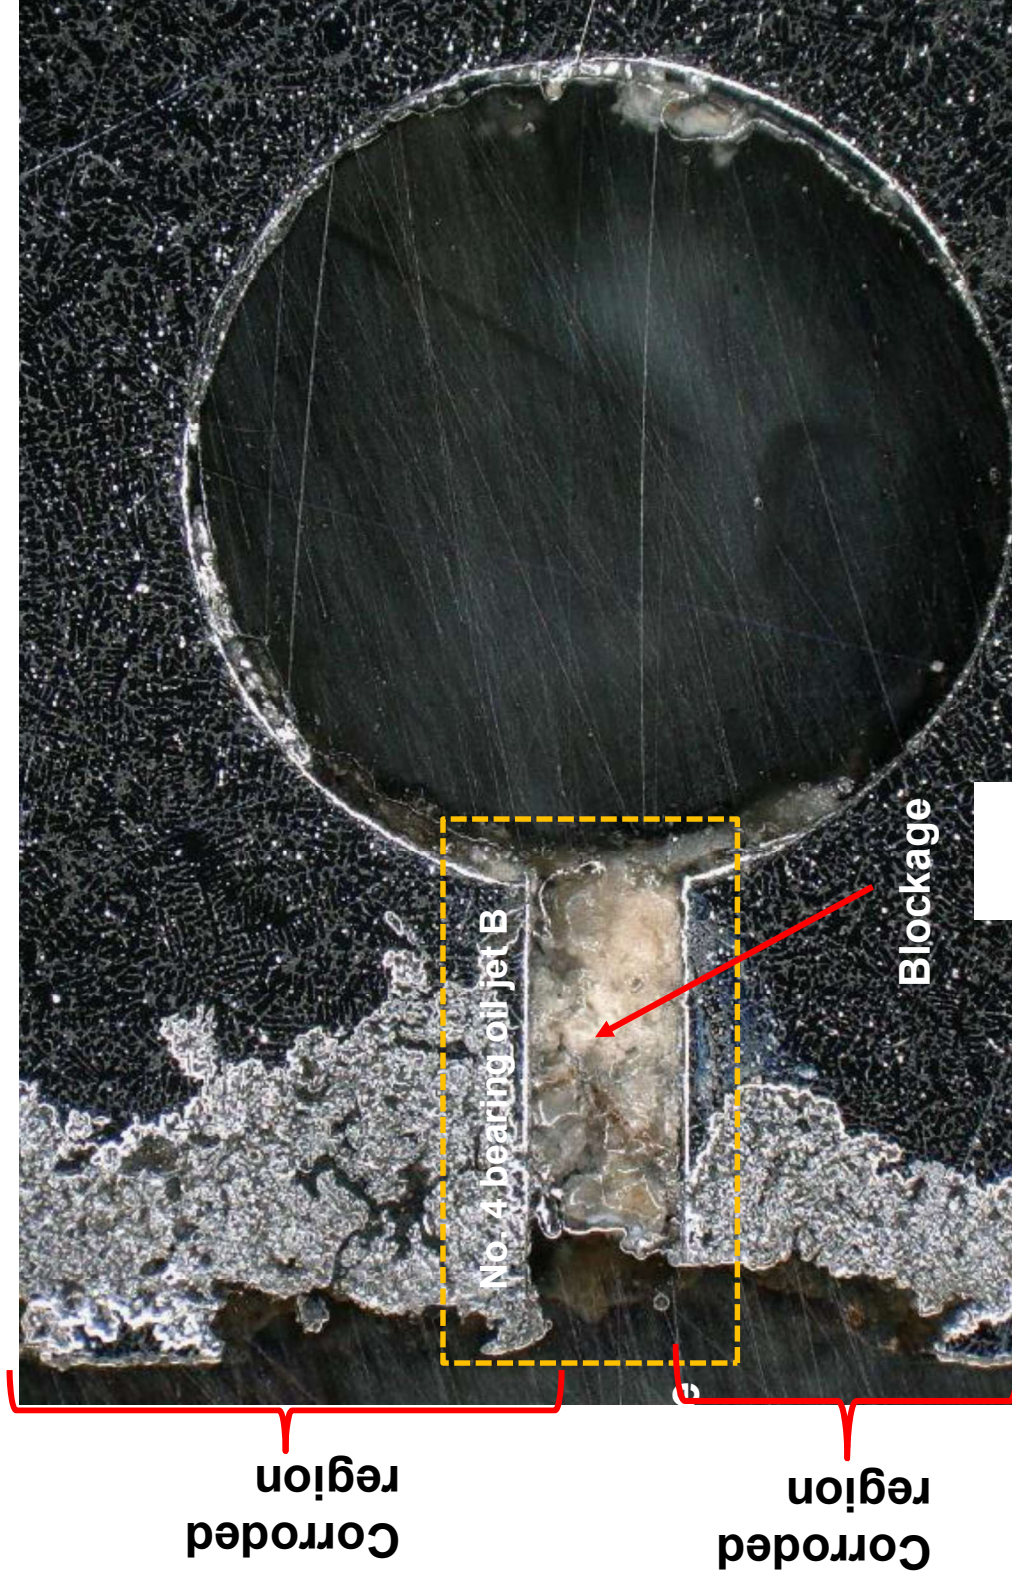
Figure 72. Metallographic section through the oil nozzle (see the red dashed line at step 3 in Figure 70). Orange boxed area is shown in more detail in Figure 114.

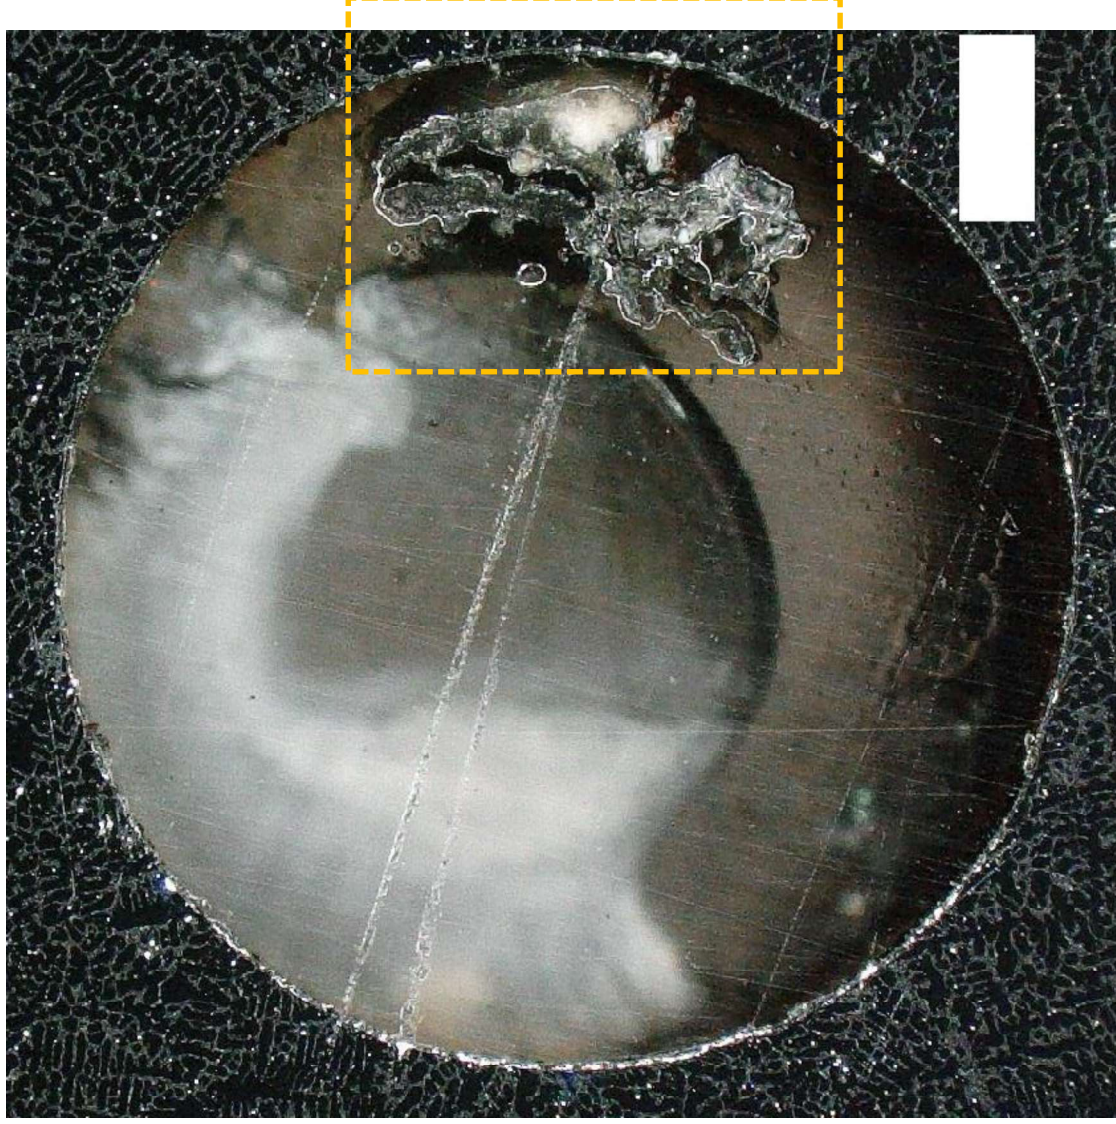
Figure 73. Metallographic section through the oil nozzle (see the red dashed line at step 4 in Figure 70), which exhibited debris. Orange boxed area is shown in more detail in Figure 120.

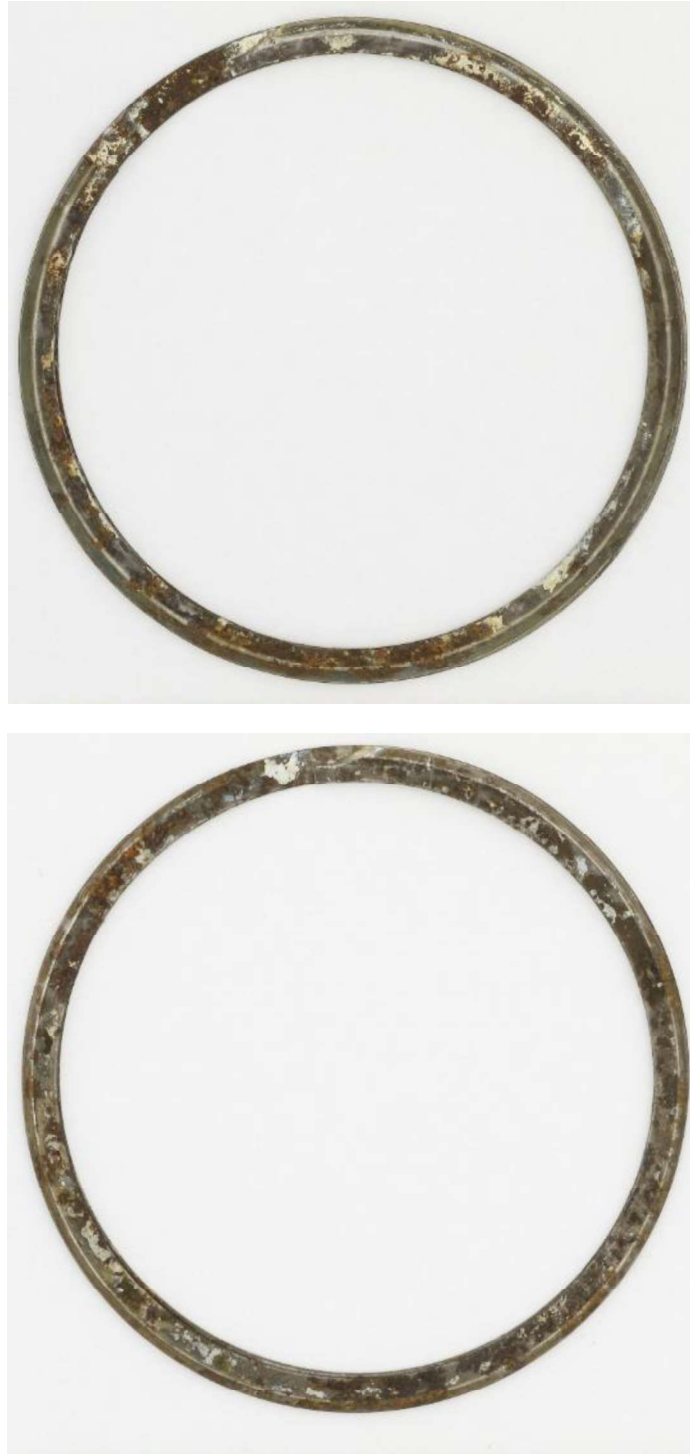
**Figure 74. General condition of the forward (top) and aft (bottom) sides of the No. 4 bearing retaining ring.**

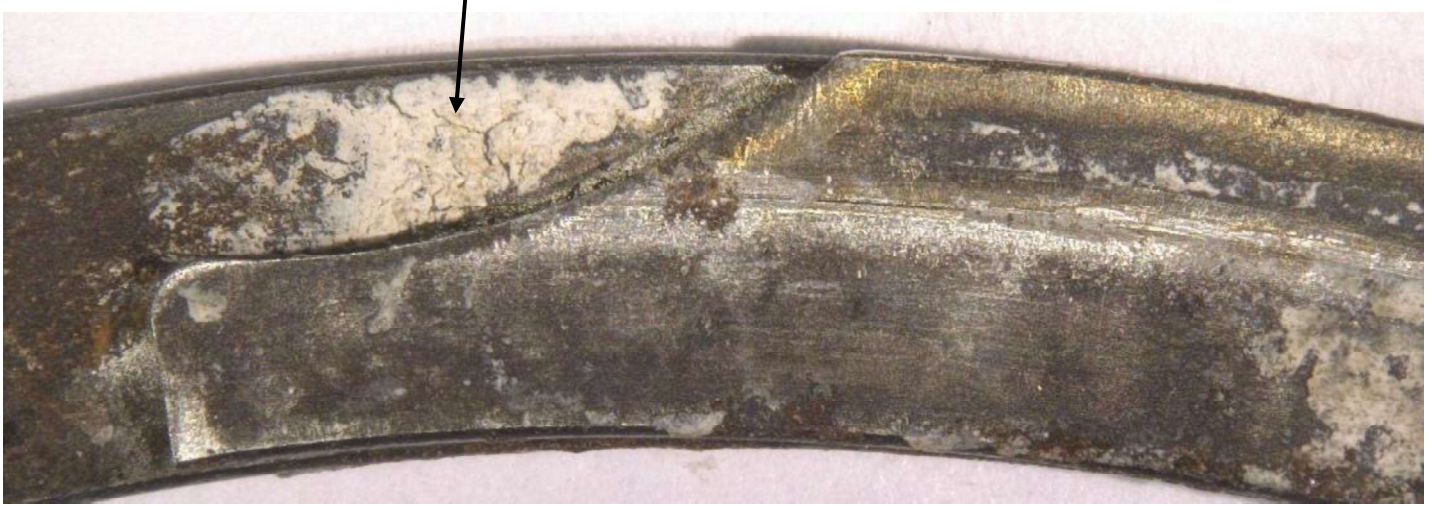
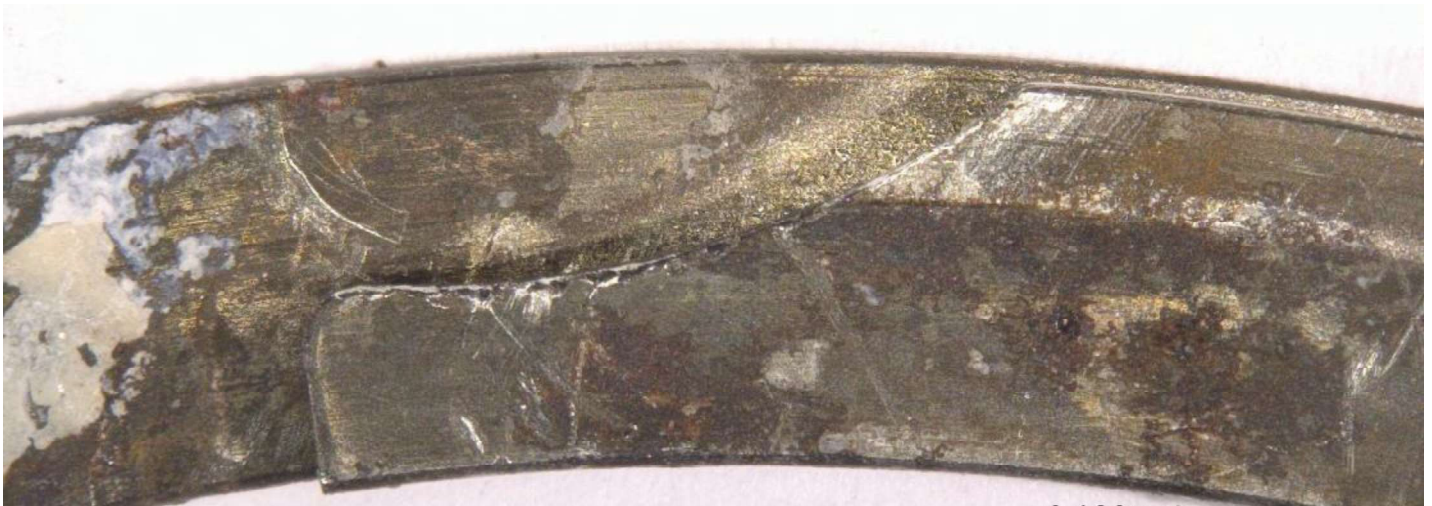
**Figure 75. Detailed views of the tabs on the forward (top) and aft (bottom) sides of the No. 4 bearing retaining ring.**

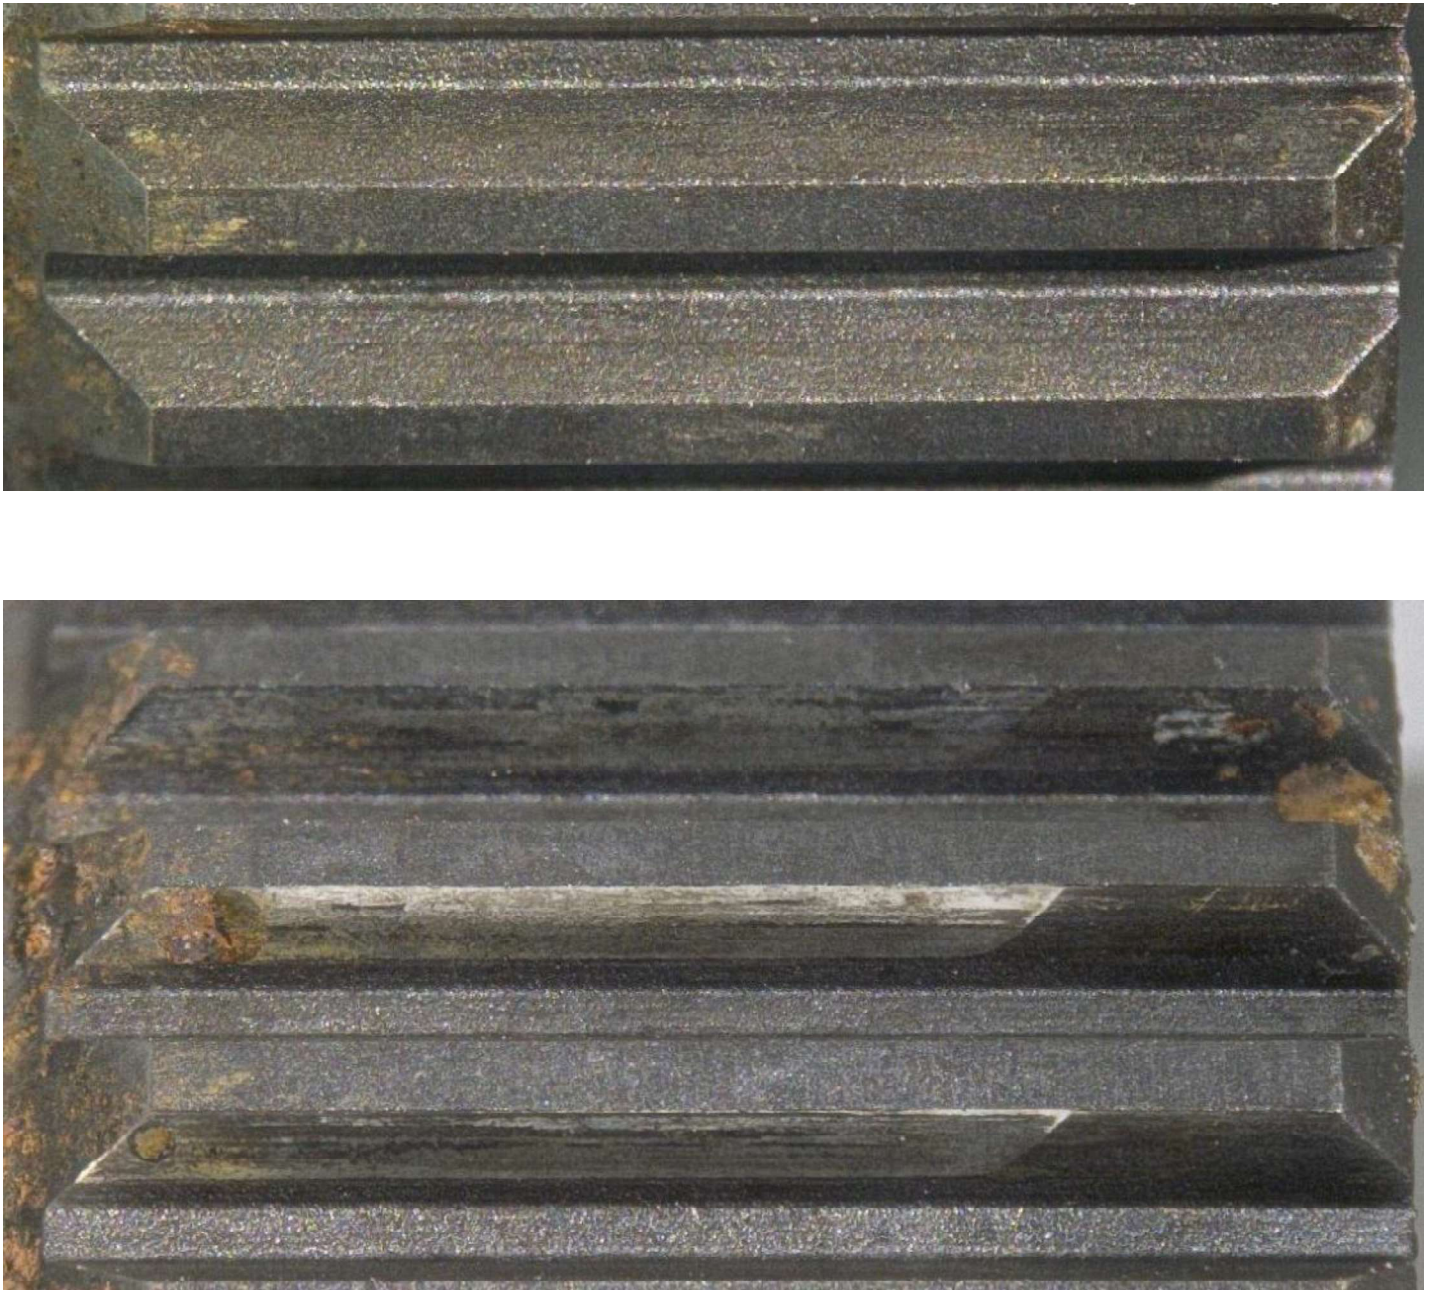
**Figure 78. Detailed views of the loaded (bottom) and unloaded (top) flanks of the aft splines on the turbine shaft to pinion coupling.**

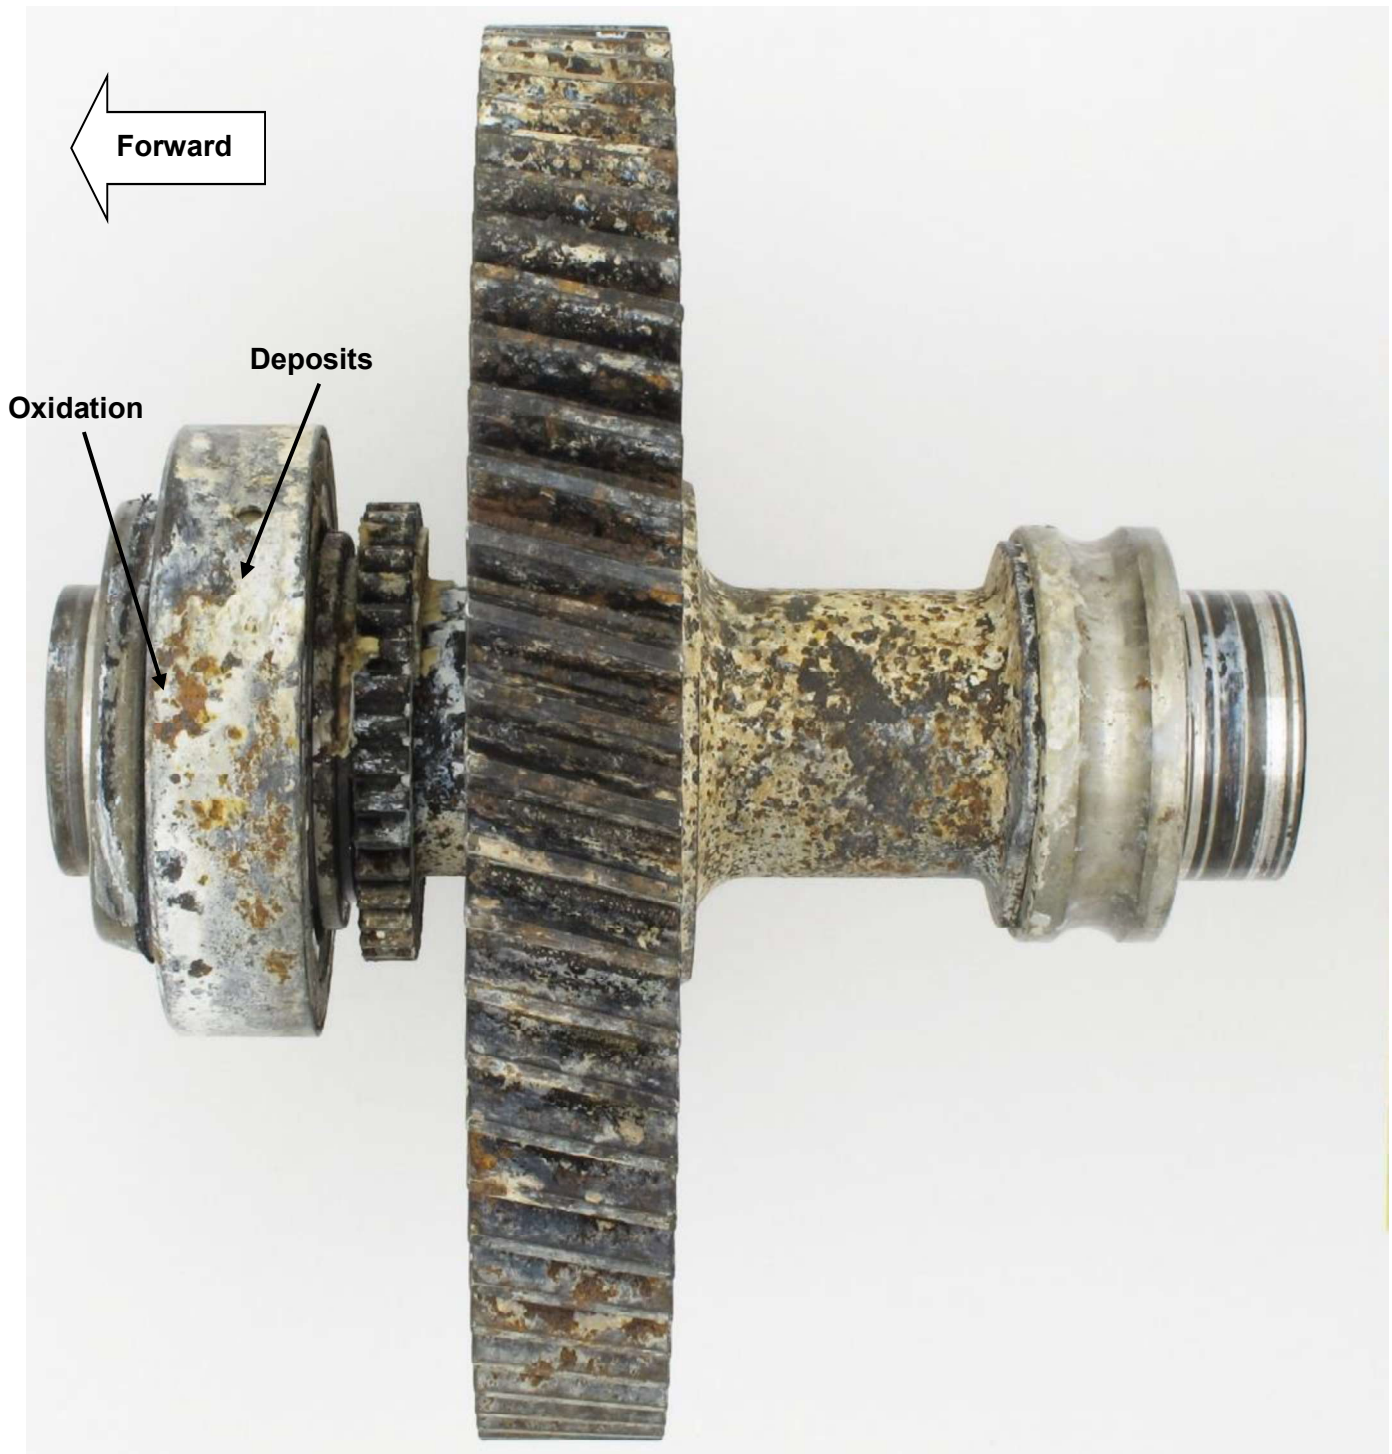
**Figure 79. General condition of the helical power takeoff gearshaft assembly after cleaning.**

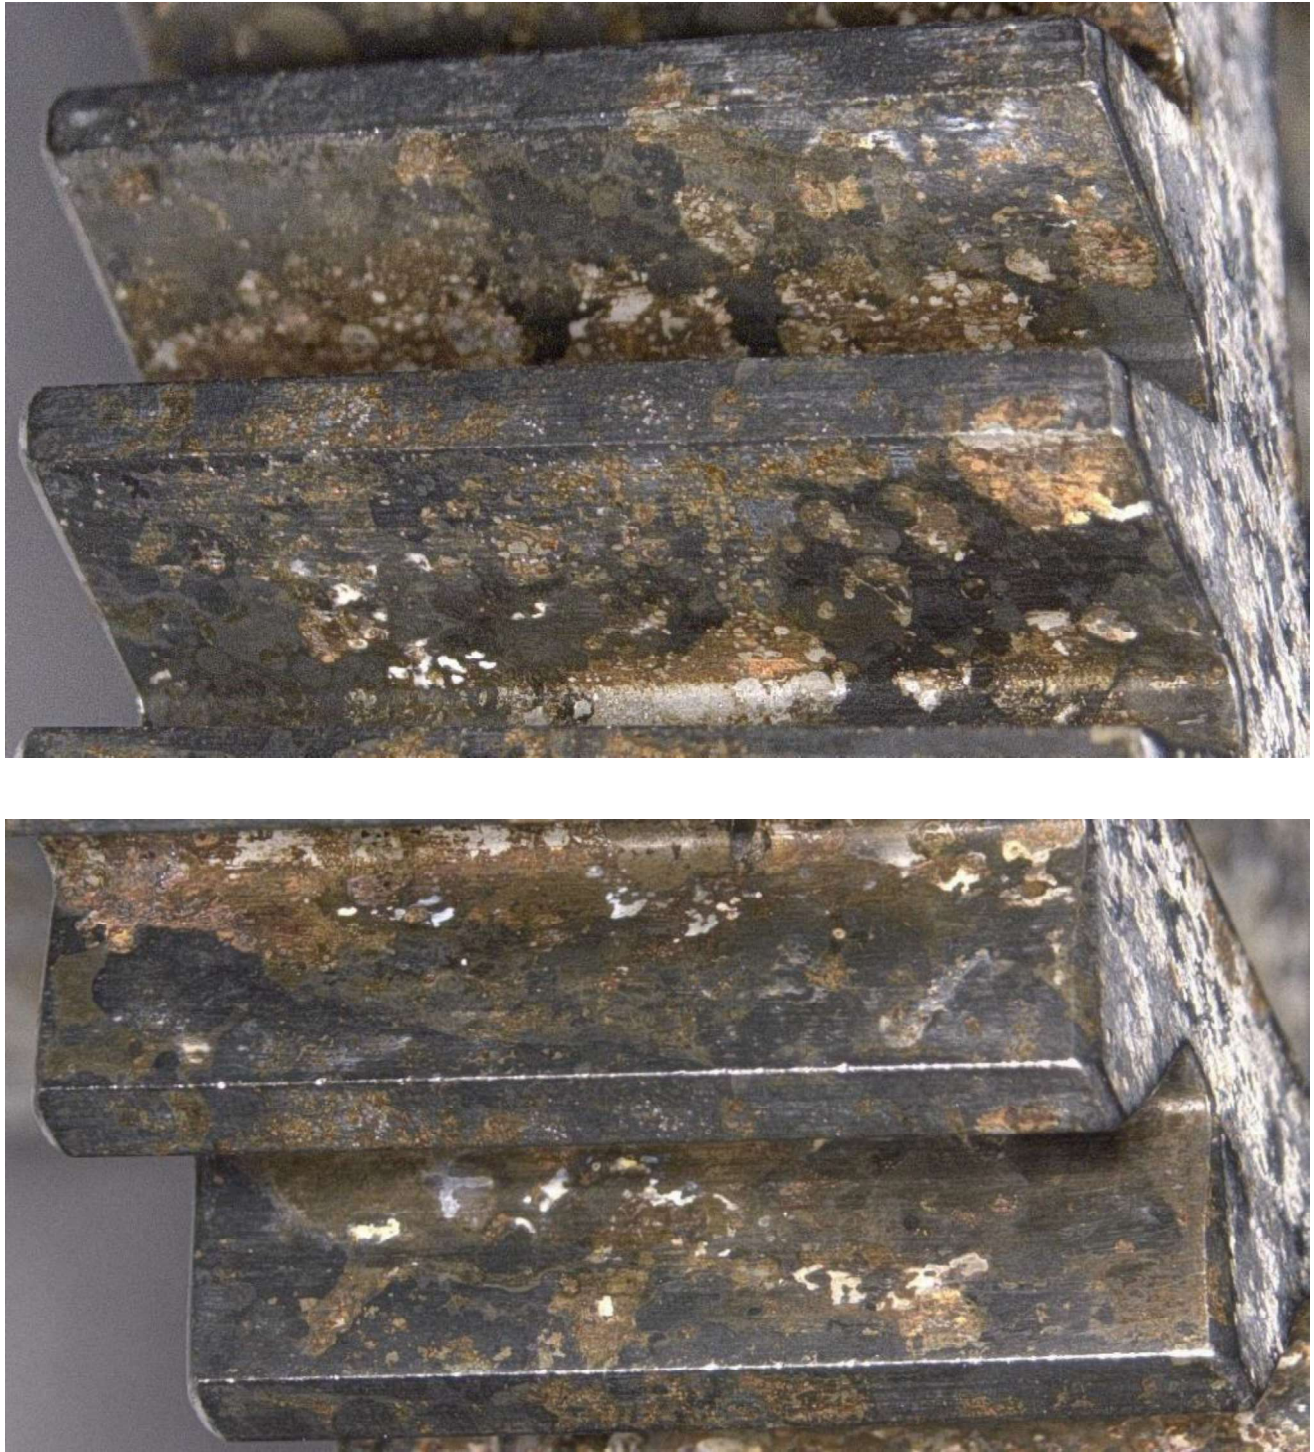
**Figure 80. Detailed views of the driven (top) and coast (bottom) flanks of the larger diameter gear teeth on the helical power takeoff gearshaft.**

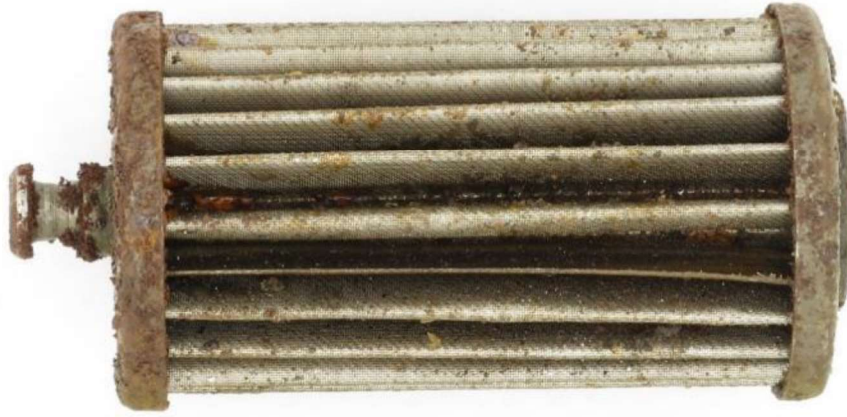
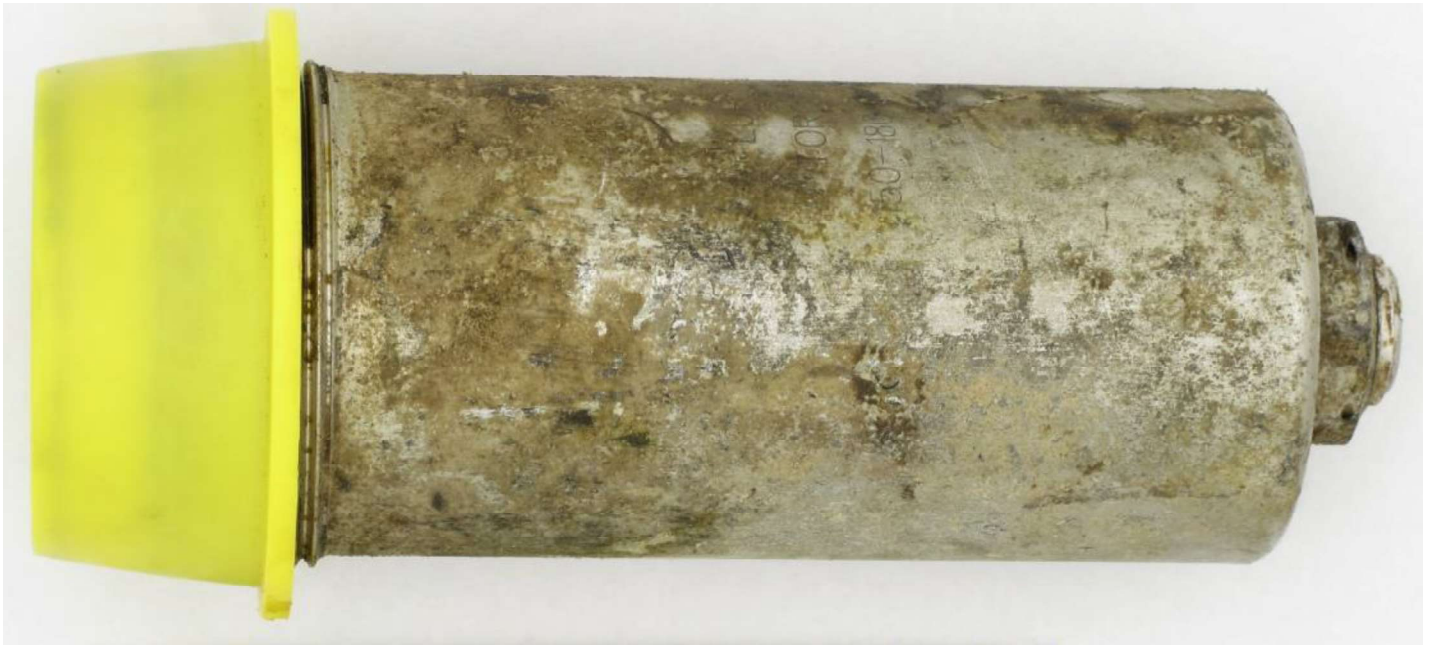
**Figure 81. General condition of the pressure oil filter (top) and CEFA oil filter bowl (bottom).**

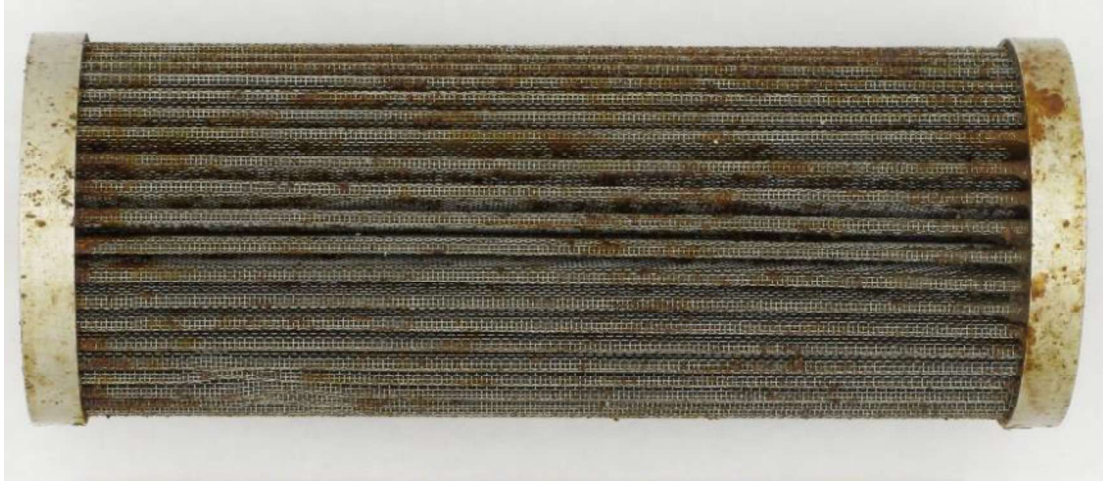
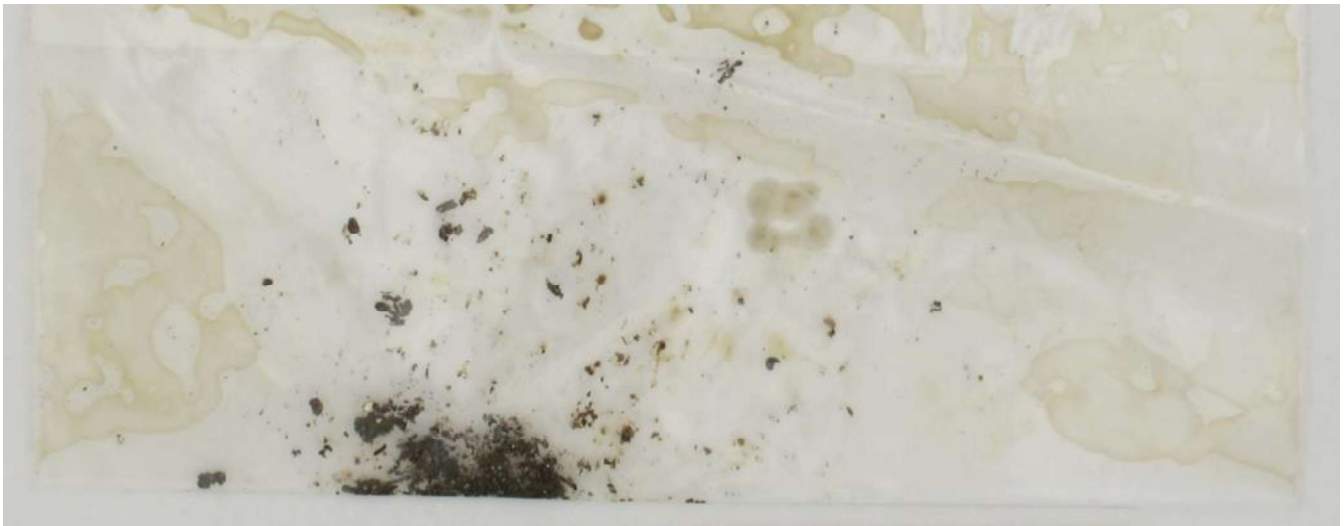
**Figure 82. General condition of the CEFA oil filter (top) and debris collected from CEFA oil filter prior to arrival to the laboratory (bottom).**

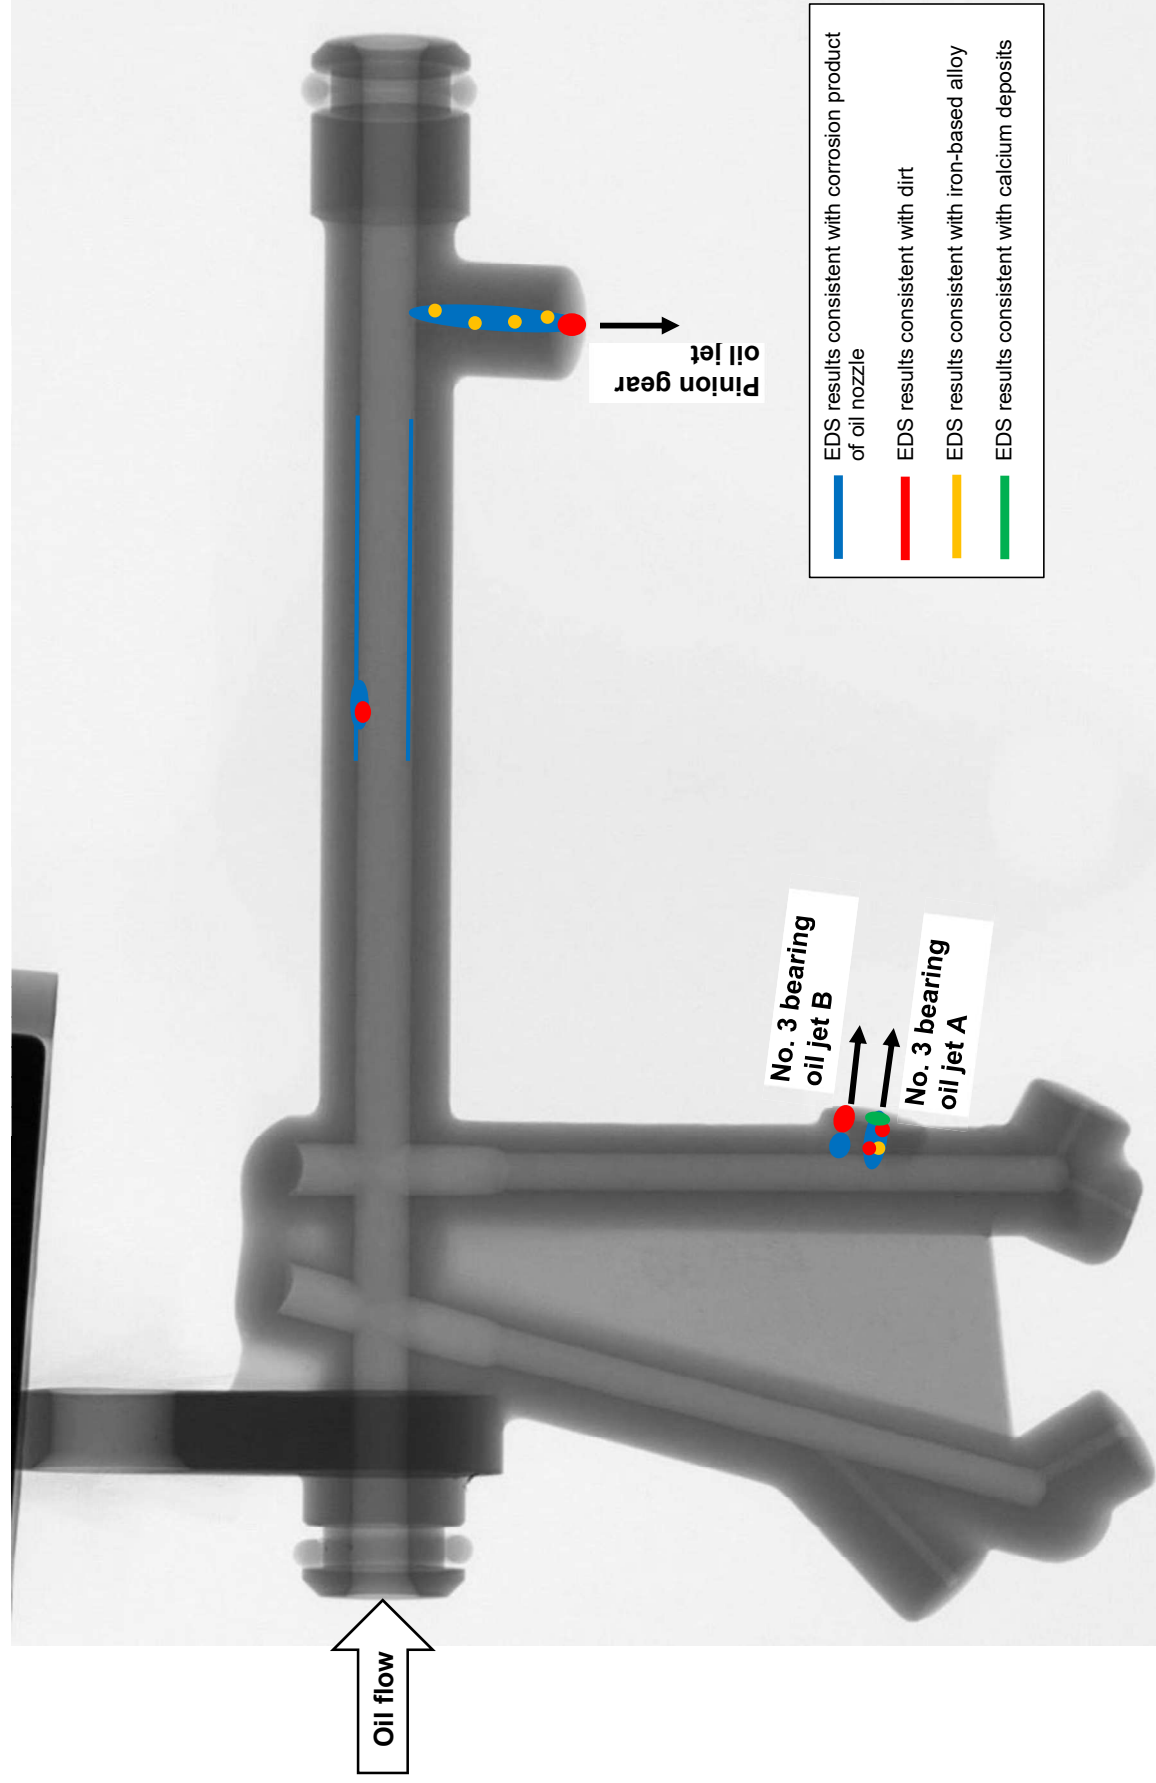
Figure 83. Color map of the EDS results for the blockage material in the oil jets and main passageway of the oil delivery tube.

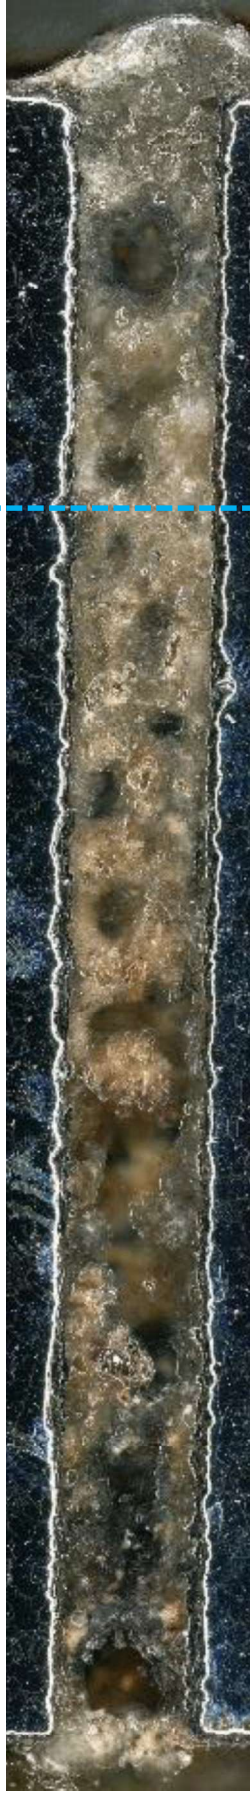
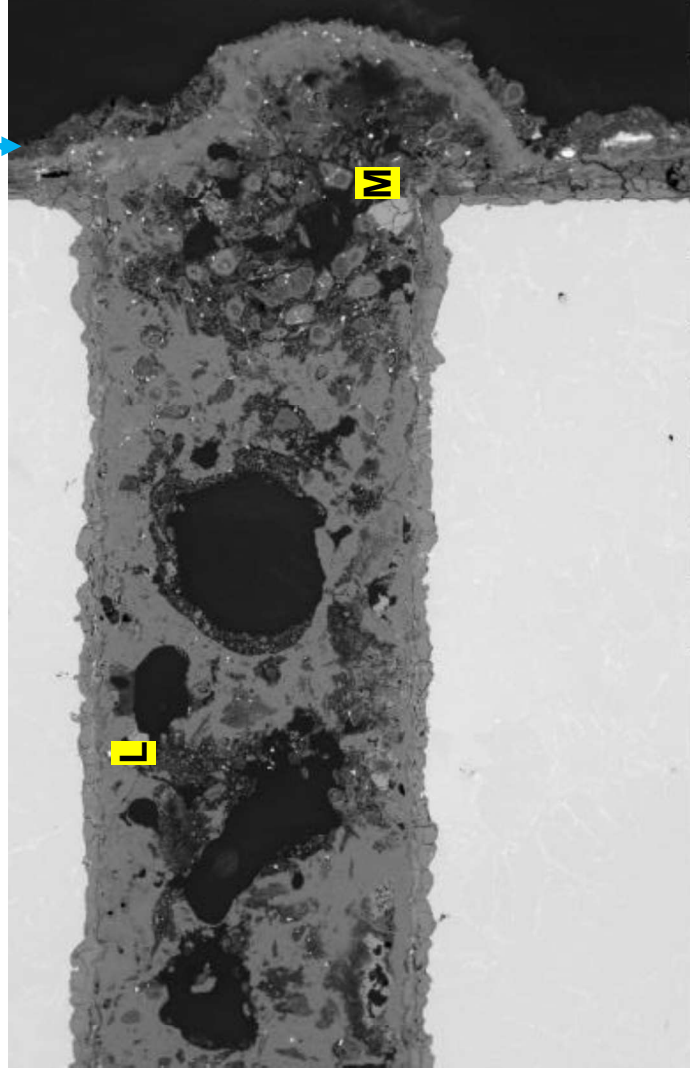
Figure 84. Optical (top) and backscattered electron SEM (bottom) images of the metallographic section through pinion gear oil jet of the oil delivery tube (see orange boxed area in Figure 61), which exhibited blockage. Locations L and M are shown in more detail in the following figure.

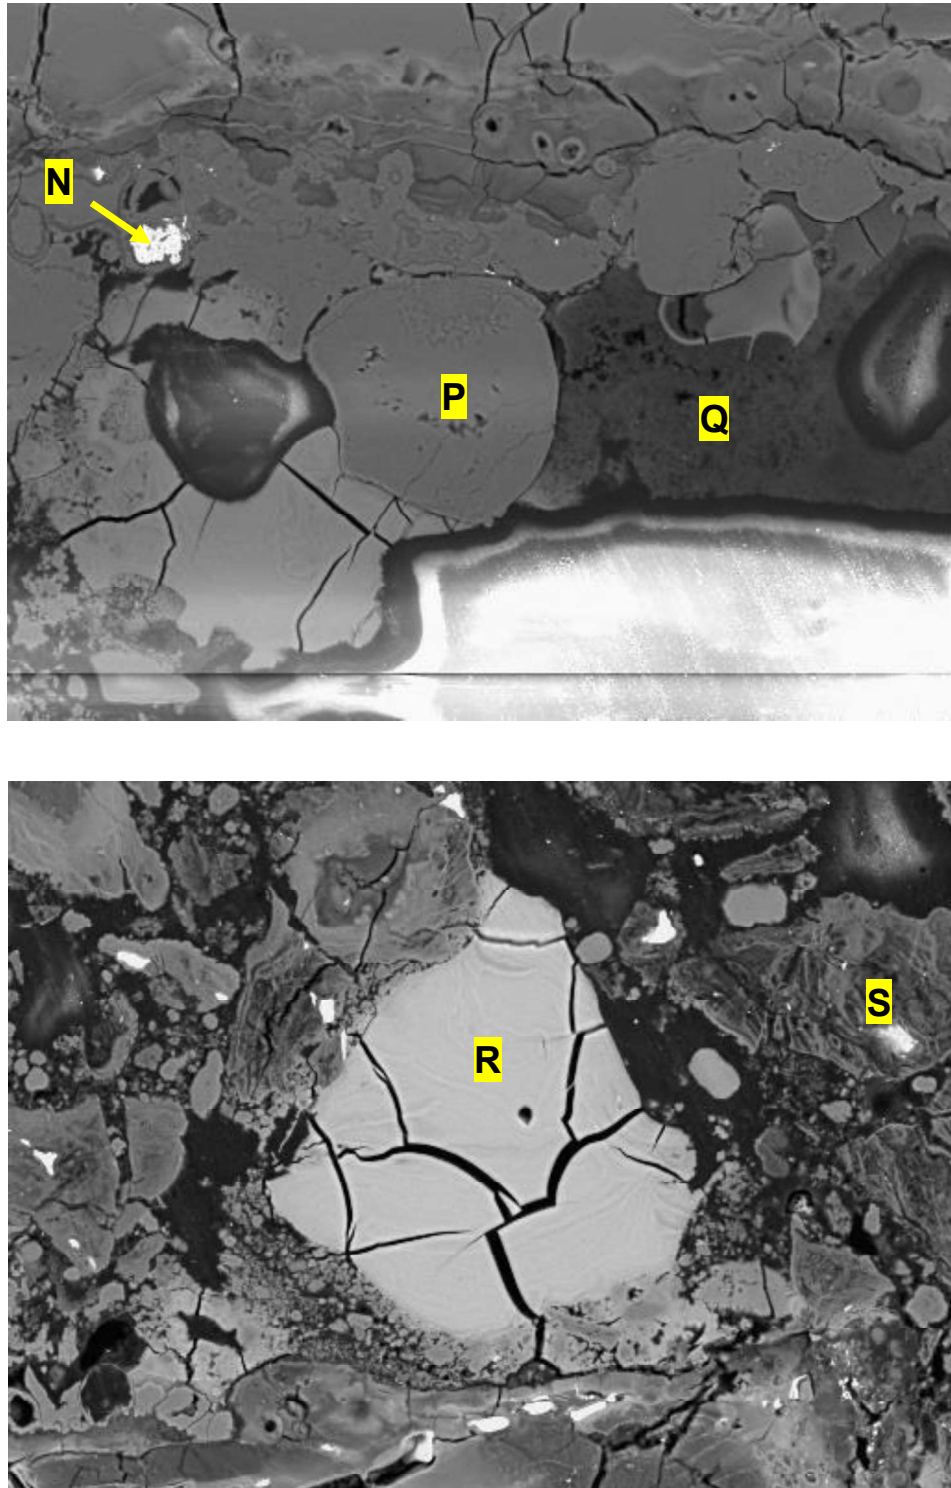
**Figure 85. Backscattered electron SEM images of the blockage in pinion gear oil jet of the oil delivery tube. Top and bottom images are detailed views of locations L and M in previous figure, respectively. Semi-quantitative EDS results for blockage material at locations N through S are shown in more detail in Figure 86 through Figure 88.**

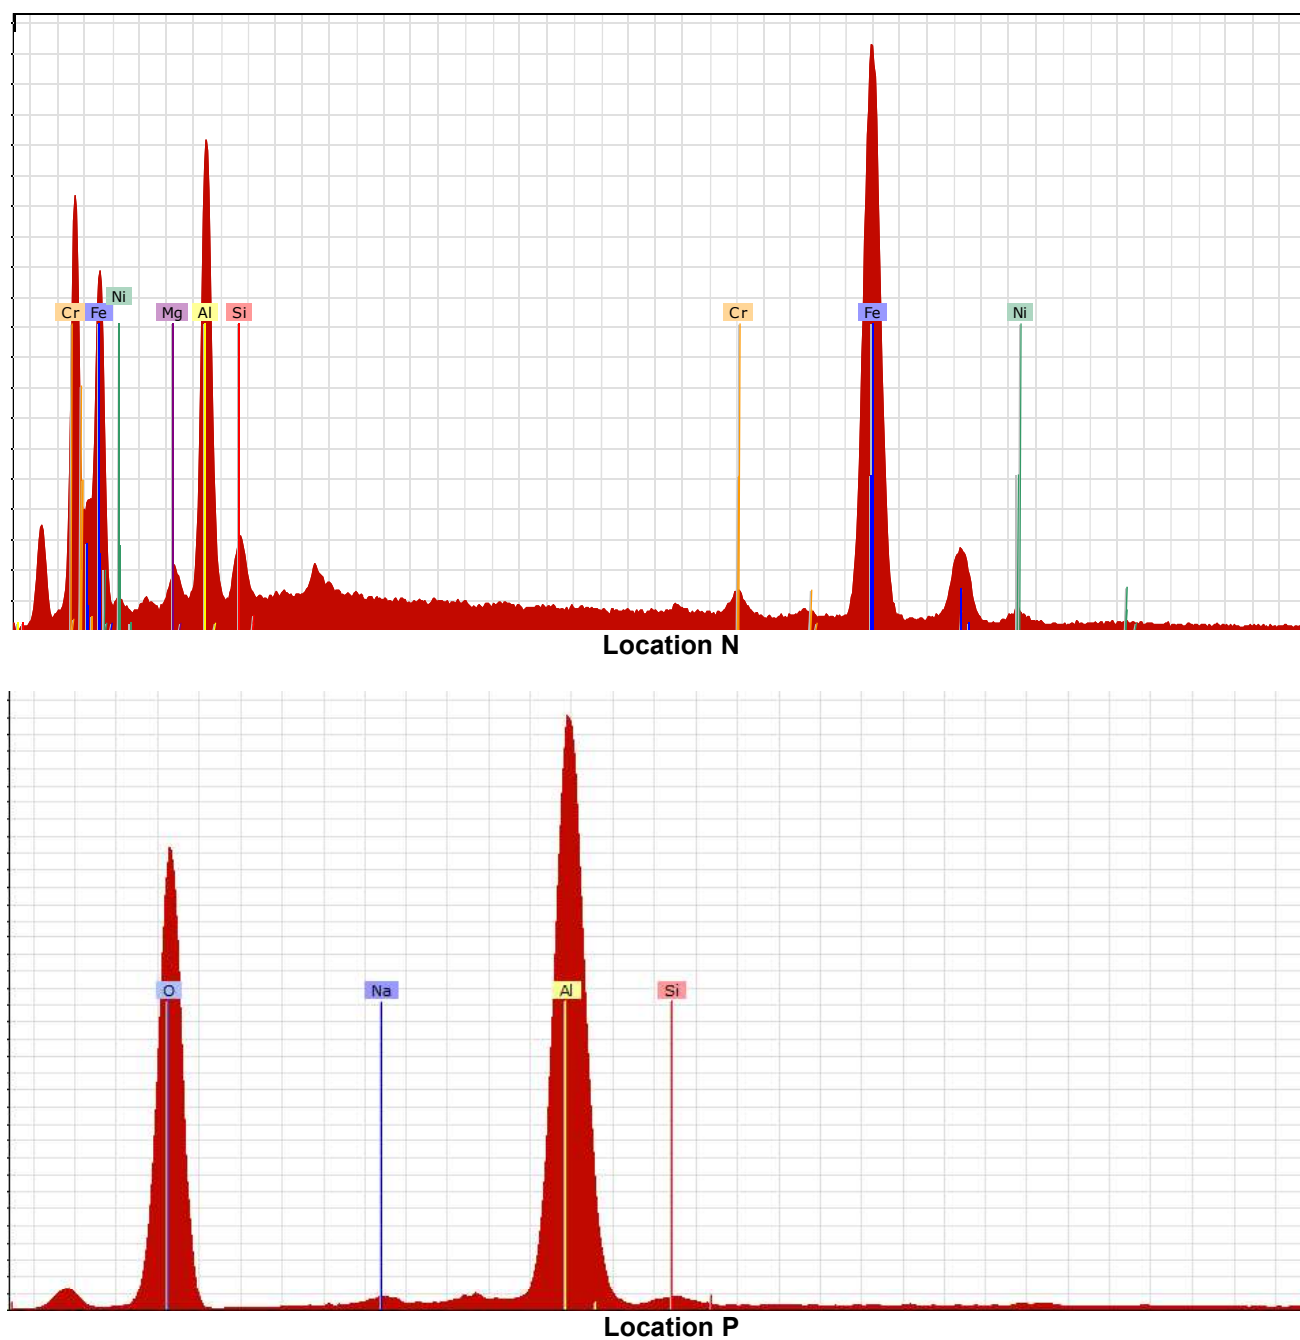
**Figure 86.** Semi-quantitative EDS results for blockage material at locations N and P in pinion gear oil jet of the oil delivery tube (see Figure 85). Location N exhibited concentrations of iron, aluminum, nickel, chromium, silicon, and magnesium. Location P exhibited concentrations of aluminum, oxygen, sodium, and silicon.
